Visual Site Inspection Report

Project Name	H-600 Pipeline Spread G	AFE	124300137	Spread	H-600 Pipeline Spread G
Contractor	Precision			Report #	32221
Inspector	Clint Sears			Date/Time	12/13/2021 1:20 PM
Permit #	TBD	Inspection Type	VA SWPP	Station Begin	10929+80
State	VA	Inspection Area	Full	Station End	11023+80
County	Giles	Ground	Wet	Temperature (°F)	55.00
Municipality	N/A	Weather	Sunny	Rain Gauge (in)	0.30
				Rain Accumulation Time (days)	1.00

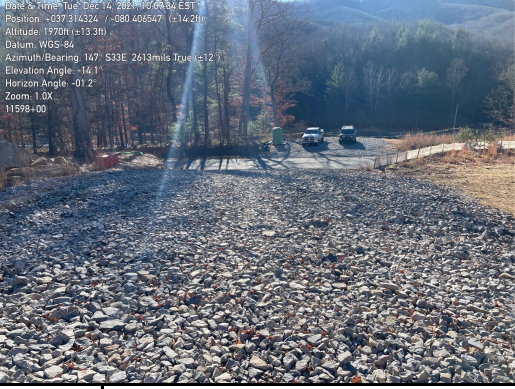
<p>Date & Time: Tue, Dec 14, 2021, 10:06:04 EST Position: +037.314224 / -080.406547 (±14.2ft) Altitude: 1970ft (±13.3ft) Datum: WGS-84 Azimuth/Bearing: 147.533E 2613mils True (±12.1) Elevation Angle: -14.1 Horizon Angle: -01.2 Zoom: 1.0x 11598+00</p>			
GPS Location	See photo	GPS Location	See photo		
Field Station#	11589+16	Field Station#	11598+00		
Pic 5 Desc.	P1 damaged	Pic 6 Desc.	RCE functional

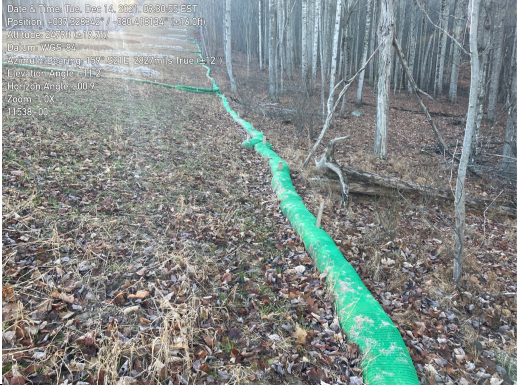
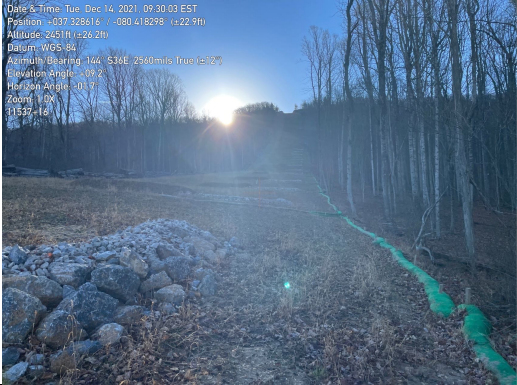
GPS Location	See photo	GPS Location	See photo		
Field Station#	11538+00	Field Station#	11537+16		
Pic 7 Desc.	CFS perimeter controls functional	Pic 8 Desc.	Permanent water bars in place

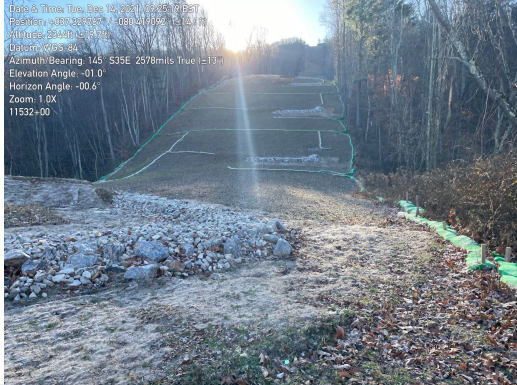
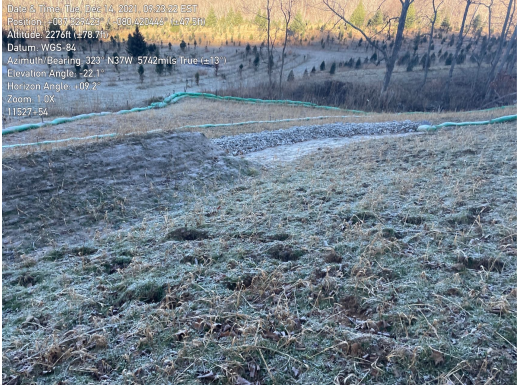
GPS Location	See photo	GPS Location	See photo		
Field Station#	11532+00	Field Station#	11527+54		
Pic 9 Desc.	CFS perimeter controls functional	Pic 10 Desc.	Erosion control blanket in place

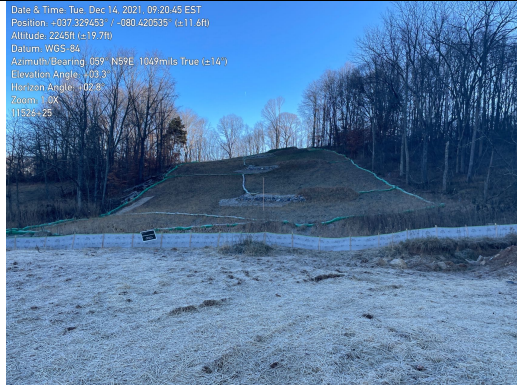
<p>Insert image here</p>	
GPS Location	See photo	GPS Location			
Field Station#	11526+25	Field Station#			
Pic 11 Desc.	P1 in place	Pic 12 Desc.

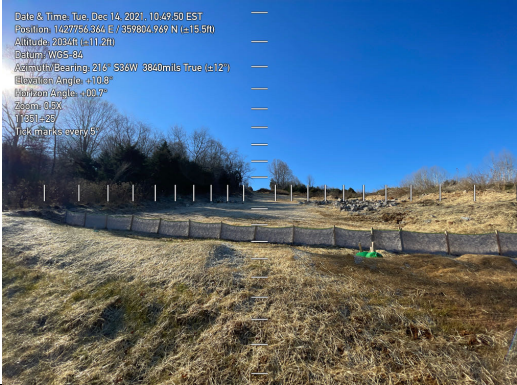
GPS Location	7	GPS Location	8		
Field Station#	11351+25	Field Station#	11352+97		
Pic 7 Desc.	Section of RoW showing conditions and controls.		Pic 8 Desc.	S-NN11 and controls.	
Insert image here		Insert image here			
GPS Location		GPS Location			
Field Station#		Field Station#			
Pic 9 Desc.		Pic 10 Desc.			
Insert image here		Insert image here			
GPS Location		GPS Location			
Field Station#		Field Station#			
Pic 11 Desc.		Pic 12 Desc.

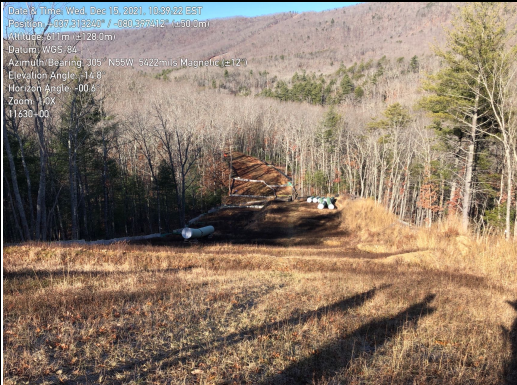
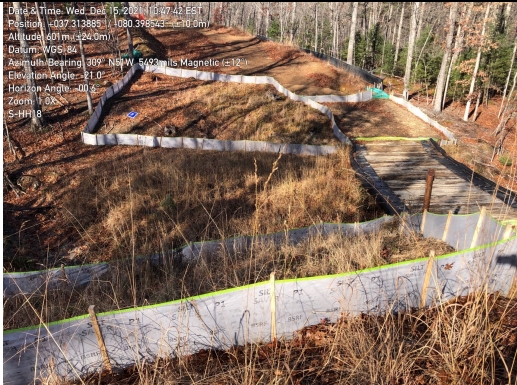
GPS Location	On photo	GPS Location	On photo		
Field Station#	11630+00	Field Station#	11626+04		
Pic 7 Desc.	ROW stable. Slope breakers functional.	Pic 8 Desc.	The S-HH18 crossing is stable.

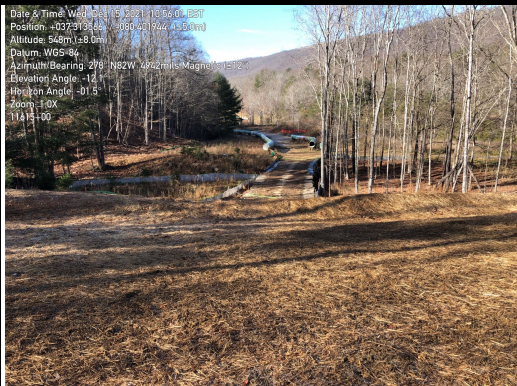
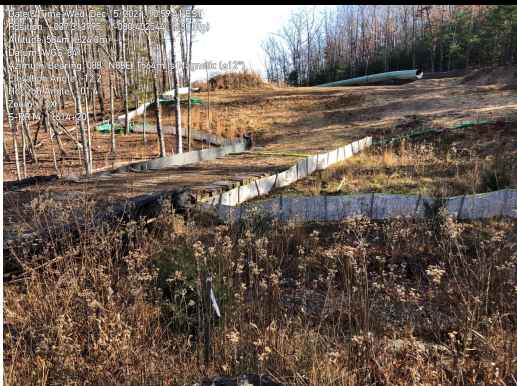
GPS Location	On photo	GPS Location	On photo		
Field Station#	11615+00	Field Station#	11614+20		
Pic 9 Desc.	Slope breakers functional. ROW stable.	Pic 10 Desc.	The S-RR14 crossing is stable.

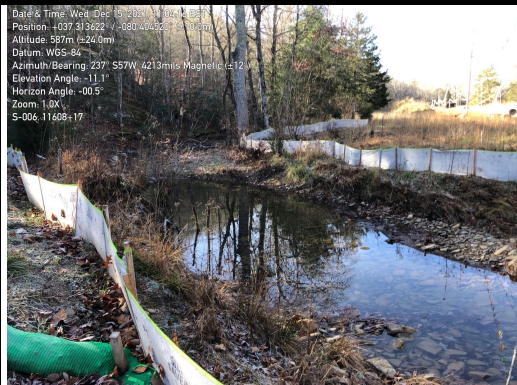
<p>Insert image here</p>			
GPS Location	On photo	GPS Location			
Field Station#	11608+17	Field Station#			
Pic 11 Desc.	No environmental concerns at the S-006 crossing.	Pic 12 Desc.

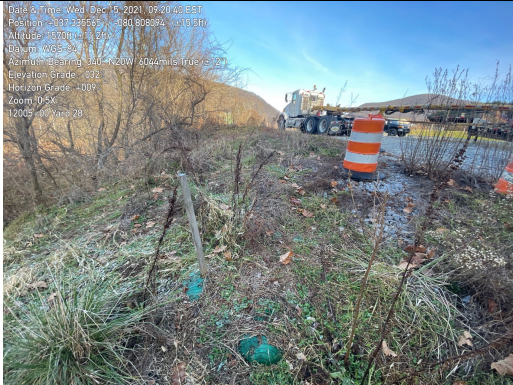
<p>Date & Time: Wed Dec 15 2021 09:20:43 EST Position: +037 333769 / -080 808098 (s:15.4ft) Altitude: 1555ft (s:11.0ft) Datum: WGS 84 Azimuth Bearing: 327° N33W 5813mils True (s:12.1) Elevation Grade: -0.13% Horizon Grade: 1000 Zoom: 0.5X 12005+00 Yard 28</p>			
GPS Location	See Photo	GPS Location	See Photo		
Field Station#	12005+00	Field Station#	12005+00		
Pic 1 Desc.	RCE requiring maintenance	Pic 2 Desc.	Perimeter CFS requiring maintenance/replacement.

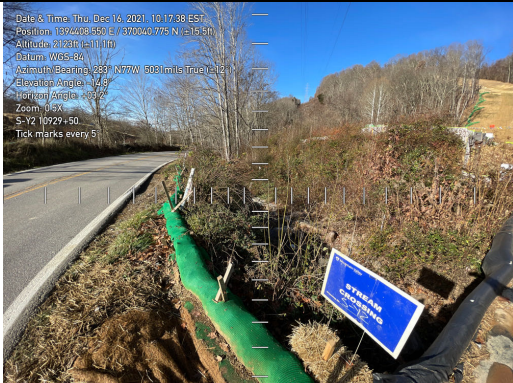
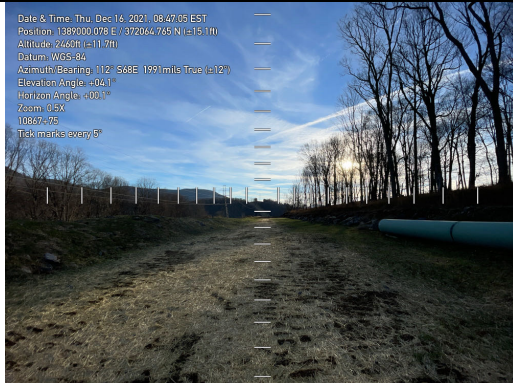
GPS Location 3		GPS Location 4			
Field Station# 10929+50		Field Station# 10867+75			
Pic 3 Desc. S-Y2 and controls.		Pic 4 Desc. Section of RoW showing conditions and controls.

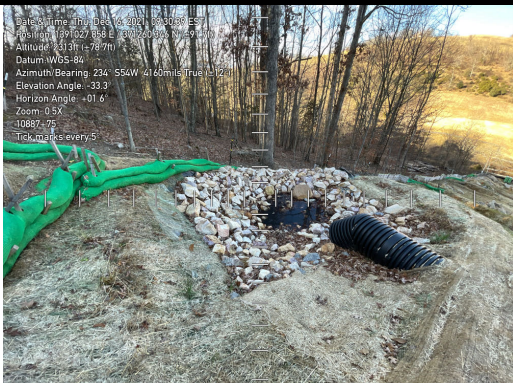
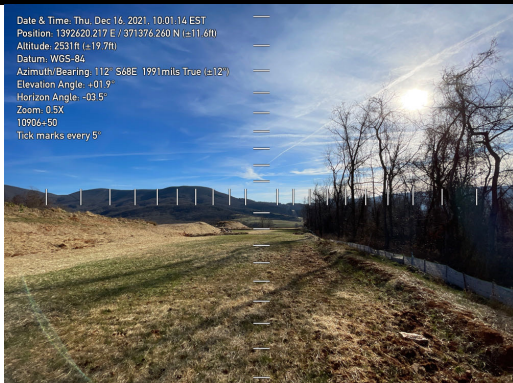
GPS Location 5		GPS Location 6			
Field Station# 10887+75		Field Station# 10906+50			
Pic 5 Desc. Plunge pool functional.		Pic 6 Desc. Section of RoW showing conditions and controls.

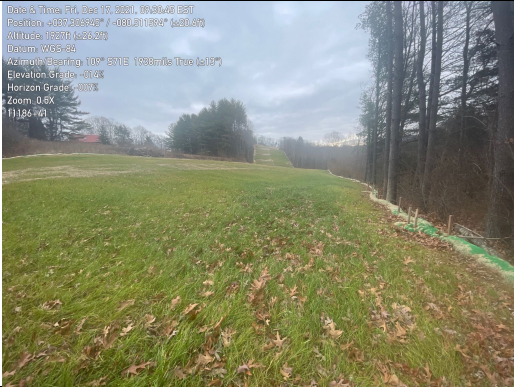
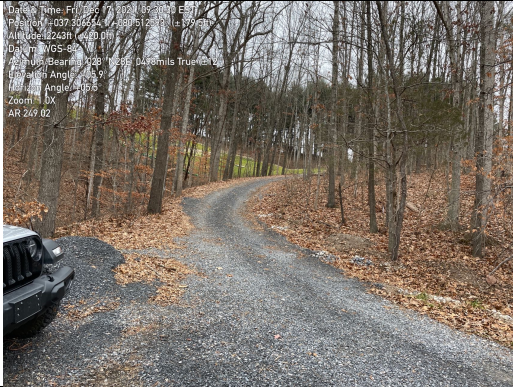
GPS Location		See photo		GPS Location	
Field Station#		11186+42		Field Station#	
Pic 1 Desc.		Permanent stabilization functional		Pic 2 Desc.	
				AR 249.02 in good condition

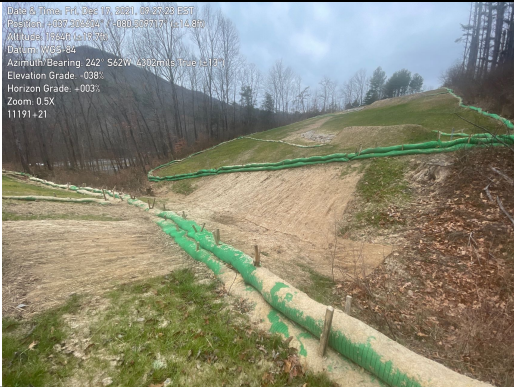
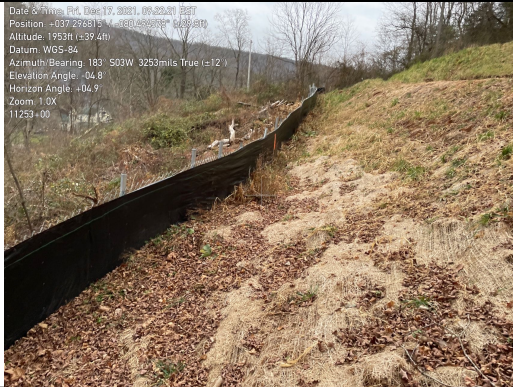
GPS Location		See photo		GPS Location	
Field Station#		11191+21		Field Station#	
Pic 3 Desc.		Clean water drainage feature functional		Pic 4 Desc.	
				SSF functional

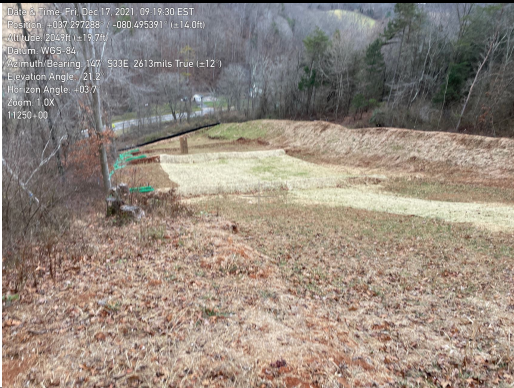
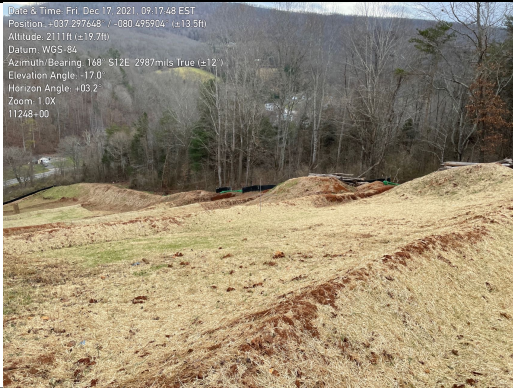
GPS Location		See photo		GPS Location	
Field Station#		11250+00		Field Station#	
Pic 5 Desc.		Erosion control blanket in place		Pic 6 Desc.	
				Water bars & ET functional

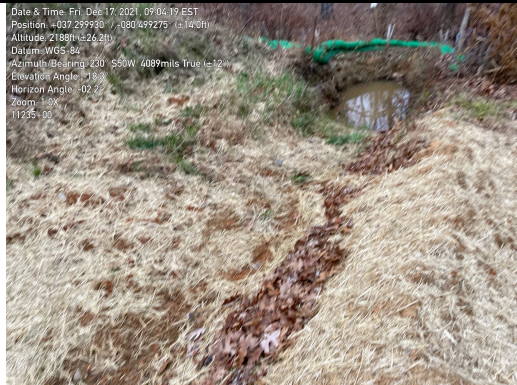
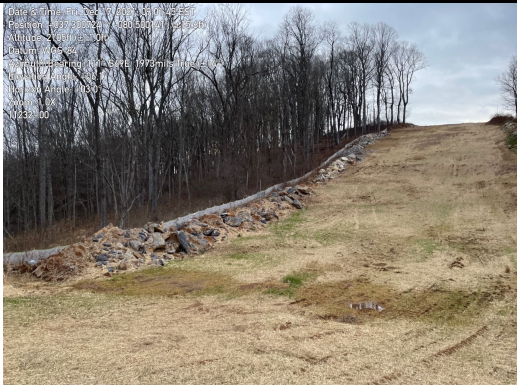
GPS Location	See photo	GPS Location	See photo		
Field Station#	11235+00	Field Station#	11232+00		
Pic 11 Desc.	ET functional	Pic 12 Desc.	P1 in place and functional

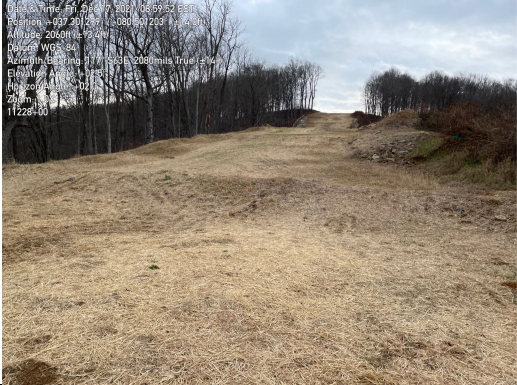
GPS Location	See photo	GPS Location			
Field Station#	11228+00	Field Station#			
Pic 13 Desc.	Temporary stabilization in place	Pic 14 Desc.			
Insert image here		Insert image here			
GPS Location		GPS Location			
Field Station#		Field Station#			
Pic 15 Desc.		Pic 16 Desc.			
Insert image here		Insert image here			
GPS Location		GPS Location			
Field Station#		Field Station#			
Pic 17 Desc.		Pic 18 Desc.
