Visual Site Inspection Report

Project Name	H-600 Pipeline Spread G	AFE	124300137	Spread	H-600 Pipeline Spread G
Contractor	Precision			Report #	31916
Inspector	Eric Hanlon			Date/Time	12/6/2021 7:04 AM
Permit #	TBD	Inspection Type	VA SWPP	Station Begin	10655+00
State	VA	Inspection Area	Full	Station End	10749+92
County	Giles	Ground	Dry	Temperature (°F)	56.00
Municipality	N/A	Weather	Sunny	Rain Gauge (in)	0.00
				Rain Accumulation Time (days)	1.00

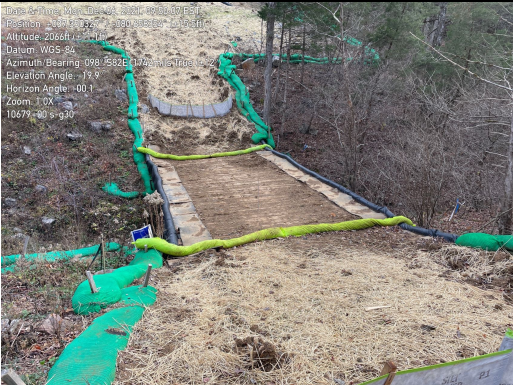
GPS Location	See photo	GPS Location	See photo		
Field Station#	10679+00	Field Station#	10679+00		
Pic 3 Desc.	S-G30 in good condition	Pic 4 Desc.	Equipment bridge functional

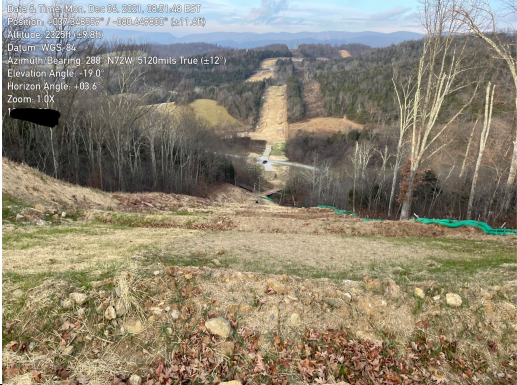
GPS Location	See photo	GPS Location	See photo		
Field Station#	10708+00	Field Station#	10708+10		
Pic 13 Desc.	Water bars in place	Pic 14 Desc.	AR 241.04 in good condition

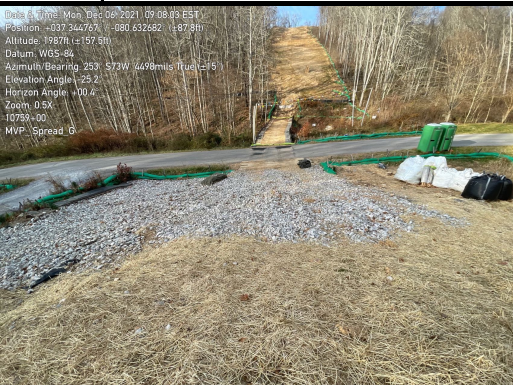
<p>Date & Time: Mon, Dec 06, 2021, 09:08:03 EST Position: +031.2447121, -080.631672, 19759+00 Altitude: 1987ft (1=19.7ft) Datum: WGS-84 Azimuth/Bearing: 253.573W 4498mils True (2=1°) Elevation Angle: +25.2° Horizon Angle: +00.4° Zoom: 0.5X 10759+00 MVP Spread G</p>			
GPS Location	See photo		GPS Location	See photo	
Field Station#	10758+00		Field Station#	10759+00	
Pic 5 Desc.	Temporary stabilization is acceptable		Pic 6 Desc.	RCE is maintained in acceptable condition

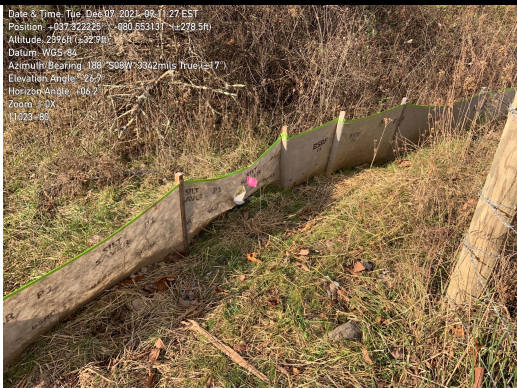
GPS Location	See photo	GPS Location	See photo		
Field Station#	11017+33	Field Station#	11023+80		
Pic 9 Desc.	Sensitive resource buffer is in acceptable condition	Pic 10 Desc.	p1 silt fence is damaged and needs repaired or replaced

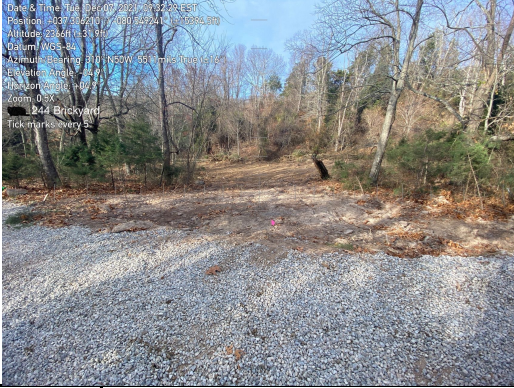
GPS Location	See Photo	GPS Location	See Photo		
Field Station#	11023+80	Field Station#	11029+28		
Pic 1 Desc.	Land Owner disturbance Needs stabilized	Pic 2 Desc.	Section of ROW showing conditions and controls

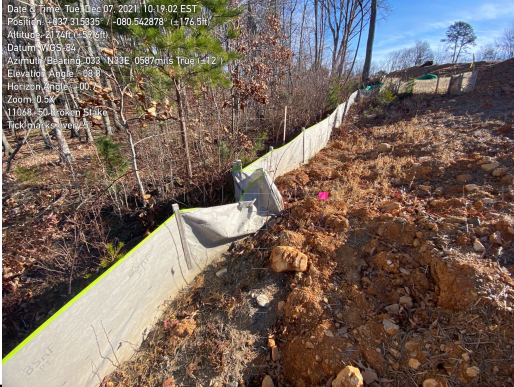
GPS Location	See Photo	GPS Location	See Photo		
Field Station#	11068+50	Field Station#	11068+80		
Pic 3 Desc.	Damaged P1	Pic 4 Desc.	Damaged P1

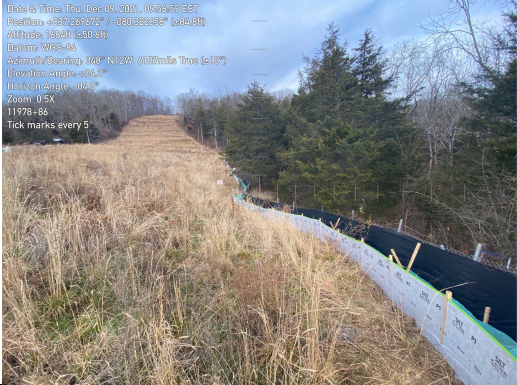
<p> <small> Date & Time Thu Dec 9, 2021, 09:52:57 EST Position: +48°22'32" N -88°53'12" W (48.3750, -88.8867) Altitude: 1350 ft (411 m) Datum: WGS-84 Azimuth/Bearing: 33° (NNW) 500m True (±12°) Elevation Angle: +11.5° Horizon Angle: -0.01° Zoom: 0.5X 11978+86 Tick marks every 5° </small> </p>			
GPS Location	See Photo	GPS Location	See Photo		
Field Station#	11964+00	Field Station#	11978+86		
Pic 7 Desc.	Damaged P1	Pic 8 Desc.	Karst Protection
