# Visual Site Inspection Report

<b>Project Name</b>	H-600 Pipeline Spread G	<b>AFE</b>	124300137	<b>Spread</b>	H-600 Pipeline Spread G
<b>Contractor</b>	Precision			<b>Report #</b>	34355
<b>Inspector</b>	Daniel Fortune			<b>Date/Time</b>	2/14/2022 11:09 AM
<b>Permit #</b>	TBD	<b>Inspection Type</b>	VA SWPP	<b>Station Begin</b>	11023+80
<b>State</b>	VA	<b>Inspection Area</b>	Partial	<b>Station End</b>	11098+47
<b>County</b>	Giles	<b>Ground</b>	Frozen	<b>Temperature (°F)</b>	23.00
<b>Municipality</b>	N/A	<b>Weather</b>	Below Freezing Temp	<b>Rain Gauge (in)</b>	0.00
				<b>Rain Accumulation Time (days)</b>	0.00

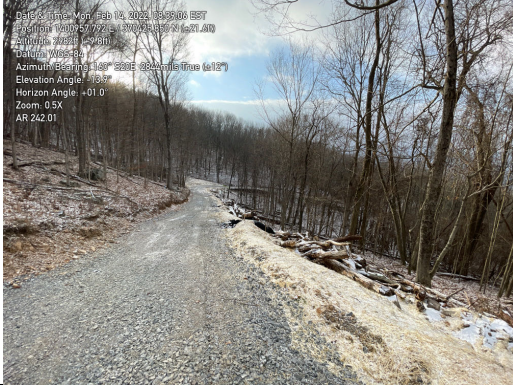
GPS Location	1	GPS Location	2		
Field Station#	10971+74	Field Station#	10971+74		
Pic 1 Desc.	AR 242.01 conditions and controls.		Pic 2 Desc.	AR 242.01 conditions and controls.

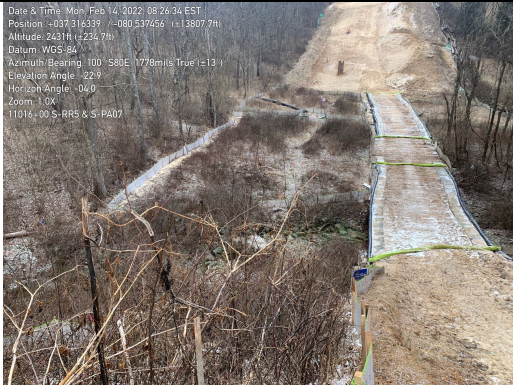
GPS Location	3	GPS Location	4		
Field Station#	11016+00	Field Station#	10986+50		
Pic 3 Desc.	Overview S-RR5/S-PA07.		Pic 4 Desc.	Overview S-E24/S-E25.

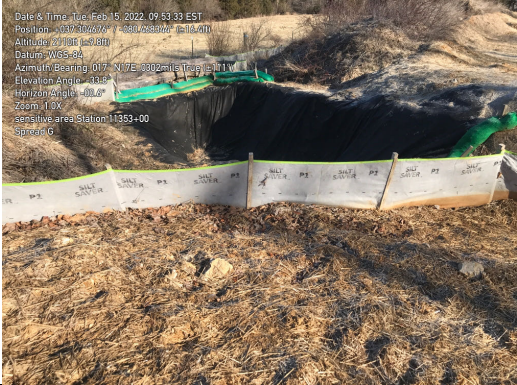
<b>GPS Location</b>	See photo	<b>GPS Location</b>	see photo		
<b>Field Station#</b>	11350+00	<b>Field Station#</b>	11353+00		
<b>Pic 7 Desc.</b>	ECDs at sensitive area	<b>Pic 8 Desc.</b>	S-NN 11

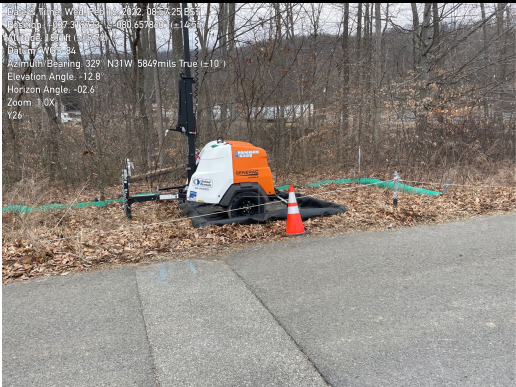
GPS Location	See photo		GPS Location	See photo	
Field Station#	12005+09		Field Station#	12005+00	
Pic 1 Desc.	Secondary containment in place		Pic 2 Desc.	CFS perimeter controls & safety fence in place

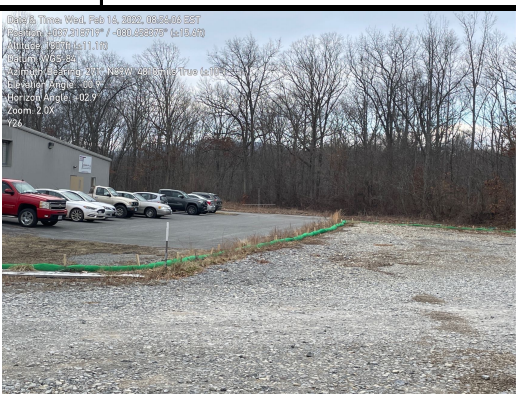
GPS Location	See photo		GPS Location	See photo	
Field Station#	12005+00		Field Station#	12005+00	
Pic 3 Desc.	CFS perimeter controls functional		Pic 4 Desc.	Housekeeping trash in place

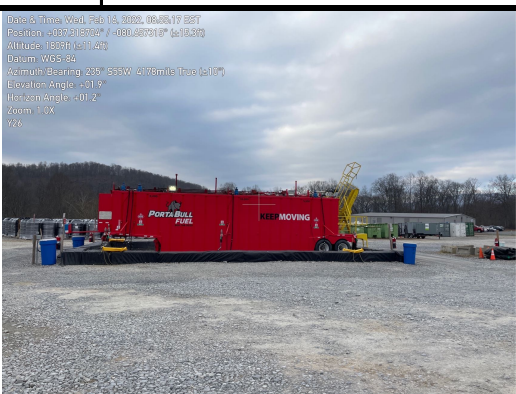
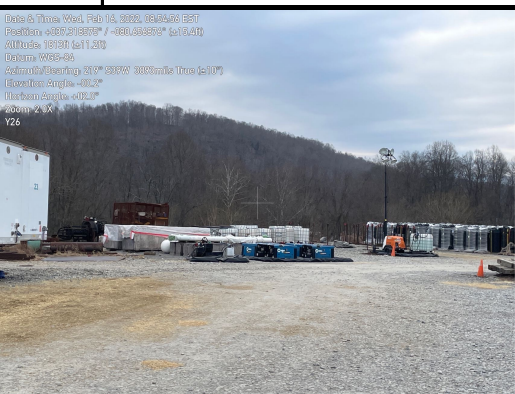
GPS Location	See photo		GPS Location	See photo	
Field Station#	12005+00		Field Station#	12005+00	
Pic 5 Desc.	Secondary containment in place		Pic 6 Desc.	Secondary containment in place

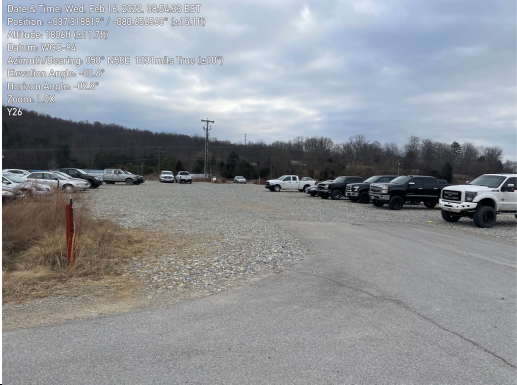
<b>GPS Location</b>		See photo		<b>GPS Location</b>	
<b>Field Station#</b>		12005+00		<b>Field Station#</b>	
<b>Pic 7 Desc.</b>		RCE functional		<b>Pic 8 Desc.</b>	
Insert image here				Insert image here	
<b>GPS Location</b>				<b>GPS Location</b>	
<b>Field Station#</b>				<b>Field Station#</b>	
<b>Pic 9 Desc.</b>				<b>Pic 10 Desc.</b>	
Insert image here				Insert image here	
<b>GPS Location</b>				<b>GPS Location</b>	
<b>Field Station#</b>				<b>Field Station#</b>	
<b>Pic 11 Desc.</b>				<b>Pic 12 Desc.</b>

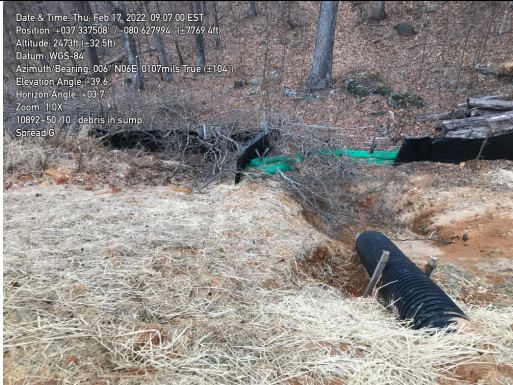
GPS Location		See photo		GPS Location		see photo			
Field Station#		10892+50		Field Station#		10860+00			
Pic 1 Desc.		PL item. Debris in sump		Pic 2 Desc.		ROW, Kow camp
