# Visual Site Inspection Report

<b>Project Name</b>	H-600 Pipeline Spread G	<b>AFE</b>	124300137	<b>Spread</b>	H-600 Pipeline Spread G
<b>Contractor</b>	Precision			<b>Report #</b>	34636
<b>Inspector</b>	Chris Burns			<b>Date/Time</b>	2/21/2022 7:29 AM
<b>Permit #</b>	TBD	<b>Inspection Type</b>	VA SWPP	<b>Station Begin</b>	11471+56
<b>State</b>	VA	<b>Inspection Area</b>	Partial	<b>Station End</b>	11524+16
<b>County</b>	Giles	<b>Ground</b>	Dry	<b>Temperature (°F)</b>	57.00
<b>Municipality</b>	N/A	<b>Weather</b>	Sunny	<b>Rain Gauge (in)</b>	0.00
				<b>Rain Accumulation Time (days)</b>	1.00

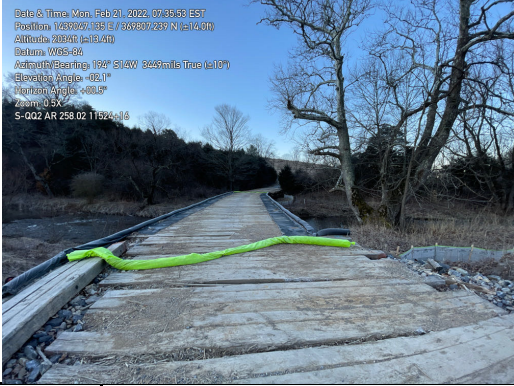
<b>GPS Location</b>	1	<b>GPS Location</b>	2		
<b>Field Station#</b>	11524+16	<b>Field Station#</b>	11472+50		
<b>Pic 1 Desc.</b>	S-QQ2 along AR 258.02.		<b>Pic 2 Desc.</b>	Karst feature protection functional.

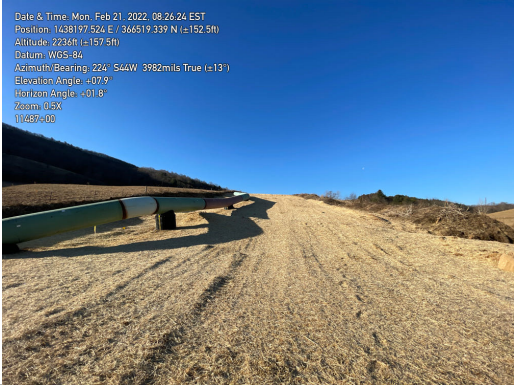
<b>GPS Location</b>	3	<b>GPS Location</b>	4		
<b>Field Station#</b>	11487+00	<b>Field Station#</b>	11498+00		
<b>Pic 3 Desc.</b>	Section of RoW showing conditions and controls.		<b>Pic 4 Desc.</b>	Crimping in straw.

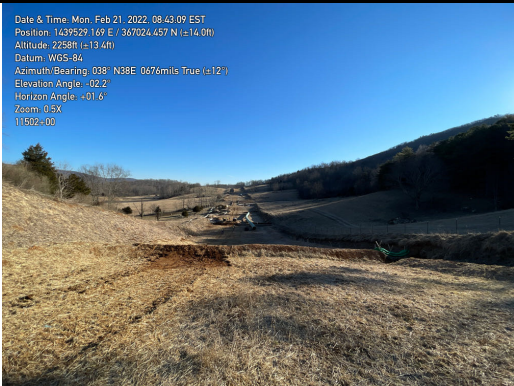
<b>GPS Location</b>	5	<b>GPS Location</b>	6		
<b>Field Station#</b>	11502+00	<b>Field Station#</b>	11505+50		
<b>Pic 5 Desc.</b>	PPL crews performing maintenance.		<b>Pic 6 Desc.</b>	Plunge pool functional.

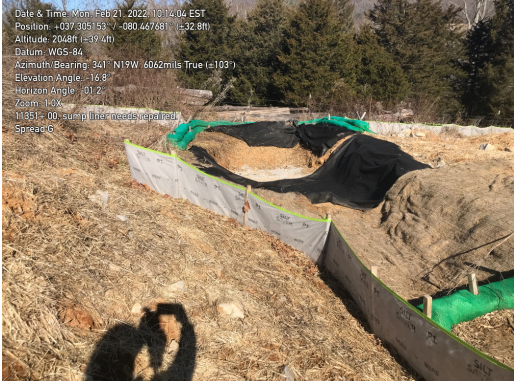
<b>GPS Location</b>	See photo		<b>GPS Location</b>	see photo	
<b>Field Station#</b>	11351+00		<b>Field Station#</b>	11258+00	
<b>Pic 1 Desc.</b>	Sump liner needs repaired		<b>Pic 2 Desc.</b>	Erosion blanket, sump

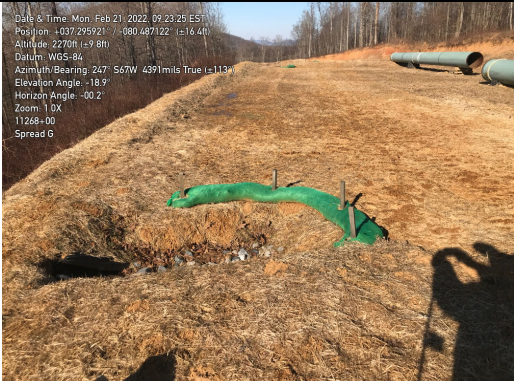
<b>GPS Location</b>	see photo		<b>GPS Location</b>	see photo	
<b>Field Station#</b>	11268+00		<b>Field Station#</b>	11289+00	
<b>Pic 3 Desc.</b>	Slope drain, stabilized ROW		<b>Pic 4 Desc.</b>	Erosion blanket, perimeter ECDs in sensitive area

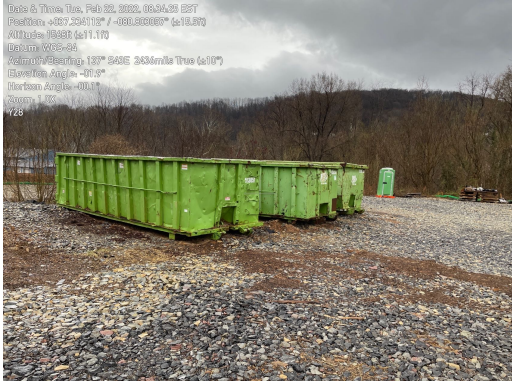
GPS Location	See photo	GPS Location	See photo		
Field Station#	12005+00	Field Station#	12005+00		
Pic 3 Desc.	Housekeeping in good condition	Pic 4 Desc.	CFS perimeter controls in place

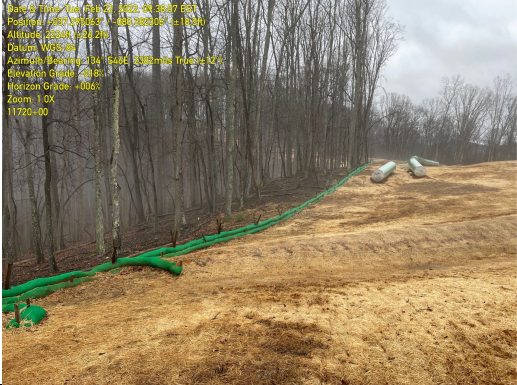
<b>GPS Location</b>	See photo	<b>GPS Location</b>	See photo		
<b>Field Station#</b>	11720+00	<b>Field Station#</b>	11741+00		
<b>Pic 7 Desc.</b>	CFS perimeter control in place	<b>Pic 8 Desc.</b>	Stream buffer in place

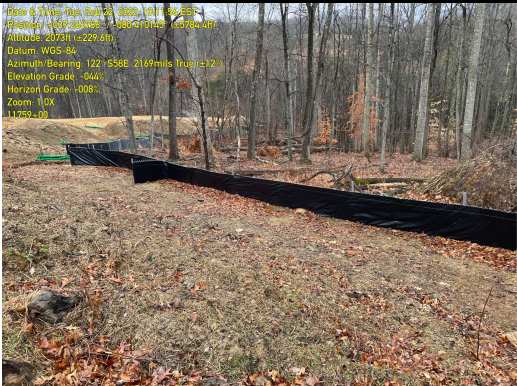
<b>GPS Location</b>	See photo	<b>GPS Location</b>	See photo		
<b>Field Station#</b>	11749+00	<b>Field Station#</b>	11759+00		
<b>Pic 9 Desc.</b>	End treatments in place	<b>Pic 10 Desc.</b>	Supersilt fence perimeter control in place

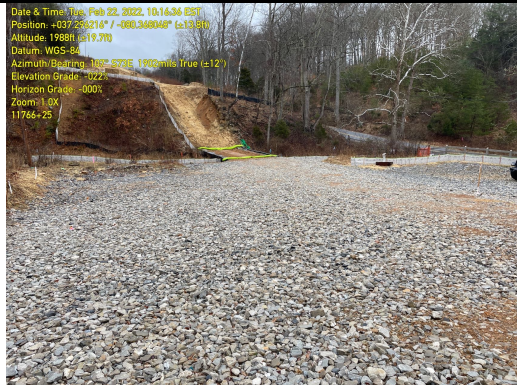
<b>GPS Location</b>	See photo	<b>GPS Location</b>	See photo		
<b>Field Station#</b>	11766+25	<b>Field Station#</b>	11782+50		
<b>Pic 11 Desc.</b>	RCE in place	<b>Pic 12 Desc.</b>	Cleanwater drainage feature in place

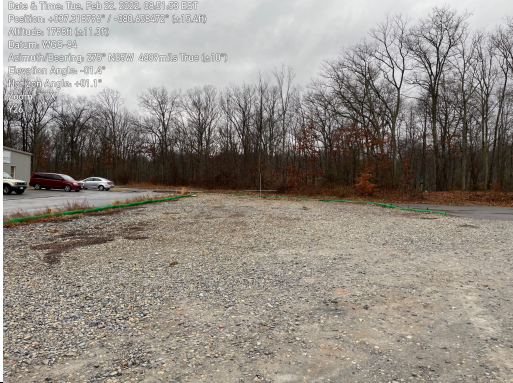
<b>GPS Location</b>	See photo	<b>GPS Location</b>	See photo		
<b>Field Station#</b>	12005+00	<b>Field Station#</b>	12005+00		
<b>Pic 1 Desc.</b>	CFS perimeter controls functional	<b>Pic 2 Desc.</b>	RCE and CFS perimeter controls functional

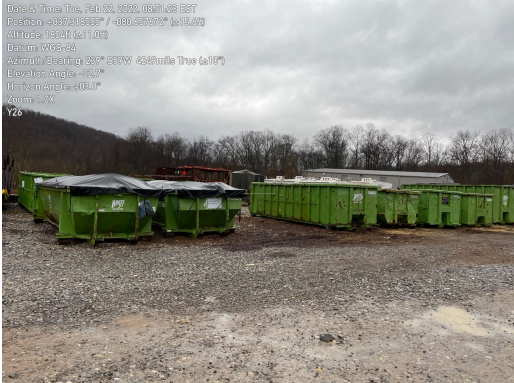
<b>GPS Location</b>	See photo	<b>GPS Location</b>	See photo		
<b>Field Station#</b>	12005+00	<b>Field Station#</b>	12005+00		
<b>Pic 3 Desc.</b>	Housekeeping in good condition	<b>Pic 4 Desc.</b>	Secondary containment in place

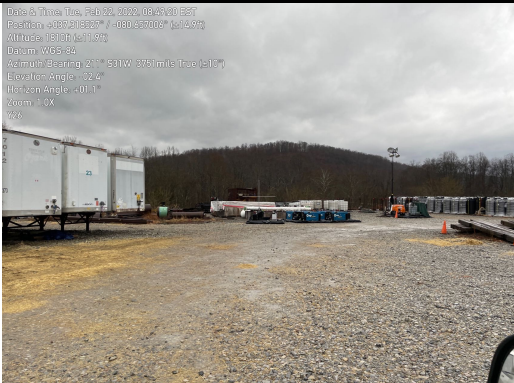
<b>GPS Location</b>	See photo	<b>GPS Location</b>	See photo		
<b>Field Station#</b>	12005+00	<b>Field Station#</b>	12005+00		
<b>Pic 5 Desc.</b>	Secondary containment in place	<b>Pic 6 Desc.</b>	Perimeter triple stack CFS in place

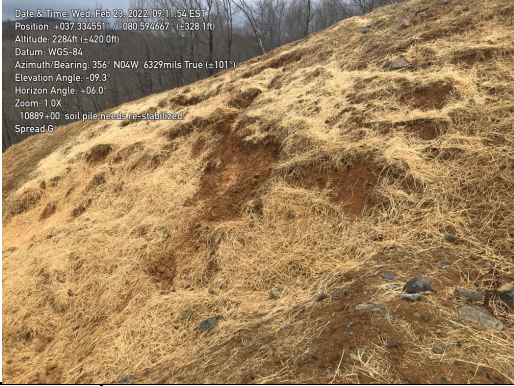
<b>GPS Location</b>	See photo		<b>GPS Location</b>	see photo	
<b>Field Station#</b>	10889+00		<b>Field Station#</b>	10893+00	
<b>Pic 1 Desc.</b>	PL item, soil pile needs restabilized		<b>Pic 2 Desc.</b>	Former PL item, debris removed from sump

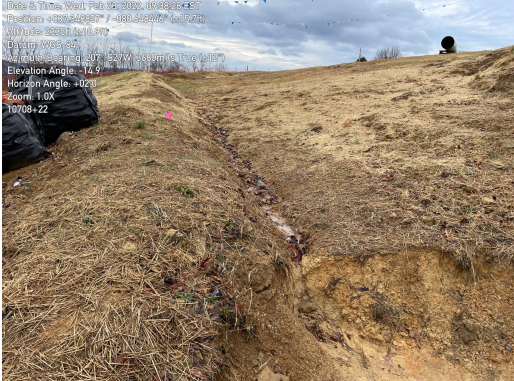
<b>GPS Location</b>	See photo		<b>GPS Location</b>	See photo	
<b>Field Station#</b>	10708+22		<b>Field Station#</b>	10711+64	
<b>Pic 1 Desc.</b>	Rilling in throat of water bar needs repaired		<b>Pic 2 Desc.</b>	SSF needs repaired

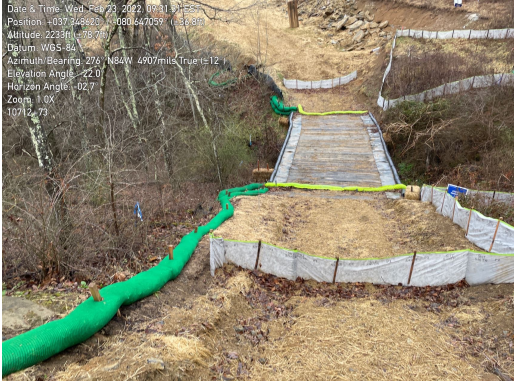
<b>GPS Location</b>	See photo		<b>GPS Location</b>	See photo	
<b>Field Station#</b>	10712+73		<b>Field Station#</b>	10697+78	
<b>Pic 3 Desc.</b>	Wattles in place		<b>Pic 4 Desc.</b>	Equipment bridge functional

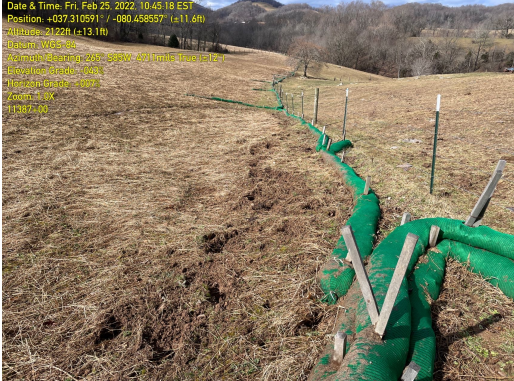
<b>GPS Location</b>		See photo		<b>GPS Location</b>	
<b>Field Station#</b>		11387+00		<b>Field Station#</b>	
<b>Pic 1 Desc.</b>		Area damaged by livestock		<b>Pic 2 Desc.</b>	
<p>Date &amp; Time: Fri, Feb 25, 2022 11:10:39 EST  Position: +037 306903° / -080 457192° (±101ft, 40ft)  Altitude: 1921ft (±107.3ft)  Datum: WGS-84  Azimuth Bearing: 212° S32W: 374mils True (±12°)  Elevation Grade: -021%  Horizon Grade: -002%  Zoom: 1.0X  11353+75</p>

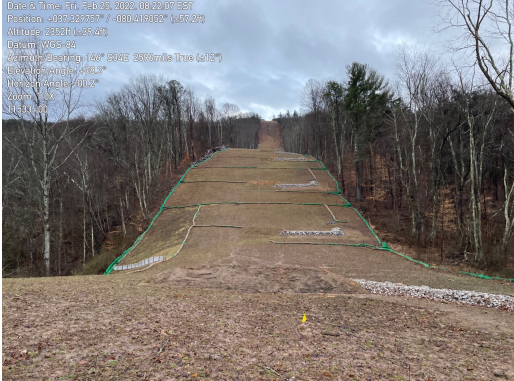
<b>GPS Location</b>	See photo	<b>GPS Location</b>	See photo		
<b>Field Station#</b>	11533+00	<b>Field Station#</b>	11528+33		
<b>Pic 1 Desc.</b>	Perimeter controls in place	<b>Pic 2 Desc.</b>	Permanent water bar and level spreader in place
