# Visual Site Inspection Report

<b>Project Name</b>	H-600 Pipeline Spread G	<b>AFE</b>	124300137	<b>Spread</b>	H-600 Pipeline Spread G
<b>Contractor</b>	Precision			<b>Report #</b>	34121
<b>Inspector</b>	Chris Burns			<b>Date/Time</b>	2/7/2022 11:38 AM
<b>Permit #</b>	TBD	<b>Inspection Type</b>	VA SWPP	<b>Station Begin</b>	10749+92
<b>State</b>	VA	<b>Inspection Area</b>	Partial	<b>Station End</b>	10798+92
<b>County</b>	Giles	<b>Ground</b>	Frozen	<b>Temperature (°F)</b>	31.00
<b>Municipality</b>	N/A	<b>Weather</b>	Snow/Sleet	<b>Rain Gauge (in)</b>	0.00
				<b>Rain Accumulation Time (days)</b>	1.00

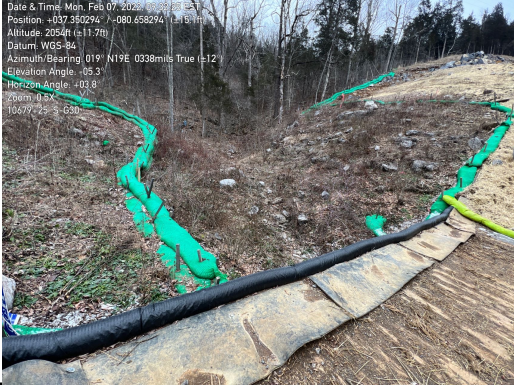
<b>GPS Location</b>	See photo	<b>GPS Location</b>	See photo		
<b>Field Station#</b>	10679+25	<b>Field Station#</b>	10733+18		
<b>Pic 5 Desc.</b>	Equipment bridge functional	<b>Pic 6 Desc.</b>	P1 in place

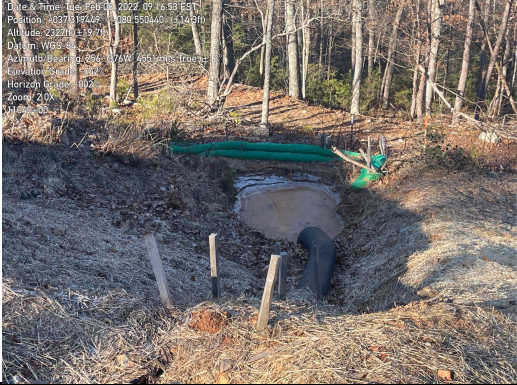
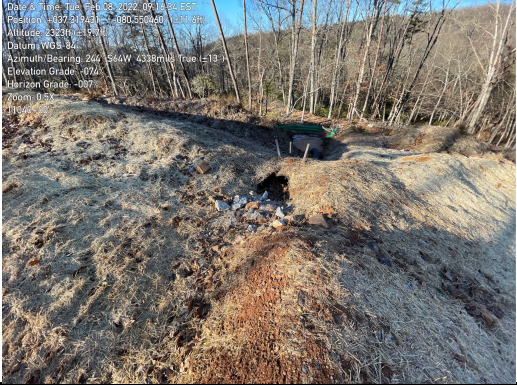
<b>GPS Location</b>	See Photo	<b>GPS Location</b>	See Photo		
<b>Field Station#</b>	11040+00	<b>Field Station#</b>	11040+00		
<b>Pic 13 Desc.</b>	TSDP and sump pit conditions. Water bar end treatment remains in a functional manner.	<b>Pic 14 Desc.</b>	Stone inlet protection condition

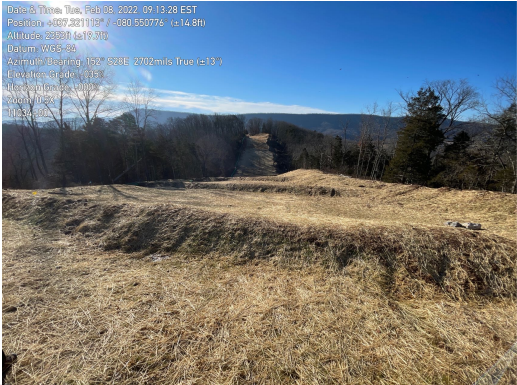
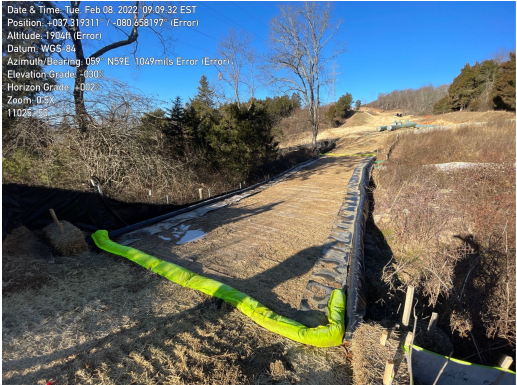
<b>GPS Location</b>	See Photo	<b>GPS Location</b>	See Photo		
<b>Field Station#</b>	11034+00	<b>Field Station#</b>	11025+50		
<b>Pic 15 Desc.</b>	Temporary stabilization and temporary stabilized diversion berm.	<b>Pic 16 Desc.</b>	Equipment bridge condition over the S-IJ18 stream resource.		
<div>Insert image here</div>		<div>Insert image here</div>			
<b>GPS Location</b>		<b>GPS Location</b>			
<b>Field Station#</b>		<b>Field Station#</b>			
<b>Pic 17 Desc.</b>		<b>Pic 18 Desc.</b>

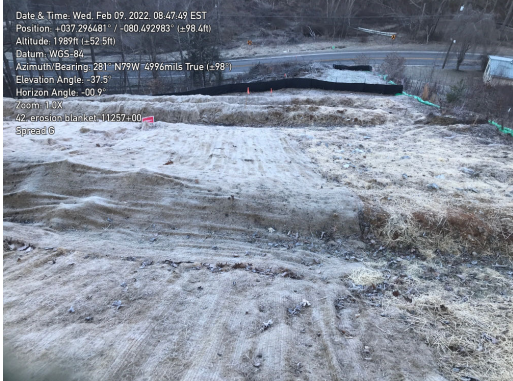
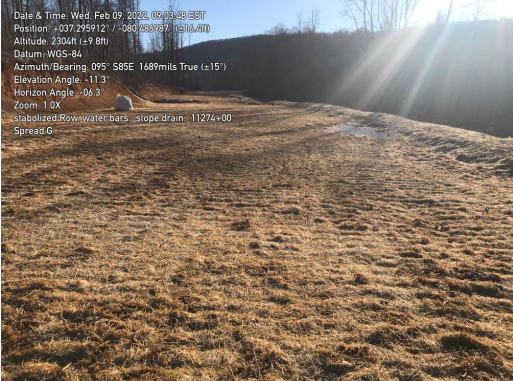
GPS Location		See photo				GPS Location		see photo			
Field Station#		11257+00				Field Station#		11274+00			
Pic 1 Desc.		Erosion blanket				Pic 2 Desc.		Stabilized ROW, water bars, slope drain

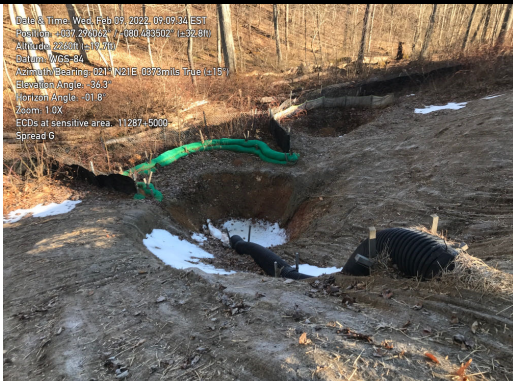
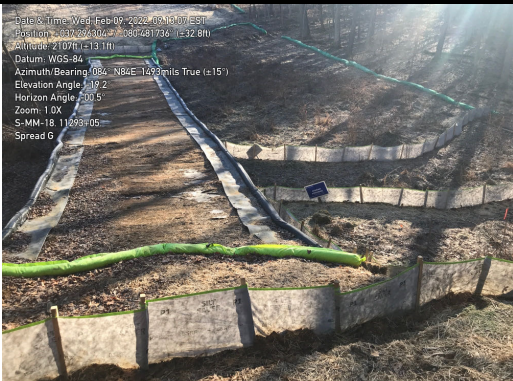
GPS Location		see photo				GPS Location		see photo			
Field Station#		11287+50				Field Station#		11293+05			
Pic 3 Desc.		ECDs at sensitive area				Pic 4 Desc.		S-MM 18

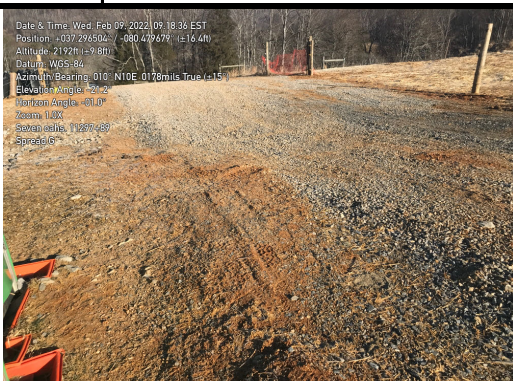
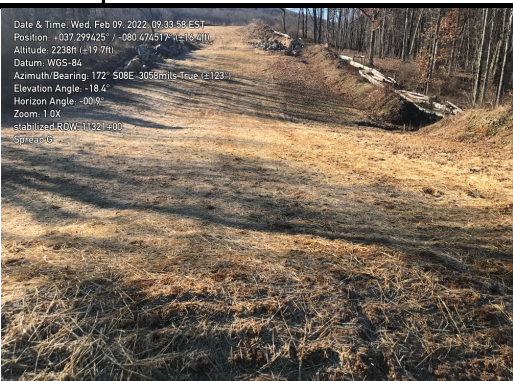
GPS Location		see photo				GPS Location		see photo			
Field Station#		11297+87				Field Station#		11321+00			
Pic 5 Desc.		Seven Oaks				Pic 6 Desc.		Stabilized ROW

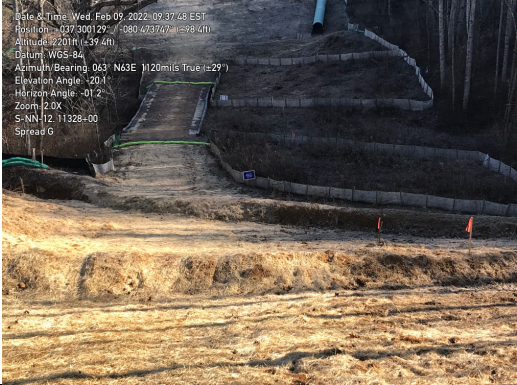
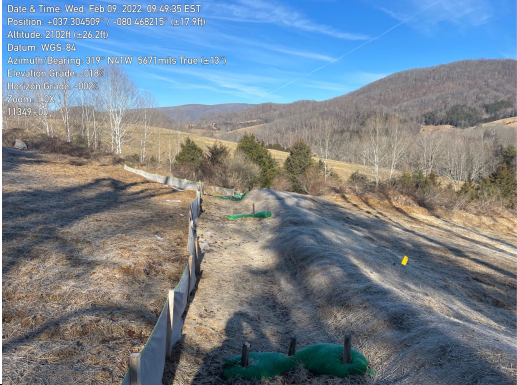
<b>GPS Location</b>	See photo	<b>GPS Location</b>	See photo		
<b>Field Station#</b>	11328+00	<b>Field Station#</b>	11349+00		
<b>Pic 7 Desc.</b>	S-NN 12	<b>Pic 8 Desc.</b>	Karst area

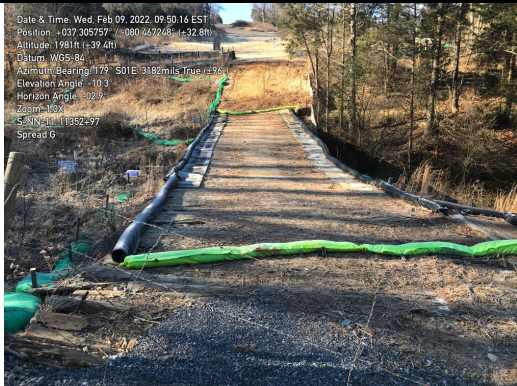
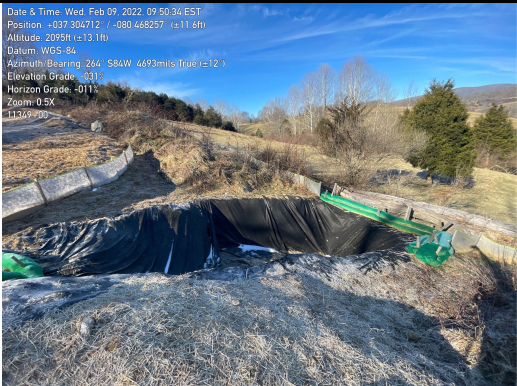
<b>GPS Location</b>	See photo	<b>GPS Location</b>	See photo		
<b>Field Station#</b>	11352+97	<b>Field Station#</b>	11349+00		
<b>Pic 9 Desc.</b>	S-NN11	<b>Pic 10 Desc.</b>	Sump		
Insert image here		Insert image here			
<b>GPS Location</b>		<b>GPS Location</b>			
<b>Field Station#</b>		<b>Field Station#</b>			
<b>Pic 11 Desc.</b>		<b>Pic 12 Desc.</b>

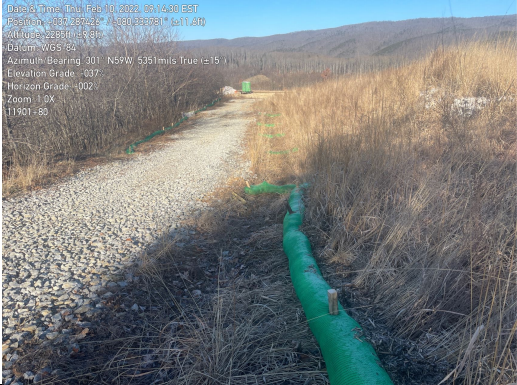
<b>GPS Location</b>		See Photo		<b>GPS Location</b>	
<b>Field Station#</b>		11901+80		<b>Field Station#</b>	
<b>Pic 13 Desc.</b>		Replaced CFS.		<b>Pic 14 Desc.</b>	
Insert image here		Insert image here			
<b>GPS Location</b>				<b>GPS Location</b>	
<b>Field Station#</b>				<b>Field Station#</b>	
<b>Pic 15 Desc.</b>				<b>Pic 16 Desc.</b>	
Insert image here		Insert image here			
<b>GPS Location</b>				<b>GPS Location</b>	
<b>Field Station#</b>				<b>Field Station#</b>	
<b>Pic 17 Desc.</b>				<b>Pic 18 Desc.</b>
