Visual Site Inspection Report

Project Name	H-600 Pipeline Spread H	AFE	124300138	Spread	H-600 Pipeline Spread H
Contractor	Precision			Report #	33571
Inspector	Norm Kitchen			Date/Time	1/24/2022 5:00 PM
Permit #	TBD	Inspection Type	VA SWPP	Station Begin	12119+17
State	VA	Inspection Area	Partial	Station End	12284+75
County	Montgomery	Ground	Frozen	Temperature (°F)	43.00
Municipality	N/A	Weather	Sunny	Rain Gauge (in)	0.00
				Rain Accumulation Time (days)	1.00

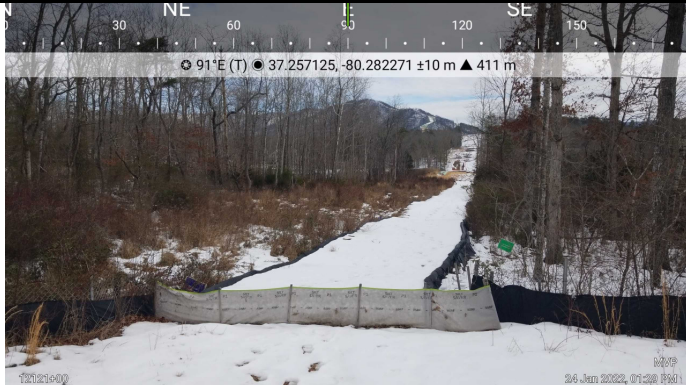
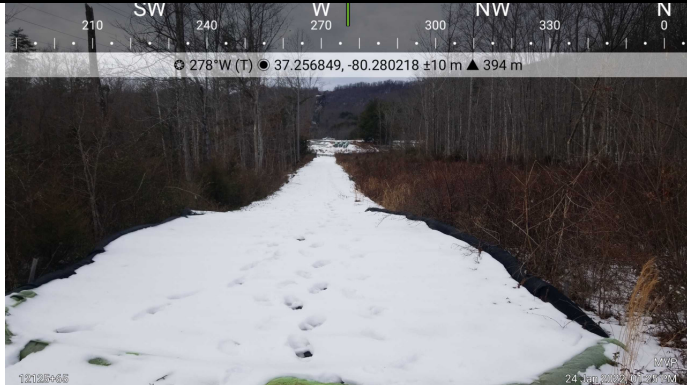
GPS Location	See Above		GPS Location	See Above	
Field Station#	12121+00		Field Station#	12125+65	
Pic 1 Desc.	Overview of Waterbody S-C36. ECDs functional and in good condition.		Pic 2 Desc.	Overview of Waterbody S-MM31. ECDs functional and in good condition.

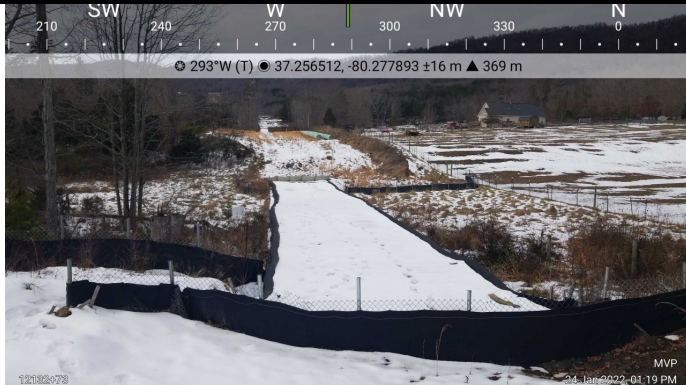
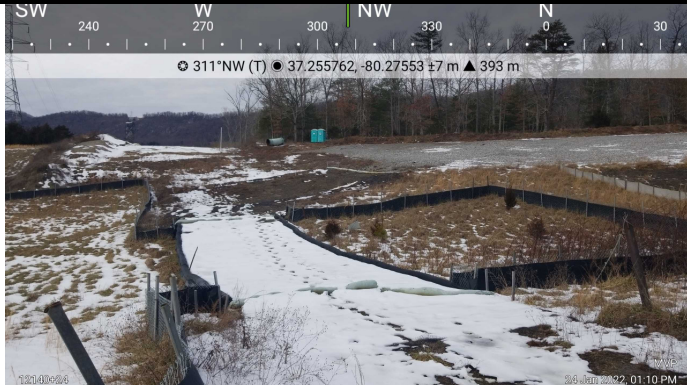
GPS Location	See Above		GPS Location	See Above	
Field Station#	12132+73		Field Station#	12140+24	
Pic 3 Desc.	Overview of Waterbody S-C29. ECDs functional and in good condition.		Pic 4 Desc.	Overview of Wetland W-C6. ECDs functional and in good condition.

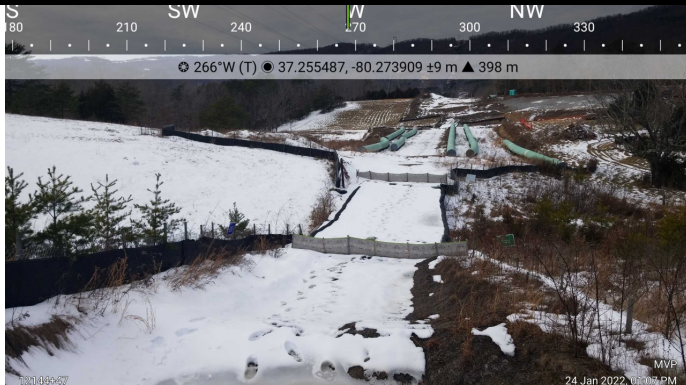
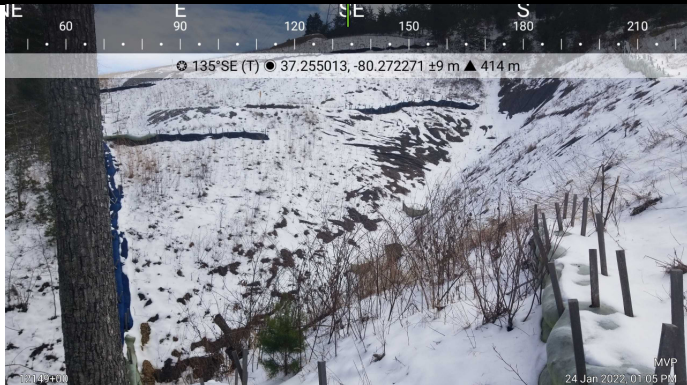
GPS Location	See Above		GPS Location	See Above	
Field Station#	12144+47		Field Station#	12149+00	
Pic 5 Desc.	Overview of Wetland W-C5. ECDs functional and in good condition.		Pic 6 Desc.	ROW Overview. ECDs functional and in good condition and ROW is stable.

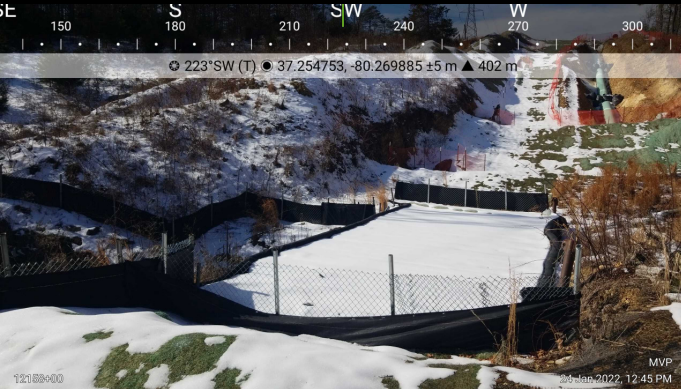
GPS Location	See Above		GPS Location	See Above	
Field Station#	12158+00		Field Station#	12163+05	
Pic 7 Desc.	Punchlist item: Repair Super Silt Fence.		Pic 8 Desc.	Overview of Waterbody S-C25. ECDs functional and in good condition.

7. Identify all remedial measures that have been taken since the previous inspection was conducted.					
One punchlist item has been added SWPPP inspection: 1. Station 12158+00, Repair Super Silt Fence.					
Comments (Reference above questions as appropriate.)					
Environmental Inspector (EI) attended the daily 6:30am online inspector's "Teams" meeting. EI performed SWPPP inspection for the section between Flatwoods Road and the right-of-way (ROW) crossing on access road MVP-MN-276.03 on Reese Mountain Rd., stations 12119+17 to 12284+75. EI inspected the following environmental resources (W-C12, S-C33, S-C36, W-C11, S-MM31, S-C29, W-C6, S-KL5, W-C5, S-C25, S-C24, S-C21, S-OO11(1), S-OO11(2). Access roads observed included MN-272, MN-273, MN-274, MN-275. and MN 276.03. No impacts or any other deficiencies were observed at any of these resources or their corresponding buffer zones or at the access roads. Right-of-way (ROW) remains stable throughout this inspection area. With the exception on the punchlist item noted above ECDs were in satisfactory condition and functioning properly. The ROW remains in a stable condition. Due to recent a snowstorm some ECDs are not visible beneath the accumulated snow. Also due to this snowstorm the SWPPP for this section could not be safely performed last week (1/19/22).

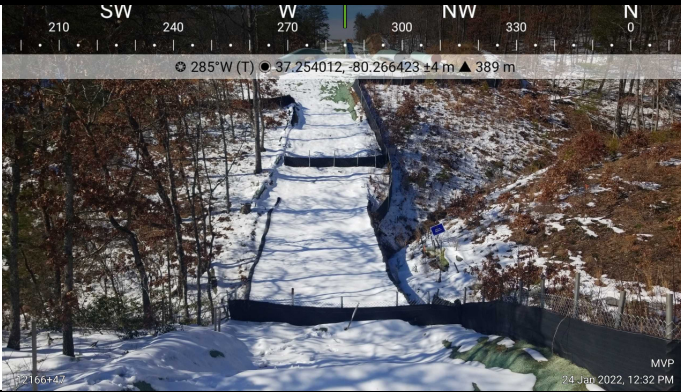
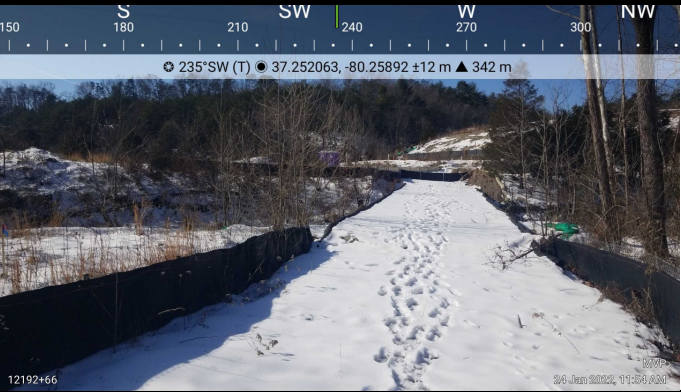
GPS Location	See Above		GPS Location	See Above	
Field Station#	12166+47		Field Station#	12192+66	
Pic 9 Desc.	Overview of Waterbody S-C24. ECDs functional and in good condition.		Pic 10 Desc.	Overview of Waterbody S-C21. ECDs functional and in good condition.

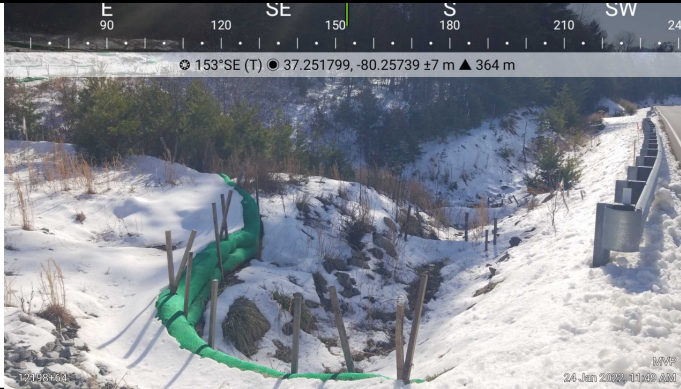
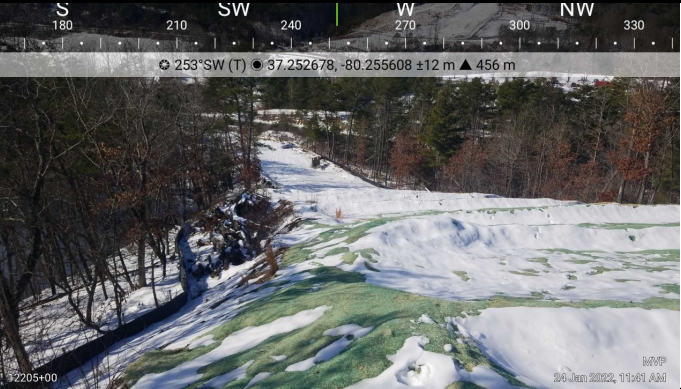
GPS Location	See Above		GPS Location	See Above	
Field Station#	12198+64		Field Station#	12205+00	
Pic 11 Desc.	ECDs near stream S-0011 are functional and in good condition. CFS is trapping sediment from off ROW before it enters creek.		Pic 12 Desc.	ROW Overview. ECDs functional and in good condition and ROW is stable.

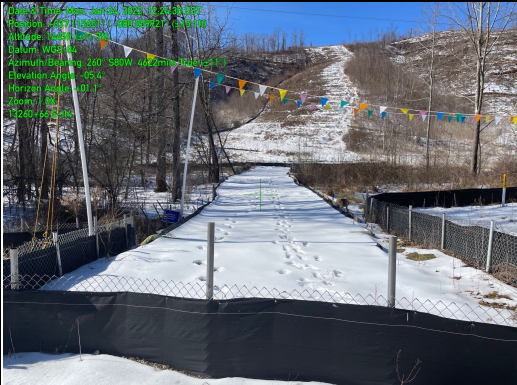
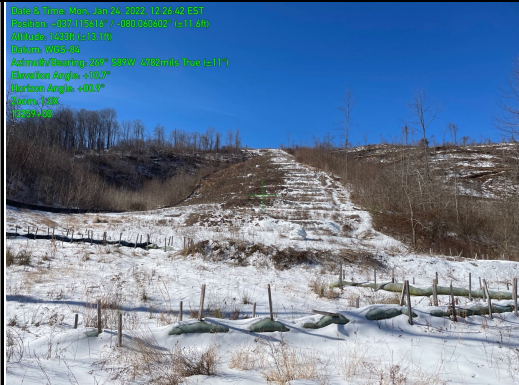
GPS Location	0	GPS Location	0		
Field Station#	13260+66	Field Station#	13259+00		
Pic 13 Desc.	MVP-S-II4 and Corresponding buffer zone In good condition	Pic 14 Desc.	ROW and ECDs In good condition and stable, covered in snow and ice and unsafe to walk

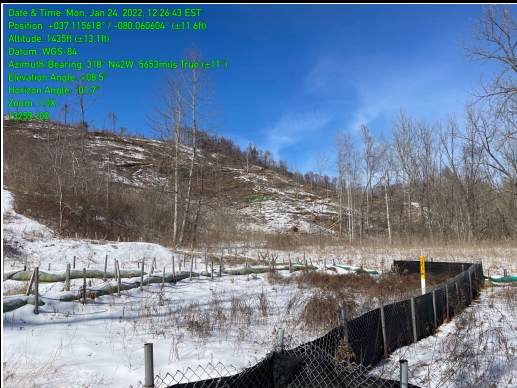
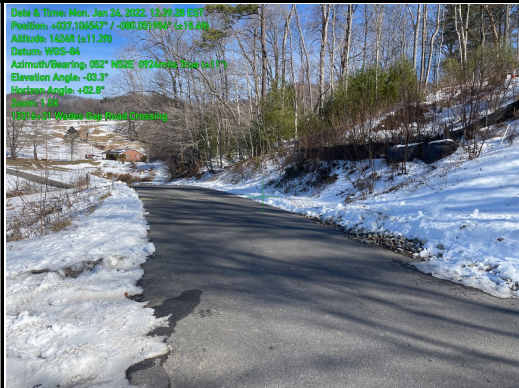
GPS Location	0	GPS Location	0		
Field Station#	13259+00	Field Station#	13316+21		
Pic 15 Desc.	Continuing to monitor logging activity adjacent to row	Pic 16 Desc.	Wades Gap Road Crossing in good condition

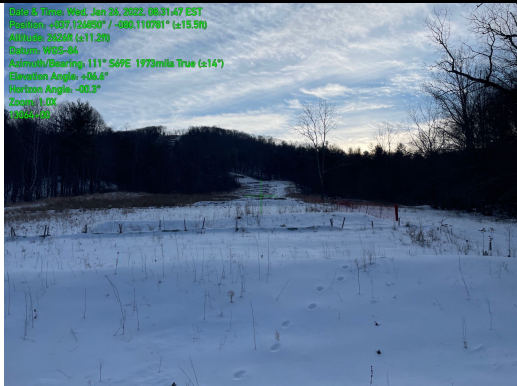
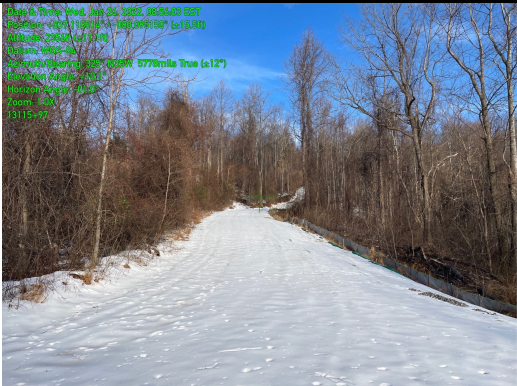
GPS Location	0	GPS Location	0		
Field Station#	13064+00	Field Station#	13115+97		
Pic 9 Desc.	ROW and ECDs In good condition and stable		Pic 10 Desc.	Access road 291 still covered in snow and unsafe to travel up

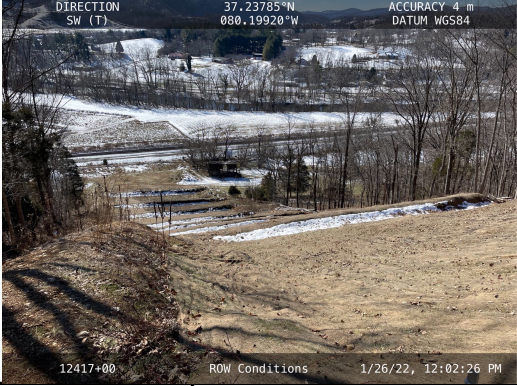
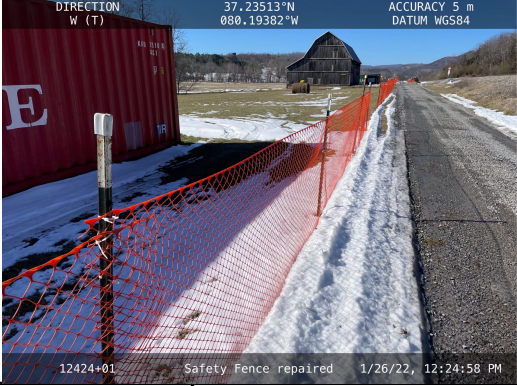
GPS Location	See photo		GPS Location	See photo	
Field Station#	12417+00		Field Station#	12424+01	
Pic 17 Desc.	Current ROW conditions. ROW is stable. ECDs are functional		Pic 18 Desc.	Safety fence has been repaired
