Visual Site Inspection Report

Project Name	H-600 Pipeline Spread H	AFE	124300138	Spread	H-600 Pipeline Spread H
Contractor	Precision			Report #	32835
Inspector	Joe Scott			Date/Time	1/3/2022 3:55 PM
Permit #	TBD	Inspection Type	VA SWPP	Station Begin	12865+00
State	VA	Inspection Area	Partial	Station End	13024+00
County	Roanoke	Ground	Frozen	Temperature (°F)	32.00
Municipality	N/A	Weather	Snow/Sleet	Rain Gauge (in)	1.10
				Rain Accumulation Time (days)	1.00

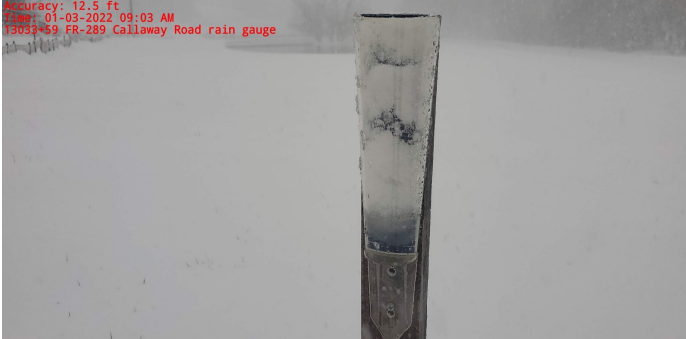
<small>Latitude: 37.123324 Longitude: -80.120915 Elevation: 2593.77±8 ft Accuracy: 12.5 ft Time: 01-03-2022 09:17 AM 13033+59 FR-289 Callaway Road rain gauge 1.1" after melting</small>

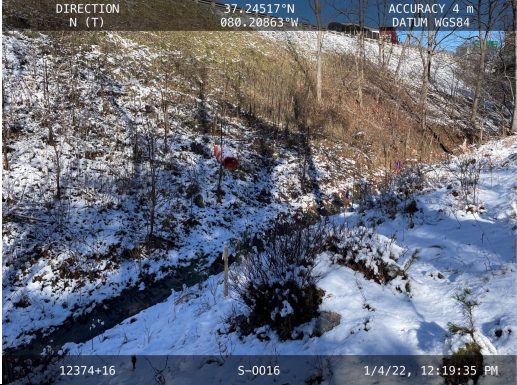
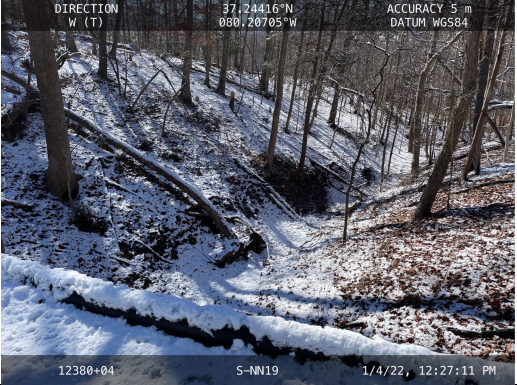
GPS Location	See photo		GPS Location	See photo	
Field Station#	12374+16		Field Station#	12380+04	
Pic 13 Desc.	Stream S-0016. No issues noted.		Pic 14 Desc.	Stream S-NN19. No issues noted.

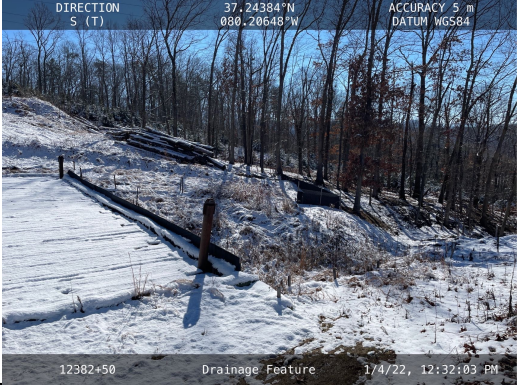
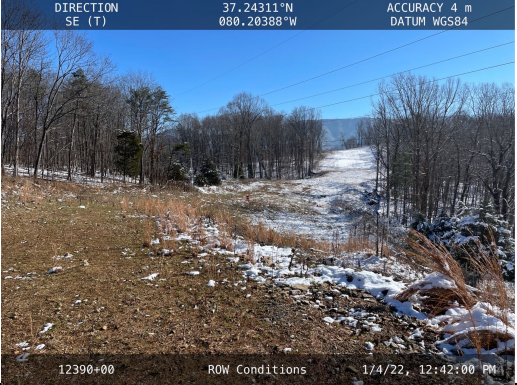
GPS Location	See photo		GPS Location	See photo	
Field Station#	12382+50		Field Station#	12390+00	
Pic 15 Desc.	ROW is covered in snow. ECDs are functional.		Pic 16 Desc.	ROW is covered in snow. ECDs are functional.

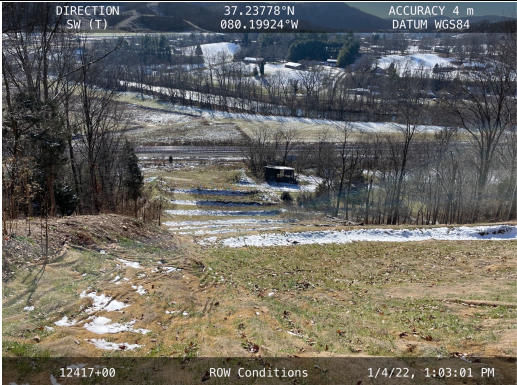
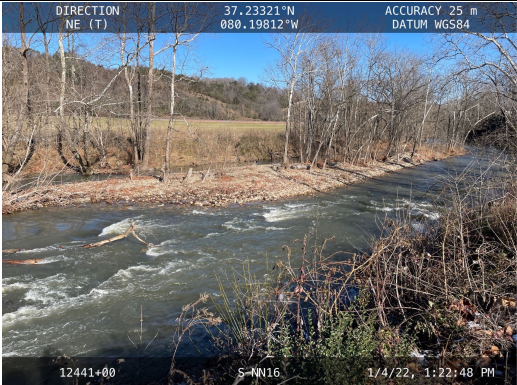
GPS Location	See photo		GPS Location	See photo	
Field Station#	12417+00		Field Station#	12441+00	
Pic 17 Desc.	ROW is covered in snow. ECDs are functional.		Pic 18 Desc.	Stream S-NN16. No issues noted.

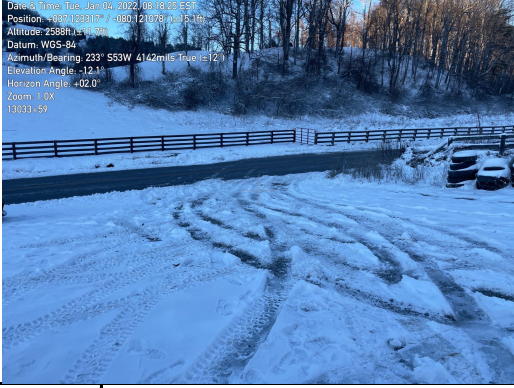
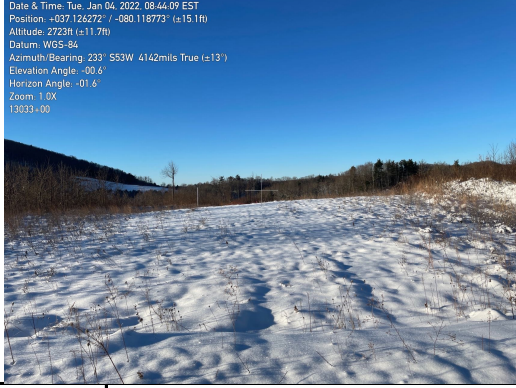
GPS Location	0	GPS Location	0		
Field Station#	13033+59	Field Station#	13033+00		
Pic 1 Desc.	RCE in good condition	Pic 2 Desc.	ROW and ECDs In good condition and stable		
<p> Date & Time: Tue, Jan 04, 2022, 08:45:45 EST Position: +037.125823° / -080.119528° (±15.1ft) Altitude: 2723ft (±11.7ft) Datum: WGS-84 Azimuth/Bearing: 249° S68W 4409mils True (±14°) Elevation Angle: -04.9° Horizon Angle: -01.1° Zoom: 1.0X 13030+00 </p>

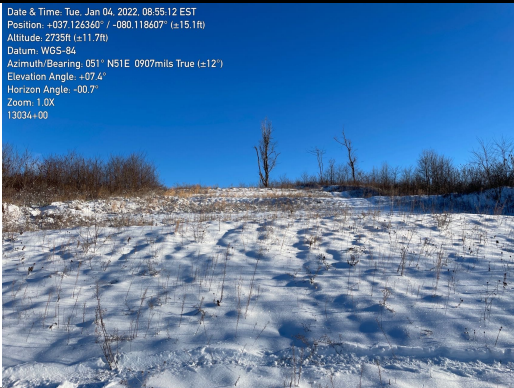
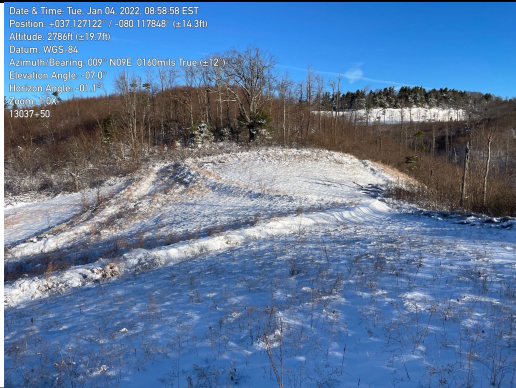
GPS Location	0	GPS Location	0		
Field Station#	13034+00	Field Station#	13037+50		
Pic 5 Desc.	ROW and ECDs In good condition and stable	Pic 6 Desc.	ROW and ECDs In good condition and stable

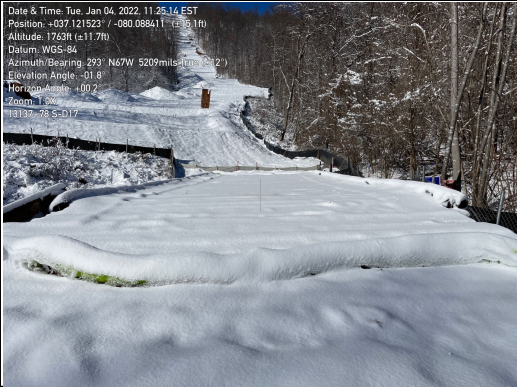
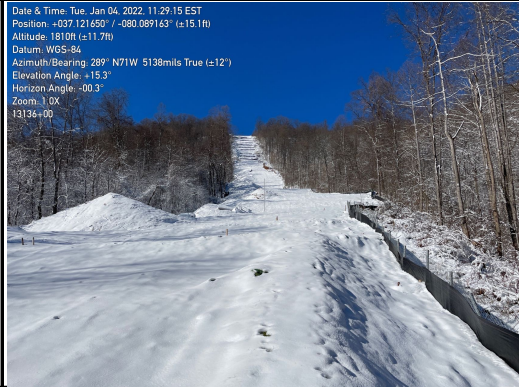
GPS Location						0					
Field Station#						13137+78					
Pic 17 Desc.						MVP-S-D17 and Corresponding buffer zone in good condition					
Pic 18 Desc.						ROW and ECDs In good condition and stable

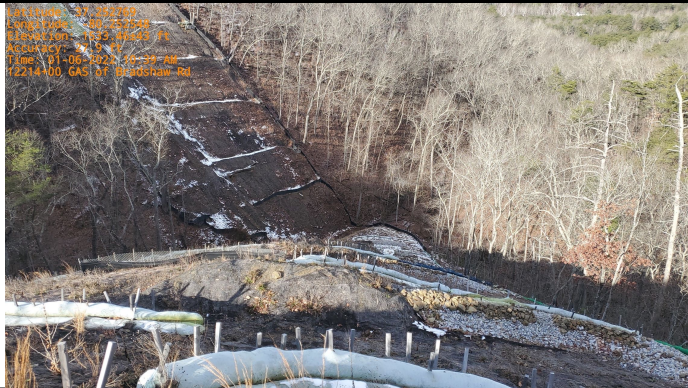
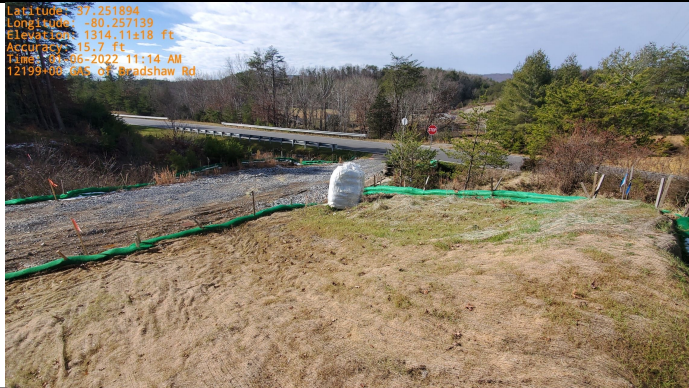
GPS Location	See pic for GPS location.		GPS Location	See pic for GPS location.	
Field Station#	12214+00		Field Station#	12199+00	
Pic 5 Desc.	Current conditions of the ROW on the CIS of MN-276.03.		Pic 6 Desc.	ECD's and BMP's in place and remain functional.
