Visual Site Inspection Report

Project Name	H-600 Pipeline Spread H	AFE	124300138	Spread	H-600 Pipeline Spread H
Contractor	Precision			Report #	33829
Inspector	Dustin Lyons			Date/Time	1/31/2022 3:30 PM
Permit #	TBD	Inspection Type	VA SWPP	Station Begin	12600+00
State	VA	Inspection Area	Partial	Station End	12725+00
County	Roanoke	Ground	Frozen	Temperature (°F)	27.00
Municipality	N/A	Weather	Sunny	Rain Gauge (in)	0.20
				Rain Accumulation Time (days)	3.00

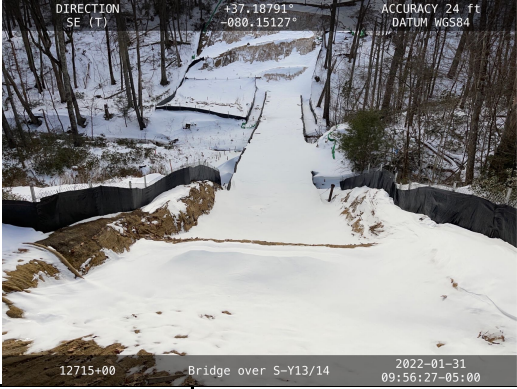
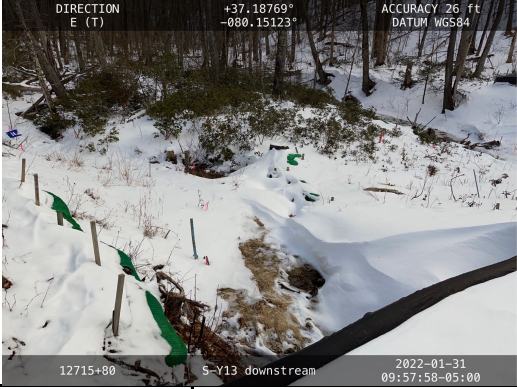
GPS Location	See photo for gps location data.		GPS Location	See photo for gps location data.	
Field Station#	12715+00		Field Station#	12715+80	
Pic 7 Desc.	Photo shows the bridge over streams S-Y13 and S-Y14.		Pic 8 Desc.	Photo shows stream S-Y13 downstream from the bridge.

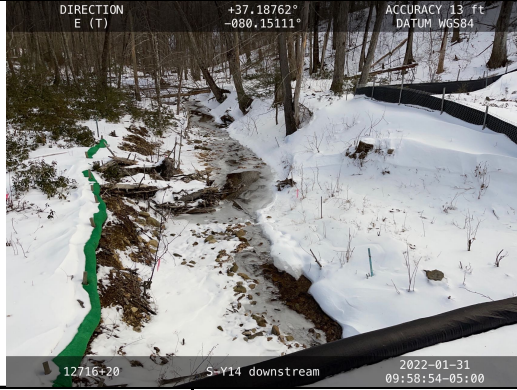
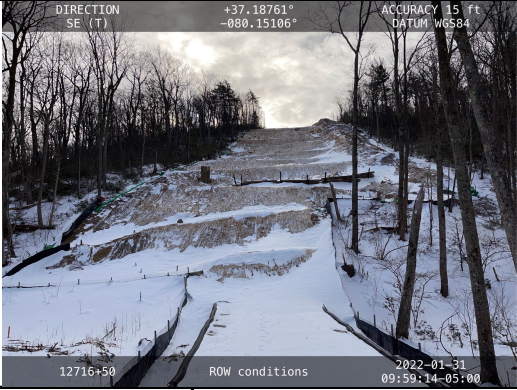
GPS Location	See photo for gps location data.		GPS Location	See photo for gps location data.	
Field Station#	12716+20		Field Station#	12716+50	
Pic 11 Desc.	Photo shows stream S-Y14 downstream from the bridge.		Pic 12 Desc.	Photo shows the ROW condition. ECDs are installed and functioning as designed.

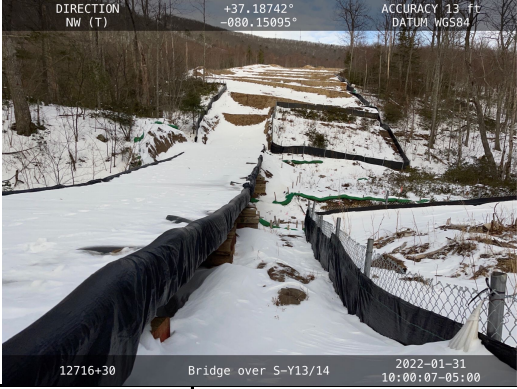
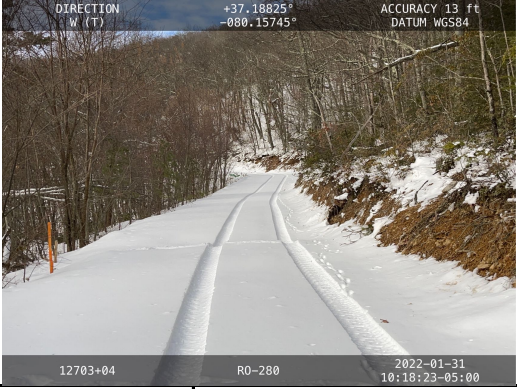
GPS Location	See photo for gps location data.		GPS Location	See photo for gps location data.	
Field Station#	12716+30		Field Station#	12703+04	
Pic 13 Desc.	Photo shows the bridge over streams S-Y13 and S-Y14.		Pic 14 Desc.	Photo shows access road RO-280.

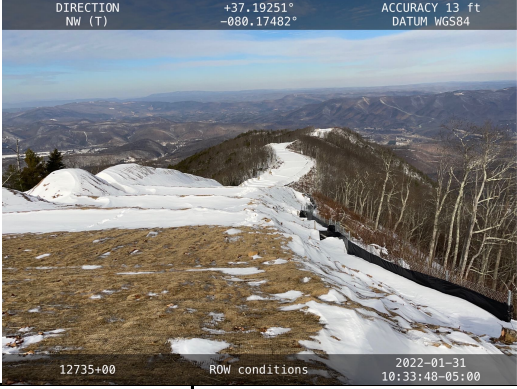
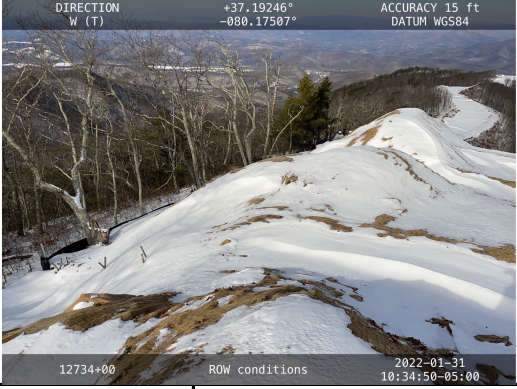
GPS Location	See photo for gps location data.		GPS Location	See photo for gps location data.	
Field Station#	12735+00		Field Station#	12734+00	
Pic 15 Desc.	Photo shows the ROW condition. ECDs are installed and functioning as designed.		Pic 16 Desc.	Photo shows the ROW condition. ECDs are installed and functioning as designed.

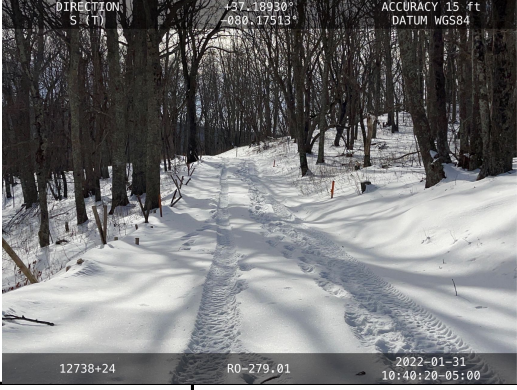
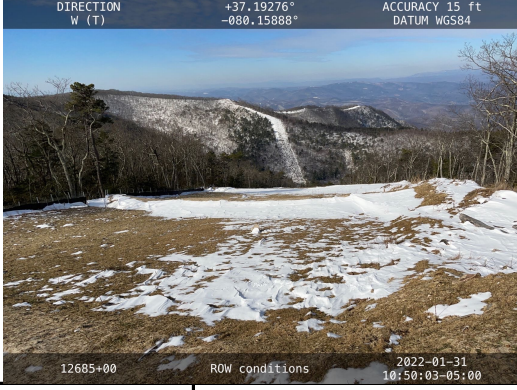
GPS Location	See photo for gps location data.		GPS Location	See photo for gps location data.	
Field Station#	12738+24		Field Station#	12685+00	
Pic 17 Desc.	Photo shows the ROW condition. ECDs are installed and functioning as designed.		Pic 18 Desc.	Photo shows the ROW condition. ECDs are installed and functioning as designed.

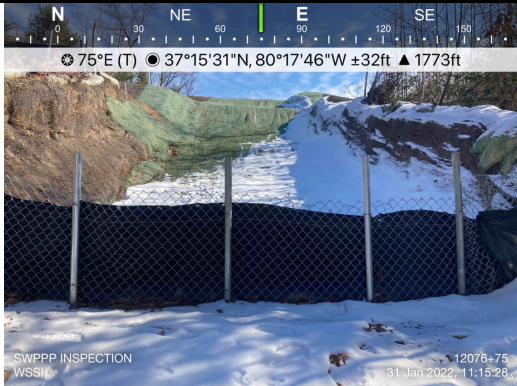
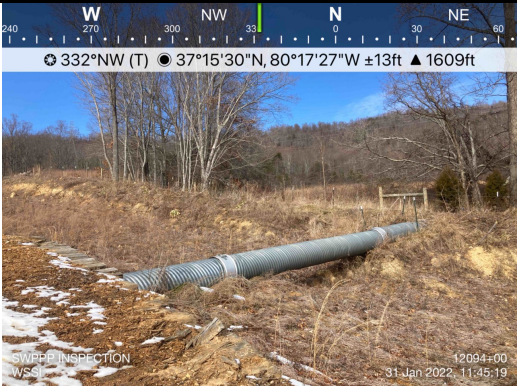
GPS Location	See Photo Watermark		GPS Location	See Photo Watermark	
Field Station#	12076+75		Field Station#	12094+00	
Pic 9 Desc.	Straw matting and erosion blankets are in place and in good condition.		Pic 10 Desc.	Clean water diversion pipe is functioning properly.

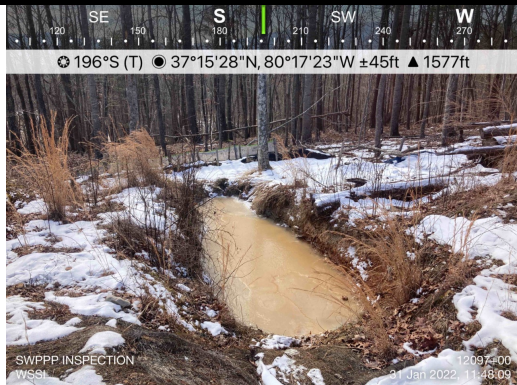
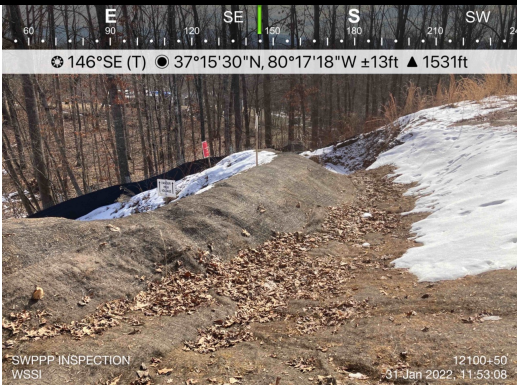
GPS Location	See Photo Watermark		GPS Location	See Photo Watermark	
Field Station#	12097+00		Field Station#	12100+50	
Pic 11 Desc.	Plunge pools are functioning properly.		Pic 12 Desc.	Water bars are in place and in good condition.

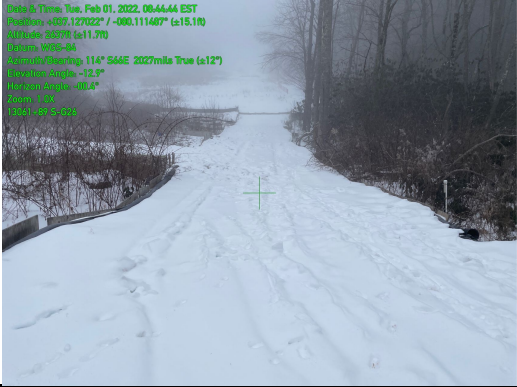
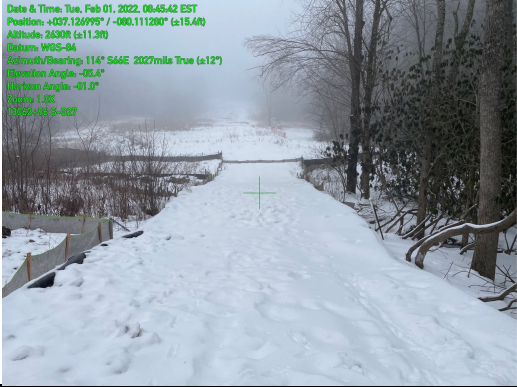
GPS Location	0	GPS Location	0
Field Station#	13061+89	Field Station#	13062+96
Pic 7 Desc.	MVP-S-G26 and Corresponding buffer zone in good condition	Pic 8 Desc.	MVP-S-G27 and Corresponding buffer zone in good condition

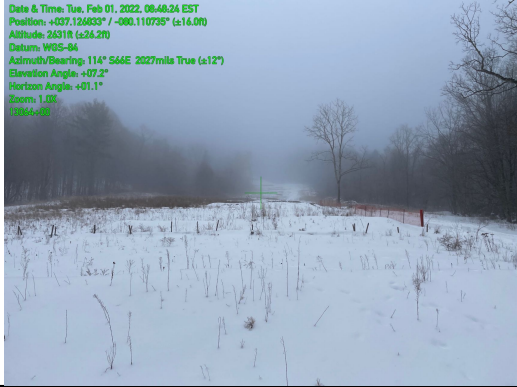
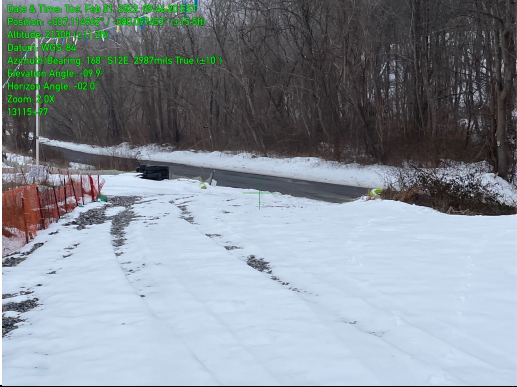
GPS Location	0	GPS Location	0
Field Station#	13064+00	Field Station#	13115+97
Pic 9 Desc.	ROW and ECDs In good condition and stable	Pic 10 Desc.	RCE in good condition, Access Road 291 still unsafe to get to the row.

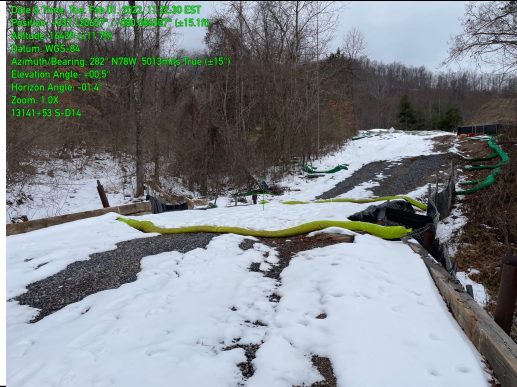
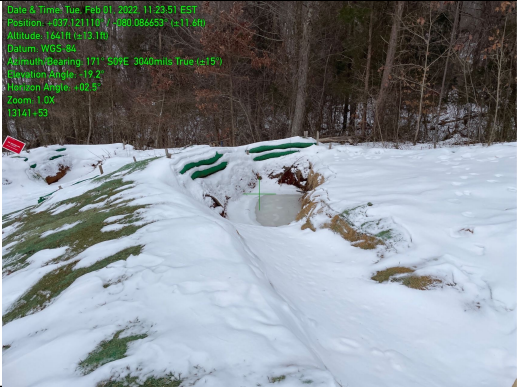
GPS Location	0	GPS Location	0
Field Station#	13141+53	Field Station#	13141+53
Pic 11 Desc.	MVP-S-D14 and Corresponding buffer zone in good condition	Pic 12 Desc.	Sump pit in good condition

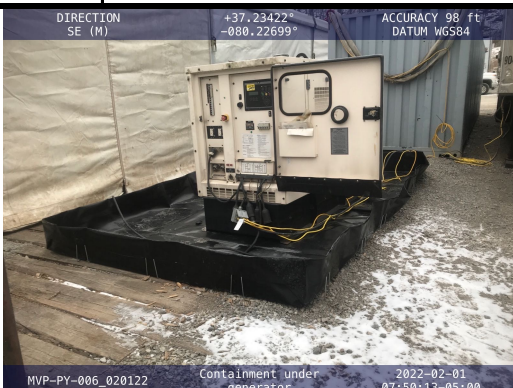
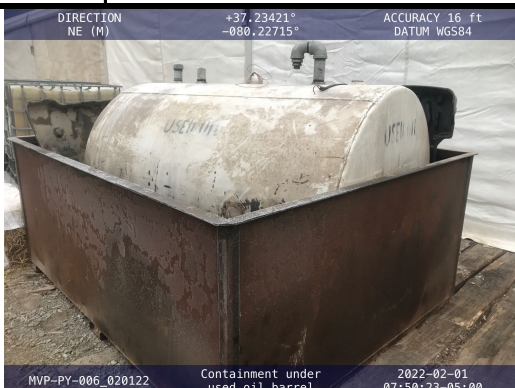
GPS Location	MVP-PY-006 See photo for gps data		GPS Location	MVP-PY-006 See photo for gps data	
Field Station#	+0		Field Station#	+0	
Pic 3 Desc.	Secondary containment under generator. Free of fluids. Looking SE.		Pic 4 Desc.	Secondary containment under used oil barrel. Free of fluids. Looking NE.

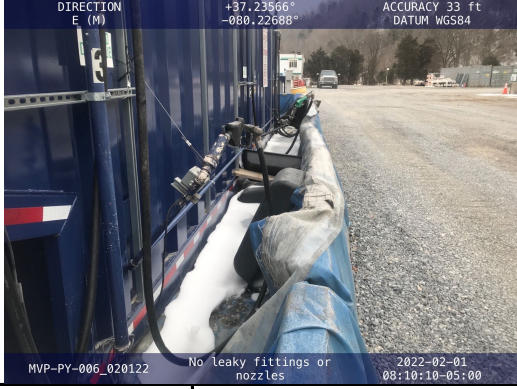
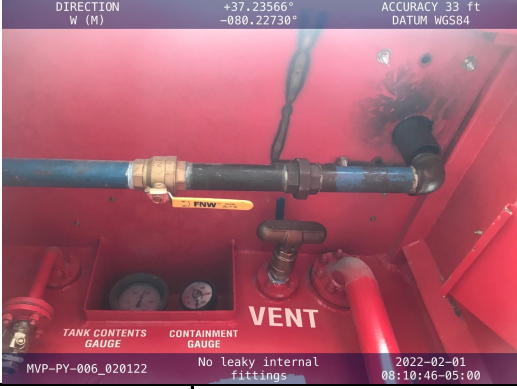
GPS Location	MVP-PY-006 See photo for gps data	GPS Location	MVP-PY-006 See photo for gps data		
Field Station#	+0	Field Station#	+0		
Pic 9 Desc.	Blue Bulk Fuel tanks no leaky fittings or nozzles. Catch pans on site. Looking E.	Pic 10 Desc.	Off Road Fuel unit no leaky internal fittings. Looking W.

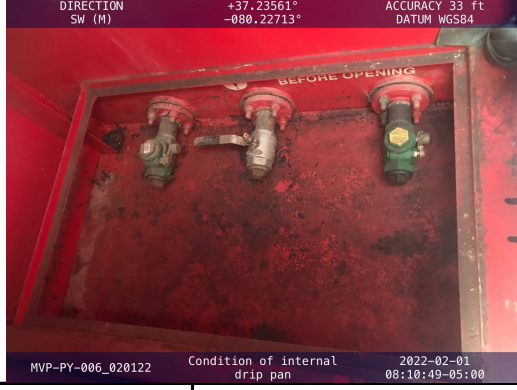
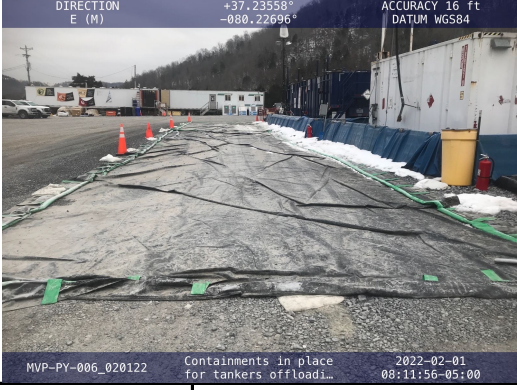
GPS Location	MVP-PY-006 See photo for gps data	GPS Location	MVP-PY-006 See photo for gps data		
Field Station#	+0	Field Station#	+0		
Pic 11 Desc.	Off Road Fuel unit condition of internal drip pan. Free of fluids. Looking SW.	Pic 12 Desc.	Secondary containment in place for tankers offloading fuel. Looking E.

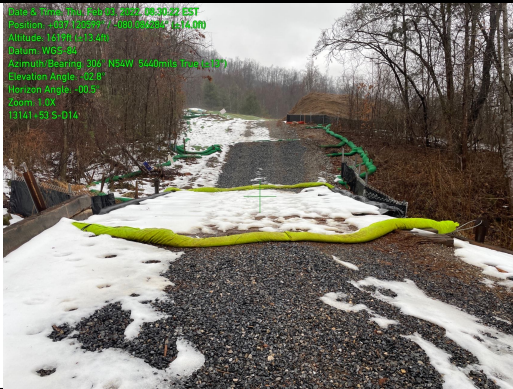
GPS Location						0					
Field Station#						13141+53					
Pic 1 Desc.						MVP-S-D14 and Corresponding buffer zone in good condition

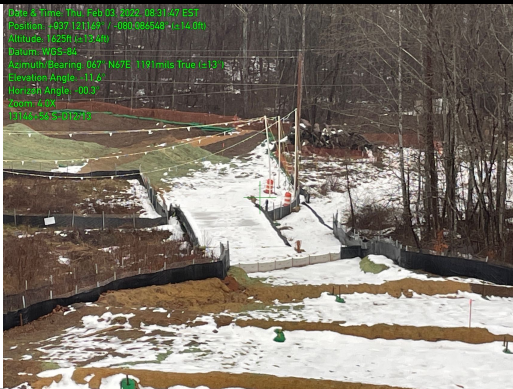
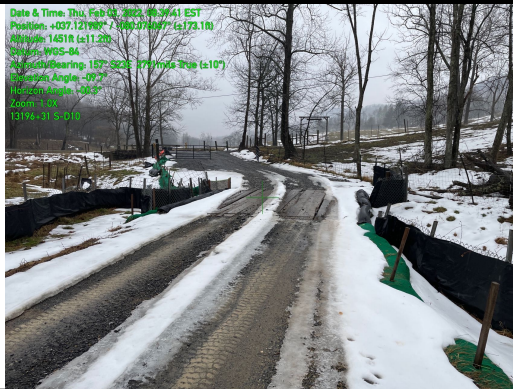
GPS Location						0					
Field Station#						13146+56					
Pic 3 Desc.						MVP-S-D12/13 and Corresponding buffer zone in good condition

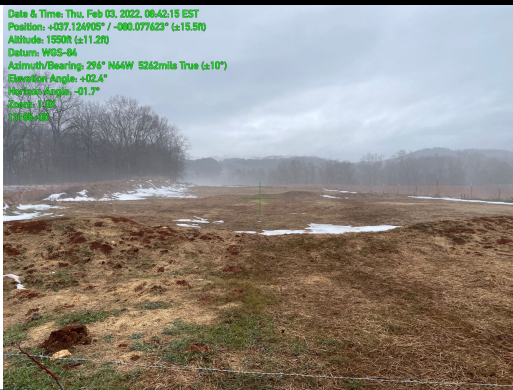
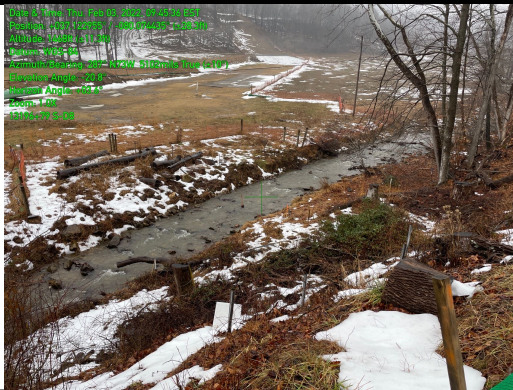
GPS Location						0					
Field Station#						13185+00					
Pic 5 Desc.						ROW and ECDs In good condition and stable					
GPS Location						0					
Field Station#						13196+79					
Pic 6 Desc.						MVP-S-D8 and Corresponding buffer zone in good condition

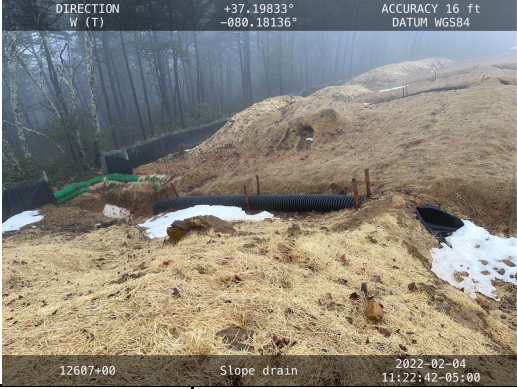
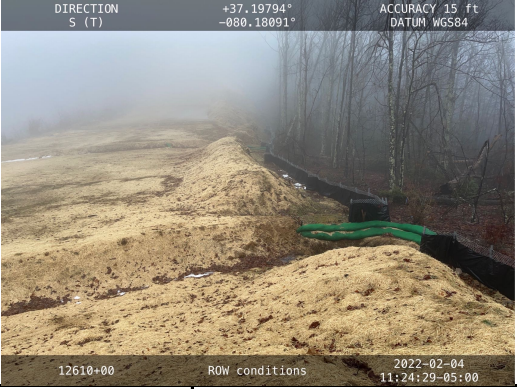
GPS Location	See photo for gps location data.		GPS Location	See photo for gps location data.	
Field Station#	12607+00		Field Station#	12610+00	
Pic 13 Desc.	Photo shows the slope drain. ECDs are installed and functioning as designed.		Pic 14 Desc.	Photo shows the ROW conditions. ECDs are installed and functioning as designed.

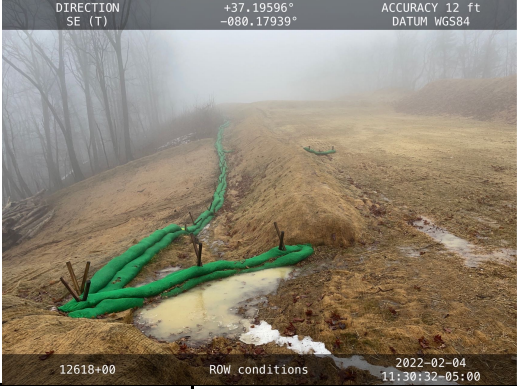
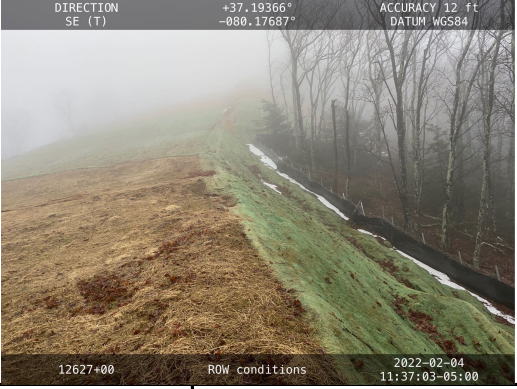
GPS Location	See photo for gps location data.		GPS Location	See photo for gps location data.	
Field Station#	12618+00		Field Station#	12627+00	
Pic 15 Desc.	Photo shows the ROW conditions. ECDs are installed and functioning as designed.		Pic 16 Desc.	Photo shows the ROW conditions. ECDs are installed and functioning as designed.

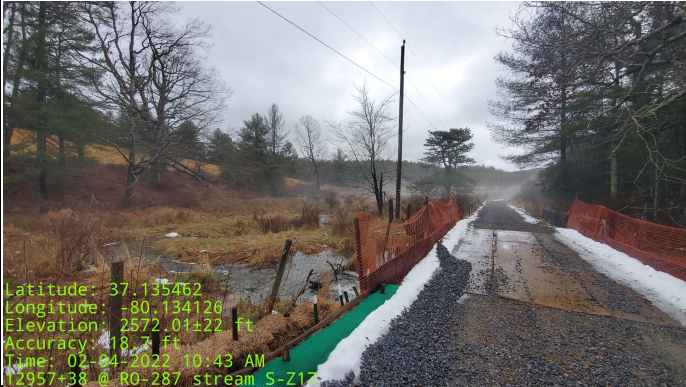
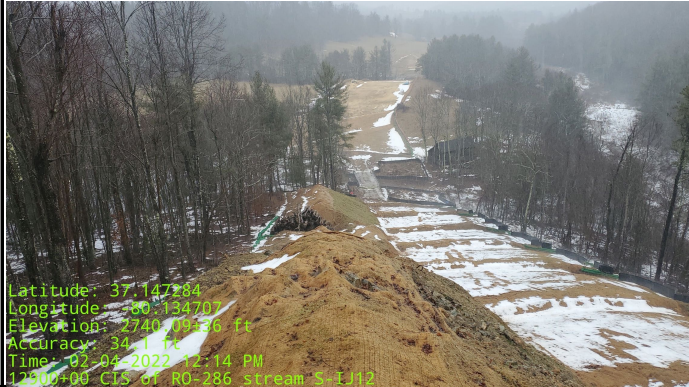
GPS Location	See pic for GPS location.		GPS Location	See pic for GPS location.	
Field Station#	12957+38		Field Station#	12900+00	
Pic 15 Desc.	Downstream side of stream S-Z17 on RO-287.		Pic 16 Desc.	Current ROW conditions at stream crossing S-IJ12.
