Visual Site Inspection Report

Project Name	H-600 Pipeline Spread H	AFE	124300138	Spread	H-600 Pipeline Spread H
Contractor	Precision			Report #	32479
Inspector	Tanner Cullop			Date/Time	12/20/2021 5:08 PM
Permit #	TBD	Inspection Type	VA SWPP	Station Begin	13316+21
State	VA	Inspection Area	Partial	Station End	13422+15
County	Franklin	Ground	Frozen	Temperature (°F)	31.00
Municipality	N/A	Weather	Sunny	Rain Gauge (in)	0.00
				Rain Accumulation Time (days)	0.00

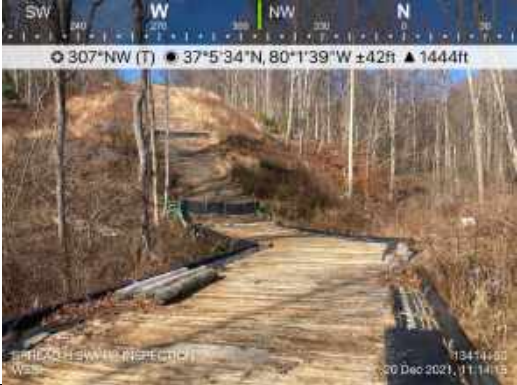
GPS Location	See photo above		GPS Location	See photo above	
Field Station#	13414+50		Field Station#	13416+50	
Pic 13 Desc.	Aquatic resource buffers are in place and functioning properly.		Pic 14 Desc.	Straw matting is in place and new vegetation has begun to establish.

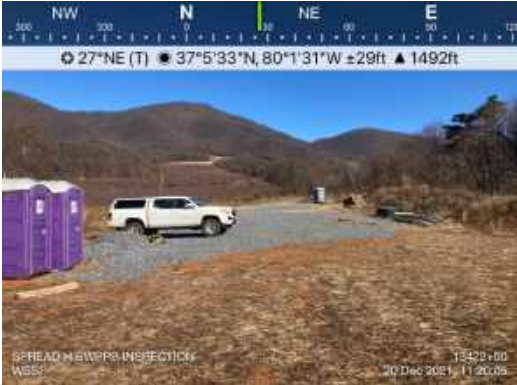
GPS Location	See photo above		GPS Location	See photo above	
Field Station#	13422+00		Field Station#	13358+50	
Pic 15 Desc.	ATWS off Cahas Mountain Rd. is in good condition.		Pic 16 Desc.	Silt fence is in good condition.

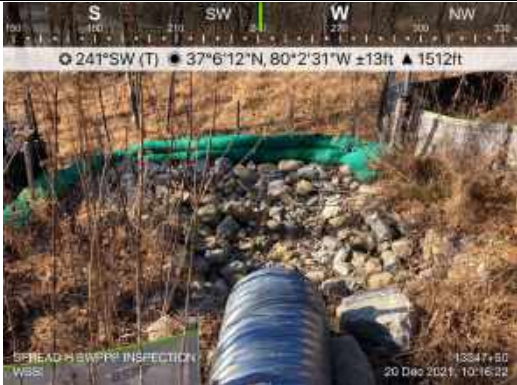
GPS Location	See photo above		GPS Location	See photo above	
Field Station#	13355+00		Field Station#	13347+50	
Pic 17 Desc.	Slopes have been temporarily stabilized and are in good condition.		Pic 18 Desc.	Plunge pools are in acceptable condition.

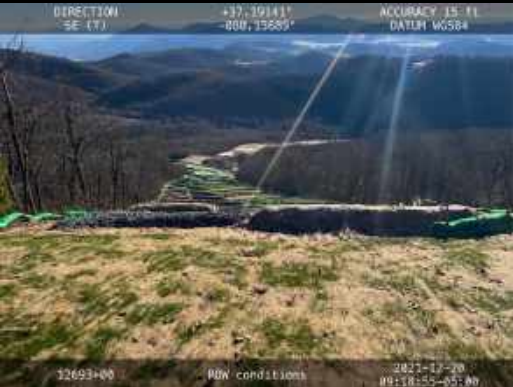
GPS Location	See photo for gps location data.		GPS Location	See photo for gps location data.	
Field Station#	12690+00		Field Station#	12693+00	
Pic 1 Desc.	Photo RCE at Honeysuckle Road.		Pic 2 Desc.	Photo shows the ROW condition. ECDs are installed and functioning as designed

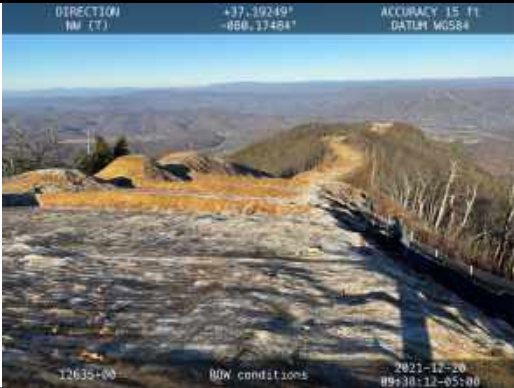
GPS Location	See photo for gps location data.		GPS Location	See photo for gps location data.	
Field Station#	12635+00		Field Station#	12634+00	
Pic 5 Desc.	Photo shows the ROW condition. ECDs are installed and functioning as designed		Pic 6 Desc.	Photo shows the slope drain.

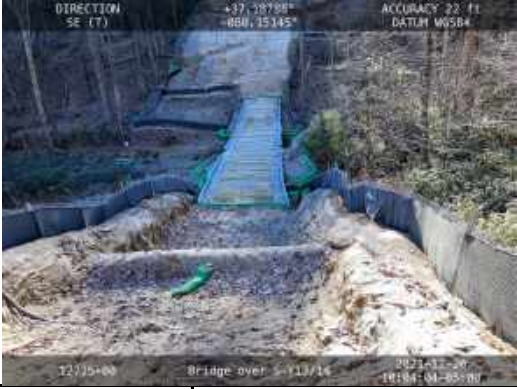
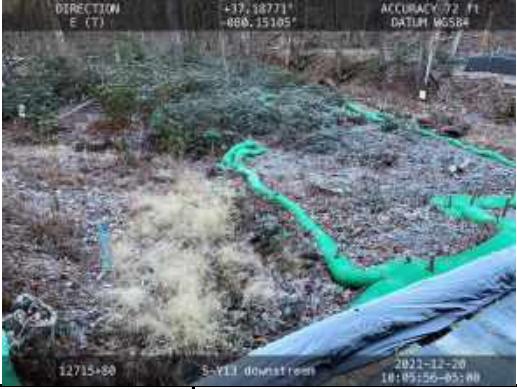
GPS Location	See photo for gps location data.		GPS Location	See photo for gps location data.	
Field Station#	12715+00		Field Station#	12715+80	
Pic 13 Desc.	Photo shows the bridge over streams S-Y13 and S-Y14.		Pic 14 Desc.	Photo shows stream S-Y13 downstream from the bridge.

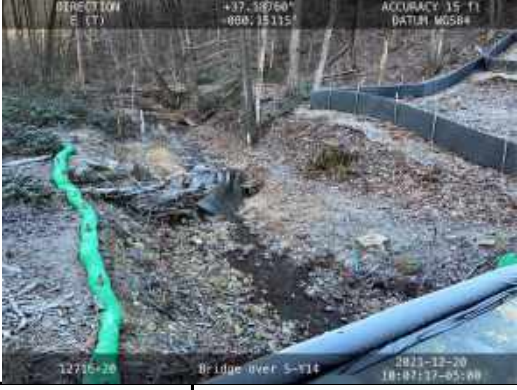
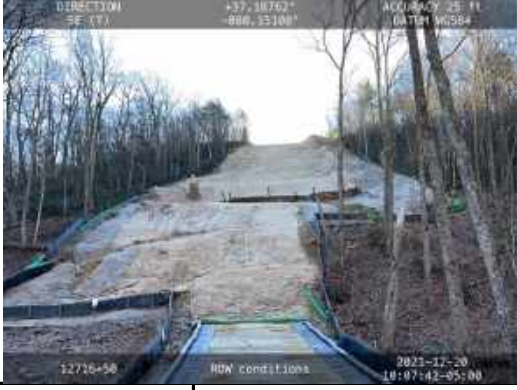
GPS Location	See photo for gps location data.		GPS Location	See photo for gps location data.	
Field Station#	12716+20		Field Station#	12716+50	
Pic 17 Desc.	Photo shows stream S-Y14 downstream from the bridge.		Pic 18 Desc.	Photo shows the ROW condition. ECDs are installed and functioning as designed

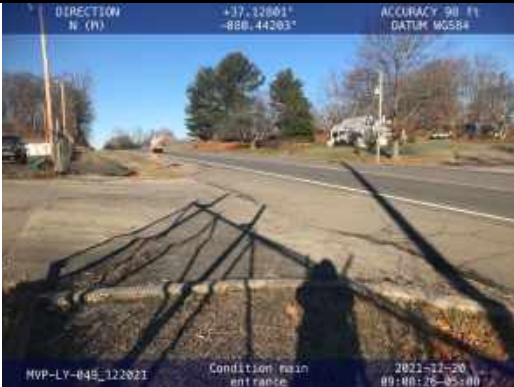
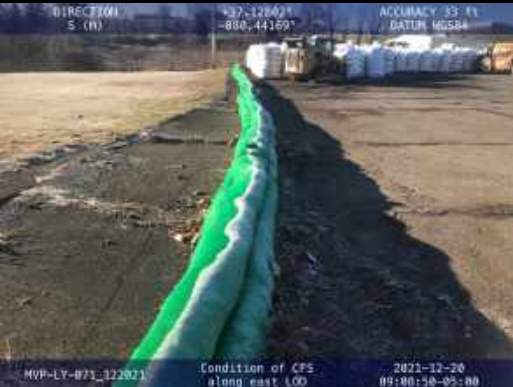
GPS Location	MVP-LY-071 See photo for gps data		GPS Location	MVP-LY-071 See photo for gps data	
Field Station#	+0		Field Station#	+0	
Pic 1 Desc.	Asphalt main entrance was free of stone, sediment, and debris. Looking N.		Pic 2 Desc.	Condition of triple stack compost filter sock along east LOD. Looking S.

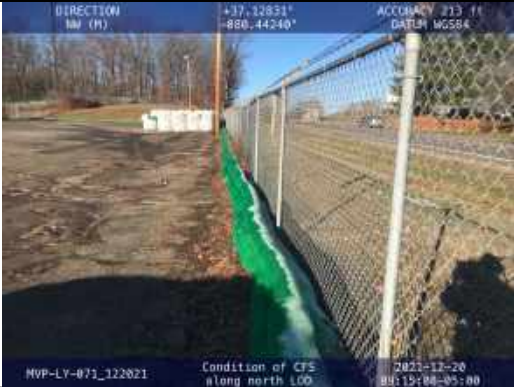
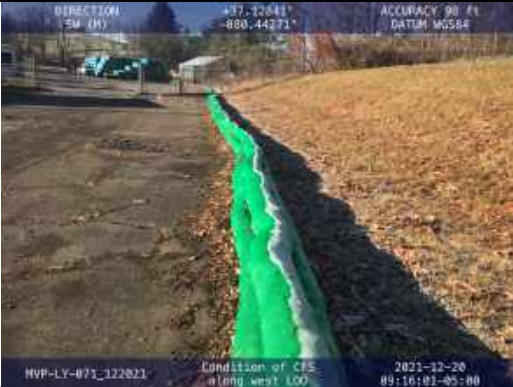
GPS Location	MVP-LY-071 See photo for gps data		GPS Location	MVP-LY-071 See photo for gps data	
Field Station#	+0		Field Station#	+0	
Pic 3 Desc.	Condition of triple stack compost filter sock along north LOD. Looking NW.		Pic 4 Desc.	Condition of triple stack compost filter sock along west LOD. Looking SW.

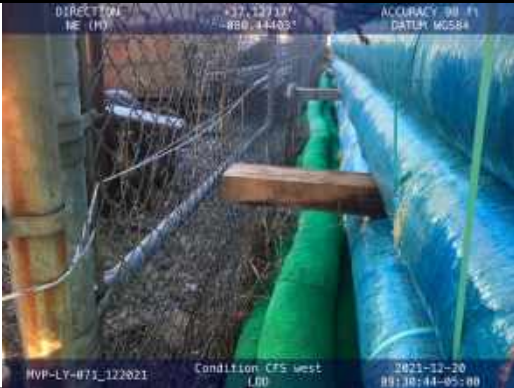
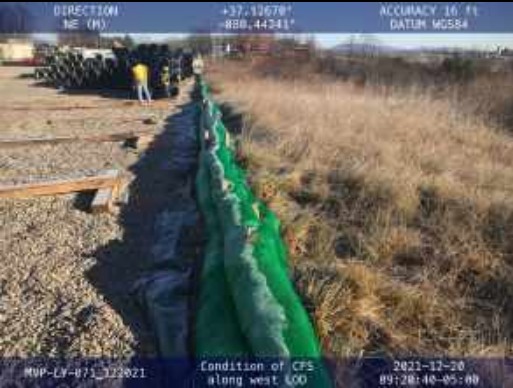
GPS Location	MVP-LY-071 See photo for gps data		GPS Location	MVP-LY-071 See photo for gps data	
Field Station#	+0		Field Station#	+0	
Pic 5 Desc.	Condition of triple stack compost filter sock along west LOD. Looking NE.		Pic 6 Desc.	Condition of triple stack compost filter sock along east LOD. Looking NE.

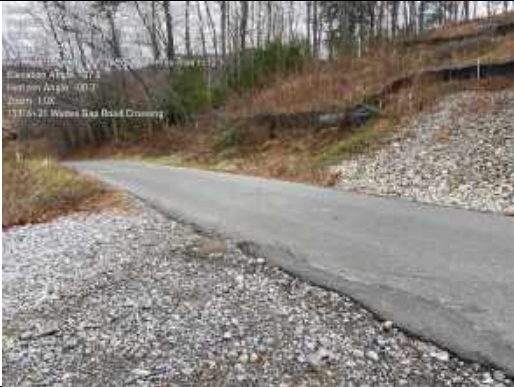
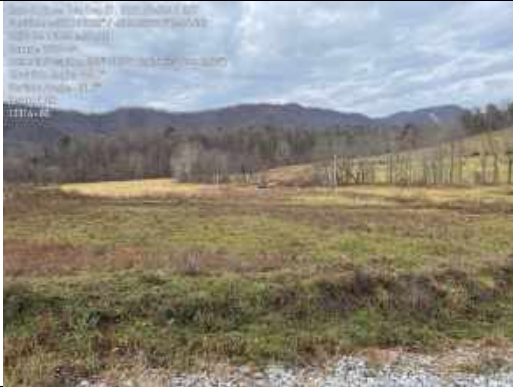
GPS Location	0	GPS Location	0		
Field Station#	13316+21	Field Station#	13314+00		
Pic 1 Desc.	Wades Gap Road Crossing in good condition	Pic 2 Desc.	ROW and ECDs In good condition with good vegetation established across ROW

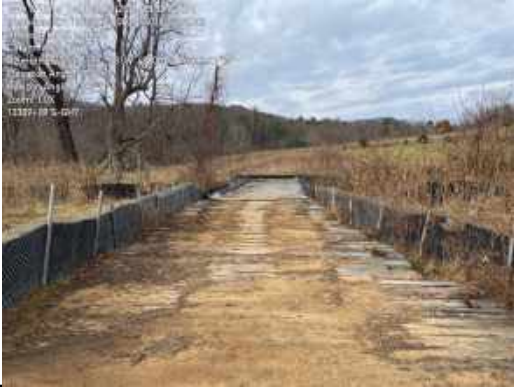
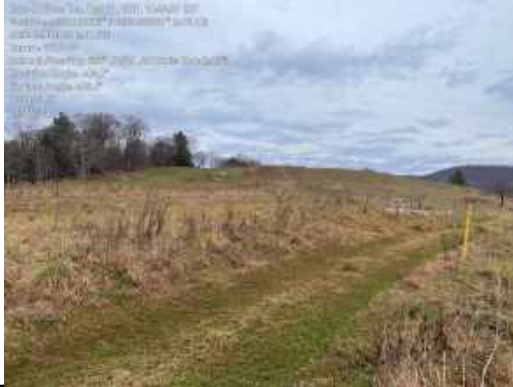
GPS Location	0	GPS Location	0		
Field Station#	13309+09	Field Station#	13306+00		
Pic 3 Desc.	MVP-S-GH7 and Corresponding buffer zone in good condition	Pic 4 Desc.	ROW and ECDs In good condition with good vegetation established across ROW

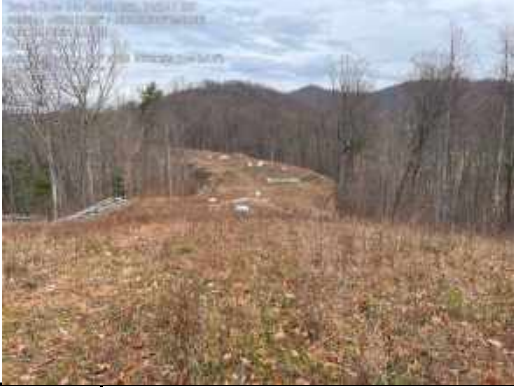
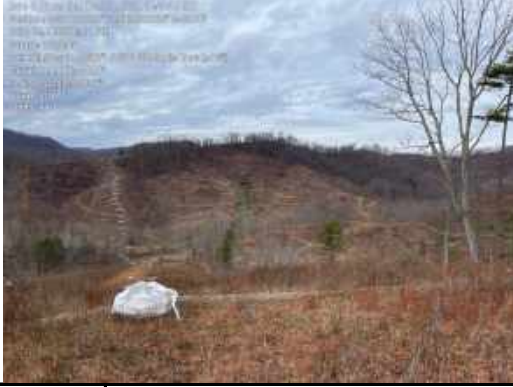
GPS Location	0	GPS Location	0		
Field Station#	13190+00	Field Station#	13273+50		
Pic 5 Desc.	ROW and ECDs In good condition with good vegetation established across ROW	Pic 6 Desc.	Overview of logging activities ongoing adjacent to ROW. Not associated with the project

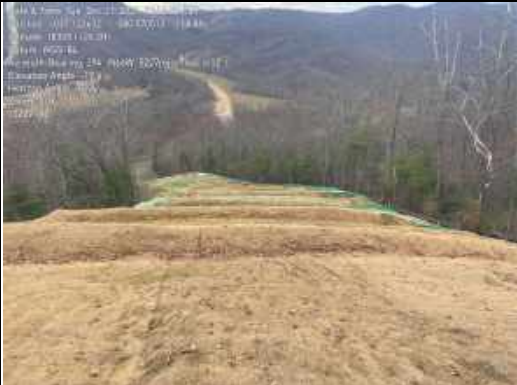
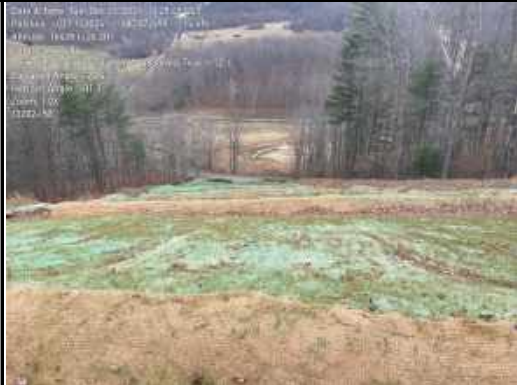
GPS Location	0		GPS Location	0	
Field Station#	13209+00		Field Station#	13202+50	
Pic 13 Desc.	ROW and ECDs In good condition and stable		Pic 14 Desc.	ROW and ECDs In good condition and stable

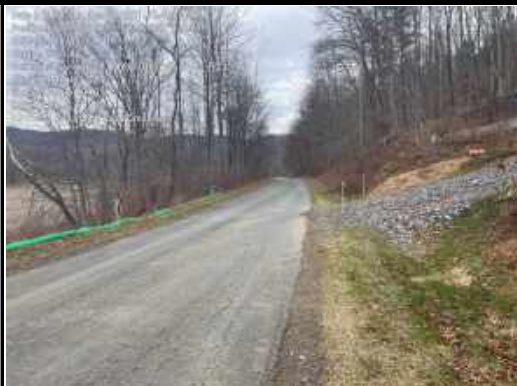
GPS Location	0		GPS Location	0	
Field Station#	13198+35		Field Station#	13297+55	
Pic 15 Desc.	RCE in good condition and functioning properly		Pic 16 Desc.	Dillion Mill Road Crossing in good condition

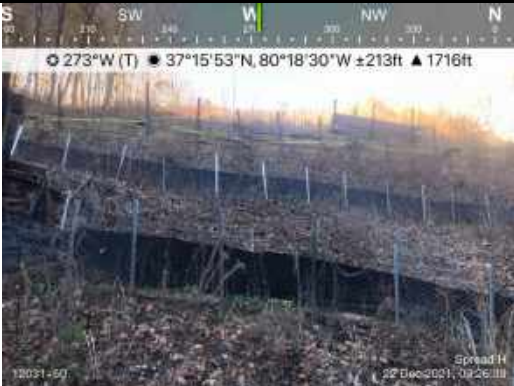
GPS Location	See photo above		GPS Location	See photo above	
Field Station#	12031+50		Field Station#	12031+50	
Pic 5 Desc.	SSF and perimeter controls are functioning properly and in good condition.		Pic 6 Desc.	PPL footpath is well marked, easily accessible, and in acceptable condition.

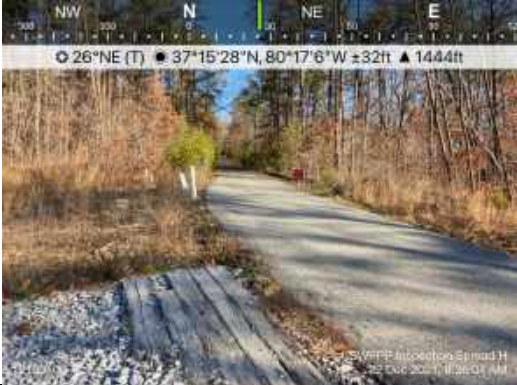
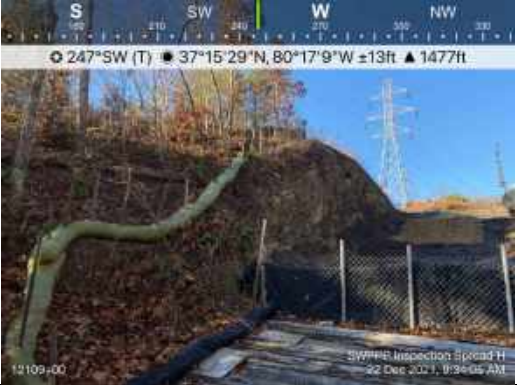
GPS Location	See photo above		GPS Location	See photo above	
Field Station#	12109+00		Field Station#	12108+40	
Pic 13 Desc.	Access roads and construction entrances are clear and in good condition.		Pic 14 Desc.	Stream crossings and perimeter controls are functioning properly. No maintenance is needed.

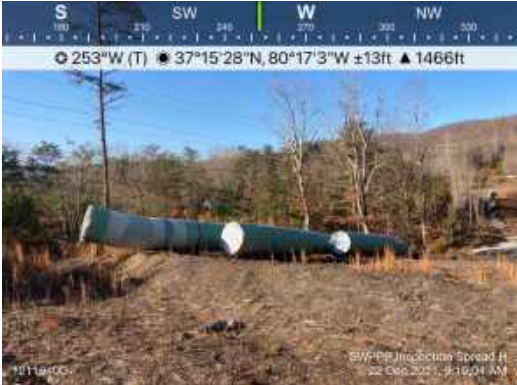
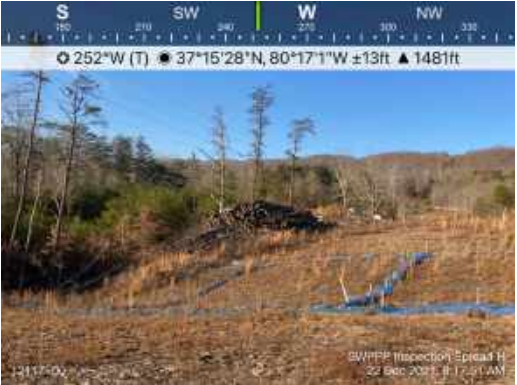
GPS Location	See photo above		GPS Location	See photo above	
Field Station#	12116+00		Field Station#	12117+60	
Pic 15 Desc.	Materials stored along the ROW are in acceptable condition.		Pic 16 Desc.	Erosion control measures including CFS are present and in good condition.

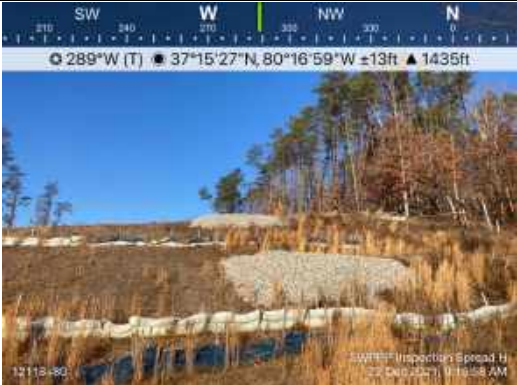
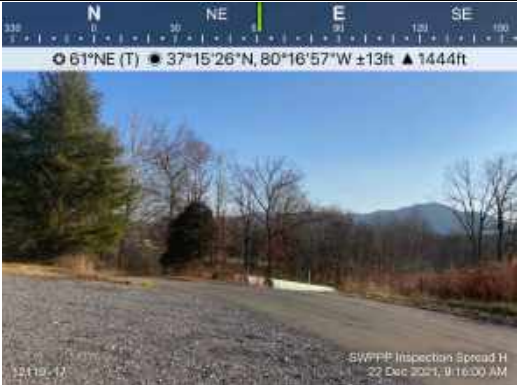
GPS Location	See photo above		GPS Location	See photo above	
Field Station#	12118+50		Field Station#	12119+17	
Pic 17 Desc.	Rock check dams and end treatments are present and in acceptable condition. No maintenance is needed.		Pic 18 Desc.	Gravel construction entrance off of Flatwoods Road is in good condition.

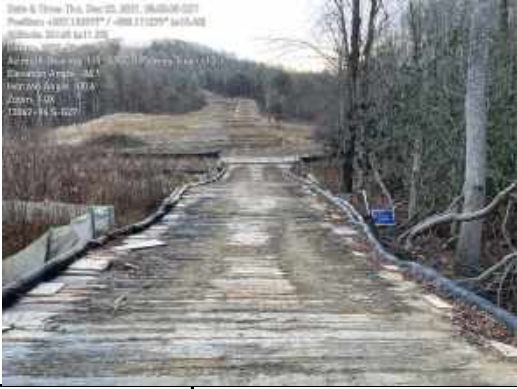
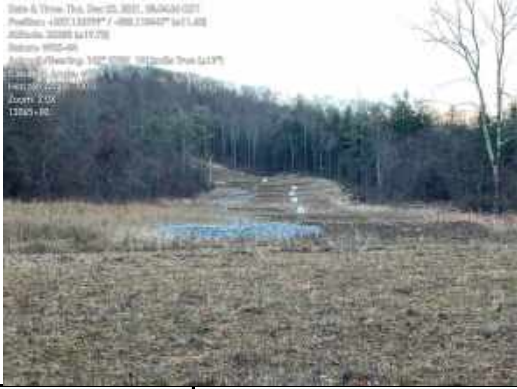
GPS Location	0	GPS Location	0		
Field Station#	13062+96	Field Station#	13065+00		
Pic 7 Desc.	MVP-S-G27 and Corresponding buffer zone in good condition	Pic 8 Desc.	ROW and ECDs In good condition with good vegetation established across ROW

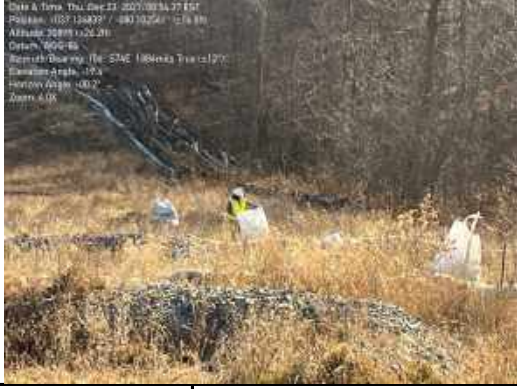
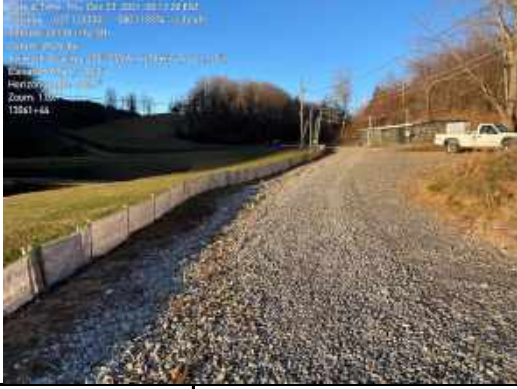
GPS Location	0	GPS Location	0		
Field Station#	13092+00	Field Station#	13061+44		
Pic 9 Desc.	Crews removing triple stack sock and cleaning up debris	Pic 10 Desc.	Perimeter controls in good condition

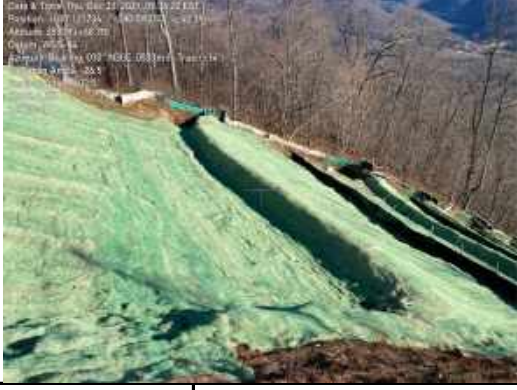
GPS Location	0	GPS Location	0		
Field Station#	13116+00	Field Station#	13120+00		
Pic 11 Desc.	ROW and ECDs In good condition and stable	Pic 12 Desc.	ROW and ECDs In good condition and stable

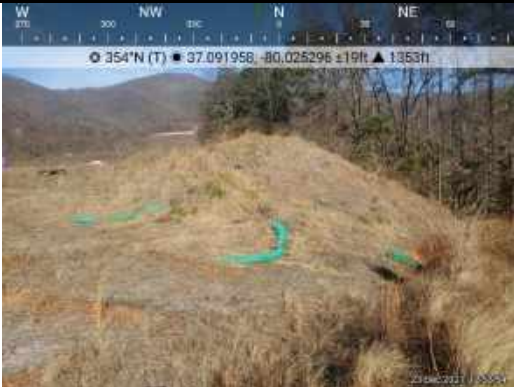
GPS Location	0	GPS Location	0		
Field Station#	13420+00	Field Station#	13423+00		
Pic 1 Desc.	CFS Checks and sump	Pic 2 Desc.	Perimeter CFS

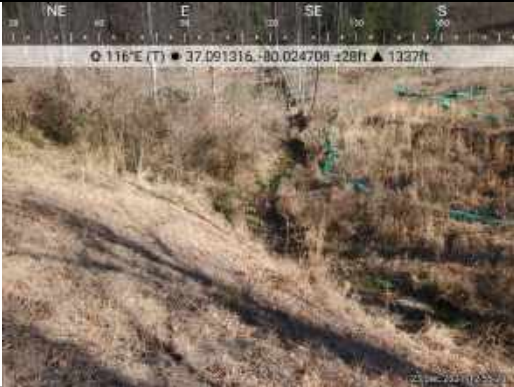
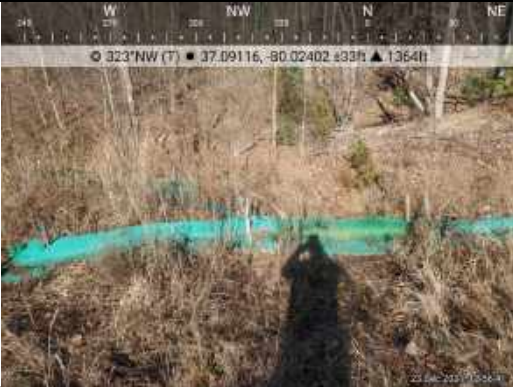
GPS Location	0	GPS Location	0		
Field Station#	13424+50	Field Station#	13427+00		
Pic 3 Desc.	CIS S-IJ4 Banks	Pic 4 Desc.	Repaired CFS

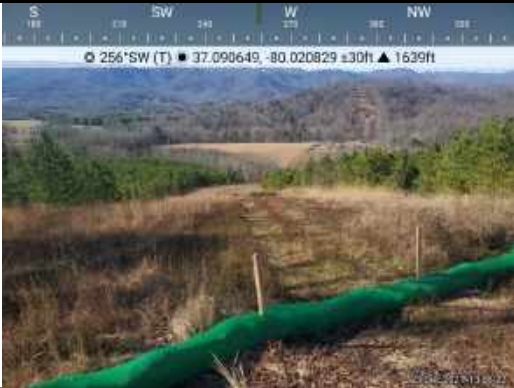
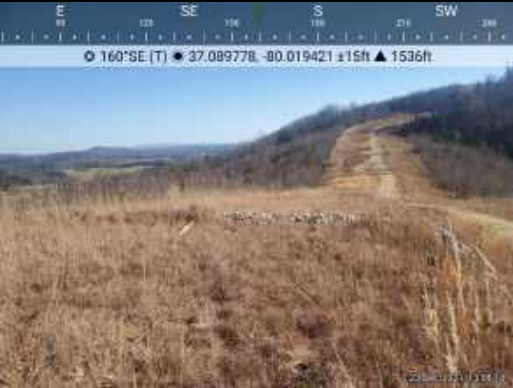
GPS Location	0	GPS Location	0		
Field Station#	13433+00	Field Station#	13442+00		
Pic 5 Desc.	CFS check	Pic 6 Desc.	Stone Waterbar outlet protection

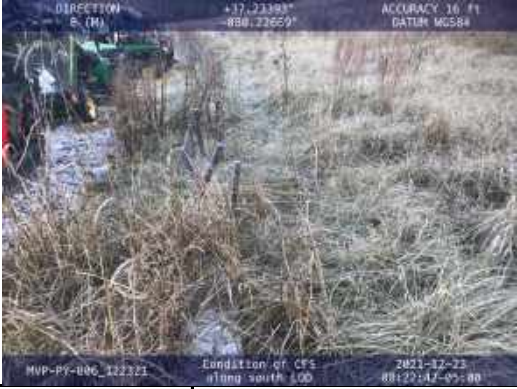
GPS Location	MVP-PY-006 See photo for gps data	GPS Location	MVP-PY-006 See photo for gps data		
Field Station#	+0	Field Station#	+0		
Pic 7 Desc.	Condition of triple stack compost filter sock along south LOD. Over grown with vegetation. Looking E.	Pic 8 Desc.	Secondary containment under refrigeration unit catching fluids. Looking W.

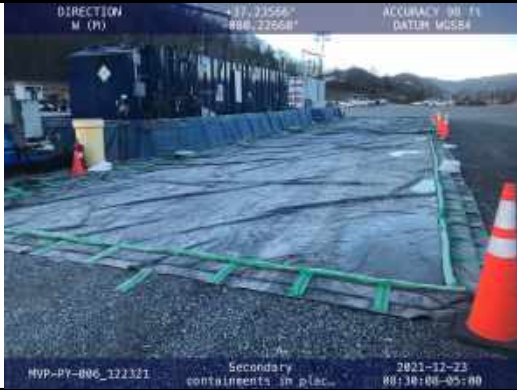
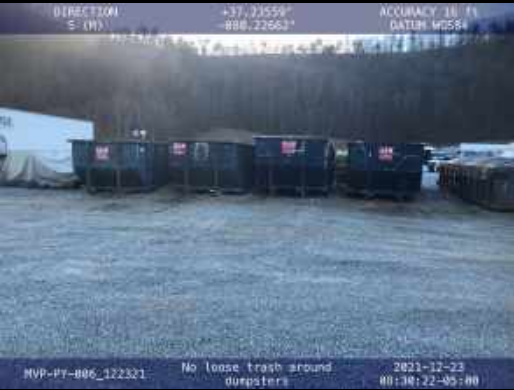
GPS Location	MVP-PY-006 See photo for gps data	GPS Location	MVP-PY-006 See photo for gps data		
Field Station#	+0	Field Station#	+0		
Pic 9 Desc.	Secondary containment in place for tankers offloading fuel. Looking W.	Pic 10 Desc.	No loose trash around dumpsters or in the yard. Looking S.

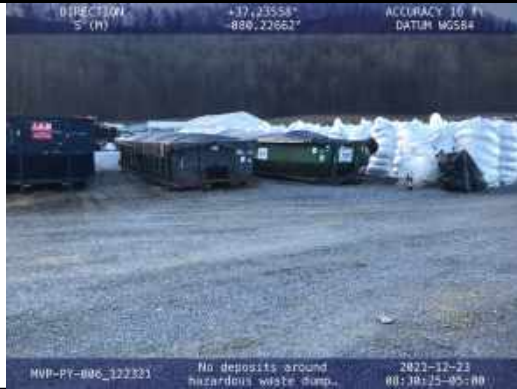
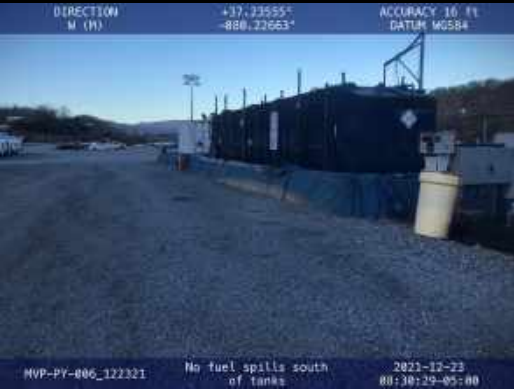
GPS Location	MVP-PY-006 See photo for gps data	GPS Location	MVP-PY-006 See photo for gps data		
Field Station#	+0	Field Station#	+0		
Pic 11 Desc.	No deposits or fluids around hazardous waste dumpsters. Looking S.	Pic 12 Desc.	Blue Bulk Fuel tanks no fuel spills south of the tanks. Looking W.

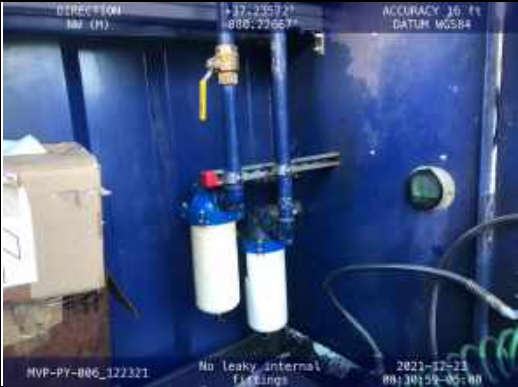
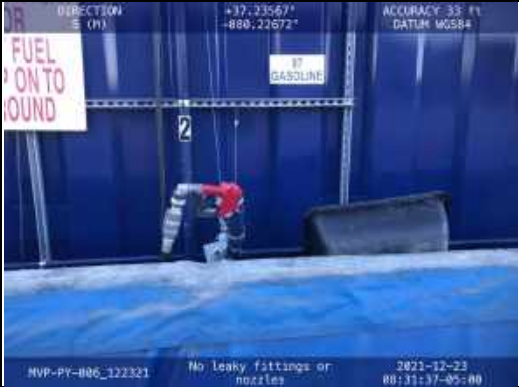
GPS Location	MVP-PY-006 See photo for gps data	GPS Location	MVP-PY-006 See photo for gps data		
Field Station#	+0	Field Station#	+0		
Pic 13 Desc.	Blue Bulk Fuel tanks no leaky internal fittings. Looking NW.	Pic 14 Desc.	Blue Bulk Fuel tanks no leaky fittings or nozzles, catch pans on site. Looking S.

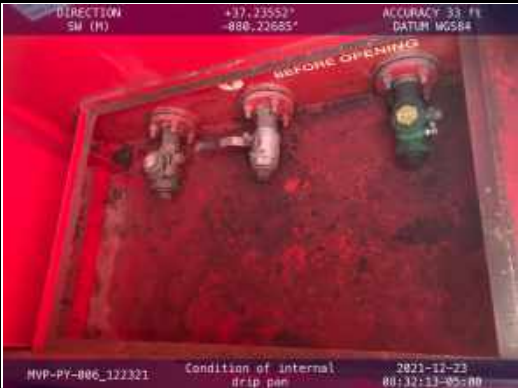
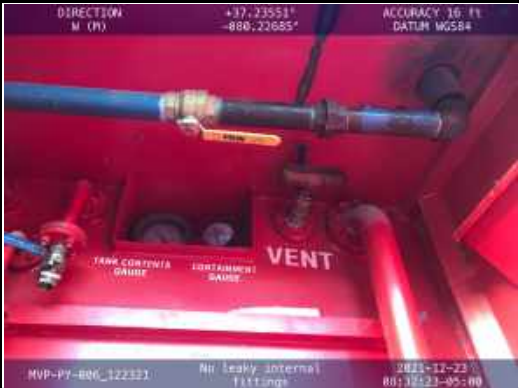
GPS Location	MVP-PY-006 See photo for gps data	GPS Location	MVP-PY-006 See photo for gps data		
Field Station#	+0	Field Station#	+0		
Pic 15 Desc.	Off Road Fuel unit condition of internal drip pan. Free of fluids. Looking SW.	Pic 16 Desc.	Off Road Fuel unit no leaky internal fittings. Looking W.

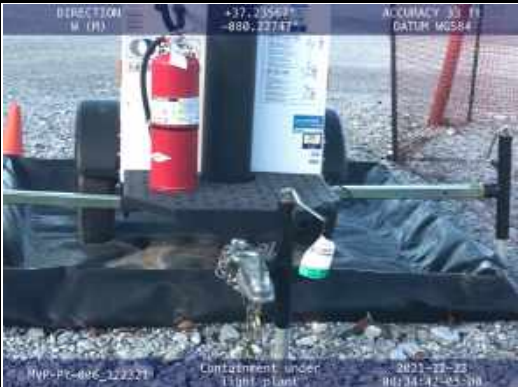
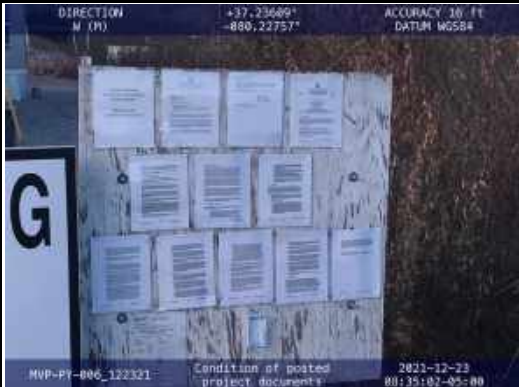
GPS Location	MVP-PY-006 See photo for gps data	GPS Location	MVP-PY-006 See photo for gps data		
Field Station#	+0	Field Station#	+0		
Pic 17 Desc.	Secondary containment under light plant holding some fluids. Looking W.	Pic 18 Desc.	Condition of posted project documents at the main entrance to the yard. Looking W.

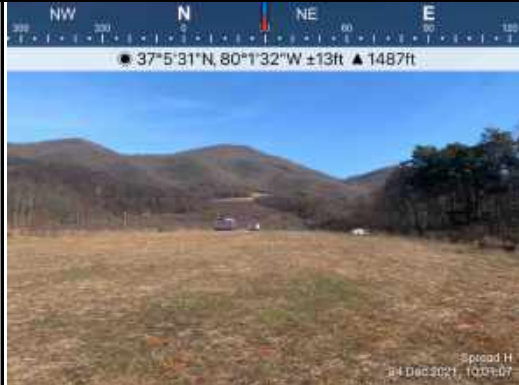
GPS Location	See Photograph		GPS Location	See Photograph	
Field Station#	13344+00		Field Station#	13422+00	
Pic 7 Desc.	EC blanket is in place and in acceptable condition. ROW is stable		Pic 8 Desc.	ATWS and construction entrance adjacent to Cahas road is in acceptable condition.

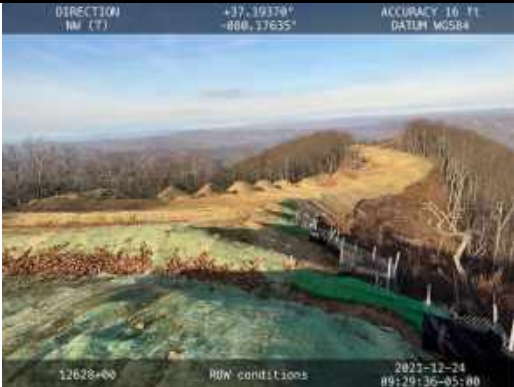
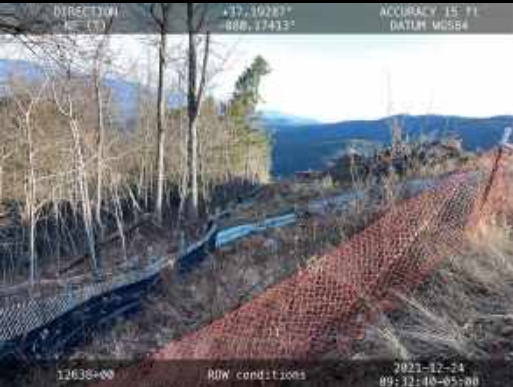
GPS Location	See photo for gps location data.		GPS Location	See photo for gps location data.	
Field Station#	12628+00		Field Station#	12638+00	
Pic 1 Desc.	Photo shows the ROW condition. ECDs are installed and functioning as designed.		Pic 2 Desc.	Photo shows the ROW condition. ECDs are installed and functioning as designed.

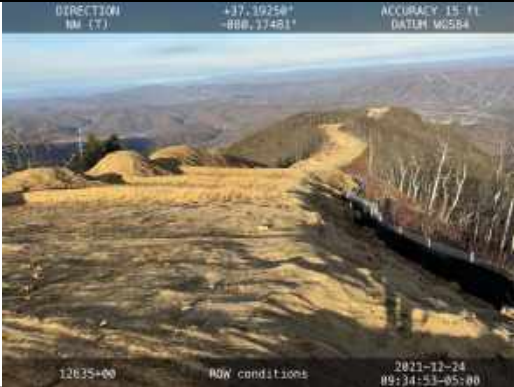
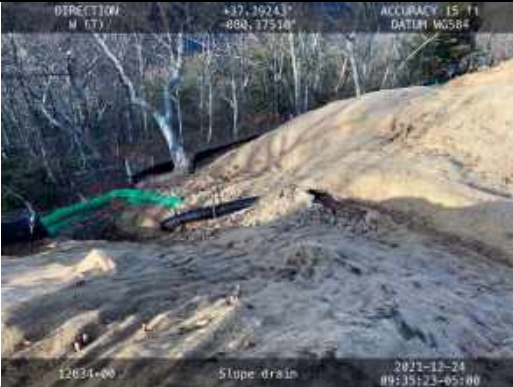
GPS Location	See photo for gps location data.		GPS Location	See photo for gps location data.	
Field Station#	12635+00		Field Station#	12634+00	
Pic 3 Desc.	Photo shows the ROW condition. ECDs are installed and functioning as designed.		Pic 4 Desc.	Photo shows the slope drain.

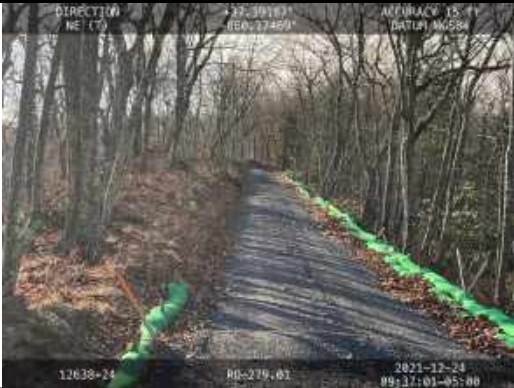
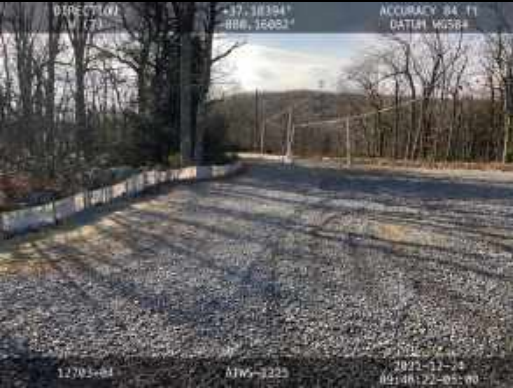
GPS Location	See photo for gps location data.		GPS Location	See photo for gps location data.	
Field Station#	12638+24		Field Station#	12703+04	
Pic 5 Desc.	Photo shows access road RO-279.01.		Pic 6 Desc.	Photo shows ECDs along ATWS-1225.

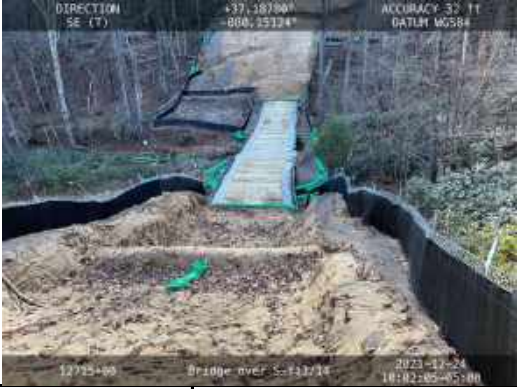
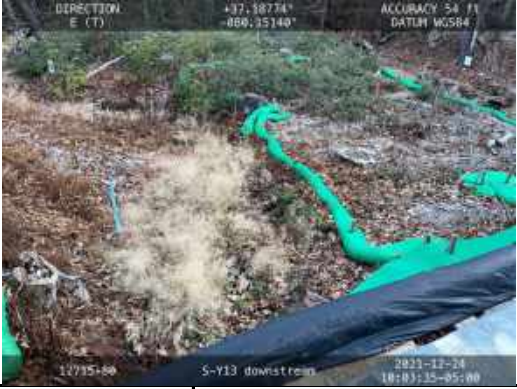
GPS Location	See photo for gps location data.		GPS Location	See photo for gps location data.	
Field Station#	12715+00		Field Station#	12715+80	
Pic 13 Desc.	Photo shows the bridge over streams S-Y13 and S-Y14.		Pic 14 Desc.	Photo shows stream S-Y13 downstream from the bridge.

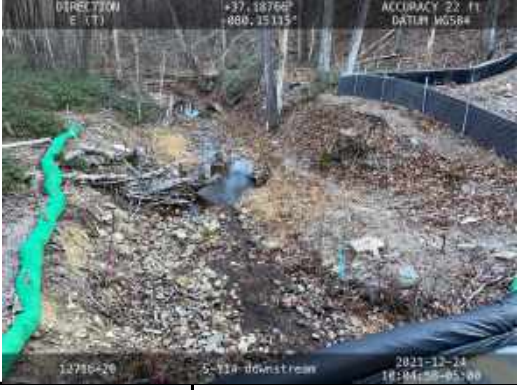
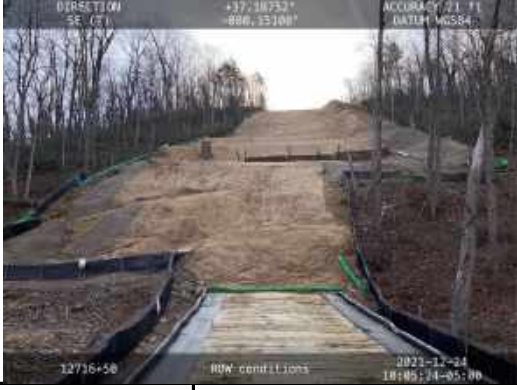
GPS Location	See photo for gps location data.		GPS Location	See photo for gps location data.	
Field Station#	12716+20		Field Station#	12716+50	
Pic 17 Desc.	Photo shows stream S-Y14 downstream from the bridge.		Pic 18 Desc.	Photo shows the ROW condition. ECDs are installed and functioning as designed.

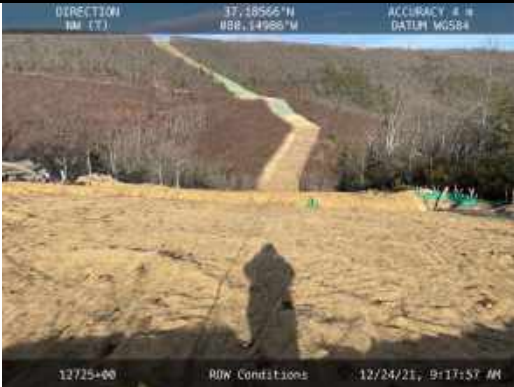
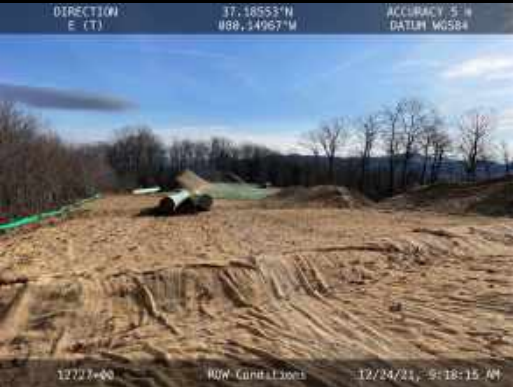
GPS Location	See photo		GPS Location	See photo	
Field Station#	12725+00		Field Station#	12727+00	
Pic 1 Desc.	Current ROW conditions. ROW is stable. ECDs are functional.		Pic 2 Desc.	Current ROW conditions. ROW is stable. ECDs are functional.

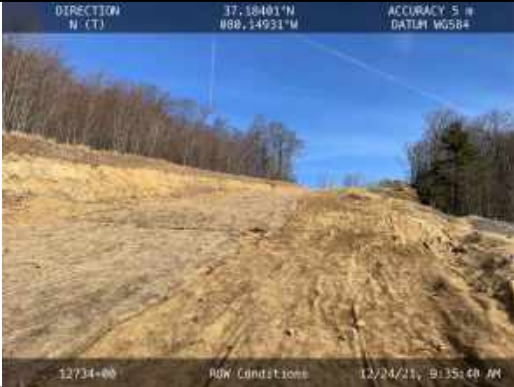
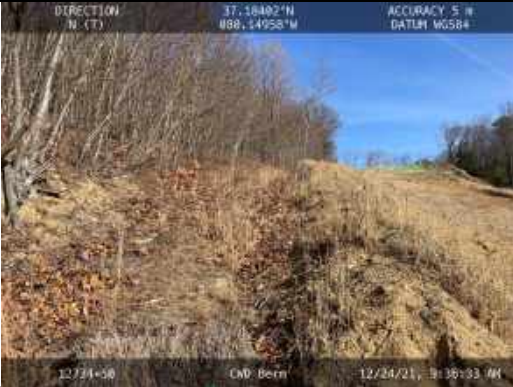
GPS Location	See photo		GPS Location	See photo	
Field Station#	12734+00		Field Station#	12734+50	
Pic 3 Desc.	Current ROW conditions. ROW is stable. ECDs are functional.		Pic 4 Desc.	CWD Berm is stable and functional.

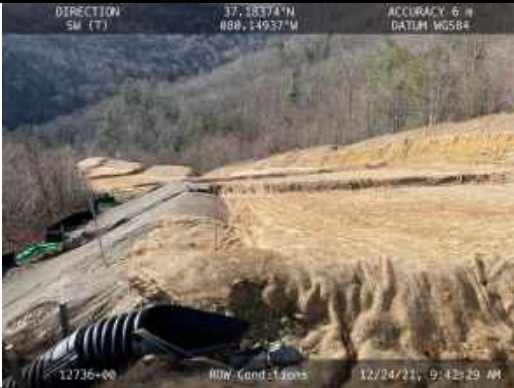
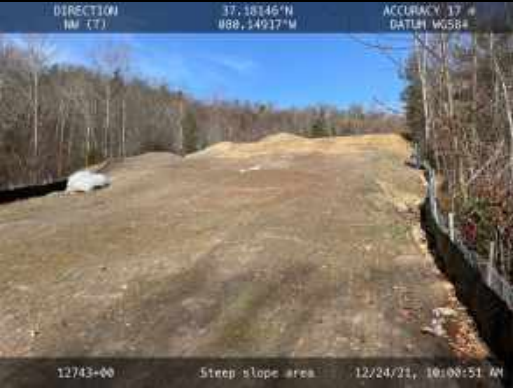
GPS Location	See photo		GPS Location	See photo	
Field Station#	12736+00		Field Station#	12743+00	
Pic 5 Desc.	Current ROW conditions. ROW is stable. ECDs are functional.		Pic 6 Desc.	Current ROW conditions. ROW is stable. ECDs are functional.
