# Visual Site Inspection Report

<b>Project Name</b>	H-600 Pipeline Spread H	<b>AFE</b>	124300138	<b>Spread</b>	H-600 Pipeline Spread H
<b>Contractor</b>	Precision			<b>Report #</b>	34647
<b>Inspector</b>	Bryan Cole			<b>Date/Time</b>	2/21/2022 2:16 PM
<b>Permit #</b>	TBD	<b>Inspection Type</b>	VA SWPP	<b>Station Begin</b>	13141+65
<b>State</b>	VA	<b>Inspection Area</b>	Partial	<b>Station End</b>	13316+21
<b>County</b>	Franklin	<b>Ground</b>	Damp	<b>Temperature (°F)</b>	59.00
<b>Municipality</b>	N/A	<b>Weather</b>	Sunny	<b>Rain Gauge (in)</b>	0.00
				<b>Rain Accumulation Time (days)</b>	0.00

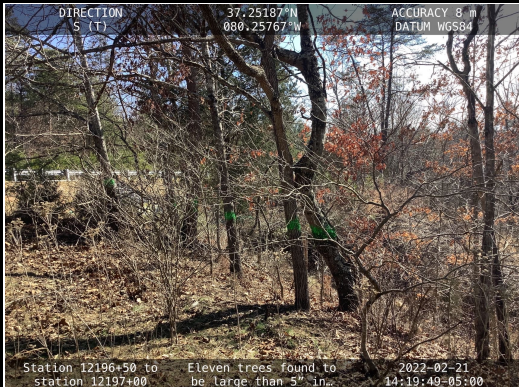
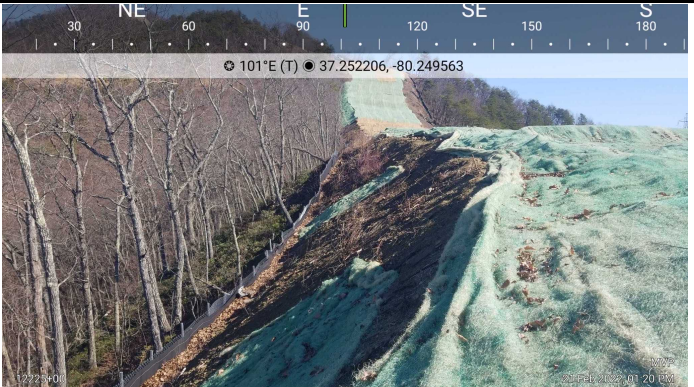
Insert image here	
GPS Location	Please see photo for details.		GPS Location	Please see photo for details.	
Field Station#	12196+50		Field Station#	12225+00	
Pic 17 Desc.	Elven trees from station 12196+00 to station 12196+50 that were spray painted green due to being over 5" in diameter.		Pic 18 Desc.	Photo shows punch list maintenance item added today. Curlex was blown out of place due to windy weather conditions.

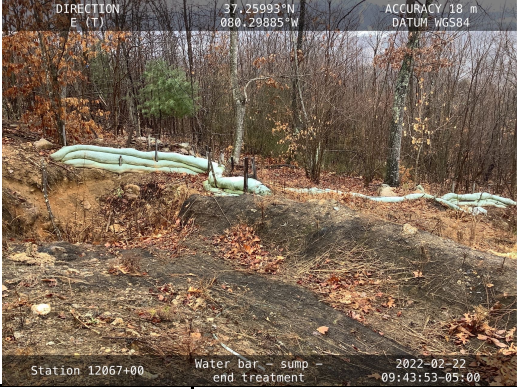
<p>DIRECTION E (T) 37.25993°N 080.29885°W ACCURACY 18 m DATUM WGS84</p> <p>Station 12067+00 Water bar - sump - end treatment 2022-02-22 09:43:53-05:00</p>

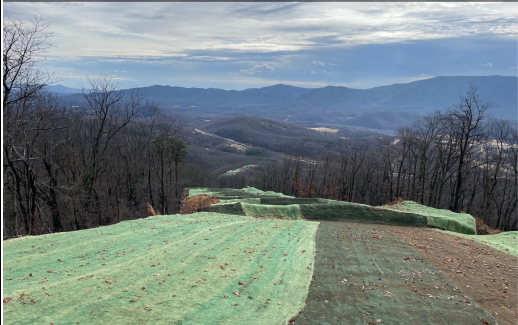
<div>12310+00      ROW Conditions      2/23/22, 9:56:02 AM</div> </div>				<div> <div>DIRECTION S (T)</div> <div>37.25263°N 080.21705°W</div> <div>ACCURACY 5 m DATUM WGS84</div>

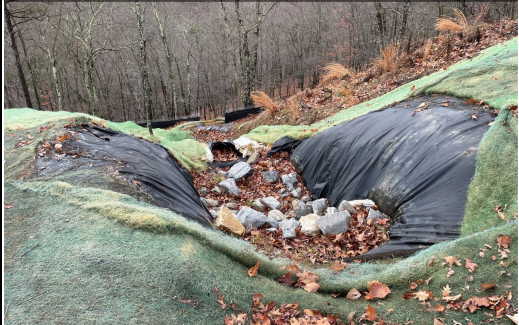
<div>12330+00      Slope drain      2/23/22, 10:09:56 AM</div> </div>	
GPS Location	Please see photo for details.		GPS Location	Please see photo for details.	
Field Station#	123+10		Field Station#	12330+00	
Pic 13 Desc.	Photo shows the stabilized ROW conditions with water bars and that all ECDs are installed and are functioning as designed.		Pic 14 Desc.	Photo shows slope drain inlet.	
<div> <div>DIRECTION E (T)</div> <div>37.25285°N 080.21418°W</div> <div>ACCURACY 13 m DATUM WGS84</div>

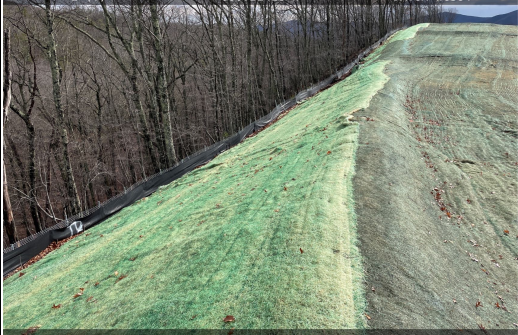
<div>12338+00      Full slope is stable      2/23/22, 10:15:17 AM</div> </div>				<div> <div>DIRECTION S (T)</div> <div>37.25272°N 080.21586°W</div> <div>ACCURACY 4 m DATUM WGS84</div>

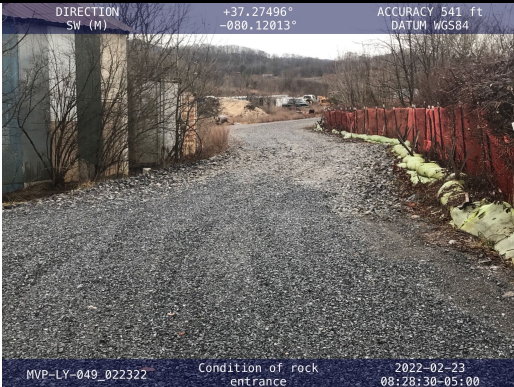
<p>DIRECTION SW (M) +37.27496° -080.12013° ACCURACY 541 ft DATUM WGS84</p> <p>MVP-LY-049_022322 Condition of rock entrance 2022-02-23 08:28:30-05:00</p>

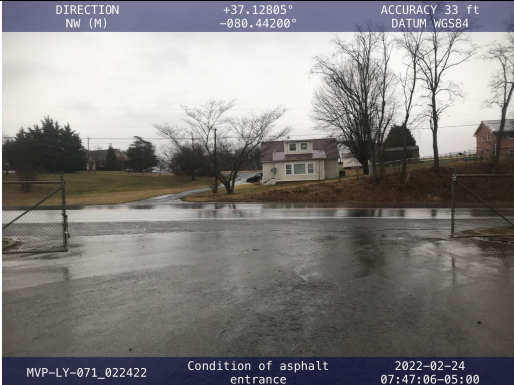
<p>DIRECTION NW (M) +37.12805° -080.44200° ACCURACY 33 ft DATUM WGS84</p> <p>MVP-LY-071_022422 Condition of asphalt entrance 2022-02-24 07:47:06-05:00</p>

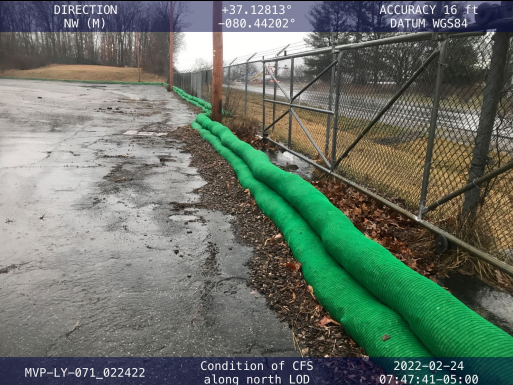
<p>DIRECTION NW (M) +37.12813° -080.44202° ACCURACY 16 ft DATUM WGS84</p> <p>MVP-LY-071_022422 Condition of CFS along north LOD 2022-02-24 07:47:41-05:00</p>			
<b>GPS Location</b>	MVP-LY-071 See photo for gps data		<b>GPS Location</b>	MVP-LY-071 See photo for gps data	
<b>Field Station#</b>	+0		<b>Field Station#</b>	+0	
<b>Pic 1 Desc.</b>	Condition of asphalt entrance. No sediment or debris on entrance. Looking NW.		<b>Pic 2 Desc.</b>	Condition of triple stack compost filter sock along north LOD. Looking NW.

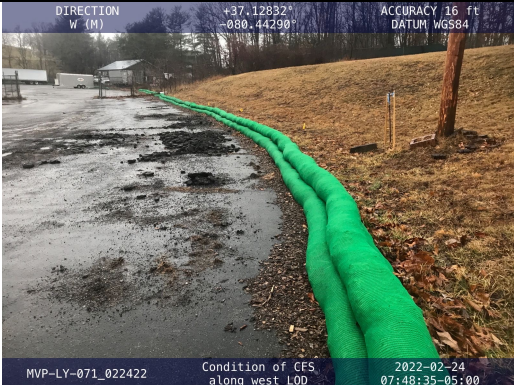
<p>DIRECTION W (M) +37.12832° -080.44290° ACCURACY 16 ft DATUM WGS84</p> <p>MVP-LY-071_022422 Condition of CFS along west LOD 2022-02-24 07:48:35-05:00</p>

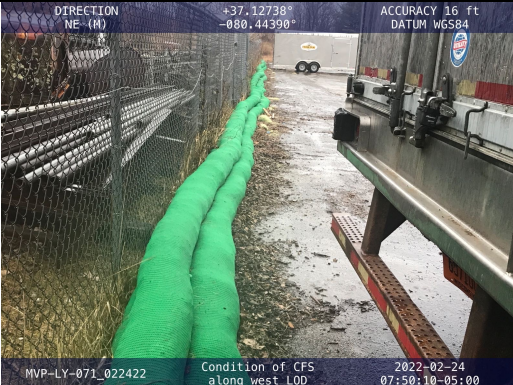
<p>DIRECTION NE (M) +37.12738° -080.44390° ACCURACY 16 ft DATUM WGS84</p> <p>MVP-LY-071_022422 Condition of CFS along west LOD 2022-02-24 07:50:10-05:00</p>

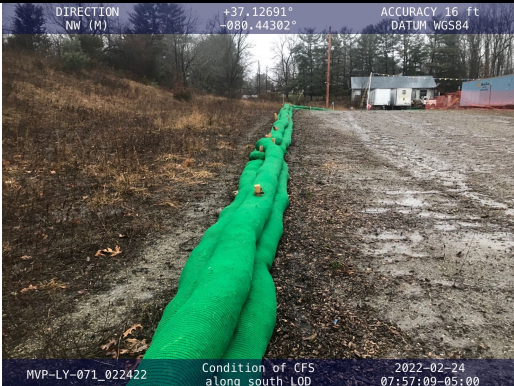
<p>DIRECTION NW (M) +37.12691° -080.44302° ACCURACY 16 ft DATUM WGS84</p> <p>MVP-LY-071_022422 Condition of CFS along south LOD 2022-02-24 07:57:09-05:00</p>

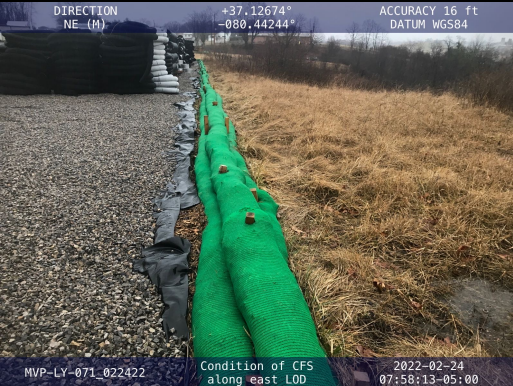
<p>DIRECTION NE (M) +37.12674° -080.44244° ACCURACY 16 ft DATUM WGS84</p> <p>MVP-LY-071_022422 Condition of CFS along east LOD 2022-02-24 07:58:13-05:00</p>			
<b>GPS Location</b>	MVP-LY-071 See photo for gps data		<b>GPS Location</b>	MVP-LY-071 See photo for gps data	
<b>Field Station#</b>	+0		<b>Field Station#</b>	+0	
<b>Pic 5 Desc.</b>	Condition of triple stack compost filter sock along south LOD. Looking NW.		<b>Pic 6 Desc.</b>	Condition of triple stack compost filter sock along east LOD. Looking NE.

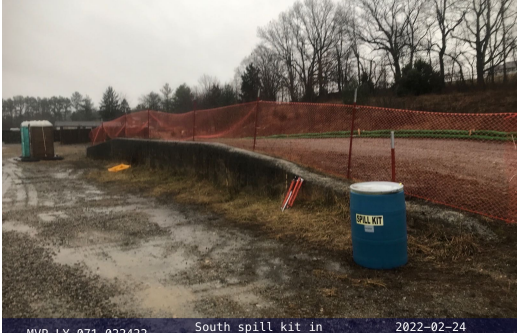
MVP-LY-071_022422 South spill kit in place and safety fence 2022-02-24 07:56:24-05:00

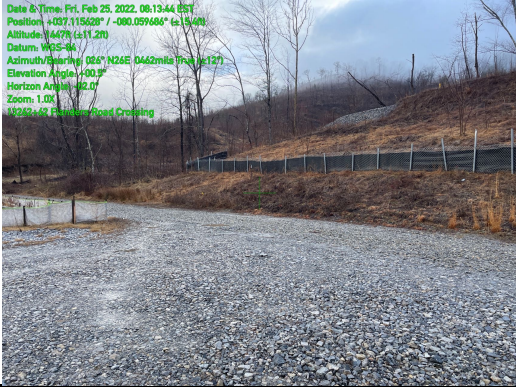
<p><small>Date &amp; Time: Fri, Feb 25, 2022, 08:13:44 EST Position: +037.115601° / -080.059948° (s15.40) Altitude: 1450ft (s11.20) Datum: WGS-84 Azimuth/Bearing: 126° N26E 0462mils True (s12°) Elevation Angle: +02.3° Horizon Angle: +02.0° Zoom: 1.0X 13262+62 Flanders Road Crossing</small></p>

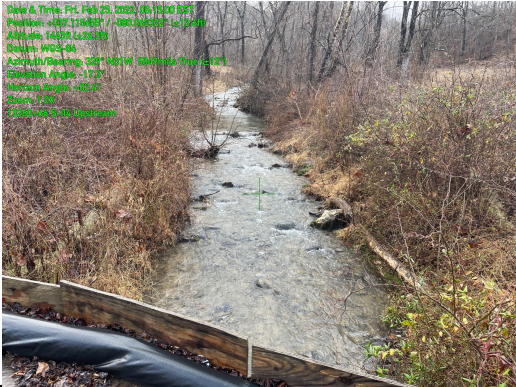
<p><small>Date &amp; Time: Fri, Feb 25, 2022, 08:15:39 EST Position: +037.115092° / -080.060558° (s15.30) Altitude: 1451ft (s11.40) Datum: WGS-84 Azimuth/Bearing: 266° S86W 472mils True (s12°) Elevation Angle: +10.1° Horizon Angle: +01.4° Zoom: 1.0X 13259+00 ROW and ECDs</small></p>  			
<b>GPS Location</b>	0	<b>GPS Location</b>	0		
<b>Field Station#</b>	13260+66	<b>Field Station#</b>	13259+00		
<b>Pic 15 Desc.</b>	MVP-S-II4 Upstream and corresponding buffer zone in good condition	<b>Pic 16 Desc.</b>	ROW and ECDs In good condition and stable		
<p><small>Date &amp; Time: Fri, Feb 25, 2022, 08:15:45 EST Position: +037.115604° / -080.060542° (s15.30) Altitude: 1447ft (s11.40) Datum: WGS-84 Azimuth/Bearing: 314° N46W 5582mils True (s12°) Elevation Angle: +03.3° Horizon Angle: +01.3° Zoom: 1.0X 13259+00 MVP-S-II4 Upstream</small></p>
