## Visual Site Inspection Report

<b>Project Name</b>	H-600 Pipeline Spread I	<b>AFE</b>	124300139	<b>Spread</b>	H-600 Pipeline Spread I
<b>Contractor</b>	Precision			<b>Report #</b>	33099
<b>Inspector</b>	Frank Craycroft			<b>Date/Time</b>	1/10/2022 2:26 PM
<b>Permit #</b>	TBD	<b>Inspection Type</b>	VA SWPP	<b>Station Begin</b>	14694+77
<b>State</b>	VA	<b>Inspection Area</b>	Full	<b>Station End</b>	14802+19
<b>County</b>	Franklin	<b>Ground</b>	Wet	<b>Temperature (°F)</b>	45.00
<b>Municipality</b>	N/A	<b>Weather</b>	Sunny	<b>Rain Gauge (in)</b>	0.50
				<b>Rain Accumulation Time (days)</b>	1.00

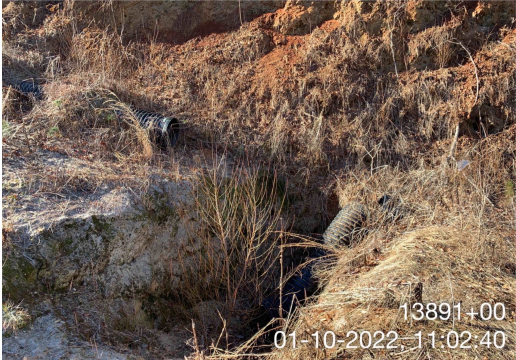
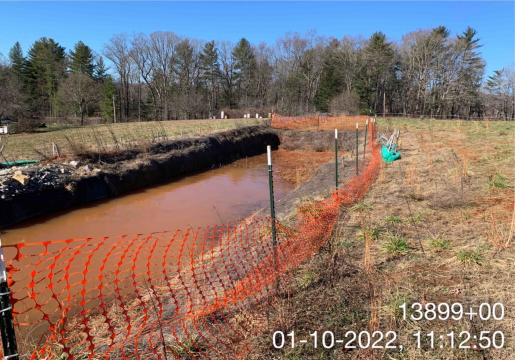
<b>GPS Location</b>	0	<b>GPS Location</b>	0		
<b>Field Station#</b>	13891+00	<b>Field Station#</b>	13899+00		
<b>Pic 1 Desc.</b>	Slope drain requiring maintenance and sump pit in acceptable condition		<b>Pic 2 Desc.</b>	Safety fence requiring maintenance and sump pit in acceptable condition

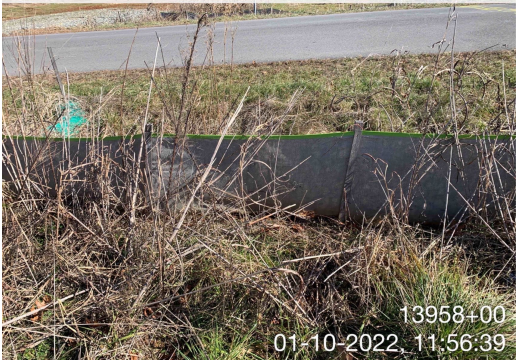
<b>GPS Location</b>	0	<b>GPS Location</b>	0		
<b>Field Station#</b>	13958+00	<b>Field Station#</b>	13869+00		
<b>Pic 3 Desc.</b>	Hole in P1 silt fence		<b>Pic 4 Desc.</b>	Clean water diversion pipe and plunge pool in acceptable conditions

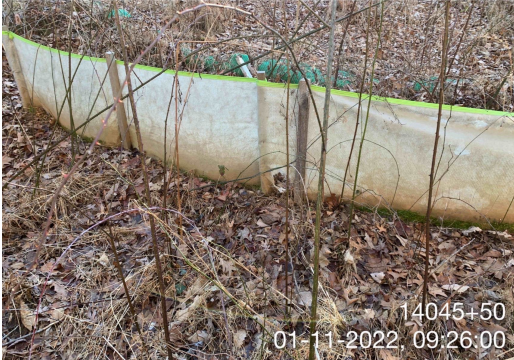
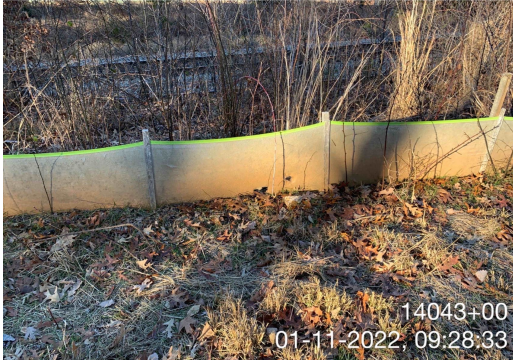
<b>GPS Location</b>	0	<b>GPS Location</b>	0		
<b>Field Station#</b>	14045+50	<b>Field Station#</b>	14043+00		
<b>Pic 1 Desc.</b>	P1 silt fence damaged by wildlife (2 panels)	<b>Pic 2 Desc.</b>	P1 silt fence damaged by wildlife (1 panel)

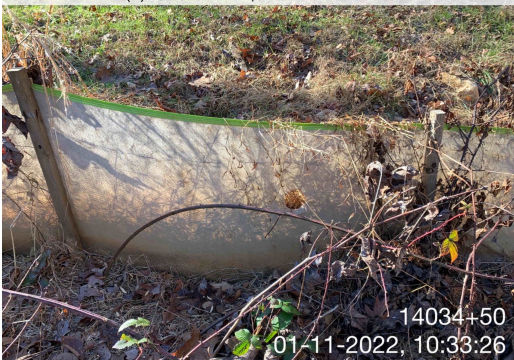
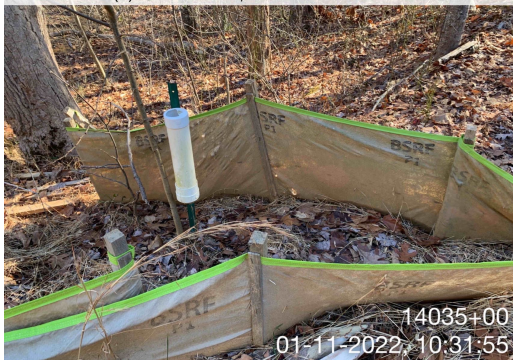
<b>GPS Location</b>	0	<b>GPS Location</b>	0		
<b>Field Station#</b>	14034+50	<b>Field Station#</b>	14035+00		
<b>Pic 3 Desc.</b>	P1 silt fence requiring maintenance (1 panel)	<b>Pic 4 Desc.</b>	P1 silt fence requiring maintenance (2 panels)

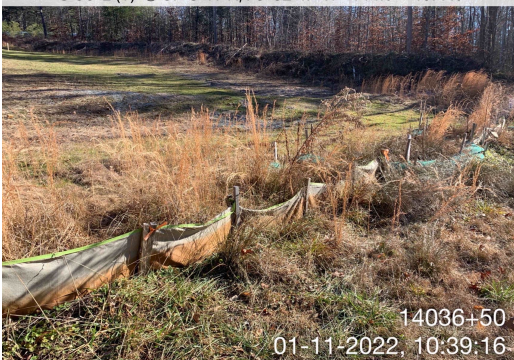
<b>GPS Location</b>	0	<b>GPS Location</b>	0		
<b>Field Station#</b>	14036+50	<b>Field Station#</b>	14058+00		
<b>Pic 5 Desc.</b>	P1 silt fence requiring maintenance (4 panels)	<b>Pic 6 Desc.</b>	Slope drain pipe and sump pit in acceptable conditions

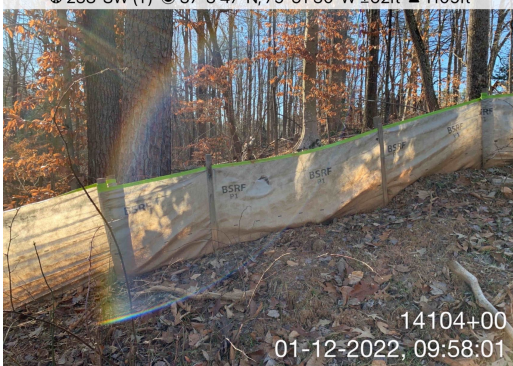
GPS Location			0		
Field Station#			14104+00		
Pic 3 Desc.			P1 silt fence damaged by wildlife (1 panel)

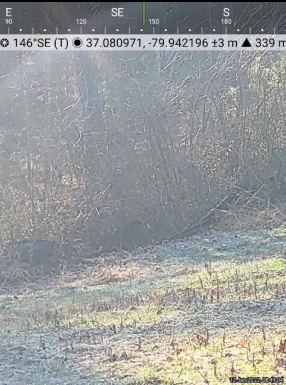
<b>GPS Location</b>	00000	<b>GPS Location</b>	00000		
<b>Field Station#</b>	13718+00	<b>Field Station#</b>	13727+40		
<b>Pic 3 Desc.</b>	Reinforced silt fence requires maintenance due to being weathered and torn, documented and added to the punch list for repair.		<b>Pic 4 Desc.</b>	Vegetation observation photo above stream crossing, good coverage observed, no environmental issues observed at the time of inspection.

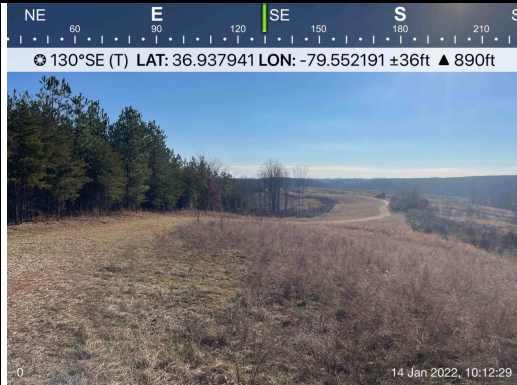
GPS Location	See photo		GPS Location	See photo	
Field Station#	15204+25		Field Station#	15204+50	
Pic 9 Desc.	CFS has been damaged and needs to be repaired		Pic 10 Desc.	CFS has been damaged and needs to be repaired

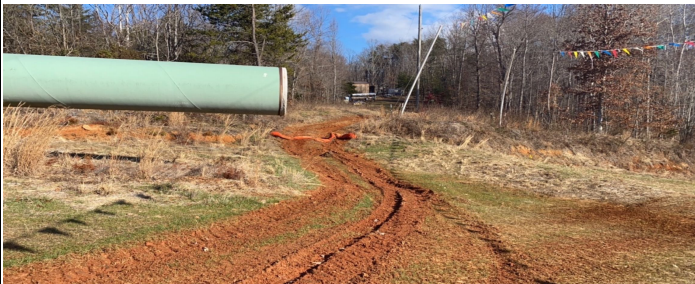
<p>236°SW 01.14.2022 10:11:12 Accur +/-23.6 Ft</p>		
GPS Location	1		GPS Location	2	
Field Station#	14707+00		Field Station#	14716+15	
Pic 1 Desc.	Routine maintenance. Repair and stabilize disturbed area from landowner damage.		Pic 2 Desc.	Routine maintenance. Replace perimeter CFS torn out from landowner damage.
