Visual Site Inspection Report

Project Name	H-600 Pipeline Spread I	AFE	124300139	Spread	H-600 Pipeline Spread I
Contractor	Precision			Report #	33542
Inspector	Charles Head			Date/Time	1/24/2022 11:07 AM
Permit #	TBD	Inspection Type	VA SWPP	Station Begin	14546+75
State	VA	Inspection Area	Full	Station End	14649+67
County	Franklin	Ground	Wet	Temperature (°F)	37.00
Municipality	N/A	Weather	Sunny	Rain Gauge (in)	0.00
				Rain Accumulation Time (days)	1.00

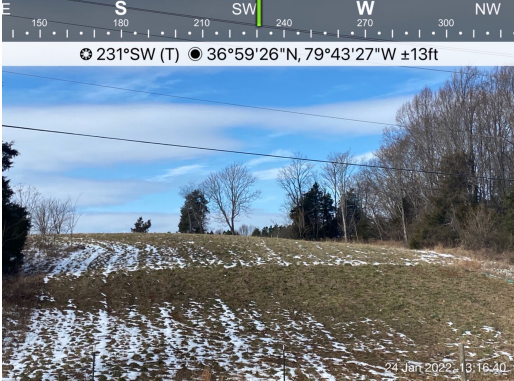
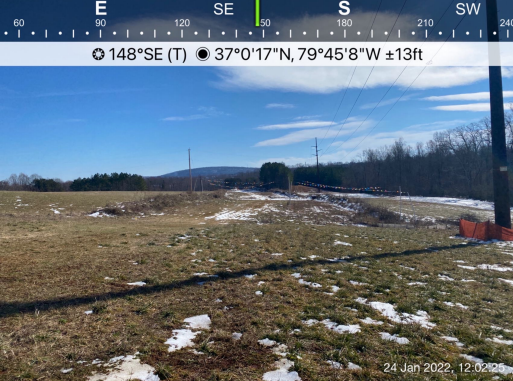
GPS Location	0	GPS Location	0		
Field Station#	14647+00	Field Station#	14551+00		
Pic 1 Desc.	Approximately 14647+00. Overview of ROW. 14644+90-14649+50 ROW has permanent vegetation.		Pic 2 Desc.	Approximately 14551+00. Overview of ROW.

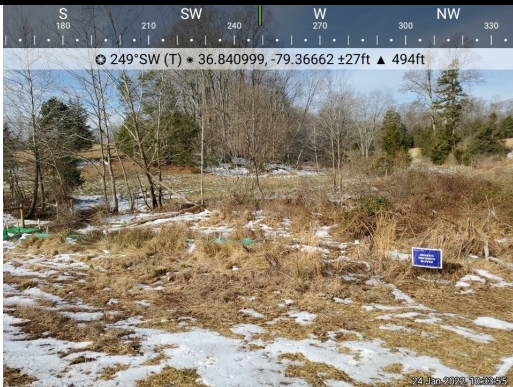
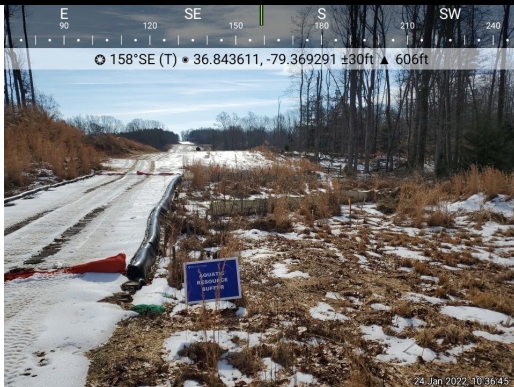
GPS Location	0		GPS Location	0	
Field Station#	15924+00		Field Station#	15911+50	
Pic 1 Desc.	GAS S-GG11 ECDs and buffer zone		Pic 2 Desc.	CIS S-H55 Vegetation and ECDs

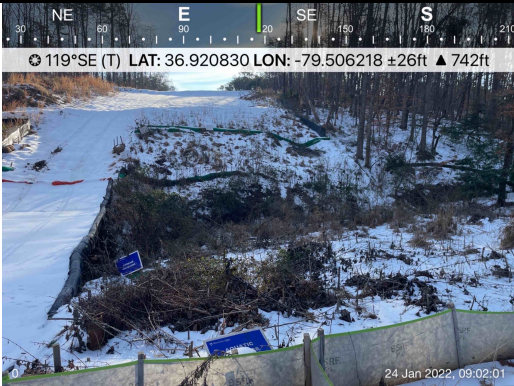
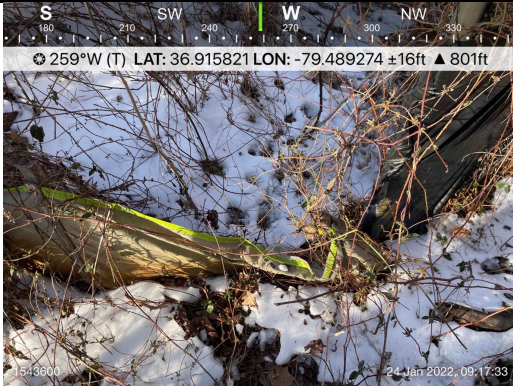
GPS Location	See photo		GPS Location	See photo	
Field Station#	15384+74		Field Station#	15346+00	
Pic 5 Desc.	Equipment bridge ECDs are in place and functioning. Stream buffers remain in good condition.		Pic 6 Desc.	P1 needs to be restaked.

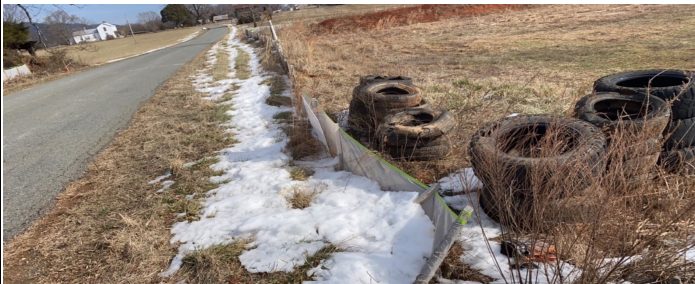
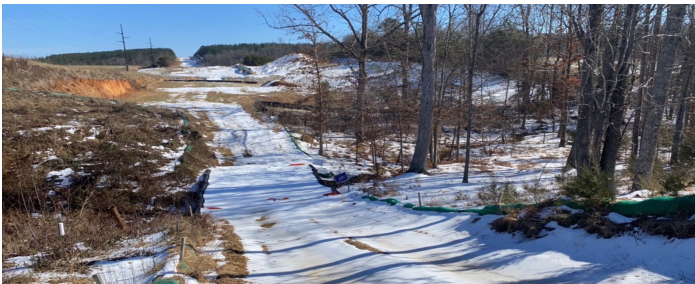
36°57'47" N 79°35'36" W 163°S COURSE -1° GPS 1923-2165 Armstrong Rd, Penhook, VA 24137, United States 01.24.2022 10:57:40 Accur +/-68.0 Ft ALT 909 Ft			36°58'3" N 79°38'12" W 122°SE COURSE 109° GPS 2082 Ramsey Memorial Rd, Penhook, VA 24137, United States 01.24.2022 12:55:25 Accur +/-35.2 Ft ALT 824 Ft		
GPS Location	1		GPS Location	2	
Field Station#	15063+85		Field Station#	14932+89	
Pic 1 Desc.	Routine maintenance. Replace damaged P1 silt fence.		Pic 2 Desc.	Equipment bridge and surrounding ECDs appear to be in place and functional at stream crossing and resource buffer; snow/ice continues to cover ROW.

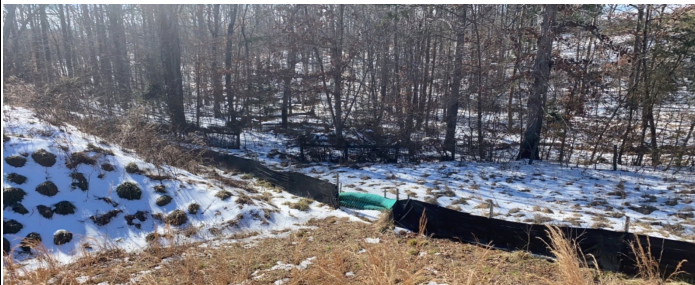
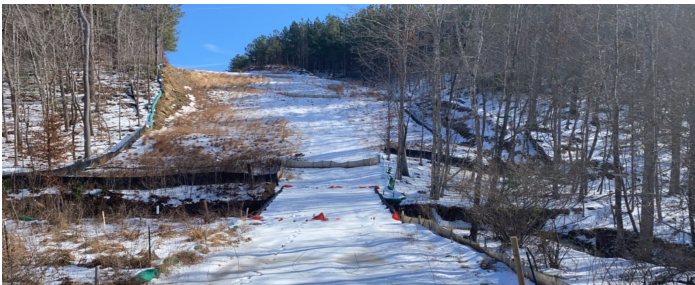
GPS Location	3		GPS Location	4	
Field Station#	14934+46		Field Station#	14950+47	
Pic 3 Desc.	Perimeter SSF and CFS in good condition.		Pic 4 Desc.	Equipment bridge and surrounding ECDs appear to be in place and functional at stream crossing and resource buffer; snow/ice continues to cover ROW.

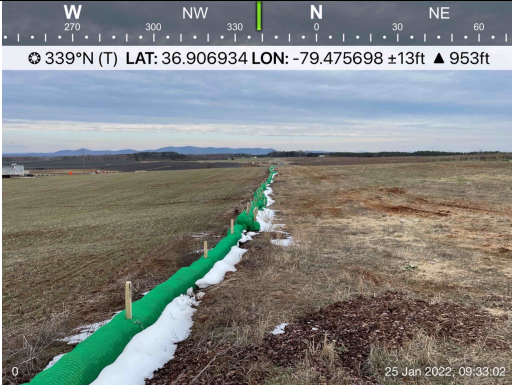
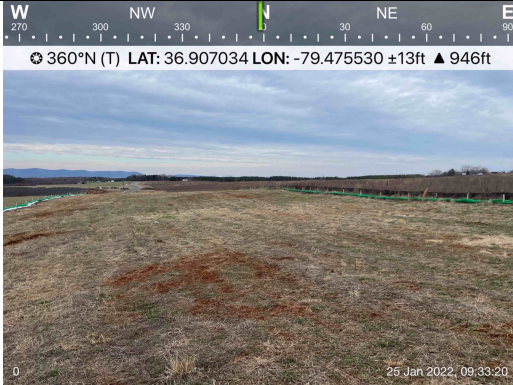
GPS Location	See photo	GPS Location	See photo		
Field Station#	15490+00	Field Station#	15495+00		
Pic 1 Desc.	Perimeter CFS is in good condition throughout this area.	Pic 2 Desc.	Vegetation continues to fill in throughout this section.

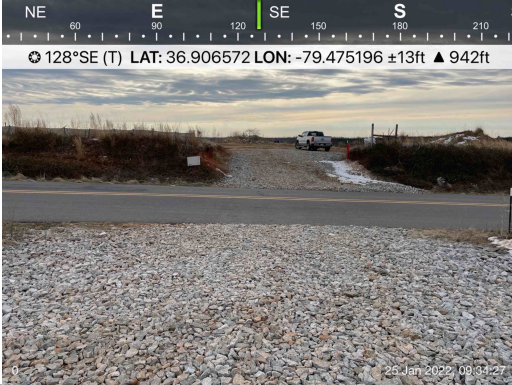
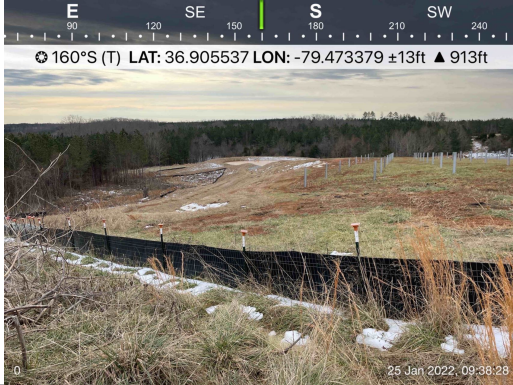
GPS Location	See photo	GPS Location	See photo		
Field Station#	15496+00	Field Station#	15501+00		
Pic 3 Desc.	RCEs are in good condition at all road crossings.	Pic 4 Desc.	No evidence of sedimentation from 3rd party disturbance.

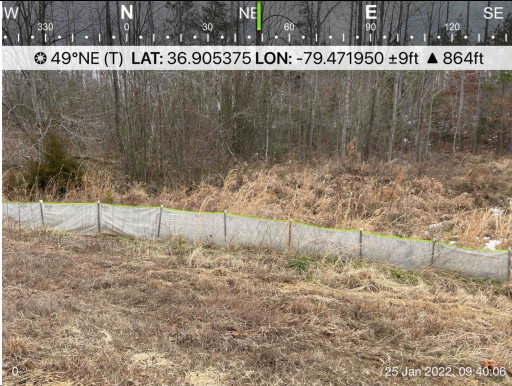
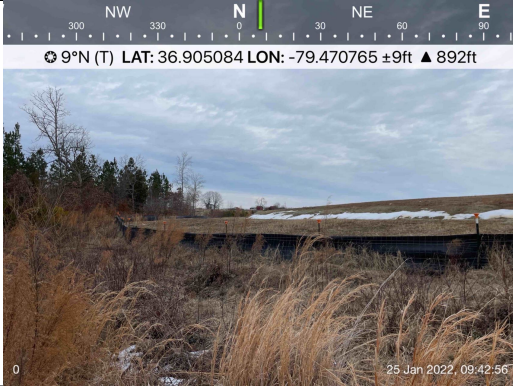
GPS Location	See photo	GPS Location	See photo		
Field Station#	15507+00	Field Station#	15510+00		
Pic 5 Desc.	P1 is in good condition at all stream and wetland buffers.	Pic 6 Desc.	3rd party ECDs appear to be in good condition.

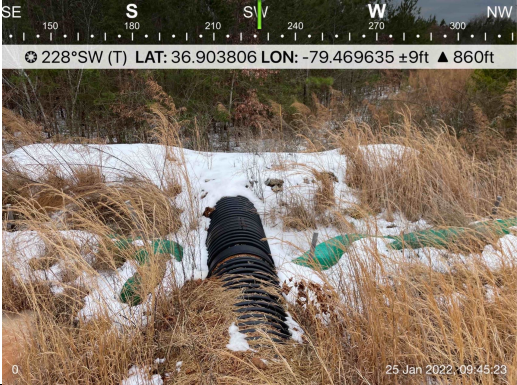
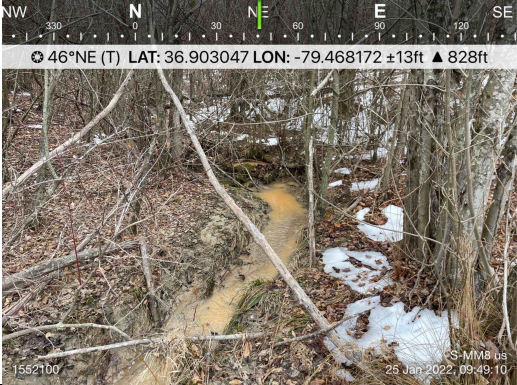
GPS Location	See photo	GPS Location	See photo		
Field Station#	15515+00	Field Station#	15521+00		
Pic 7 Desc.	CWD is in good condition and functioning.	Pic 8 Desc.	S-MM8 entering ROW containing turbid water from upstream disturbance. Not pipeline related.

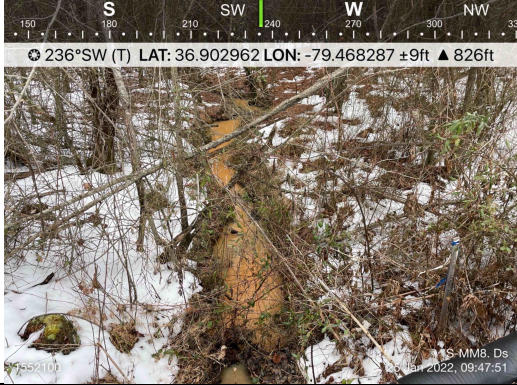
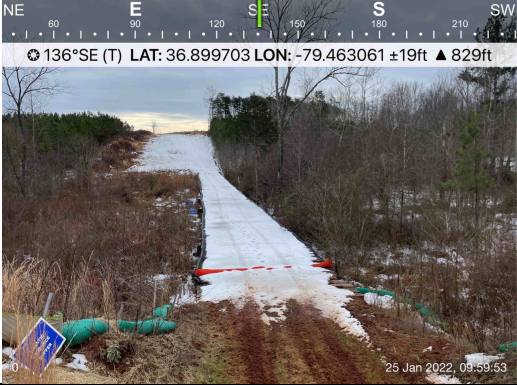
GPS Location	See photo	GPS Location	See photo		
Field Station#	15521+00	Field Station#	15540+00		
Pic 9 Desc.	S-MM8 entering ROW containing turbid water from upstream disturbance. Not pipeline related.	Pic 10 Desc.	Equipment bridge ECDs are in place and functioning.

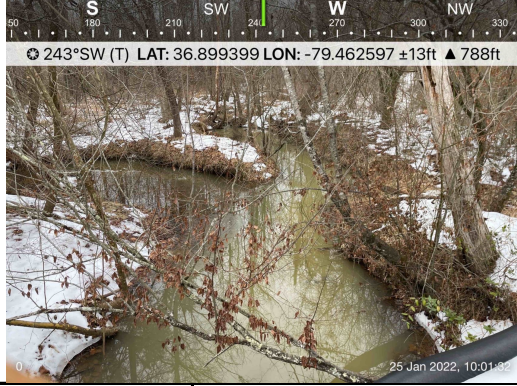
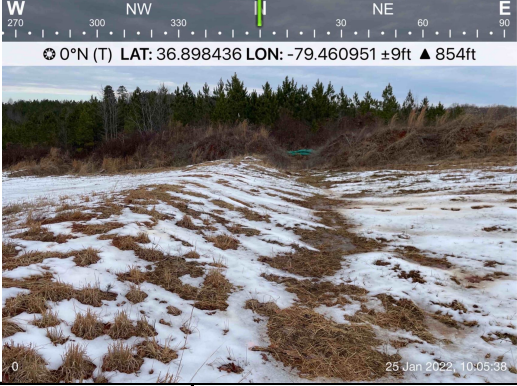
GPS Location	See photo	GPS Location	See photo		
Field Station#	15542+11	Field Station#	15548+00		
Pic 11 Desc.	S-CC5 entering ROW containing turbid water from upstream disturbance. Not pipeline related.	Pic 12 Desc.	Waterbars are in good condition.

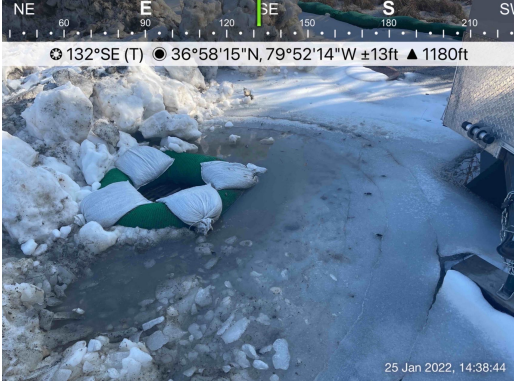
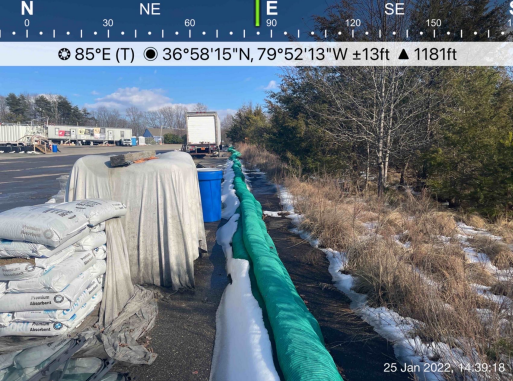
GPS Location	See picture		GPS Location	See picture
Field Station#	0000+00		Field Station#	0000+00
Pic 1 Desc.	Inlet protection for catch basin on south end of LY-046 in good condition.		Pic 2 Desc.	Perimeter ECD's on south end of LY-046 in good condition.

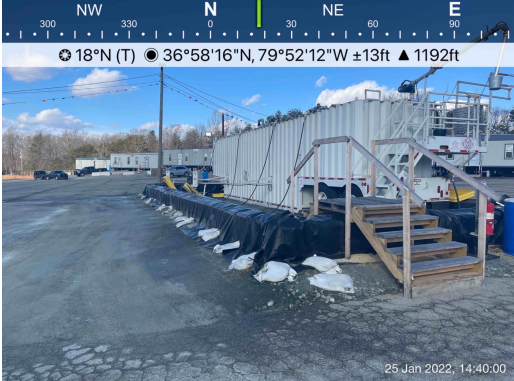
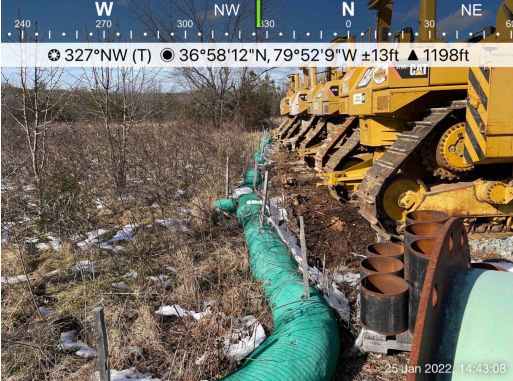
GPS Location	See picture		GPS Location	See picture
Field Station#	0000+00		Field Station#	00000+00
Pic 3 Desc.	Secondary containment structure for fuel cell at LY-046 in good condition.		Pic 4 Desc.	Perimeter ECD's on north end of LY-045 in acceptable condition.

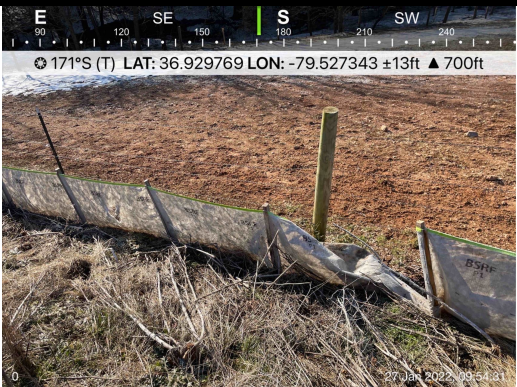
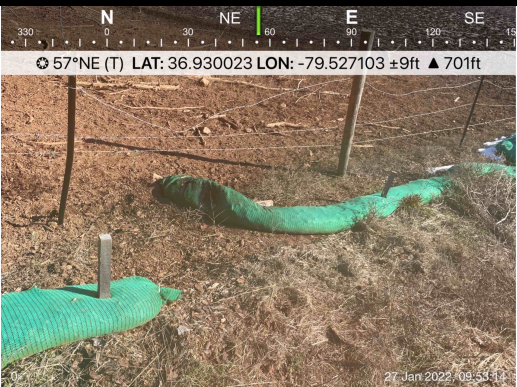
GPS Location	See photo		GPS Location	See photo	
Field Station#	15310+90		Field Station#	15311+87	
Pic 3 Desc.	Perimeter P1 has been damaged by livestock and needs to be replaced		Pic 4 Desc.	Perimeter CFS has been displaced by livestock and needs to be restaked.

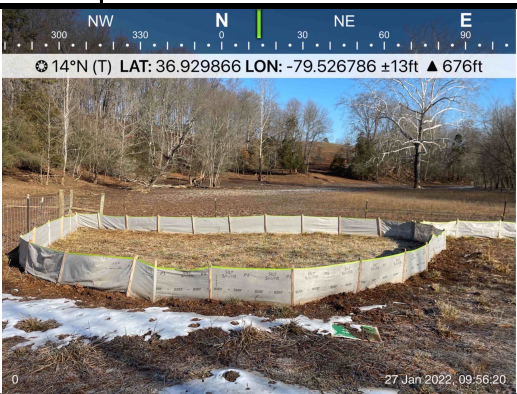
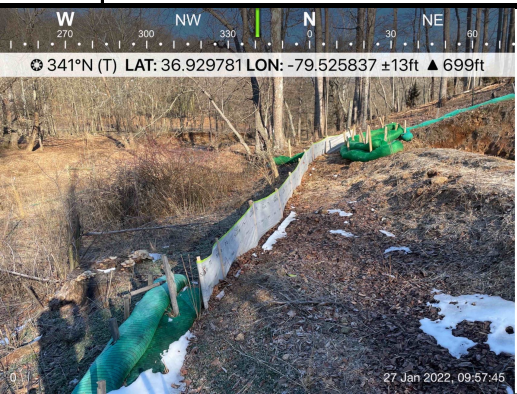
GPS Location	See photo		GPS Location	See photo	
Field Station#	15311+87		Field Station#	15314+50	
Pic 5 Desc.	Wetland buffer P1 is in good condition.		Pic 6 Desc.	P1 is in good condition at all stream buffers.

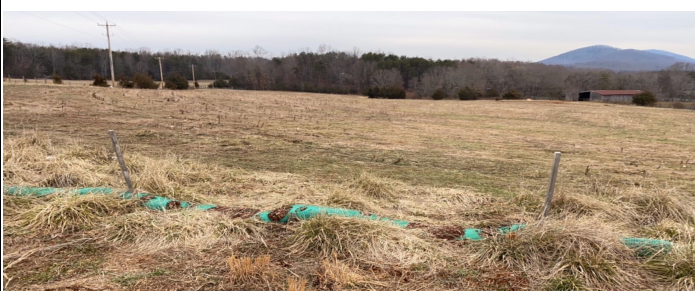
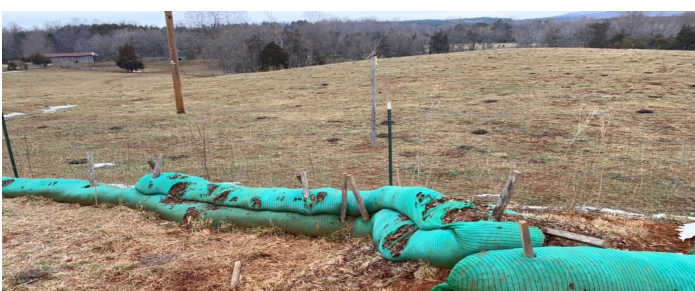
36°57'56" N 79°37'12" W 300°NW COURSE 312' GPS 19100-19382 Snow Creek Rd, Penhook, VA 24137, United States 01.28.2022 08:59:20 Accur +/-23.7 Ft ALT 942 Ft			36°57'54" N 79°37'4" W 101°E COURSE 52' GPS 101-119 Ashworth Rd, Penhook, VA 24137, United States 01.28.2022 08:54:10 Accur +/-27.6 Ft ALT 929 Ft		
GPS Location	1	GPS Location	2		
Field Station#	14982+50	Field Station#	14988+00		
Pic 1 Desc.	Routine maintenance. Replace damaged perimeter CFS from landowner damage.		Pic 2 Desc.	Routine maintenance. Replace damaged CFS triple stack from cattle damage.

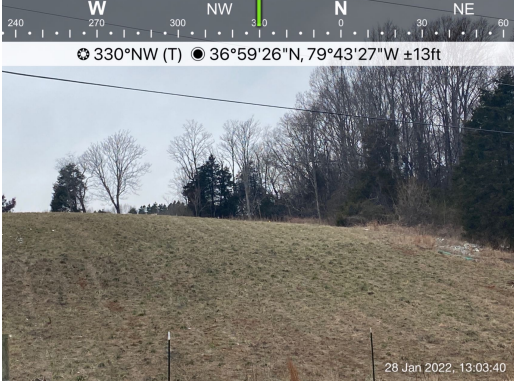
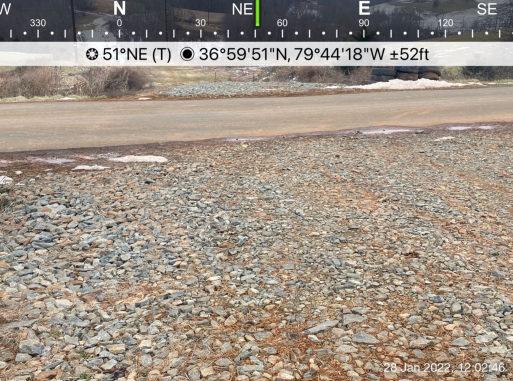
GPS Location	0	GPS Location	0		
Field Station#	14646+00	Field Station#	14599+00		
Pic 1 Desc.	Approximately 14646+00. Overview of ROW.		Pic 2 Desc.	Approximately 14599+00. Overview of road crossing and RCEs.
