Visual Site Inspection Report

Project Name	H-603 Pipeline Spread I	AFE	124300139	Spread	H-603 Pipeline Spread I	
Contractor	Precision			Report #	32850	
Inspector	John White			Date/Time	1/3/2022 2:33 PM	
Permit #	TBD	Inspection Type	VA SWPP	Station Begin	00+00	
State	VA	Inspection Area	Full	Station End	24+53	
County	Pittsylvania	Ground	Wet	Temperature (°F)	38.00	
Municipality	Chatham	Weather	Snow/Sleet	Rain Gauge (in)	2.30	
				Rain Accumulation Time (days)	6.00

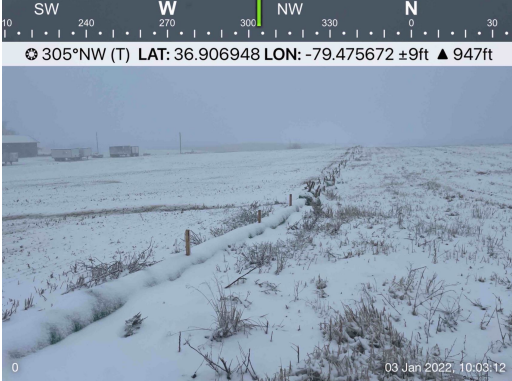
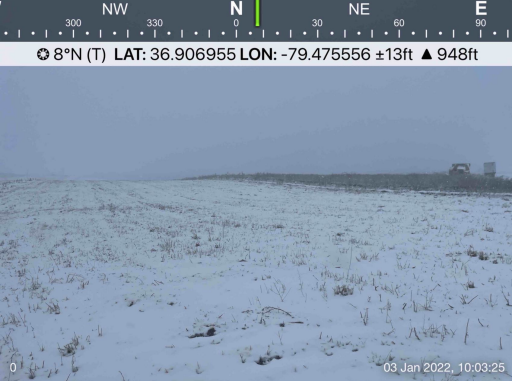
GPS Location	See photo	GPS Location	See photo		
Field Station#	15490+00	Field Station#	15495+00		
Pic 1 Desc.	Perimeter CFS is in good condition.	Pic 2 Desc.	This section remains temporarily stabilized.

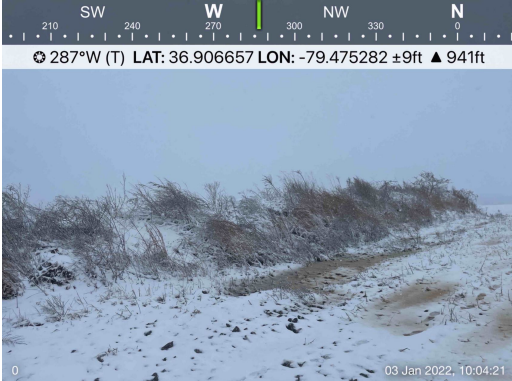
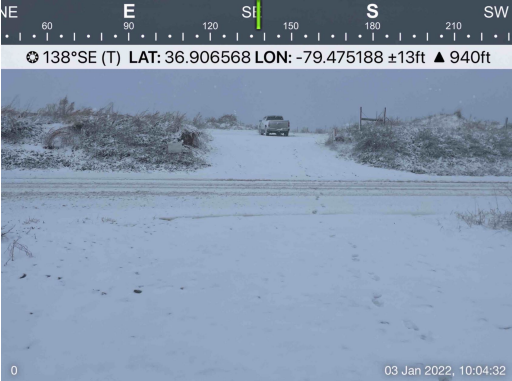
GPS Location	See photo	GPS Location	See photo		
Field Station#	15496+00	Field Station#	15496+70		
Pic 3 Desc.	Topsoil berm remains stabilized.	Pic 4 Desc.	RCEs are in good condition at all road crossings.

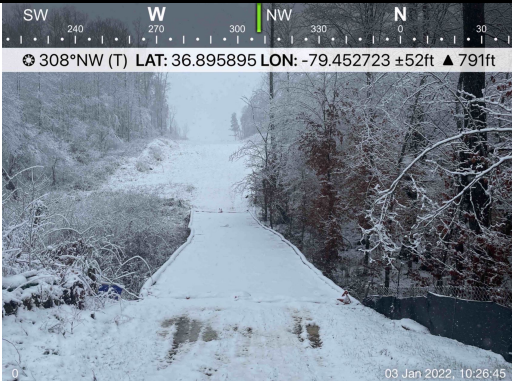
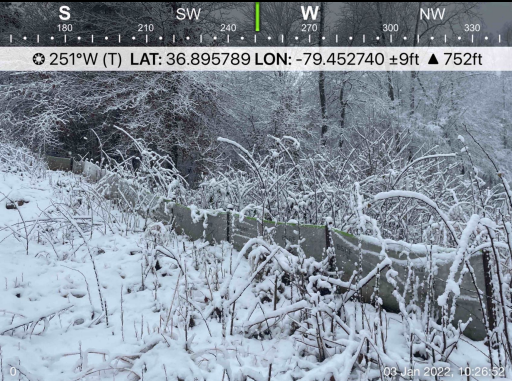
GPS Location	See photo	GPS Location	See photo		
Field Station#	15573+54	Field Station#	15573+75		
Pic 5 Desc.	Equipment bridge ECDs are in place and functioning.	Pic 6 Desc.	P1 is in good condition at all stream and wetland buffers.

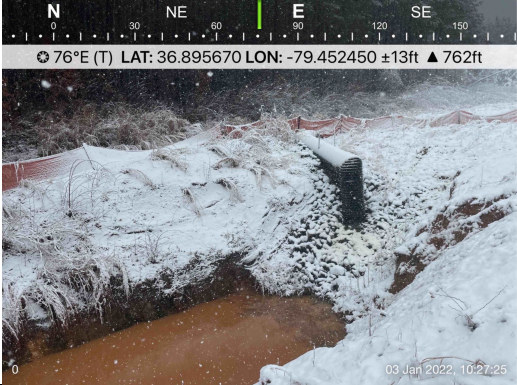
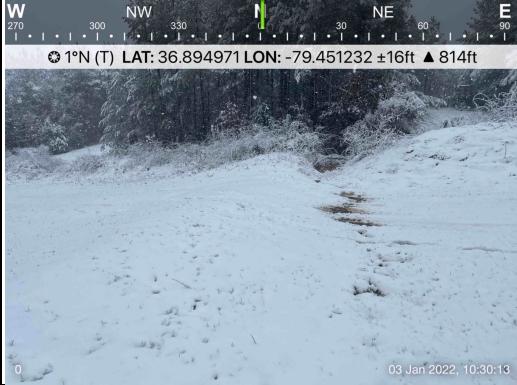
GPS Location	See photo	GPS Location	See photo		
Field Station#	15575+00	Field Station#	15580+00		
Pic 7 Desc.	Slope drain functioning as intended.	Pic 8 Desc.	Waterbars are in good condition.

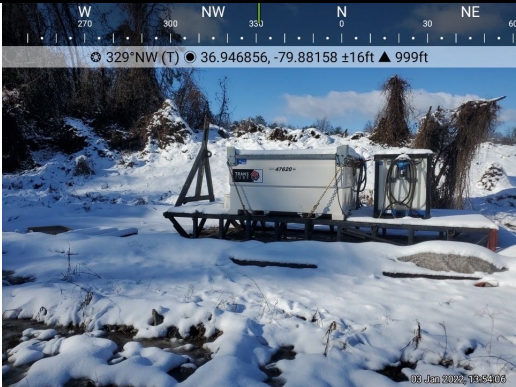
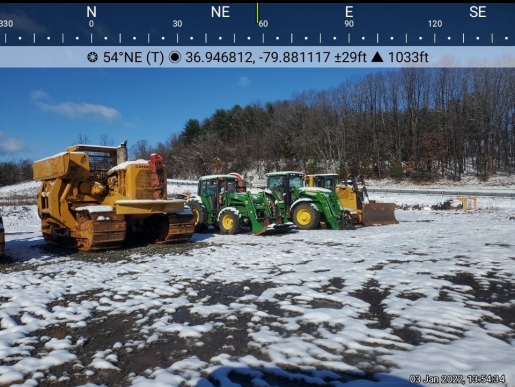
GPS Location	0		GPS Location	0	
Field Station#	0+00		Field Station#	0+00	
Pic 1 Desc.	LY-032 Secondary containment		Pic 2 Desc.	LY-032 Equipment staging

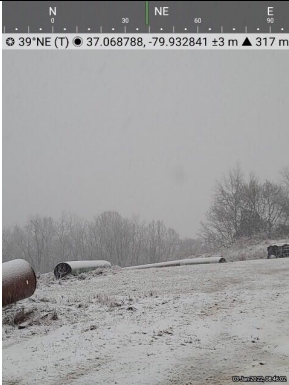
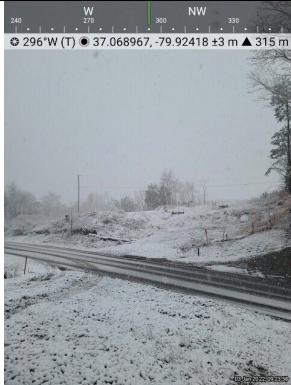
GPS Location	00000	GPS Location	00000		
Field Station#	13784+35	Field Station#	13810+90		
Pic 1 Desc.	Row photo showing snow throughout the early part of the day.		Pic 2 Desc.	Road crossing photo during snow events , no environmental issues observed at the time of inspection.

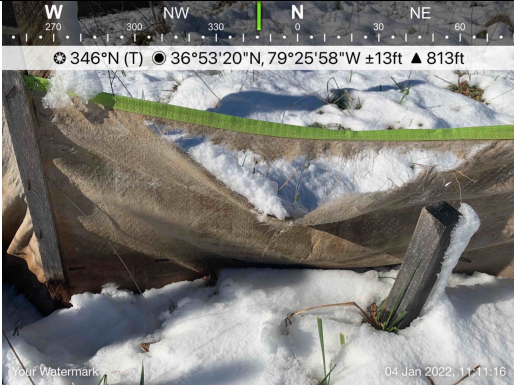
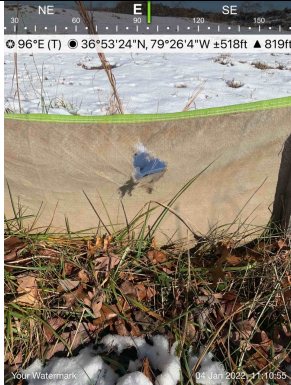
GPS Location	O	GPS Location	O		
Field Station#	15646+80	Field Station#	15646+80		
Pic 1 Desc.	Observing P1 that requires maintenance	Pic 2 Desc.	Observing P1 that requires maintenance

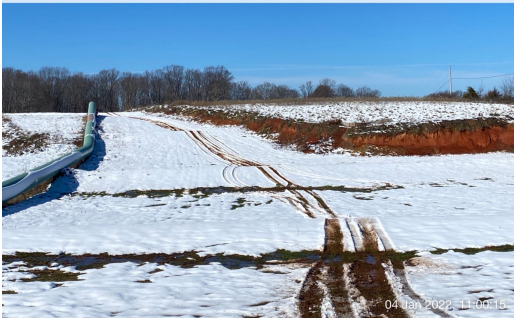
GPS Location	0	GPS Location	0		
Field Station#	14451+00	Field Station#	14415+00		
Pic 1 Desc.	Approximately 14451+00. Overview of ROW. Observed third party ATV tracks in area.	Pic 2 Desc.	Approximately 14415+00. Overview of ROW.

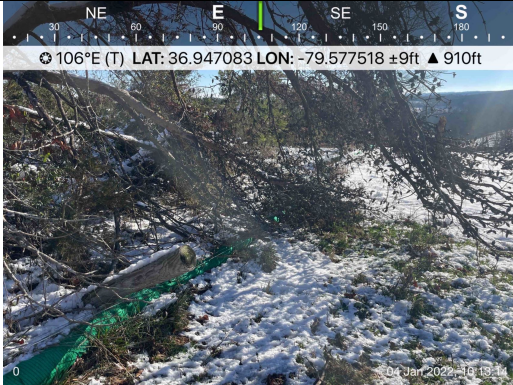
GPS Location	See photo		GPS Location	See photo	
Field Station#	15142+66		Field Station#	15150+00	
Pic 1 Desc.	RCE is in good condition at Rockcreek Rd.		Pic 2 Desc.	Tree has fallen across perimeter CFS and needs to be removed.

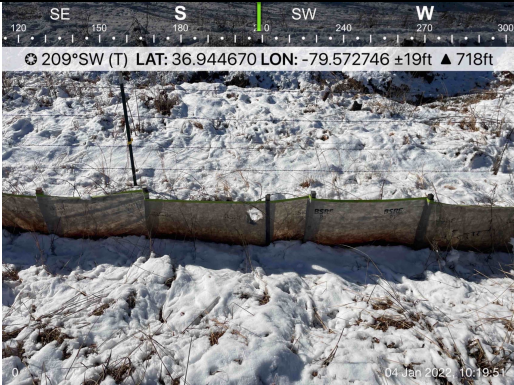
GPS Location	See photo		GPS Location	See photo	
Field Station#	15164+00		Field Station#	15165+57	
Pic 3 Desc.	Perimeter P1 has been damaged and needs to be replaced.		Pic 4 Desc.	Rock inlet remains in good condition.

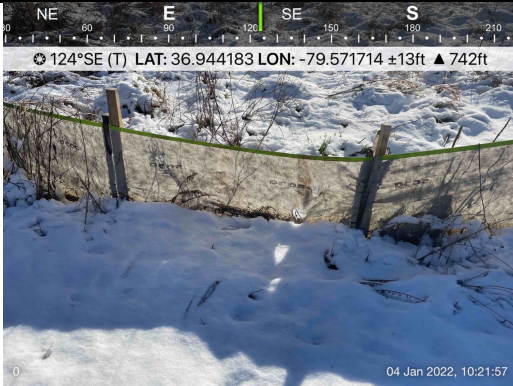
GPS Location	See photo		GPS Location	See photo	
Field Station#	15166+00		Field Station#	15168+00	
Pic 5 Desc.	Rock outlet remains in good condition.		Pic 6 Desc.	Buffer P1 has been damaged and needs to be replaced.

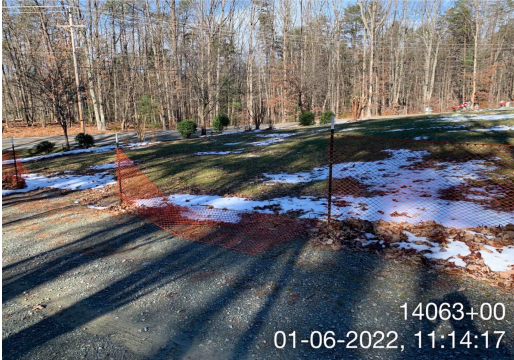
GPS Location	0	GPS Location	0		
Field Station#	14063+00	Field Station#	14071+00		
Pic 1 Desc.	Safety fence along access road MVP-FR-309.05 requires maintenance	Pic 2 Desc.	Clean water diversion pipe and plunge pool in acceptable conditions
