Visual Site Inspection Report

Project Name	H-600 Pipeline Spread I		AFE	124300139	Spread	H-600 Pipeline Spread I	
Contractor	Precision				Report #	33721	
Inspector	Ben Davenport				Date/Time	1/31/2022 10:30 AM	
Permit #	TBD	Inspection Type	VA SWPP		Station Begin	15063+85	
State	VA	Inspection Area	Partial		Station End	15142+66	
County	Pittsylvania	Ground	Frozen		Temperature (°F)	40.00	
Municipality	Chatham	Weather	Sunny		Rain Gauge (in)	1.00	
					Rain Accumulation Time (days)	0.00

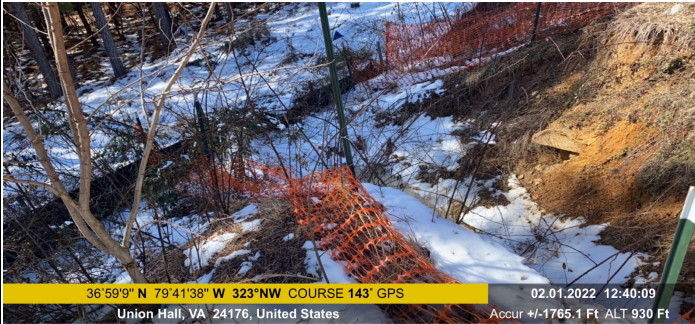
GPS Location			1	GPS Location		2					
Field Station#			14730+00	Field Station#		14750+25					
Pic 1 Desc.			Routine maintenance. Repair damaged safety fence around sump pits as needed.			Pic 2 Desc.			Routine maintenance. Repair/replace damaged CFS in resource buffer.

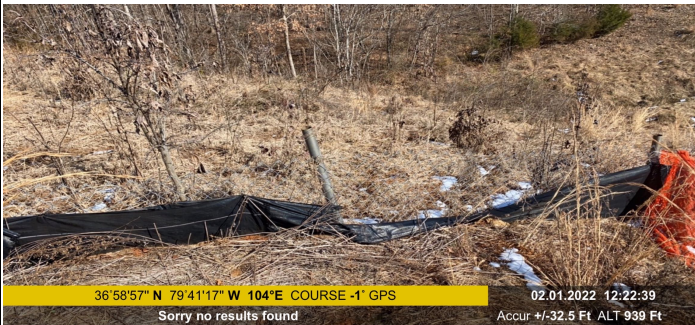
GPS Location			3	GPS Location		4					
Field Station#			14764+00	Field Station#		14694+77					
Pic 3 Desc.			Routine maintenance. Repair damaged perimeter SSF.			Pic 4 Desc.			RCE in good condition.

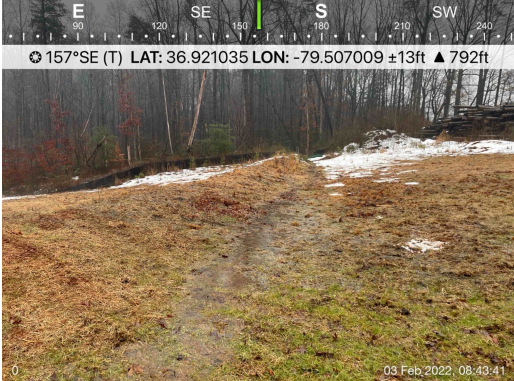
GPS Location	See photo	GPS Location	See photo		
Field Station#	15380+00	Field Station#	15384+50		
Pic 3 Desc.	Waterbars are functioning as intended.	Pic 4 Desc.	P1 is degraded and needs to be replaced at this stream buffer.

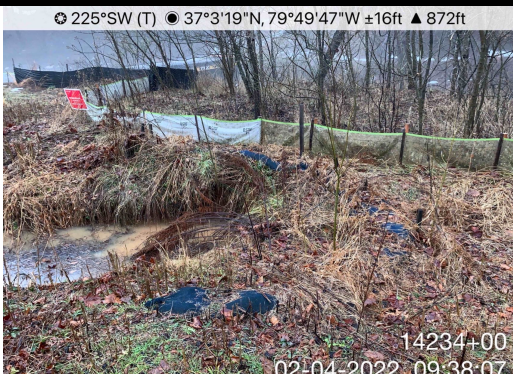
<div>14234+00 02-04-2022 12:05:23</div>			
GPS Location	0		GPS Location	0	
Field Station#	14234+00		Field Station#	14234+00	
Pic 1 Desc.	P1 silt fence is old and weathered. The contractor replaced it immediately		Pic 2 Desc.	P1 silt fence after replacement.	
<div>☉ 225°SW (T) ● 37°3'19"N, 79°49'47"W ±16ft ▲ 872ft</div>

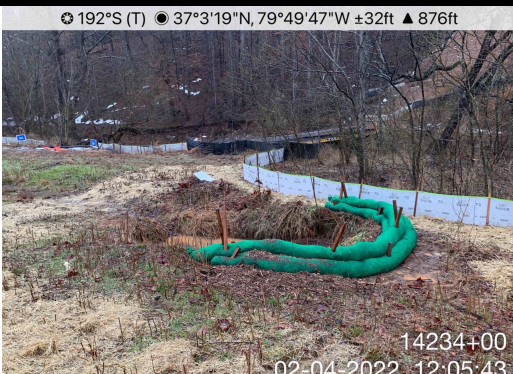
<div>14234+00 02-04-2022 12:05:43</div>			
GPS Location	0		GPS Location	0	
Field Station#	14234+00		Field Station#	14234+00	
Pic 3 Desc.	CFS on waterbar end treatment is old and weathered. The contractor replaced it immediately.		Pic 4 Desc.	CFS after replacement

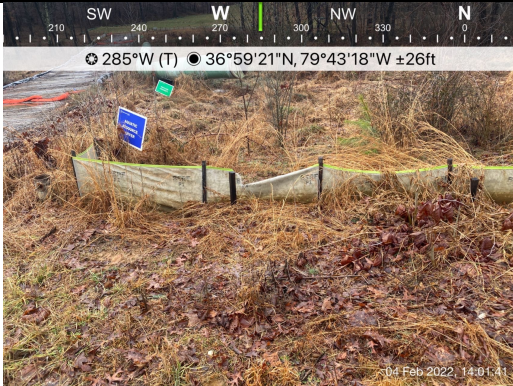
GPS Location	0	GPS Location	0		
Field Station#	14656+91	Field Station#	14658+75		
Pic 5 Desc.	Approximately 14656+91. Upstream view of stream S-H38.		Pic 6 Desc.	Approximately 14658+75. P-1 requires maintenance. Appears to have been damaged by wildlife.

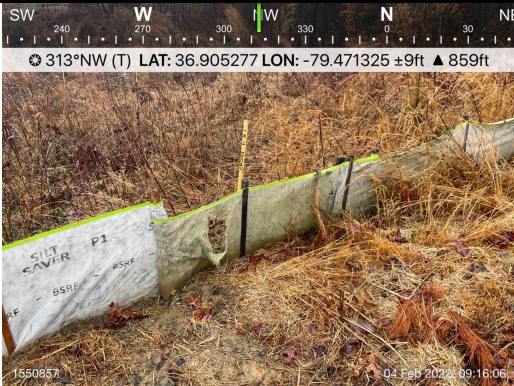
GPS Location	See photo	GPS Location	See photo		
Field Station#	15508+57	Field Station#	15510+00		
Pic 5 Desc.	P1 has been damaged and needs to be replaced.	Pic 6 Desc.	3rd party ECDs appear to be in good condition.

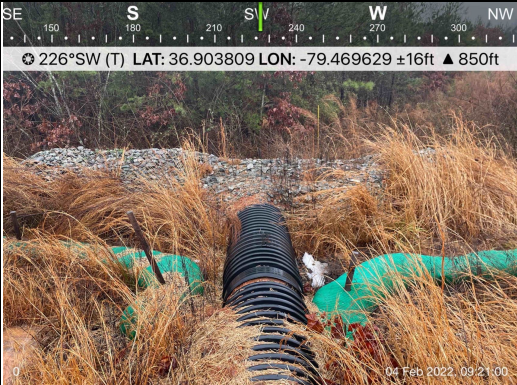
GPS Location	See photo		GPS Location	See photo	
Field Station#	15515+00		Field Station#	15521+00	
Pic 7 Desc.	CWDs are functioning as intended.		Pic 8 Desc.	Turbid water in stream S-MM8 entering ROW from upstream 3rd party disturbance.

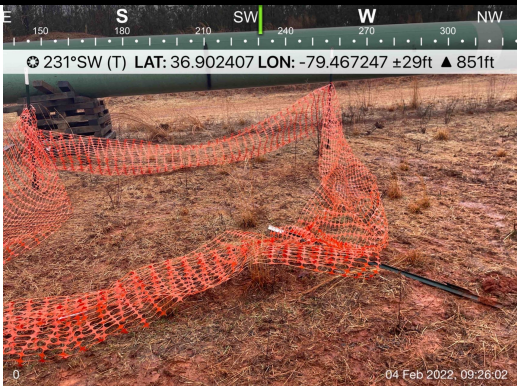
GPS Location	See photo		GPS Location	See photo	
Field Station#	15521+00		Field Station#	15525+00	
Pic 9 Desc.	S-MM8 downstream of ROW.		Pic 10 Desc.	Safety fence needs to be restaked.
