Visual Site Inspection Report

Project Name	H-600 Pipeline Spread I	AFE	124300139	Spread	H-600 Pipeline Spread I
Contractor	Precision			Report #	32208
Inspector	Justin Burch			Date/Time	12/13/2021 11:37 AM
Permit #	TBD	Inspection Type	VA SWPP	Station Begin	13853+45
State	VA	Inspection Area	Full	Station End	13958+31
County	Franklin	Ground	Damp	Temperature (°F)	60.00
Municipality	N/A	Weather	Sunny	Rain Gauge (in)	0.20
				Rain Accumulation Time (days)	6.00

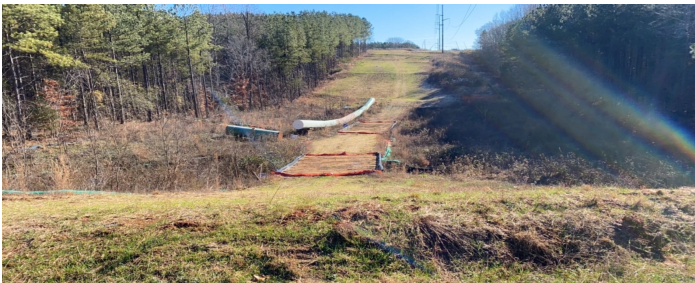
36°59'17" N 79°42'8" W 269°W COURSE 159° GPS 12.13.2021 10:04:01 Accur +/-86.6 Ft ALT 909 Ft			36°59'16" N 79°42'3" W 83°E COURSE 213° GPS 12.13.2021 10:07:46 Union Hall, VA 24176, United States Accur +/-51.5 Ft ALT 888 Ft		
GPS Location	1		GPS Location	2	
Field Station#	14716+96		Field Station#	14722+60	
Pic 1 Desc.	Equipment bridge and surrounding ECDs in place and functional at stream crossing and resource buffer; all signage visible and intact.		Pic 2 Desc.	Equipment bridge and surrounding ECDs in place and functional at stream crossing and resource buffer; all signage visible and intact.

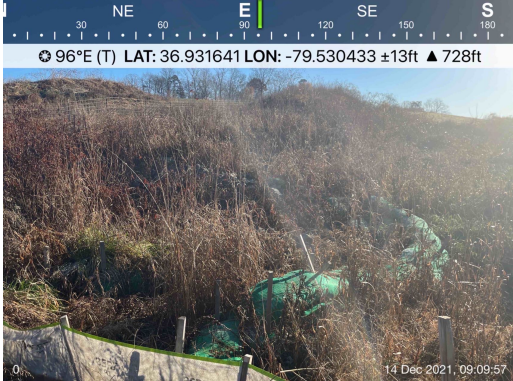
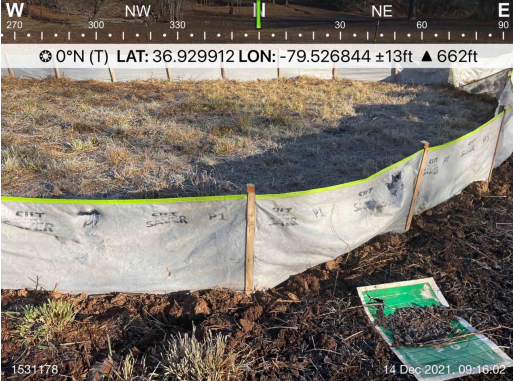
GPS Location	See photo		GPS Location	See photo	
Field Station#	15299+00		Field Station#	15311+78	
Pic 1 Desc.	CWD remains in good condition and functioning.		Pic 2 Desc.	Wetland buffer P1 has been damaged by livestock and needs to be replaced.

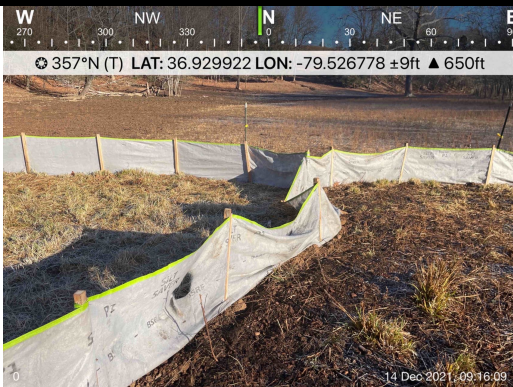
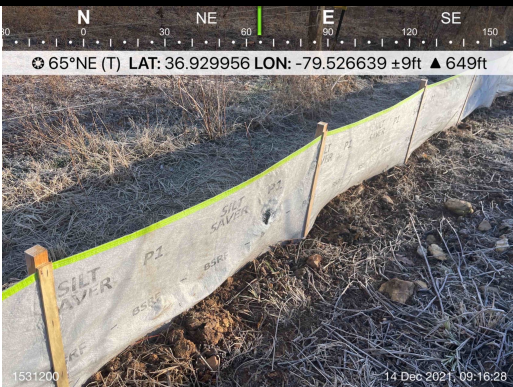
4. E&S BMPs (List BMPs and note if installed and maintained as per the plan. If corrective action is needed, a picture is required.)					
E&S BMPs	Compliance Level	Corrective Action		Corrective Time Frame	Date Repaired
Compost Filter Sock	Acceptable				
Equipment Bridge	Acceptable				
Rock Construction Entrance	Acceptable				
Sensitive Resource Buffer	Acceptable				
Sensitive Resource Signage	Acceptable				
Silt Fence (Filter Fabric Fence)	Communication	Replace damaged and deteriorating			
Silt Fence (Reinforce Filter Fence)	Acceptable				
3rd Party Damages	Communication	Replace P-1 damaged by livestock/\

GPS Location	See photo		GPS Location	See photo	
Field Station#	15311+78		Field Station#	15312+00	
Pic 3 Desc.	Wetland buffer P1 has been damaged by livestock and needs to be replaced.		Pic 4 Desc.	Perimeter P1 has been damaged by livestock and needs to be replaced.

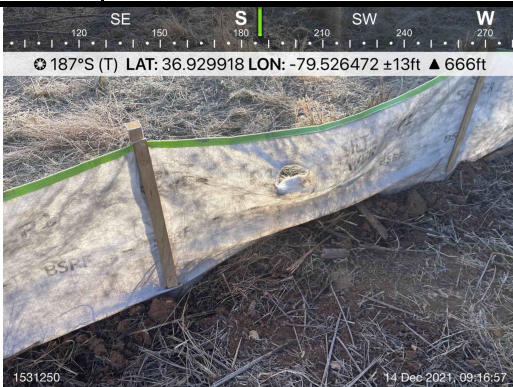
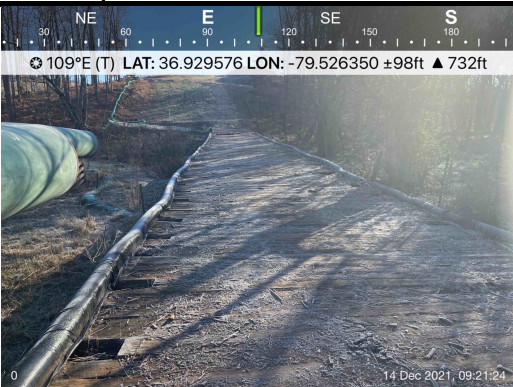
GPS Location	See photo		GPS Location	See photo	
Field Station#	15312+50		Field Station#	15314+00	
Pic 5 Desc.	Stream buffer P1 has been damaged by livestock and needs to be replaced.		Pic 6 Desc.	Equipment bridge ECDs are in place and functioning.

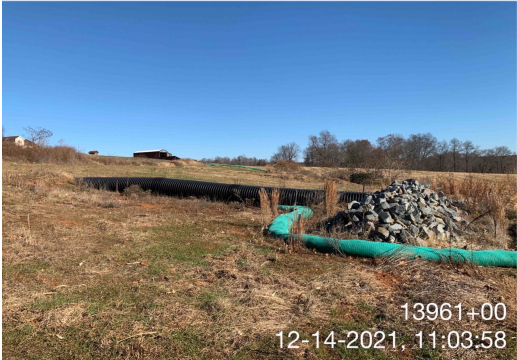
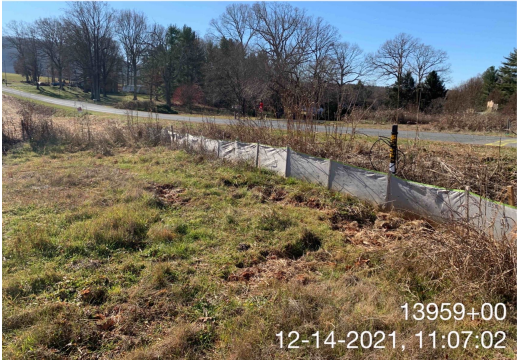
GPS Location	0	GPS Location	0		
Field Station#	13961+00	Field Station#	13959+00		
Pic 7 Desc.	Clean water diversion pipe and CFS in acceptable conditions	Pic 8 Desc.	P1 silt fence in acceptable condition		
Insert image here		Insert image here			
GPS Location		GPS Location			
Field Station#		Field Station#			
Pic 9 Desc.		Pic 10 Desc.			
Insert image here		Insert image here			
GPS Location		GPS Location			
Field Station#		Field Station#			
Pic 11 Desc.		Pic 12 Desc.

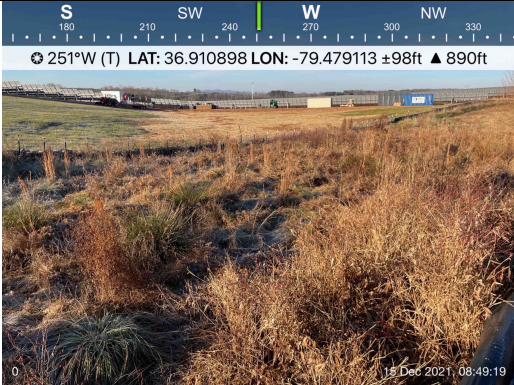
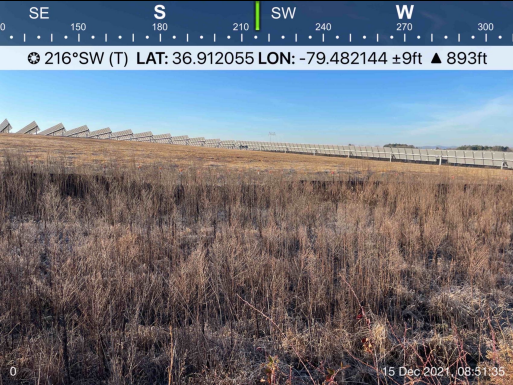
GPS Location	See photo		GPS Location	See photo	
Field Station#	15475+00		Field Station#	15465+00	
Pic 1 Desc.	3rd party rock outlet appears to be in good condition along this drainage.		Pic 2 Desc.	No evidence of sedimentation from 3rd party disturbance.

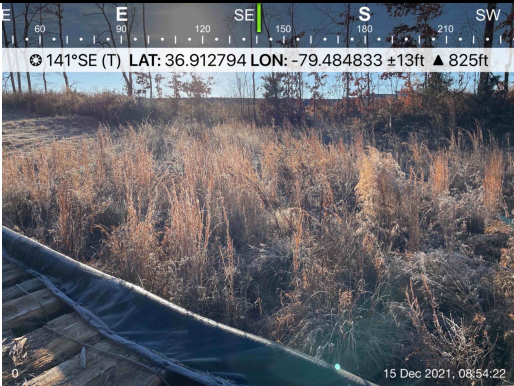
GPS Location	See photo		GPS Location	See photo	
Field Station#	15457+00		Field Station#	15453+00	
Pic 5 Desc.	No evidence of sedimentation within drainage feature.		Pic 6 Desc.	CWD is in good condition with no evidence of sedimentation.

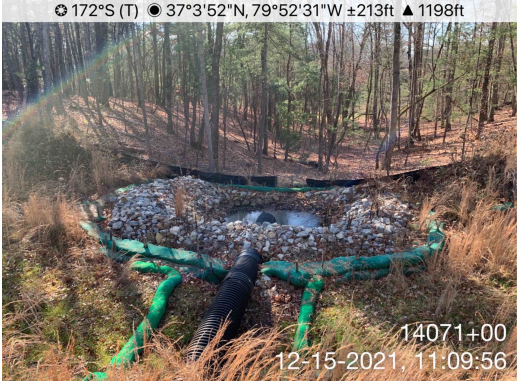
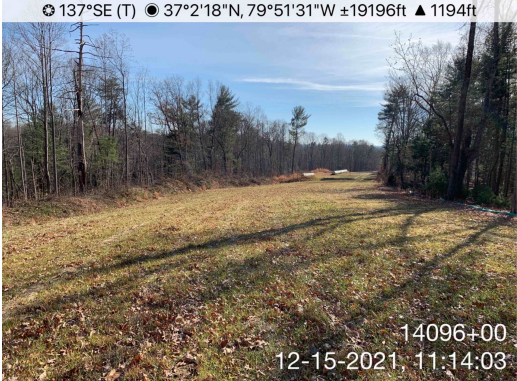
GPS Location	0	GPS Location	0		
Field Station#	14071+00	Field Station#	14096+00		
Pic 7 Desc.	Clean water diversion pipe and plunge pool in acceptable conditions	Pic 8 Desc.	Temporary vegetative stabilization in acceptable condition

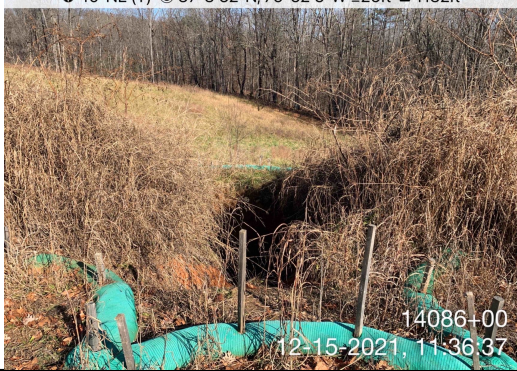
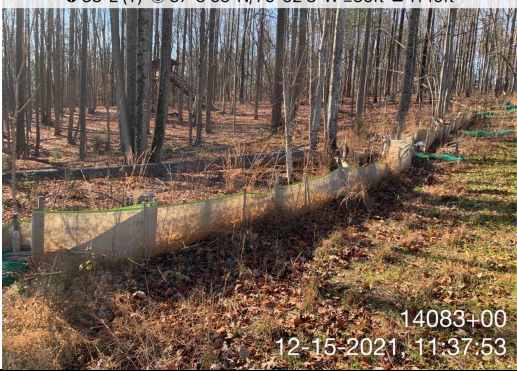
GPS Location	0	GPS Location	0		
Field Station#	14086+00	Field Station#	14083+00		
Pic 9 Desc.	Sump pit in acceptable condition	Pic 10 Desc.	P1 silt fence in acceptable condition		
Insert image here		Insert image here			
GPS Location		GPS Location			
Field Station#		Field Station#			
Pic 11 Desc.		Pic 12 Desc.

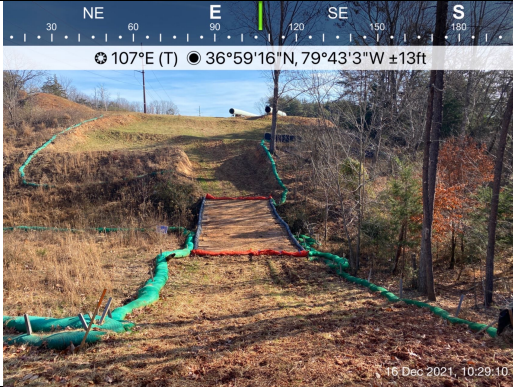
GPS Location	0	GPS Location	0		
Field Station#	14656+90	Field Station#	14673+10		
Pic 1 Desc.	Approximately 14656+90. Overview of stream crossing, equipment bridge and ECDs at stream S-H38.		Pic 2 Desc.	Approximately 14673+10. Overview of stream crossing, equipment bridge and ECDs at stream S-H37.

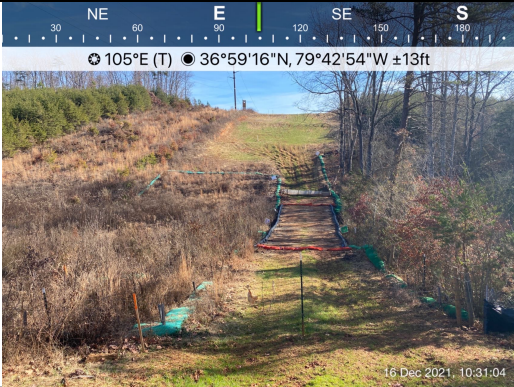
GPS Location	0	GPS Location	0		
Field Station#	14680+30	Field Station#	14692+00		
Pic 3 Desc.	Approximately 14680+30. Overview of stream crossing, equipment bridge and ECDs at stream S-H36.		Pic 4 Desc.	Approximately 14692+00. Overview of ROW.

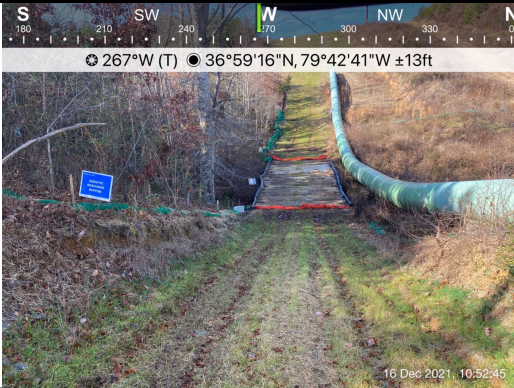
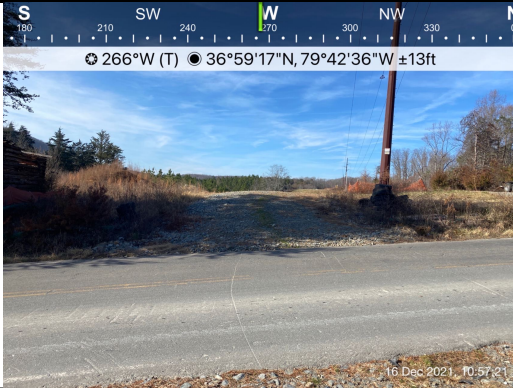
GPS Location	0	GPS Location	0		
Field Station#	14689+36	Field Station#	14694+50		
Pic 5 Desc.	Approximately 14689+36. Overview of stream crossing, equipment bridge and ECDs at stream S-H34.		Pic 6 Desc.	Approximately 14694+50. Overview of road crossing and RCE.

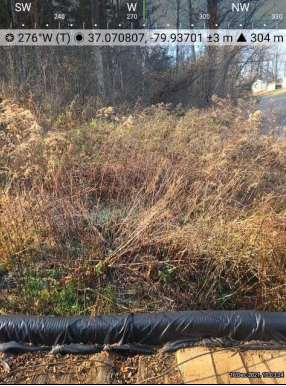
GPS Location	00000	GPS Location	0000		
Field Station#	13770+69	Field Station#	13770+69		
Pic 1 Desc.	Stream observation photo facing upstream during routine inspection today, no environmental issues observed at the time of inspection.	Pic 2 Desc.	Stream observation photo facing downstream during routine inspection today, good vegetation in area with no environmental issues observed at the time of inspection.

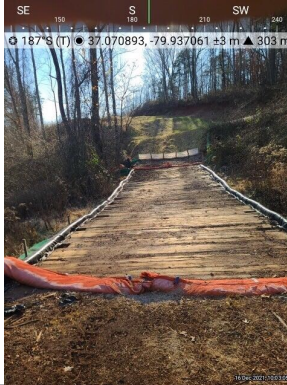
GPS Location	0000	GPS Location	0000		
Field Station#	13755+49	Field Station#	13770+13		
Pic 3 Desc.	Stream observation photo facing upstream during routine inspection today, no environmental issues observed at the time of inspection.	Pic 4 Desc.	Monitored equipment bridges and ECDs at stream crossings, no environmental issues observed at the time of inspection.

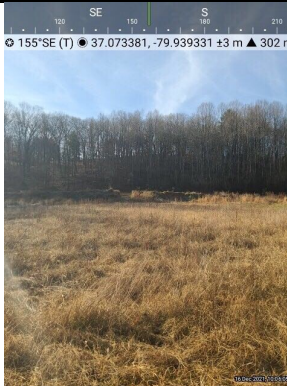
Field Station#	13755+49	Field Station#	13757+00		
Pic 5 Desc.	Stream observation photo facing downstream during routine inspection today, no environmental issues observed at the time of inspection.	Pic 6 Desc.	Row photo showing vegetation in work space area, stabilized spoil piles. No environmental issues observed at the time of inspection.

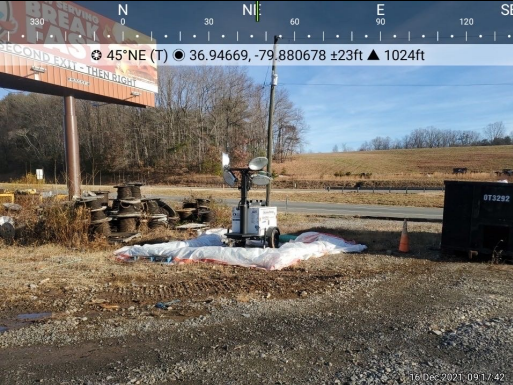
GPS Location	0	GPS Location	0		
Field Station#	0+00	Field Station#	0+00		
Pic 1 Desc.	LY-032 Temporary vegetation		Pic 2 Desc.	LY-032 Secondary containment

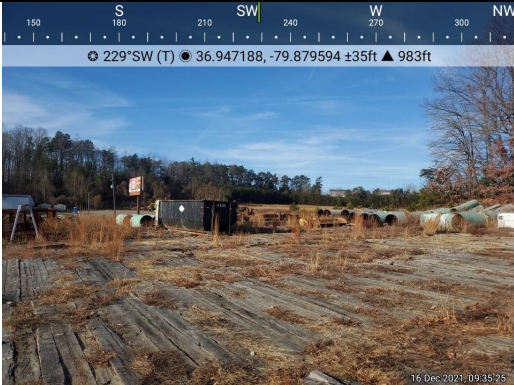
GPS Location	0	GPS Location	0		
Field Station#	0+00	Field Station#	0+00		
Pic 3 Desc.	LY-033 Staging area		Pic 4 Desc.	LY-033 Stormwater drain inlet

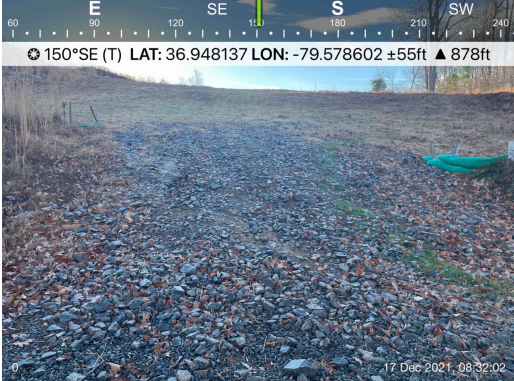
GPS Location	See photo		GPS Location	See photo	
Field Station#	15142+66		Field Station#	15147+00	
Pic 1 Desc.	RCE in good condition at Rockcreek Rd.		Pic 2 Desc.	Perimeter CFS is in good condition.

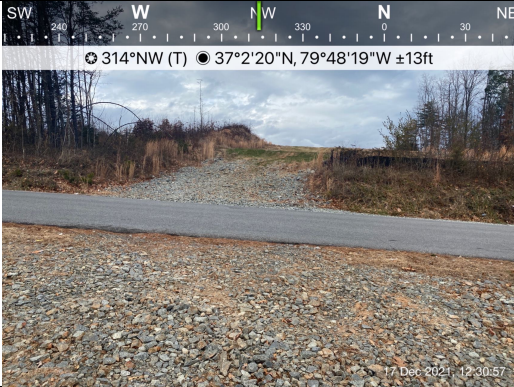
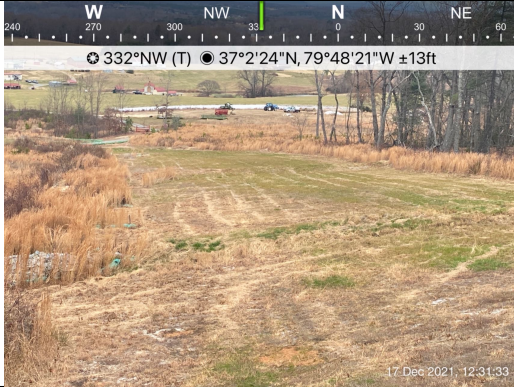
GPS Location	0	GPS Location	0		
Field Station#	14333+50	Field Station#	14326+00		
Pic 1 Desc.	Approximately 14333+50. Overview of road crossing and RCEs.	Pic 2 Desc.	Approximately 14326+00. Overview of ROW.

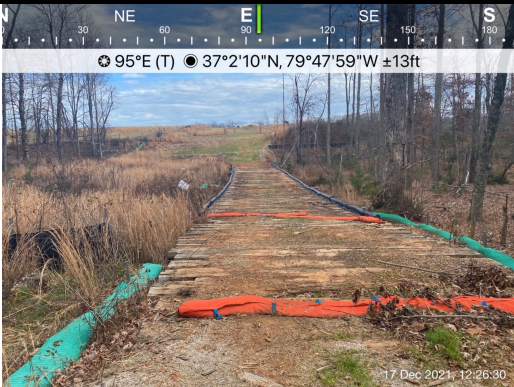
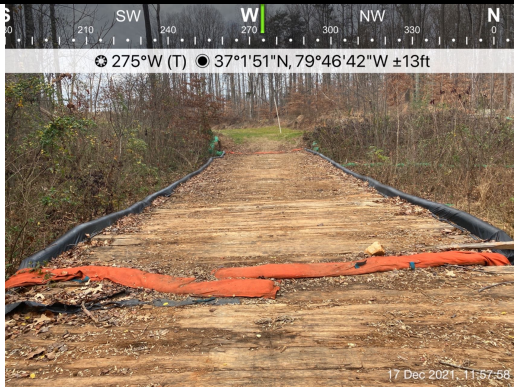
GPS Location	0	GPS Location	0		
Field Station#	14353+53	Field Station#	14420+70		
Pic 3 Desc.	Approximately 14353+53. Overview of stream crossing, equipment bridge and ECDs at stream S-A38.	Pic 4 Desc.	Approximately 14420+70. Overview of stream crossing, equipment bridge and ECDs at stream S-KL17.

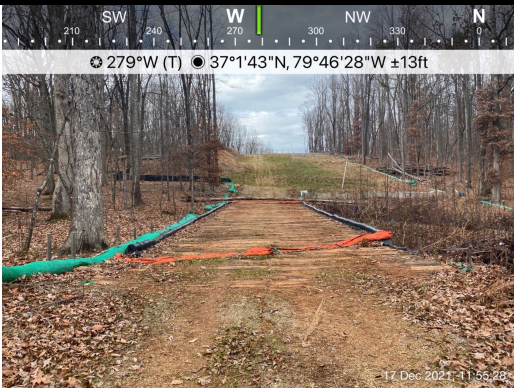
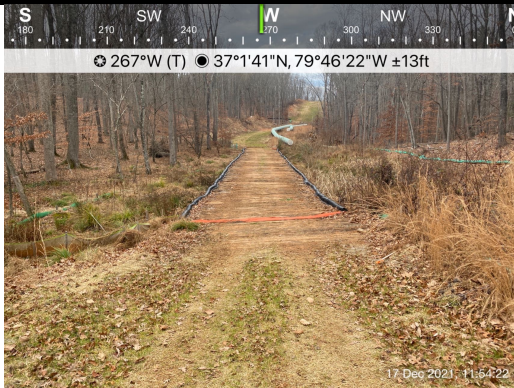
GPS Location	0	GPS Location	0		
Field Station#	14434+01	Field Station#	14438+49		
Pic 5 Desc.	Approximately 14434+01. Overview of stream crossing, equipment bridge and ECDs at stream S-GH40.	Pic 6 Desc.	Approximately 14438+49. Overview of stream crossing, equipment bridge and ECDs at stream S-IJ47.

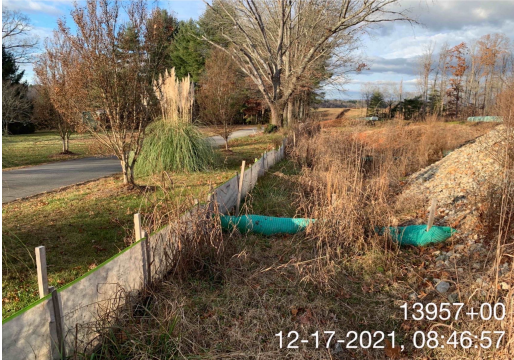
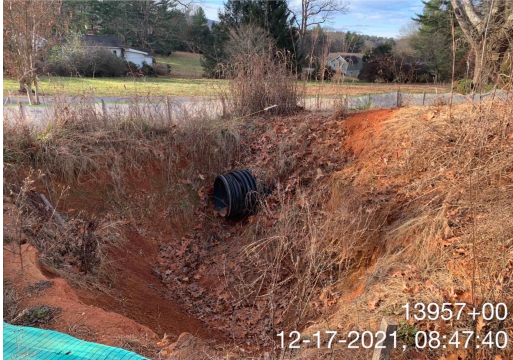
13957+00 12-17-2021, 08:47:40			
GPS Location	0	GPS Location	0		
Field Station#	13957+00	Field Station#	13957+00		
Pic 1 Desc.	Perimeter P1 silt fence in acceptable condition	Pic 2 Desc.	Sump pit and slope drain pipe in acceptable conditions		
337°NW (T) 37°2'56"N, 79°54'0"W ±213ft ▲ 1128ft

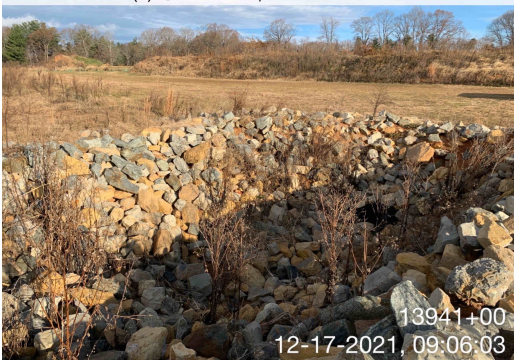
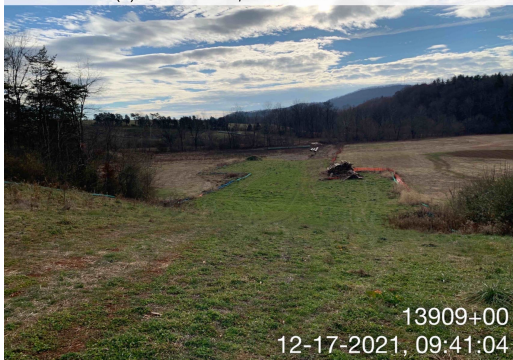
13909+00 12-17-2021, 09:41:04			
GPS Location	0	GPS Location	0		
Field Station#	13941+00	Field Station#	13909+00		
Pic 3 Desc.	Clean water diversion pipe and plunge pool in acceptable conditions	Pic 4 Desc.	Permanent vegetative stabilization in acceptable condition		
131°SE (T) 37°3'26"N, 79°54'47"W ±39ft ▲ 1031ft

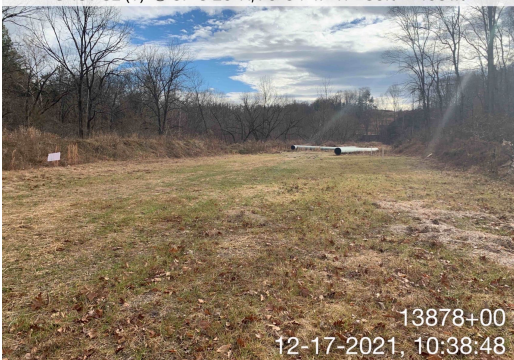
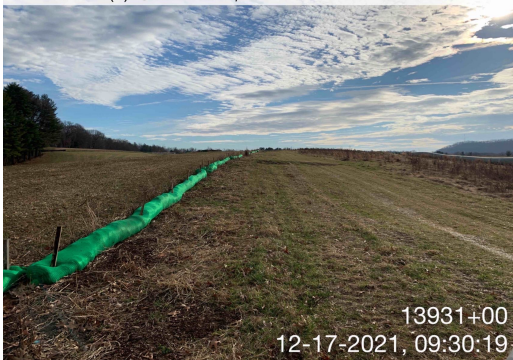
GPS Location	0	GPS Location	0		
Field Station#	13878+00	Field Station#	13931+00		
Pic 5 Desc.	Temporary vegetative stabilization in acceptable condition	Pic 6 Desc.	Perimeter CFS and permanent vegetative stabilization in acceptable conditions

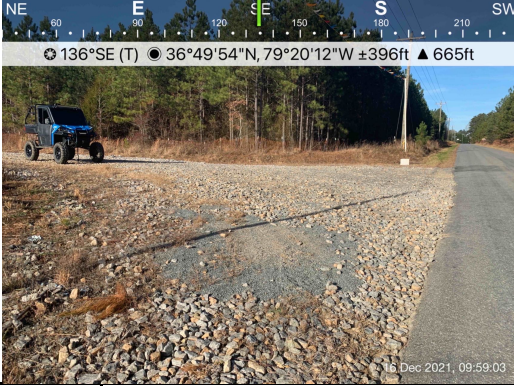
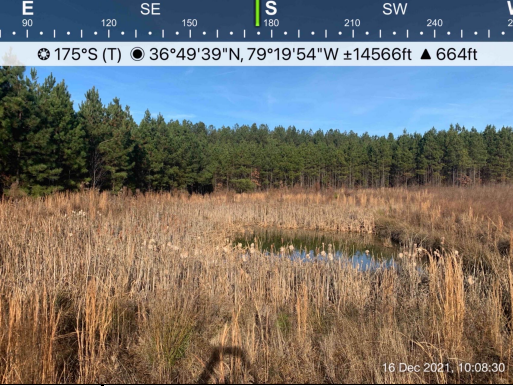
GPS Location	O	GPS Location	O		
Field Station#	00+00	Field Station#	00+00		
Pic 1 Desc.	Observing RCE	Pic 2 Desc.	Observing temporary stabilization and sediment basin

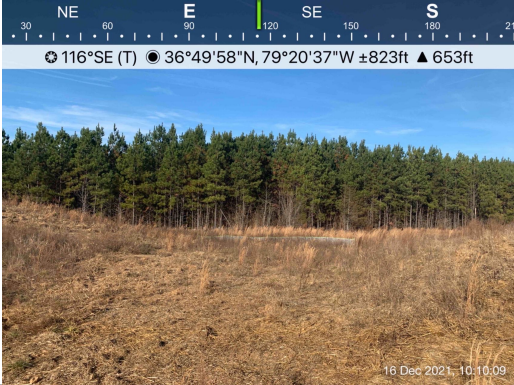
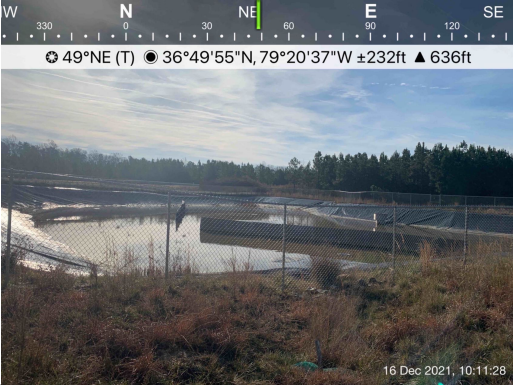
GPS Location	O	GPS Location	O		
Field Station#	00+00	Field Station#	00+00		
Pic 3 Desc.	Observing temporary stabilization and ECD's	Pic 4 Desc.	Observing temporary stabilization, storm water pond and ECD's

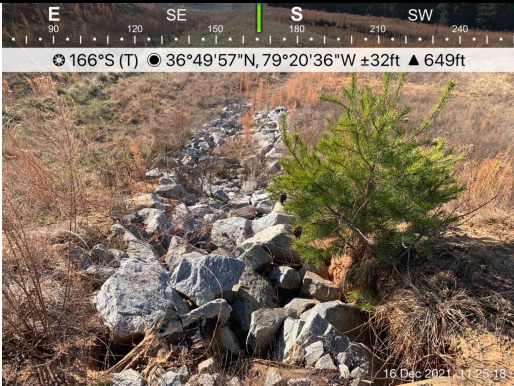
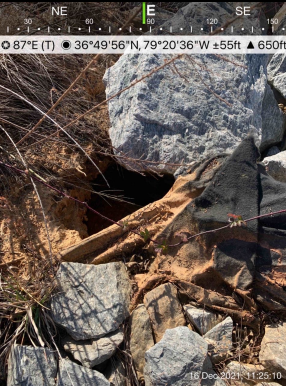
GPS Location	O	GPS Location	O		
Field Station#	00+00	Field Station#	00+00		
Pic 5 Desc.	Observing rock drain that was installed not to spec.	Pic 6 Desc.	Observing rock drain eroding and being undermined.
