Visual Site Inspection Report

Project Name	H-600 Pipeline Spread I	AFE	124300139	Spread	H-600 Pipeline Spread I
Contractor	Precision			Report #	32463
Inspector	Justin Burch			Date/Time	12/20/2021 12:00 PM
Permit #	TBD	Inspection Type	VA SWPP	Station Begin	13958+31
State	VA	Inspection Area	Full	Station End	14062+17
County	Franklin	Ground	Damp	Temperature (°F)	44.00
Municipality	N/A	Weather	Sunny	Rain Gauge (in)	0.10
				Rain Accumulation Time (days)	6.00

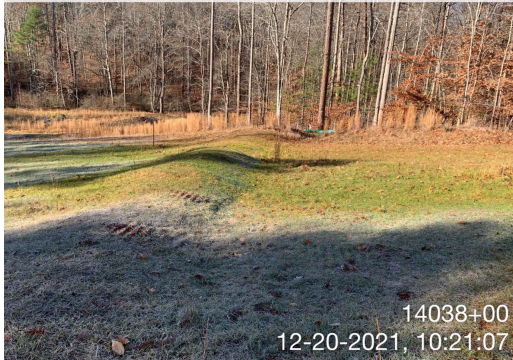
GPS Location			0		
Field Station#			14030+00		
Pic 1 Desc.			Perimeter CFS and temporary vegetative stabilization in acceptable conditions

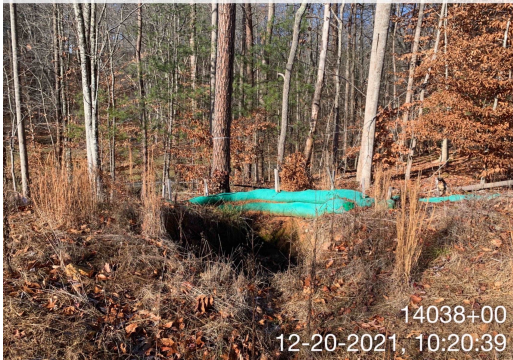
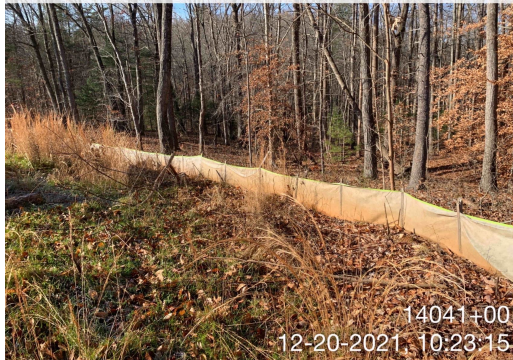
GPS Location			0		
Field Station#			14038+00		
Pic 3 Desc.			Waterbar end treatment in acceptable condition

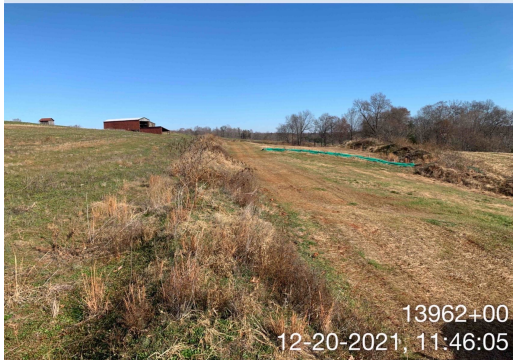
GPS Location			0		
Field Station#			13999+00		
Pic 5 Desc.			Super silt fence in acceptable condition

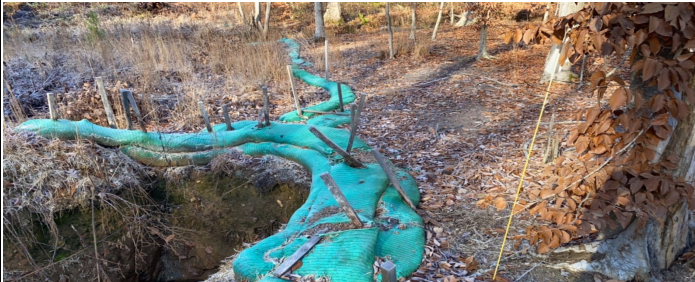
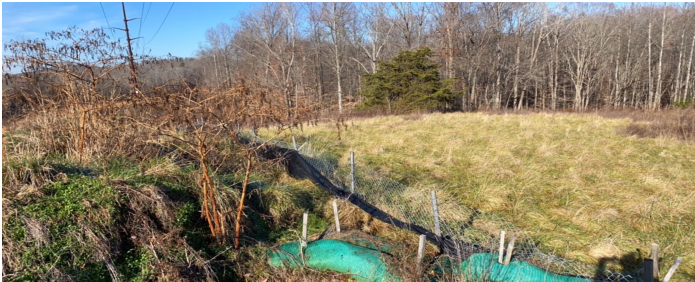
36°58'24" N 79°40'21" W 318°NW COURSE 79° GPS Penhook, VA 24137, United States 12.20.2021 10:22:06 Accur +/-120.0 Ft ALT 872 Ft			36°58'24" N 79°40'9" W 312°NW COURSE 99° GPS Penhook, VA 24137, United States 12.20.2021 10:27:01 Accur +/-54.6 Ft ALT 935 Ft		
GPS Location	1	GPS Location	2		
Field Station#	14824+00	Field Station#	14834+00		
Pic 1 Desc.	Routine maintenance. Repair damaged CFS triple stack.		Pic 2 Desc.	Routine maintenance. Reattach geotextile fabric to SSF fencing.

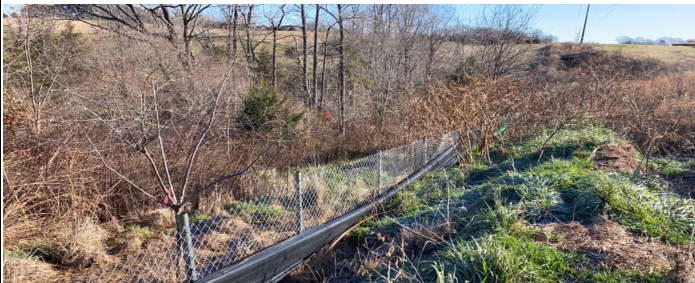
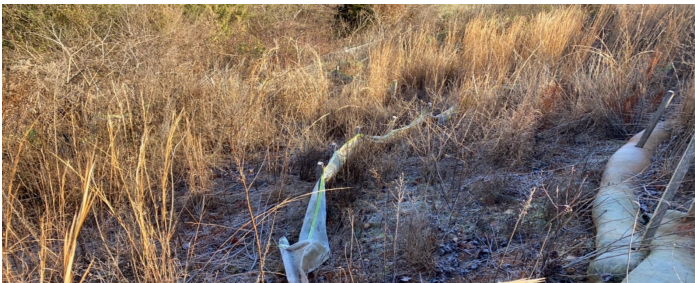
Pic 3 Desc.	Routine maintenance. Reattach geotextile fabric to SSF fencing.		Pic 4 Desc.	Routine maintenance. Replace damaged row of P1 silt fence on side slope.

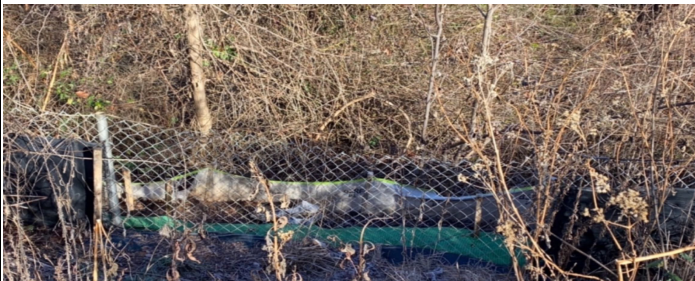
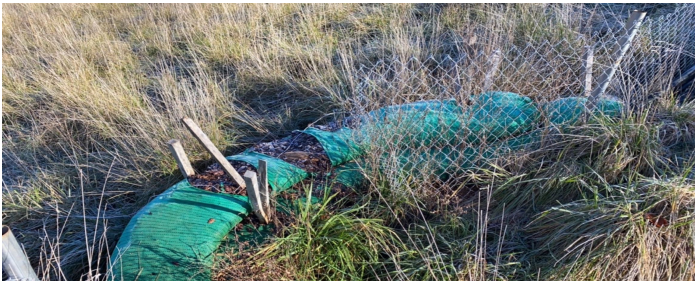
36°58'23" N 79°40'2" W 41°NE COURSE 322° GPS 1120 Listening Hill Rd, Penhook, VA 24137, United States 12.20.2021 10:32:17 Accur +/-53.0 Ft ALT 957 Ft			36°58'22" N 79°39'59" W 76°E COURSE 49° GPS 1120 Listening Hill Rd, Penhook, VA 24137, United States 12.20.2021 10:34:50 Accur +/-52.5 Ft ALT 954 Ft		
GPS Location	5	GPS Location	6		
Field Station#	14838+00	Field Station#	14841+00		
Pic 5 Desc.	Routine maintenance. Replace damaged row of P1 silt fence behind perimeter CFS.		Pic 6 Desc.	Routine maintenance. Repair/replace damaged CFS triple stack.

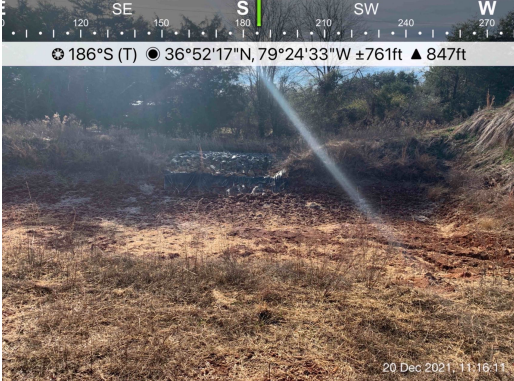
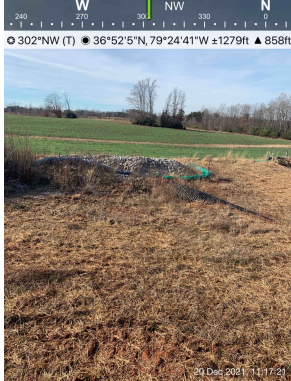
GPS Location	O	GPS Location	O		
Field Station#	15740+00	Field Station#	15735+00		
Pic 1 Desc.	Observing temporary stabilization, sump and end treatment	Pic 2 Desc.	Observing temporary stabilization, CWD outlet and ECD's

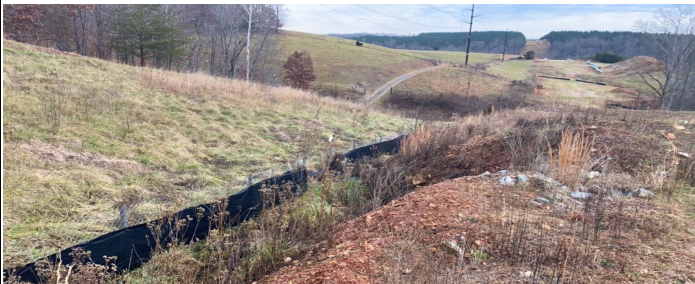
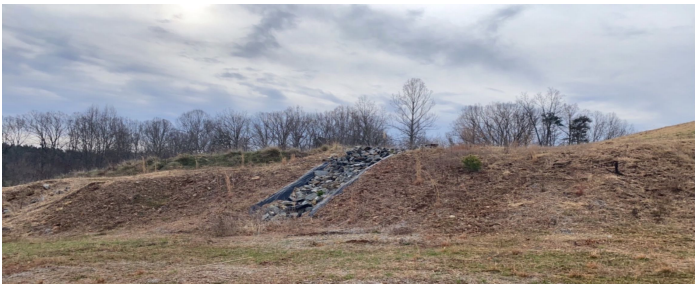
36°58'4" N 79°38'15" W 134°SE COURSE -1' GPS 2082 Ramsey Memorial Rd, Penhook, VA 24137, United States 12.21.2021 10:10:36 Accur +/-47.6 Ft ALT 865 Ft			36°58'4" N 79°38'14" W 148°SE COURSE 121' GPS 2082 Ramsey Memorial Rd, Penhook, VA 24137, United States 12.21.2021 10:10:54 Accur +/-14.7 Ft ALT 860 Ft		
GPS Location	1		GPS Location	2	
Field Station#	14929+50		Field Station#	14930+00	
Pic 1 Desc.	Perimeter SSF in good condition.		Pic 2 Desc.	Rock-lined channel performing intended function.

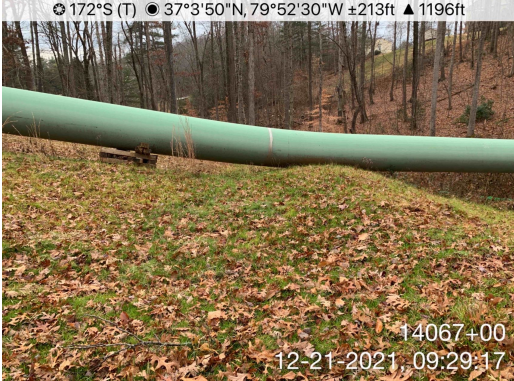
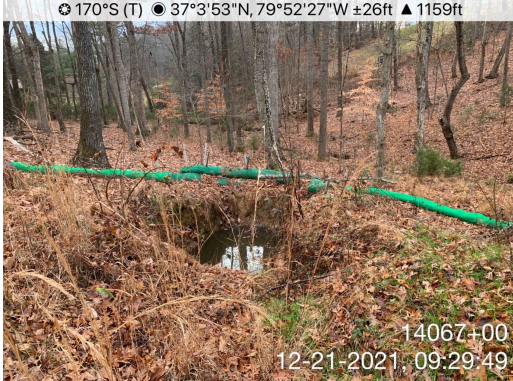
GPS Location	0	GPS Location	0		
Field Station#	14067+00	Field Station#	14067+00		
Pic 1 Desc.	Waterbar in acceptable condition		Pic 2 Desc.	Waterbar end treatment in acceptable condition

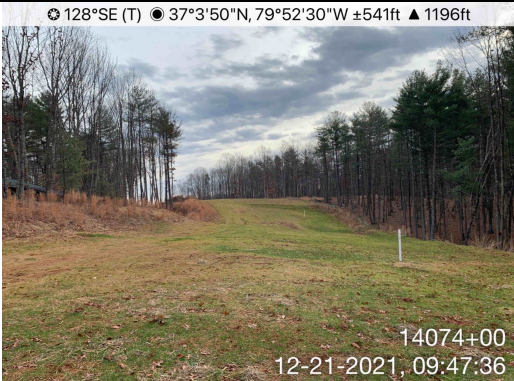
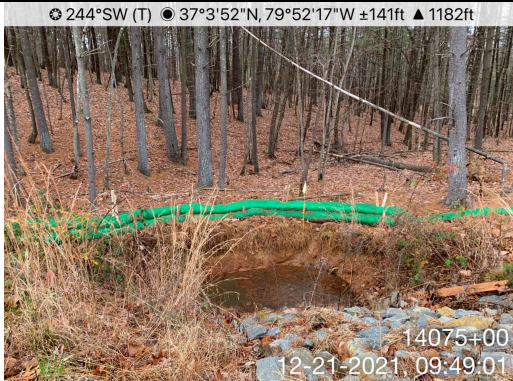
GPS Location	0	GPS Location	0		
Field Station#	14074+00	Field Station#	14075+00		
Pic 3 Desc.	Temporary vegetative stabilization in acceptable condition		Pic 4 Desc.	Sump pit in acceptable condition

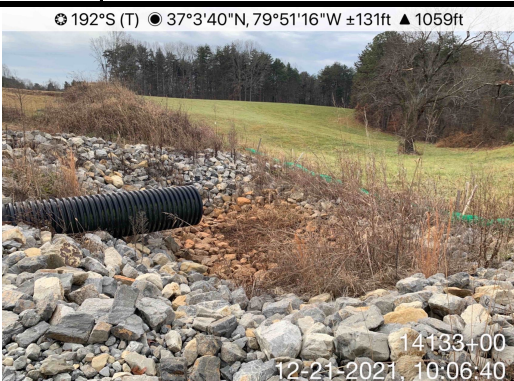
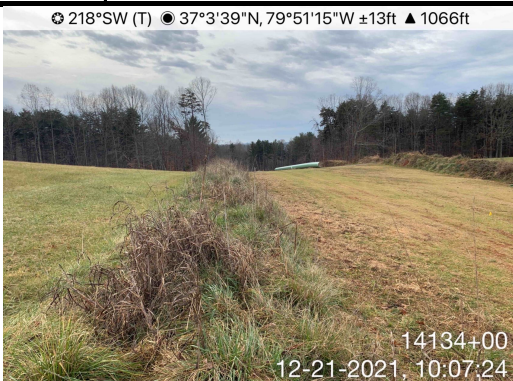
GPS Location	0	GPS Location	0		
Field Station#	14133+00	Field Station#	14134+00		
Pic 5 Desc.	Clean water diversion pipe and plunge pool in acceptable conditions		Pic 6 Desc.	Clean water diversion berm in acceptable condition

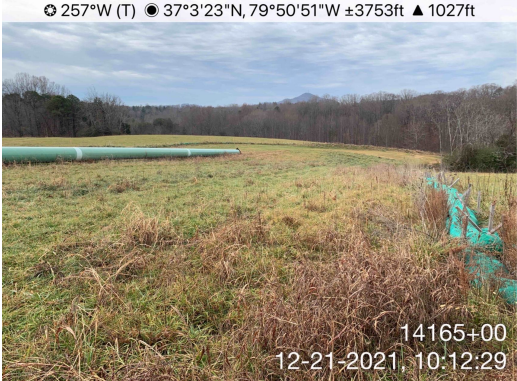
Insert image here	
GPS Location	0	GPS Location			
Field Station#	14165+00	Field Station#			
Pic 7 Desc.	Permanent vegetative stabilization and perimeter CFS in acceptable conditions		Pic 8 Desc.		
Insert image here		Insert image here			
GPS Location		GPS Location			
Field Station#		Field Station#			
Pic 9 Desc.		Pic 10 Desc.			
Insert image here		Insert image here			
GPS Location		GPS Location			
Field Station#		Field Station#			
Pic 11 Desc.		Pic 12 Desc.

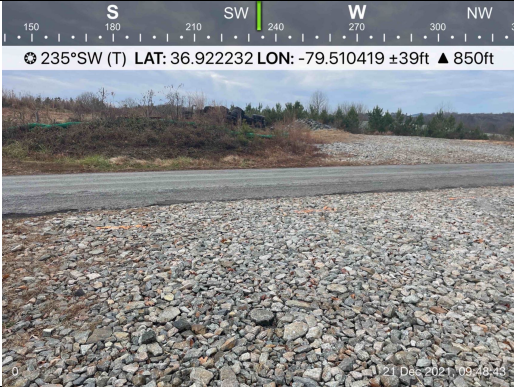
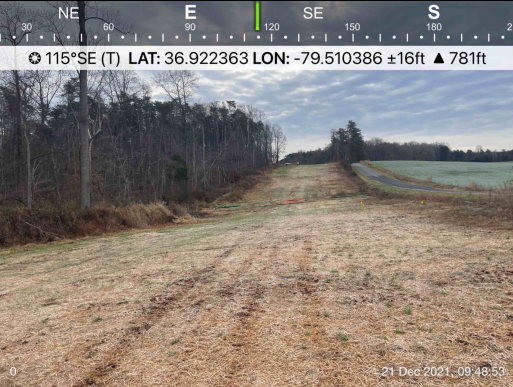
GPS Location	See photo		GPS Location	See photo	
Field Station#	15370+62		Field Station#	15371+00	
Pic 1 Desc.	RCEs are in good condition at all road crossings.		Pic 2 Desc.	Area remains temporarily stabilized.

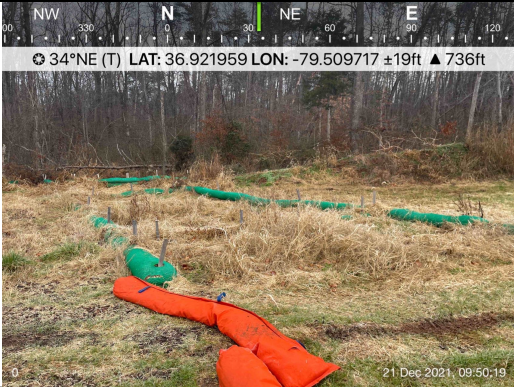
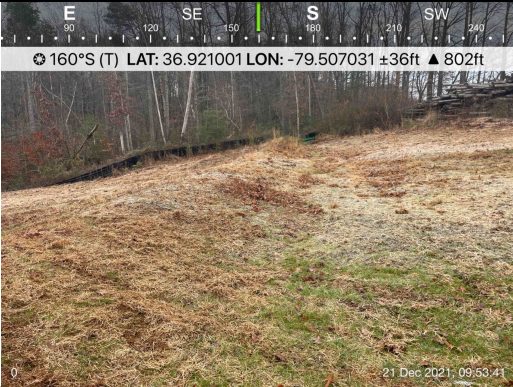
GPS Location	See photo		GPS Location	See photo	
Field Station#	15375+00		Field Station#	15380+00	
Pic 3 Desc.	Drainage ECDs are in place and functioning.		Pic 4 Desc.	Waterbars are in good condition.

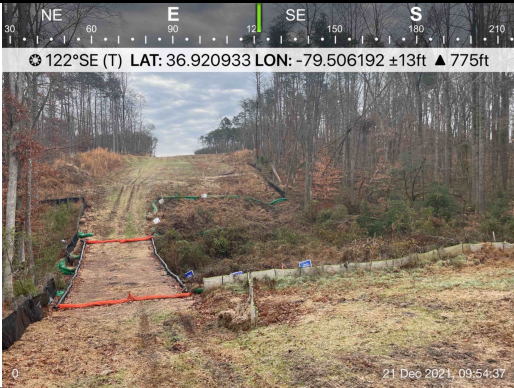
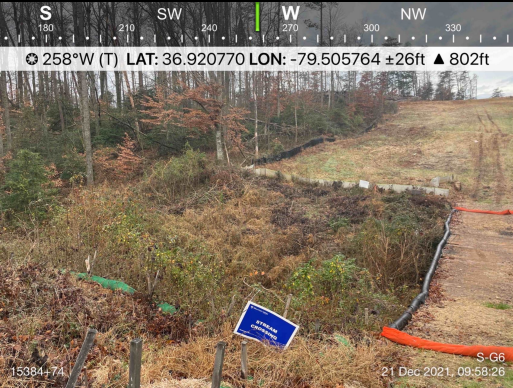
GPS Location	See photo		GPS Location	See photo	
Field Station#	15384+74		Field Station#	15384+74	
Pic 5 Desc.	Equipment bridge ECDs are in good condition and functioning.		Pic 6 Desc.	Stream buffers remain in good condition.

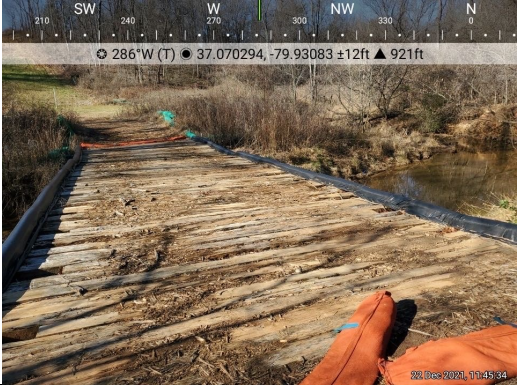
GPS Location	0	GPS Location	0		
Field Station#	13791+00	Field Station#	13789+00		
Pic 7 Desc.	S-D23 Equipment bridge	Pic 8 Desc.	S-D22 Buffer zone vegetation

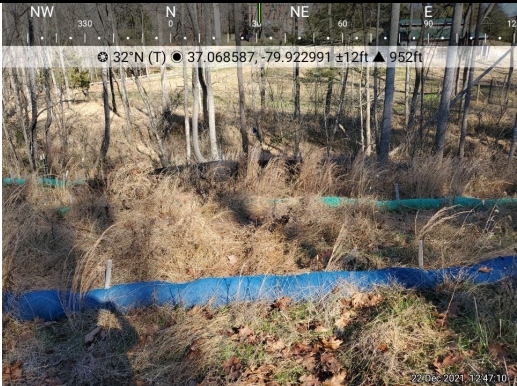
<p>Insert image here</p>	
GPS Location	0	GPS Location	0		
Field Station#	13815+00	Field Station#	13817+00		
Pic 9 Desc.	Plunge pool and perimeter ECDs	Pic 10 Desc.	Sideslope ECDs and stabilization

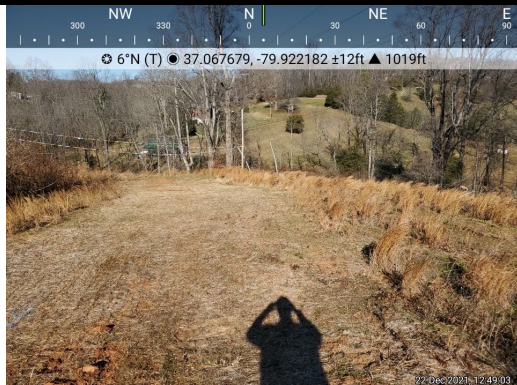
GPS Location	0	GPS Location	0		
Field Station#	13821+00	Field Station#	13823+00		
Pic 11 Desc.	Travel lane stabilization	Pic 12 Desc.	Soil stockpile stabilization

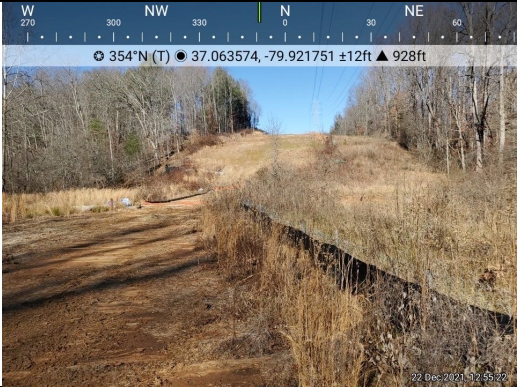
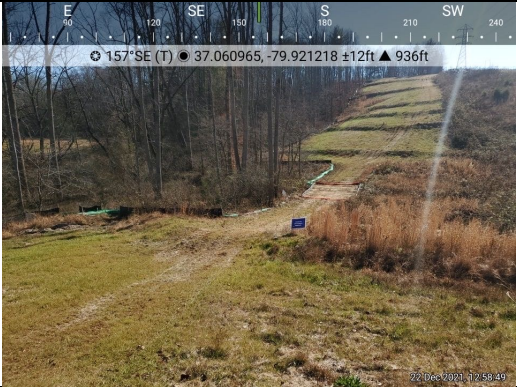
GPS Location	0	GPS Location	0		
Field Station#	13835+50	Field Station#	13845+00		
Pic 13 Desc.	GAS S-C14 Buffer zone	Pic 14 Desc.	S-C16 Vegetation		
Insert image here		Insert image here			
GPS Location		GPS Location			
Field Station#		Field Station#			
Pic 15 Desc.		Pic 16 Desc.			
Insert image here		Insert image here			
GPS Location		GPS Location			
Field Station#		Field Station#			
Pic 17 Desc.		Pic 18 Desc.

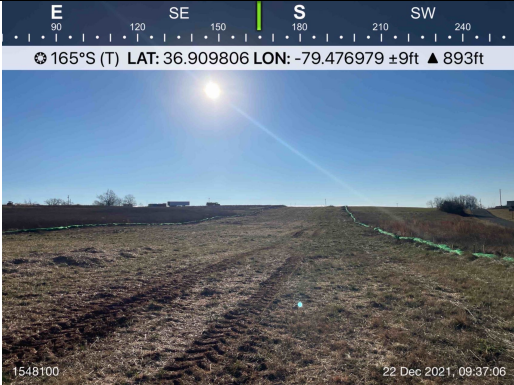
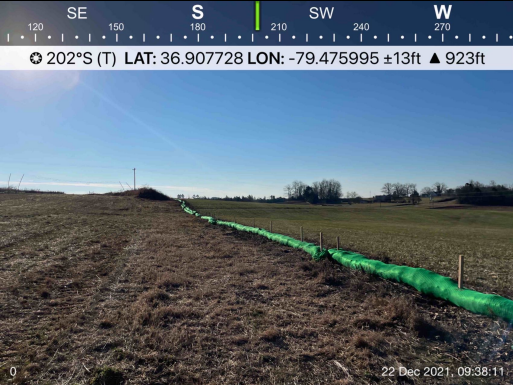
GPS Location	See photo		GPS Location	See photo	
Field Station#	15481+00		Field Station#	15485+00	
Pic 1 Desc.	Vegetation continues to fill in throughout this section		Pic 2 Desc.	Perimeter CFS is in good condition.

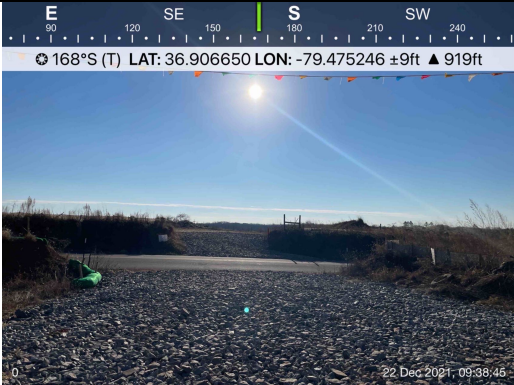
GPS Location	See photo		GPS Location	See photo	
Field Station#	15496+70		Field Station#	15501+00	
Pic 3 Desc.	RCEs are in good condition at all road crossings.		Pic 4 Desc.	No evidence of sedimentation from 3rd party disturbance.

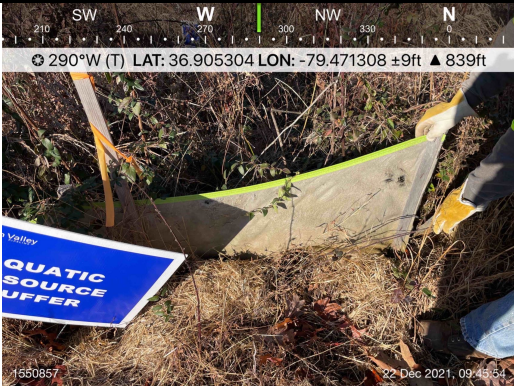
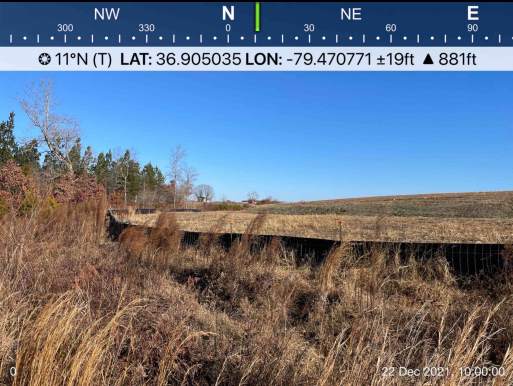
GPS Location	See photo		GPS Location	See photo	
Field Station#	15508+57		Field Station#	15510+00	
Pic 5 Desc.	P1 is degraded and needs to be replaced		Pic 6 Desc.	3rd party ECDs appear to be in good condition.

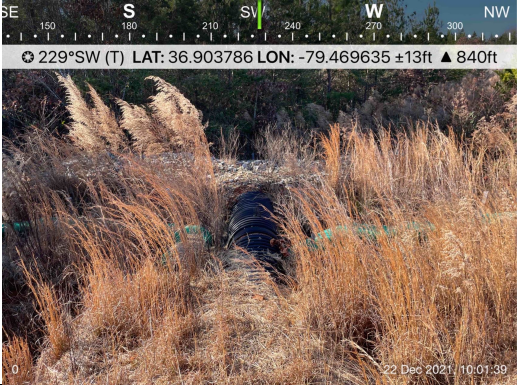
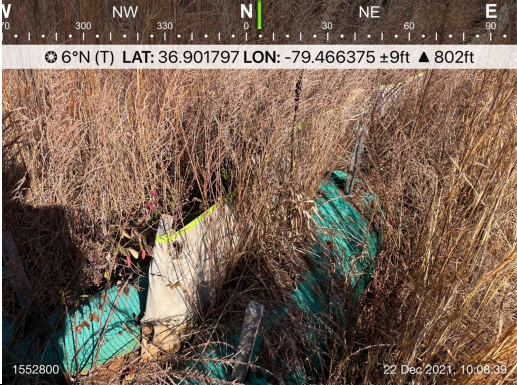
GPS Location	See photo		GPS Location	See photo	
Field Station#	15515+00		Field Station#	15528+00	
Pic 7 Desc.	CWDs are functioning as intended.		Pic 8 Desc.	P1 is degraded and needs to be replaced.

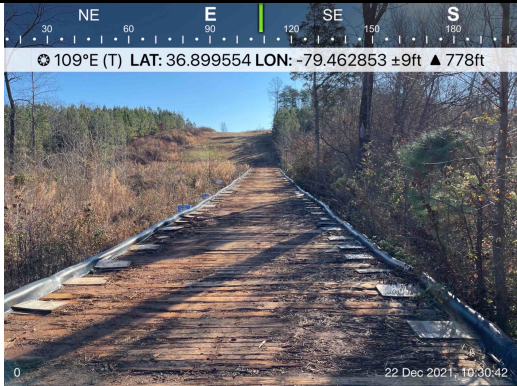
GPS Location	See photo		GPS Location	See photo	
Field Station#	15540+00		Field Station#	15556+83	
Pic 9 Desc.	Equipment bridge ECDs are in place and functioning.		Pic 10 Desc.	No evidence of sedimentation from 3rd party disturbance.

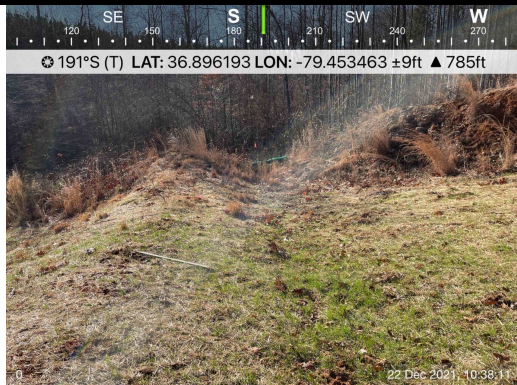
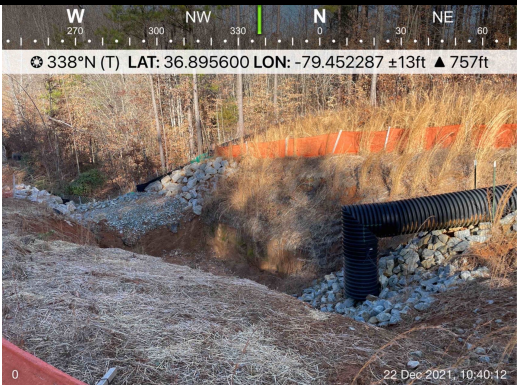
GPS Location	See photo		GPS Location	See photo	
Field Station#	15570+00		Field Station#	15575+00	
Pic 11 Desc.	Waterbars are in good condition and functioning.		Pic 12 Desc.	Slope drain is functioning as intended.

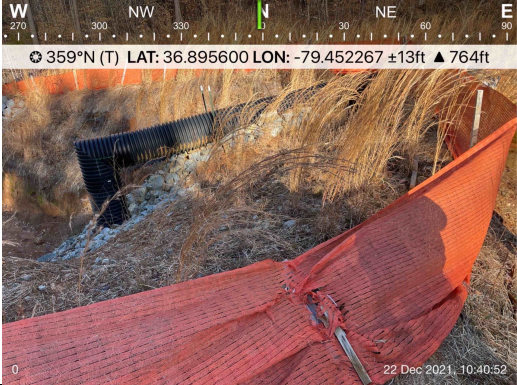
Insert image here			
GPS Location	See photo	GPS Location			
Field Station#	15575+00	Field Station#			
Pic 13 Desc.	Safety fence around slope drain sump needs to be restaked.	Pic 14 Desc.			
Insert image here		Insert image here			
GPS Location		GPS Location			
Field Station#		Field Station#			
Pic 15 Desc.		Pic 16 Desc.			
Insert image here		Insert image here			
GPS Location		GPS Location			
Field Station#		Field Station#			
Pic 17 Desc.		Pic 18 Desc.

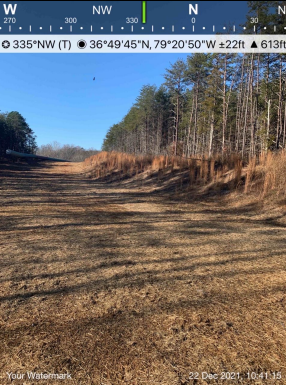
GPS Location	O	GPS Location	O		
Field Station#	16004+00	Field Station#	16009+00		
Pic 1 Desc.	Observing temporary stabilization, signage and buffer	Pic 2 Desc.	Observing temporary stabilization and CWD berm.

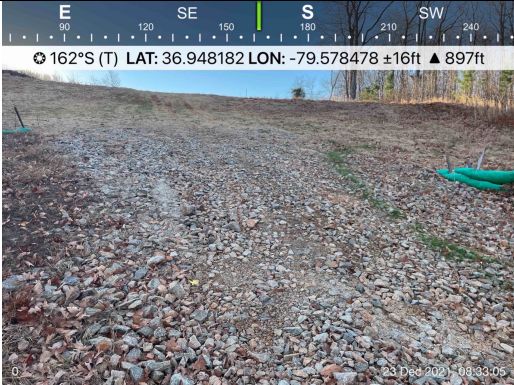
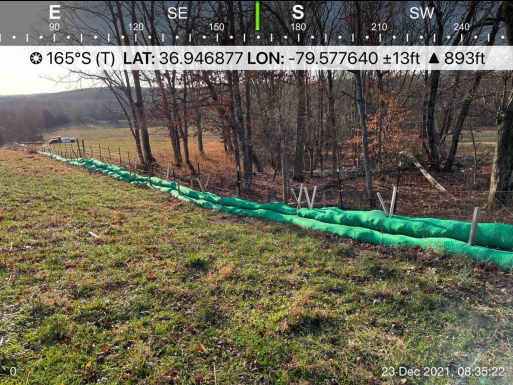
GPS Location	See photo		GPS Location	See photo	
Field Station#	15142+66		Field Station#	15147+00	
Pic 1 Desc.	RCE is in good condition at Rockcreek Rd.		Pic 2 Desc.	Perimeter CFS is in good condition

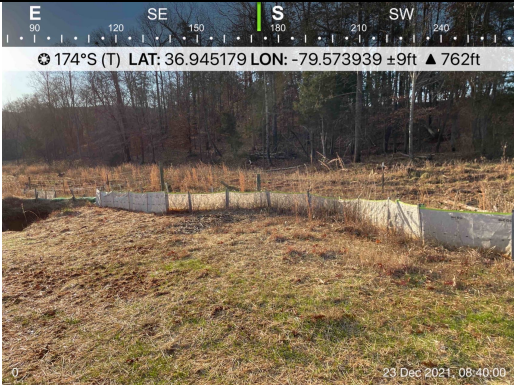
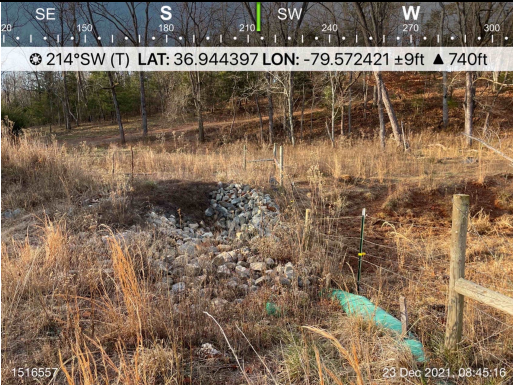
GPS Location	See photo		GPS Location	See photo	
Field Station#	15160+00		Field Station#	15165+57	
Pic 3 Desc.	Perimeter P1 is in good condition.		Pic 4 Desc.	Rock inlet remains in good condition

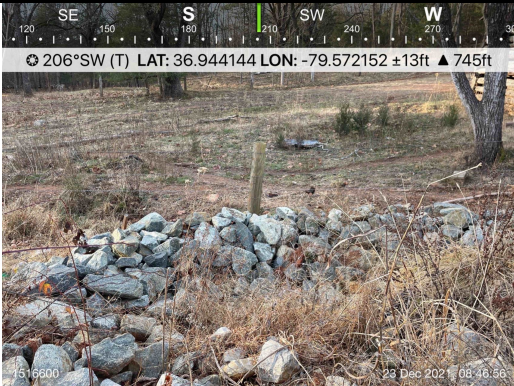
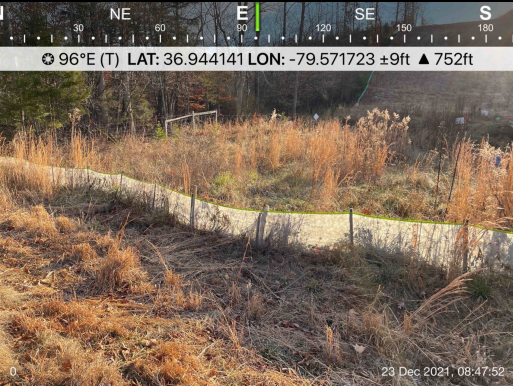
GPS Location	See photo		GPS Location	See photo	
Field Station#	15166+00		Field Station#	15168+49	
Pic 5 Desc.	Rock outlet remains in good condition.		Pic 6 Desc.	P1 is in good condition at stream buffer.

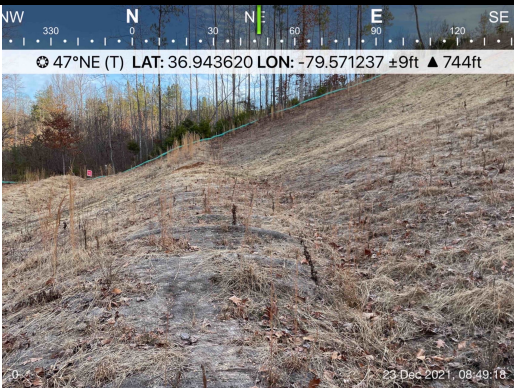
GPS Location	See photo		GPS Location	See photo	
Field Station#	15170+00		Field Station#	15195+00	
Pic 9 Desc.	Waterbars are in good condition		Pic 10 Desc.	Drainage ECDs are in good condition and functioning.	
 		<div>Insert image here</div>			
GPS Location	See photo		GPS Location		
Field Station#	15230+00		Field Station#		
Pic 11 Desc.	Vegetation continues to fill in throughout this section.		Pic 12 Desc.

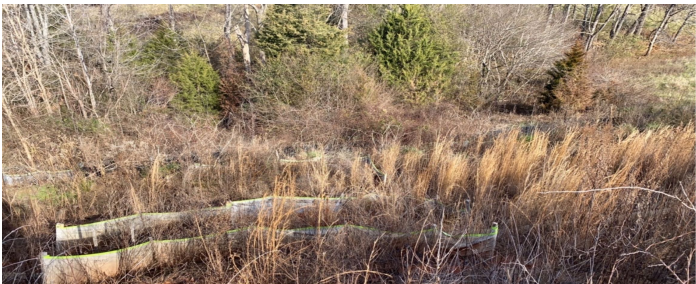
36°58'23" N 79°40'5" W 116°SE COURSE 36° GPS 1120 Listening Hill Rd, Penhook, VA 24137, United States 12.24.2021 11:20:02 Accur +/-15.4 Ft ALT 964 Ft			36°58'22" N 79°40'2" W 2°N COURSE 297° GPS 1120 Listening Hill Rd, Penhook, VA 24137, United States 12.24.2021 11:18:23 Accur +/-15.4 Ft ALT 964 Ft		
GPS Location	1		GPS Location	2	
Field Station#	14834+00		Field Station#	14839+00	
Pic 1 Desc.	Contractor repaired perimeter SSF per punch list item.		Pic 2 Desc.	Contractor replaced damaged P1 silt fence per punch list item.

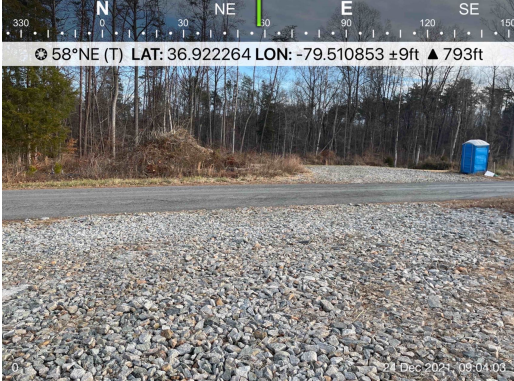
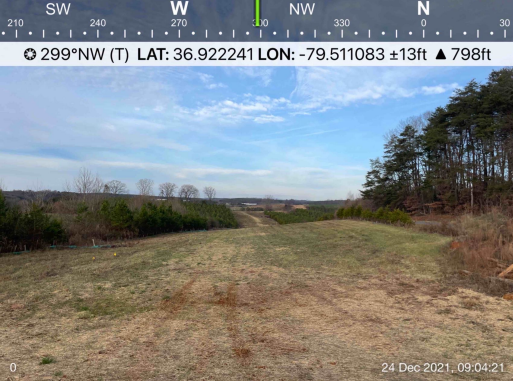
GPS Location	See photo		GPS Location	See photo	
Field Station#	15370+62		Field Station#	15370+00	
Pic 1 Desc.	RCEs are in good condition at all road crossings.		Pic 2 Desc.	Vegetation continues to fill in throughout this section.

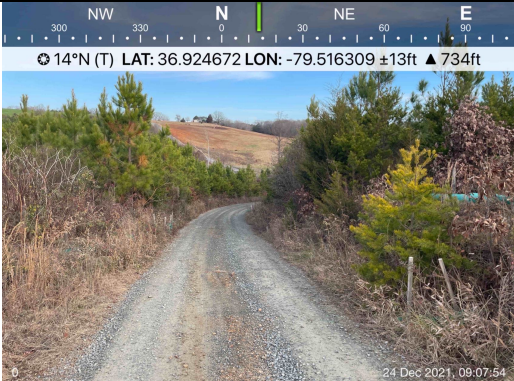
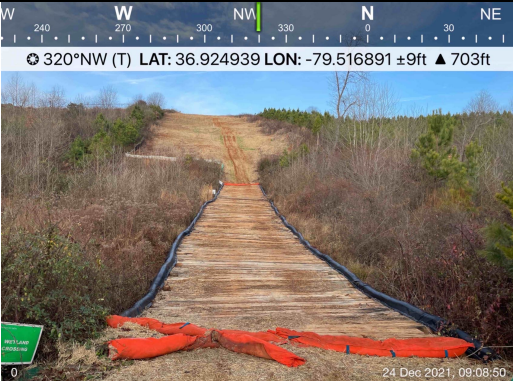
GPS Location	See photo		GPS Location	See photo	
Field Station#	15350+00		Field Station#	15348+21	
Pic 3 Desc.	MVP-PI-332 remains in good condition with controls in place.		Pic 4 Desc.	Equipment bridge ECDs are in place and functioning.

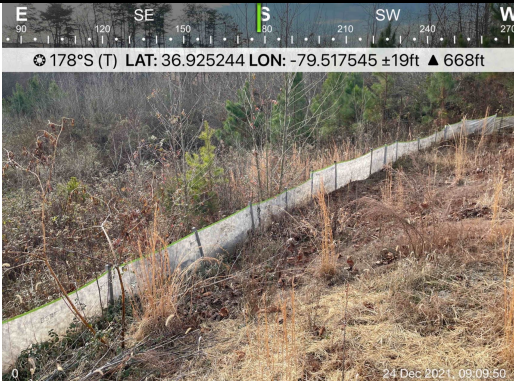
GPS Location	See photo		GPS Location	See photo	
Field Station#	15346+50		Field Station#	15345+00	
Pic 5 Desc.	P1 is in good condition at all stream and wetland buffers.		Pic 6 Desc.	Waterbars are in good condition.

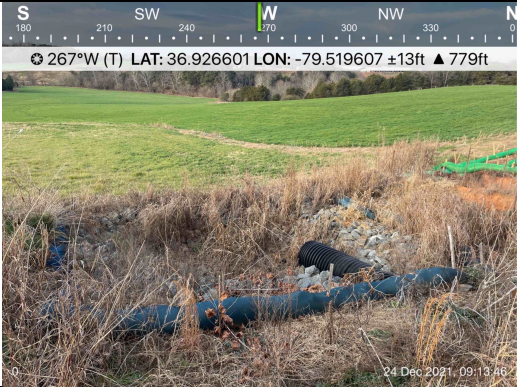
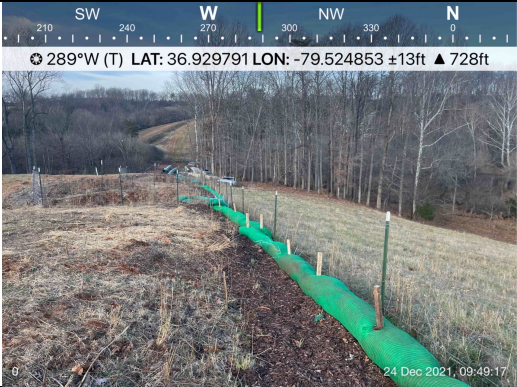
GPS Location	See photo		GPS Location	See photo	
Field Station#	15338+00		Field Station#	15318+00	
Pic 7 Desc.	CWD is functioning as intended.		Pic 8 Desc.	Perimeter CFS is in good condition.

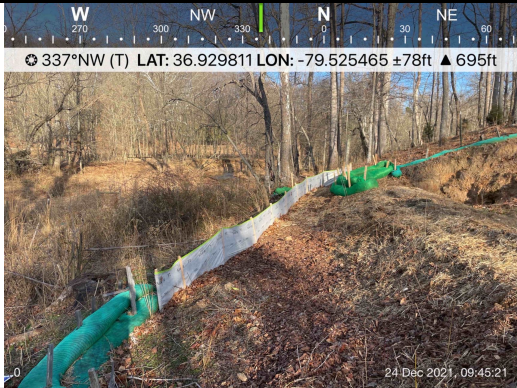
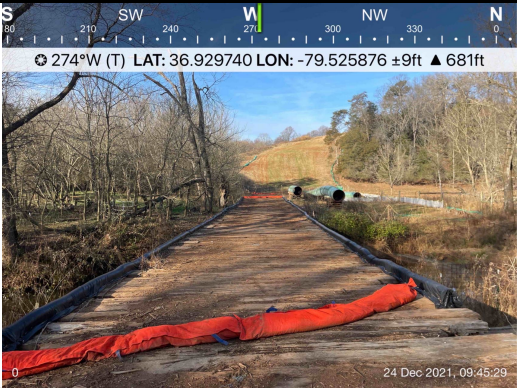
GPS Location	See photo		GPS Location	See photo	
Field Station#	15315+00		Field Station#	15312+00	
Pic 9 Desc.	ECDs are in good condition at stream buffer.		Pic 10 Desc.	Equipment bridge ECDs are in place and functioning.

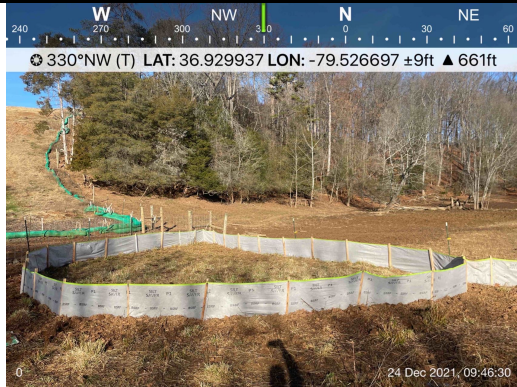
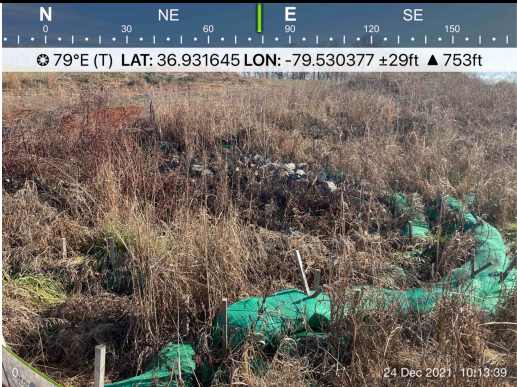
GPS Location	See photo		GPS Location	See photo	
Field Station#	15311+78		Field Station#	15299+00	
Pic 11 Desc.	P1 is in good condition at wetland buffer		Pic 12 Desc.	CWD is in good condition.
