Visual Site Inspection Report

Project Name	H-600 Pipeline Spread I	AFE	124300139	Spread	H-600 Pipeline Spread I
Contractor	Precision			Report #	32656
Inspector	Justin Burch			Date/Time	12/27/2021 7:02 AM
Permit #	TBD	Inspection Type	VA SWPP	Station Begin	14062+17
State	VA	Inspection Area	Full	Station End	14171+36
County	Franklin	Ground	Damp	Temperature (°F)	60.00
Municipality	N/A	Weather	Cloudy	Rain Gauge (in)	0.00
				Rain Accumulation Time (days)	6.00

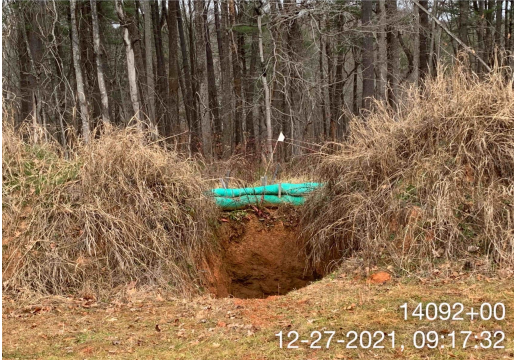
<p>14092+00 12-27-2021, 09:17:32</p>		  <p>14127+00 12-27-2021, 09:49:50</p>			
GPS Location	0	GPS Location	0		
Field Station#	14092+00	Field Station#	14127+00		
Pic 1 Desc.	Sump pit in acceptable condition	Pic 2 Desc.	Waterbar in acceptable condition		
  <p>14127+00 12-27-2021, 09:50:10</p>		  <p>14095+00 12-27-2021, 09:18:45</p>			
GPS Location	0	GPS Location	0		
Field Station#	14127+00	Field Station#	14095+00		
Pic 3 Desc.	Waterbar end treatment in acceptable condition	Pic 4 Desc.	Temporary vegetative stabilization in acceptable condition		
  <p>14118+00 12-27-2021, 09:55:50</p>		  <p>14108+00 12-27-2021, 10:02:20</p>			
GPS Location	0	GPS Location	0		
Field Station#	14118+00	Field Station#	14108+00		
Pic 5 Desc.	Permanent vegetative stabilization in acceptable condition	Pic 6 Desc.	P1 silt fence in acceptable condition

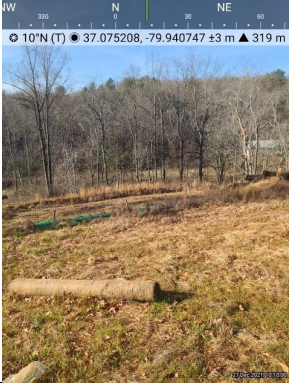
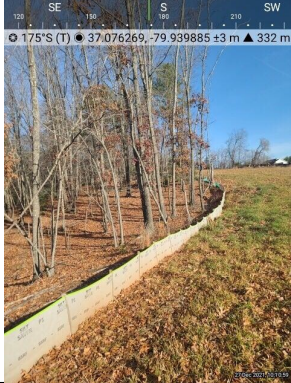
GPS Location	00000	GPS Location	00000		
Field Station#	13746+86	Field Station#	13740+00		
Pic 1 Desc.	Vegetation observation, monitored water bar and CFS , no environmental issues observed at the time of inspection.		Pic 2 Desc.	Monitored P1 along the edge of row in low area. No environmental issues observed at the time of inspection.

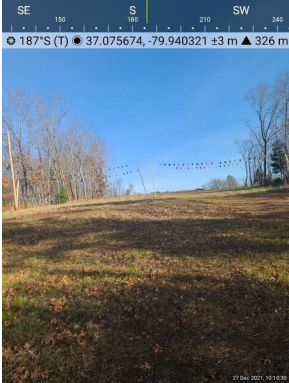
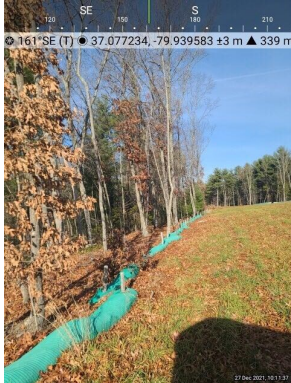
GPS Location	00000	GPS Location	0000		
Field Station#	13743+00	Field Station#	13737+40		
Pic 3 Desc.	Vegetation observation photo in permanently restored area. No environmental issues observed at the time of inspection.		Pic 4 Desc.	Monitored CFS along the row edge, no environmental issues observed at the time of inspection

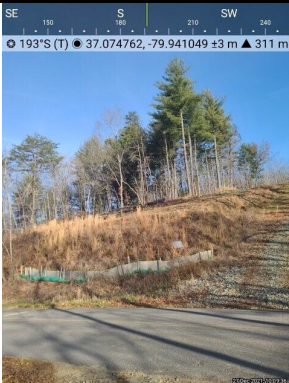
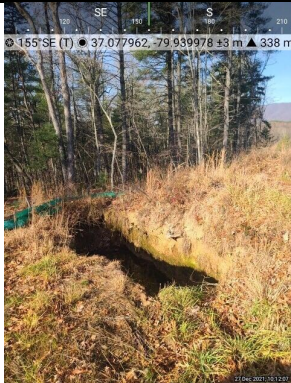
GPS Location	0000	GPS Location	00000		
Field Station#	13747+80	Field Station#	13734+00		
Pic 5 Desc.	Monitored ECDs at road crossings, no environmental issues observed at the time of inspection.		Pic 6 Desc.	Monitored sump pit and end treatment as well as vegetation stabilization throughout. No environmental issues observed at the time of inspection.

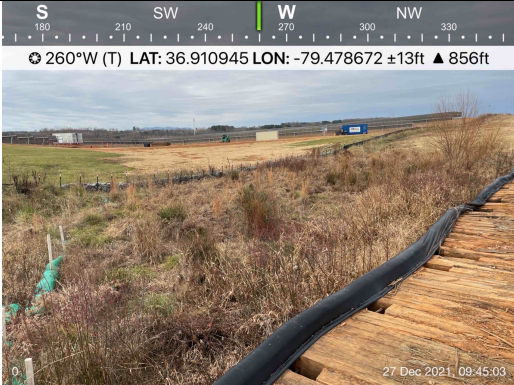
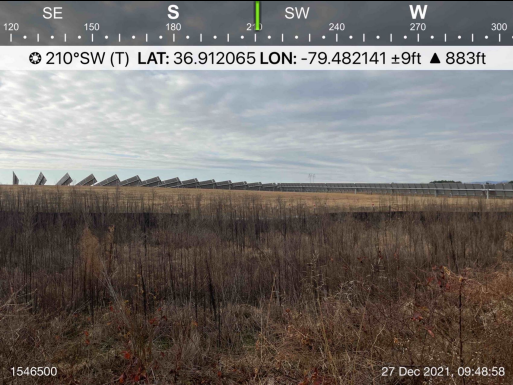
GPS Location	See photo	GPS Location	See photo		
Field Station#	15475+00	Field Station#	15465+00		
Pic 1 Desc.	3rd party rock outlet appears to be in good condition along this drainage.	Pic 2 Desc.	No evidence of sedimentation from 3rd party disturbance.

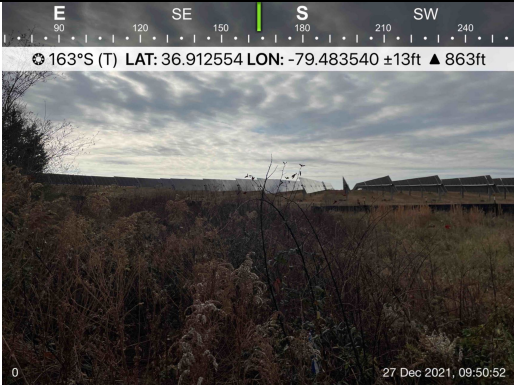
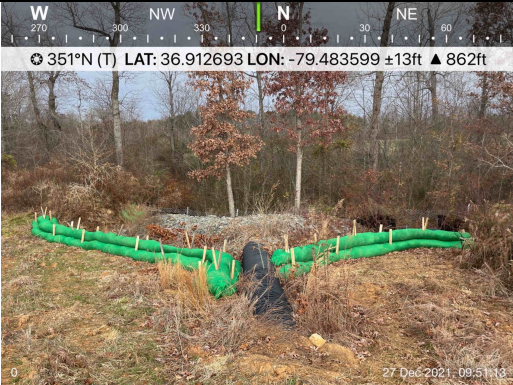
GPS Location	See photo	GPS Location	See photo		
Field Station#	15460+81	Field Station#	15460+81		
Pic 3 Desc.	No evidence of sedimentation from 3rd party disturbance into CWD inlet.	Pic 4 Desc.	CWD remains in good condition.

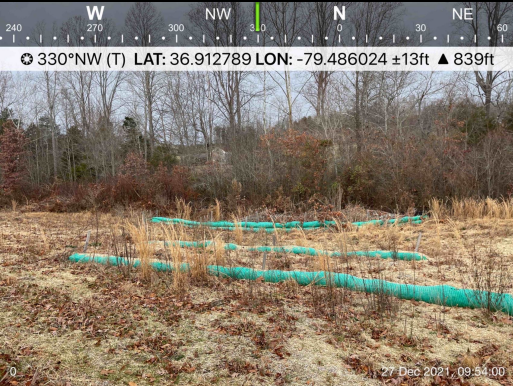
GPS Location	See photo	GPS Location	See photo		
Field Station#	15457+00	Field Station#	15453+00		
Pic 5 Desc.	No evidence of sedimentation within drainage feature.	Pic 6 Desc.	CWD remains in good condition.

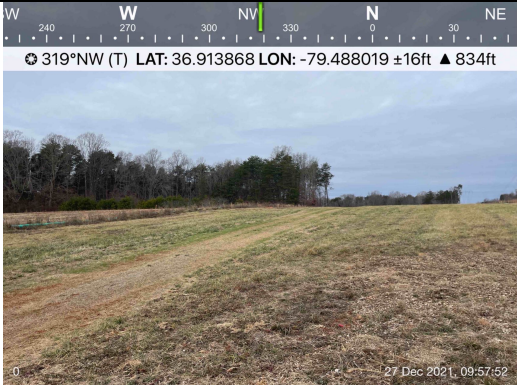
GPS Location	See photo		GPS Location	See photo	
Field Station#	15445+00		Field Station#	15443+00	
Pic 7 Desc.	Perimeter CFS is in good condition.		Pic 8 Desc.	Vegetation continues to fill in throughout this section.

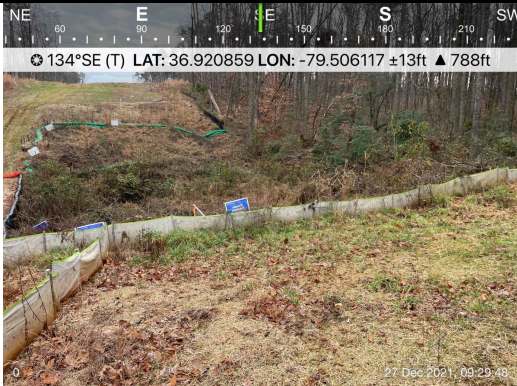
GPS Location	See photo		GPS Location	See photo	
Field Station#	15384+74		Field Station#	15384+74	
Pic 9 Desc.	Equipment bridge ECDs are in place and functioning		Pic 10 Desc.	P1 is in good condition at all stream and wetland buffers.

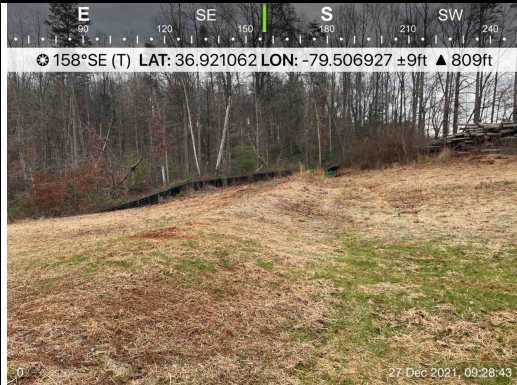
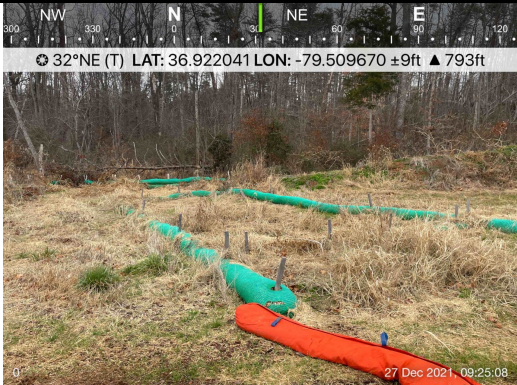
GPS Location	See photo		GPS Location	See photo	
Field Station#	15380+00		Field Station#	15375+00	
Pic 11 Desc.	Waterbars are in good condition		Pic 12 Desc.	Drainage feature ECDs are in good condition and functioning.

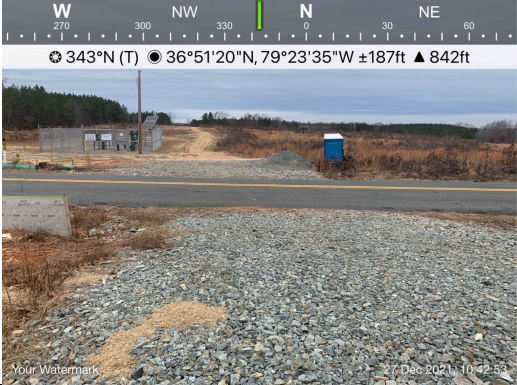
Insert image here			
GPS Location	O	GPS Location			
Field Station#	15826+77	Field Station#			
Pic 7 Desc.	Observing road crossing and RCE's	Pic 8 Desc.			
Insert image here		Insert image here			
GPS Location		GPS Location			
Field Station#		Field Station#			
Pic 9 Desc.		Pic 10 Desc.			
Insert image here		Insert image here			
GPS Location		GPS Location			
Field Station#		Field Station#			
Pic 11 Desc.		Pic 12 Desc.

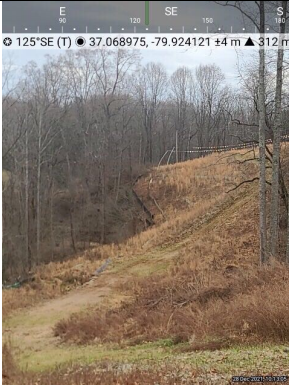
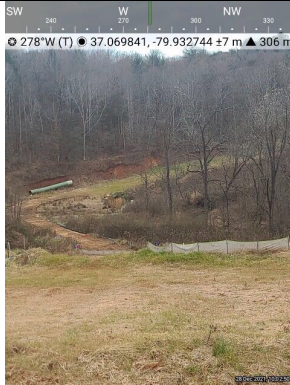
GPS Location	0000	GPS Location	0000		
Field Station#	13814+00	Field Station#	13784+00		
Pic 1 Desc.	Monitored vegetation on hill side , all ECDs in place and functioning properly, no environmental issues observed at the time of inspection		Pic 2 Desc.	ECDs monitored good vegetation stabilization in area on hill side above stream crossing, no environmental issues observed at the time of inspection

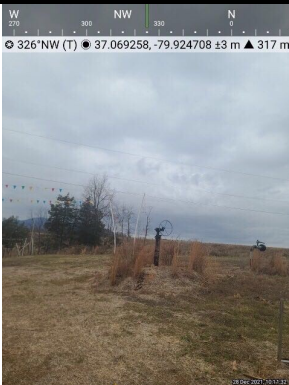
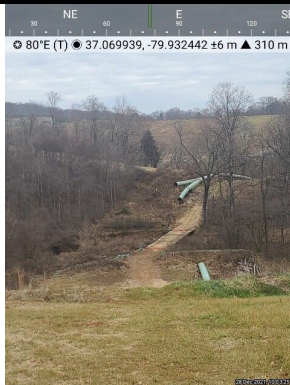
GPS Location	0000	GPS Location	0000		
Field Station#	13810+00	Field Station#	13787+04		
Pic 3 Desc.	Valve site photo showing vegetation stabilization, no environmental issues observed at the time of inspection		Pic 4 Desc.	Row photo showing vegetation on hill side above stream crossing, equipment bridge and ECDs in place with no environmental issues observed at the time of inspection

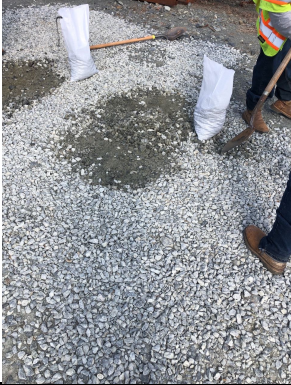
<p>Insert image here</p>		<p>Insert image here</p>	
GPS Location	See picture #6	GPS Location			
Field Station#	0000+00	Field Station#			
Pic 7 Desc.	Fuel spill at LY-045 addressed by contractor.	Pic 8 Desc.			
<p>Insert image here</p>		<p>Insert image here</p>			
GPS Location		GPS Location			
Field Station#		Field Station#			
Pic 9 Desc.		Pic 10 Desc.			
<p>Insert image here</p>		<p>Insert image here</p>			
GPS Location		GPS Location			
Field Station#		Field Station#			
Pic 11 Desc.		Pic 12 Desc.

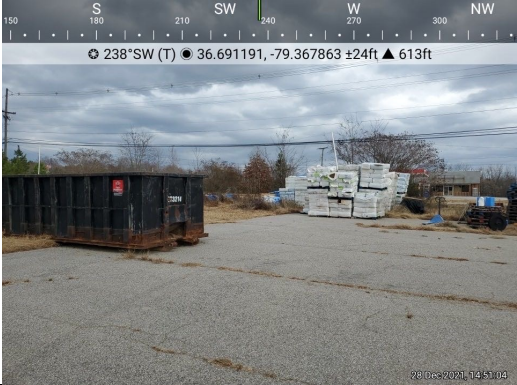
GPS Location	0	GPS Location	0		
Field Station#	0+00	Field Station#	0+00		
Pic 7 Desc.	LY-048 Housekeeping	Pic 8 Desc.	LY-048 West perimeter CFS		
Insert image here		Insert image here			
GPS Location		GPS Location			
Field Station#		Field Station#			
Pic 9 Desc.		Pic 10 Desc.			
Insert image here		Insert image here			
GPS Location		GPS Location			
Field Station#		Field Station#			
Pic 11 Desc.		Pic 12 Desc.

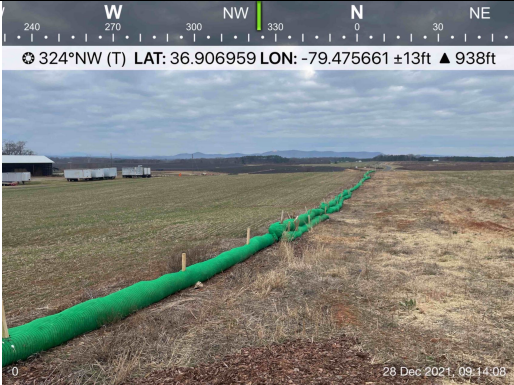
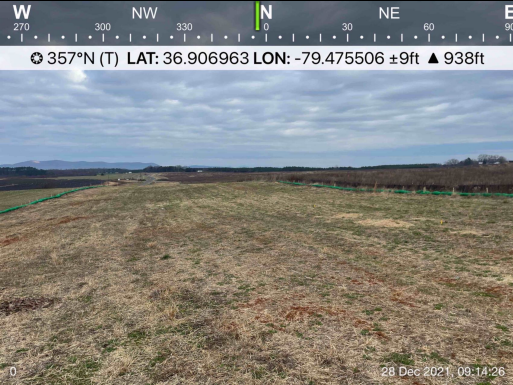
GPS Location	See photo		GPS Location	See photo	
Field Station#	15490+00		Field Station#	15493+00	
Pic 1 Desc.	Perimeter CFS is in good condition		Pic 2 Desc.	Vegetation continues to fill in throughout this section.

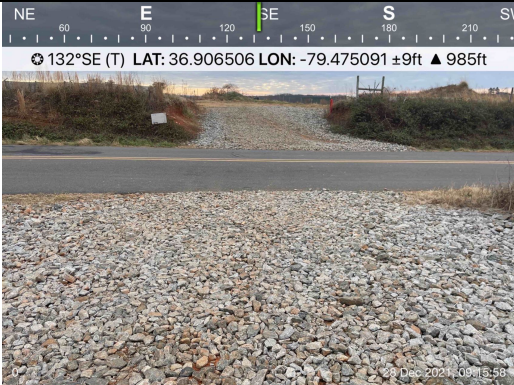
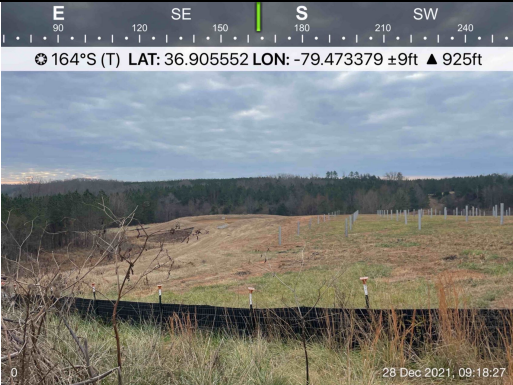
GPS Location	See photo		GPS Location	See photo	
Field Station#	15496+70		Field Station#	15501+00	
Pic 3 Desc.	RCEs are in good condition at all road crossings.		Pic 4 Desc.	3rd party ECDs appear to be in good.

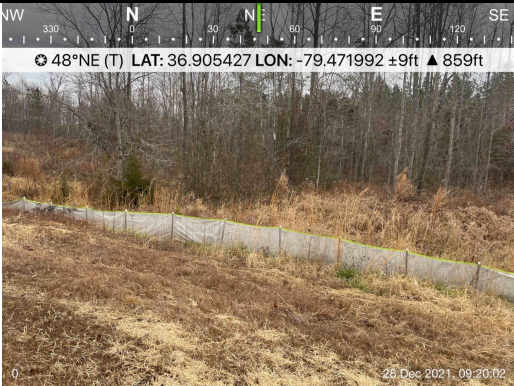
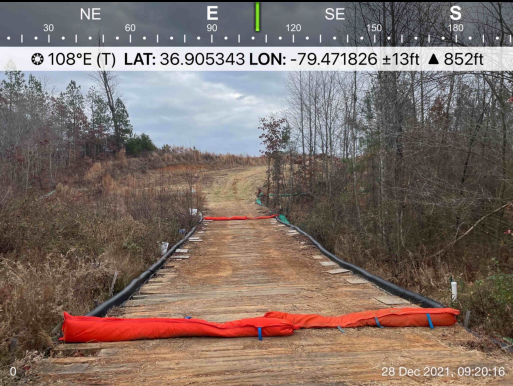
GPS Location	See photo		GPS Location	See photo	
Field Station#	15506+98		Field Station#	15507+77	
Pic 5 Desc.	P1 is in good condition at all stream and wetland buffers		Pic 6 Desc.	Equipment bridge ECDs are in place and functioning.

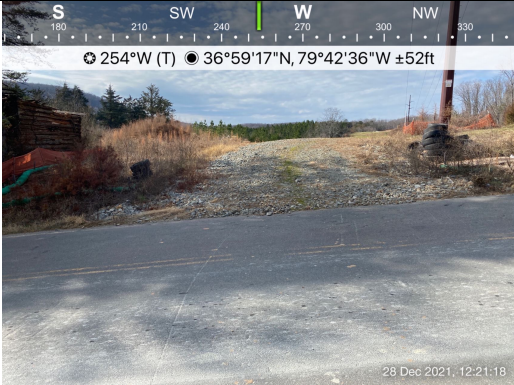
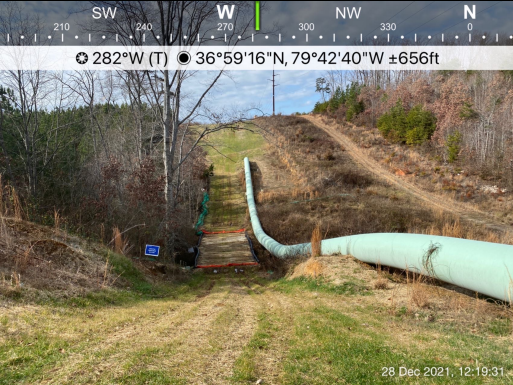
GPS Location	0	GPS Location	0		
Field Station#	14694+50	Field Station#	14689+36		
Pic 1 Desc.	Approximately 14694+50. Overview of road crossing and RCE.		Pic 2 Desc.	Approximately 14689+36. Overview of stream crossing, equipment bridge and ECDs at stream S-H34.

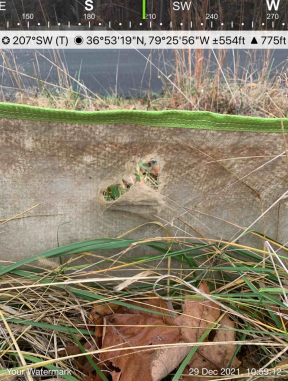
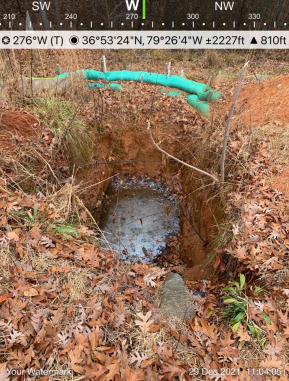
GPS Location	O	GPS Location	O		
Field Station#	15646+80	Field Station#	15640+00		
Pic 1 Desc.	Observing P1 that requires maintenance	Pic 2 Desc.	Observing temporary stabilization, sump and end treatment

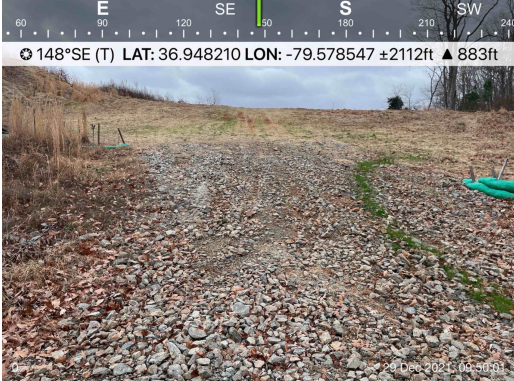
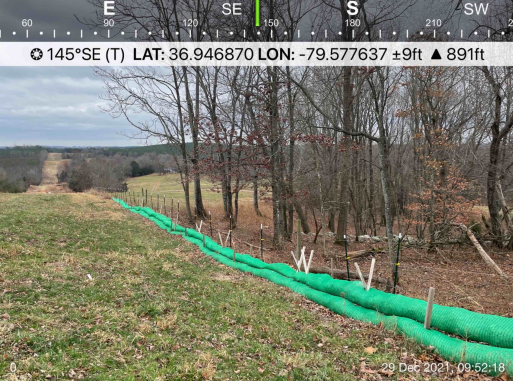
GPS Location	See photo		GPS Location	See photo	
Field Station#	15142+66		Field Station#	15148+00	
Pic 1 Desc.	RCE is in good at Rockcreek.		Pic 2 Desc.	Perimeter CFS is in good condition.

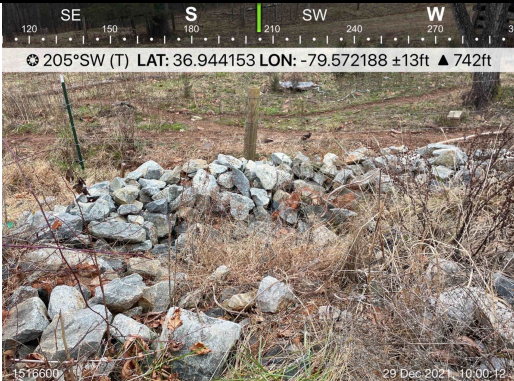
GPS Location	See photo		GPS Location	See photo	
Field Station#	15166+00		Field Station#	15168+40	
Pic 5 Desc.	Rock outlet remains in good condition.		Pic 6 Desc.	Buffer P1 is in good condition.

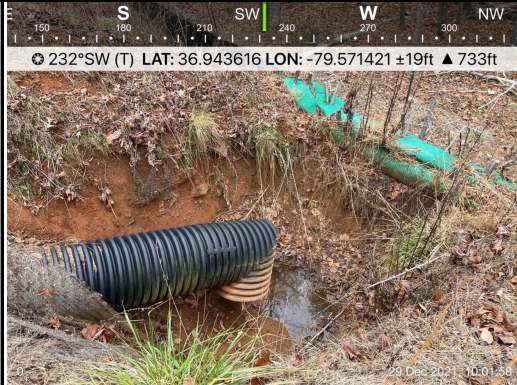
GPS Location	See photo		GPS Location	See photo	
Field Station#	15168+40		Field Station#	15170+00	
Pic 7 Desc.	Equipment bridge ECDs are in place and functioning		Pic 8 Desc.	Slope drain is functioning as intended.

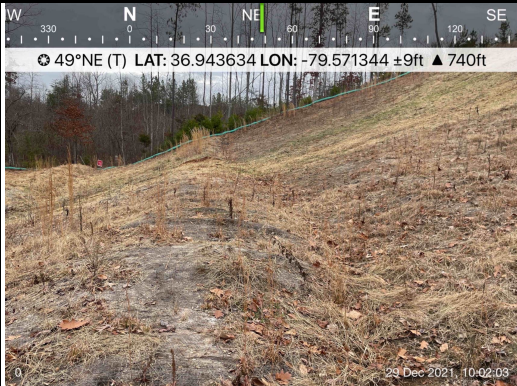
GPS Location	See photo		GPS Location	See photo	
Field Station#	15170+00		Field Station#	15195+00	
Pic 9 Desc.	Waterbars are in good condition		Pic 10 Desc.	Drainage feature ECDs are in good condition and functioning.	
 		Insert image here			
GPS Location	See photo		GPS Location		
Field Station#	15230+00		Field Station#		
Pic 11 Desc.	Vegetation continues to fill in throughout this section.		Pic 12 Desc.

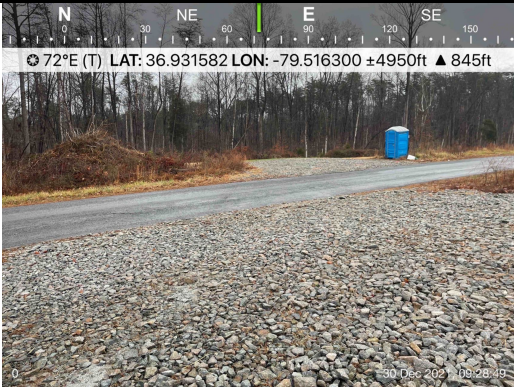
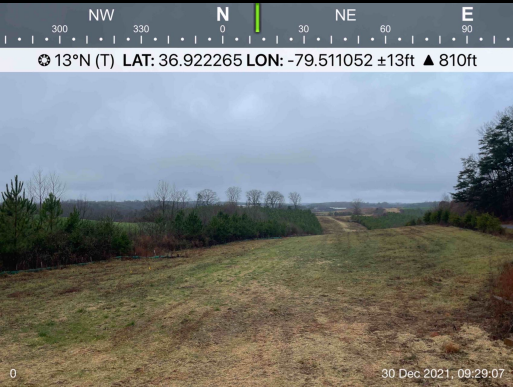
GPS Location	See photo		GPS Location	See photo	
Field Station#	15370+62		Field Station#	15370+00	
Pic 1 Desc.	RCEs are in good condition at all road crossings.		Pic 2 Desc.	Vegetation continues to fill in throughout this section.

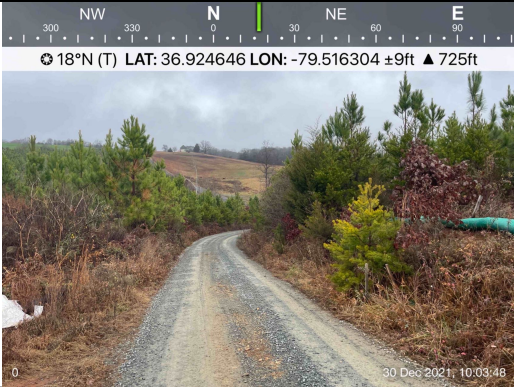
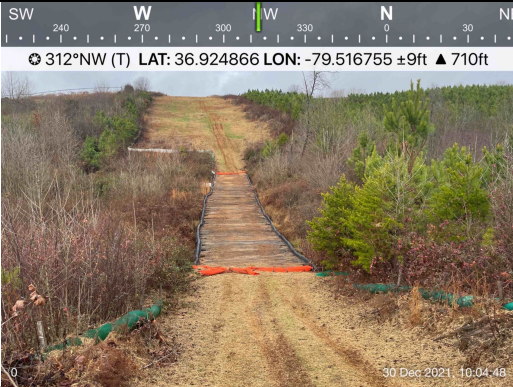
GPS Location	See photo		GPS Location	See photo	
Field Station#	15350+00		Field Station#	15348+00	
Pic 3 Desc.	MVP-PI-332 remains in good condition with controls in place.		Pic 4 Desc.	Equipment bridge ECDs are in place and functioning.

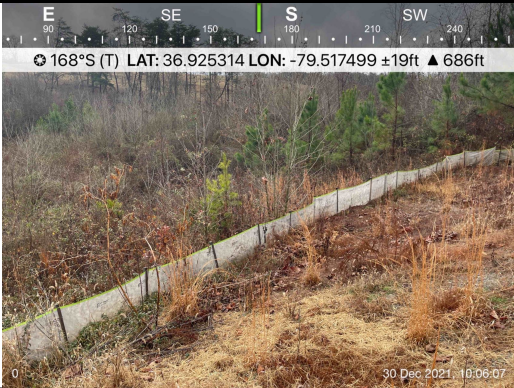
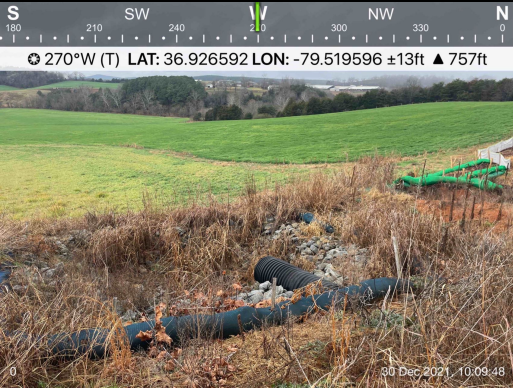
GPS Location	See photo		GPS Location	See photo	
Field Station#	15346+00		Field Station#	15338+00	
Pic 5 Desc.	P1 is in good condition at all stream and wetland buffers.		Pic 6 Desc.	CWDs are functioning as intended

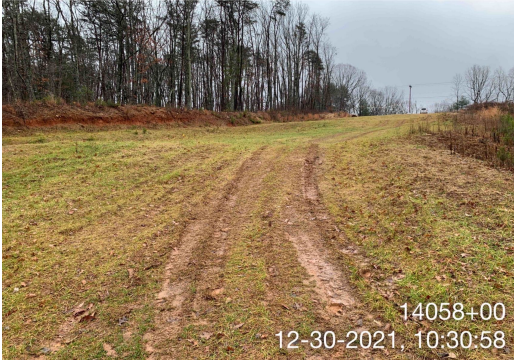
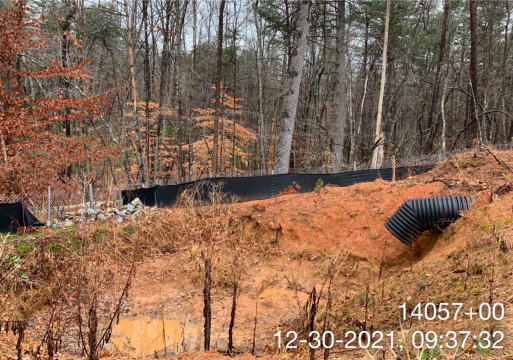
<p>14057+00 12-30-2021, 09:37:32</p>			
GPS Location	0	GPS Location	0		
Field Station#	14058+00	Field Station#	14057+00		
Pic 1 Desc.	Temporary vegetative stabilization damaged by third party from 14057+00 to 14059+00		Pic 2 Desc.	Sump pit and slope drain pipe in acceptable conditions

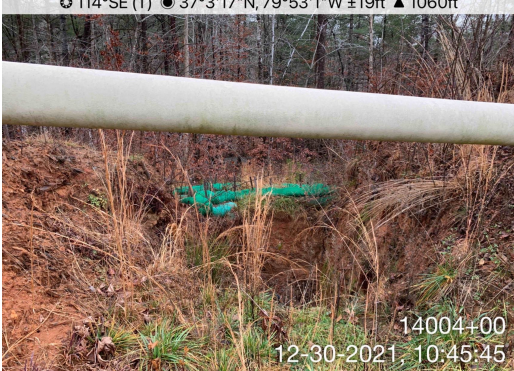
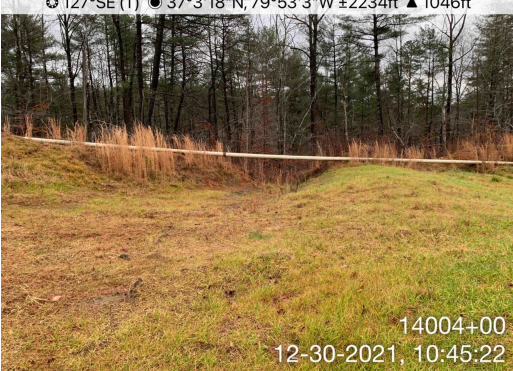
<p>14004+00 12-30-2021, 10:45:22</p>			
GPS Location	0	GPS Location	0		
Field Station#	14004+00	Field Station#	14004+00		
Pic 3 Desc.	Waterbar end treatment in acceptable condition		Pic 4 Desc.	Waterbar in acceptable condition

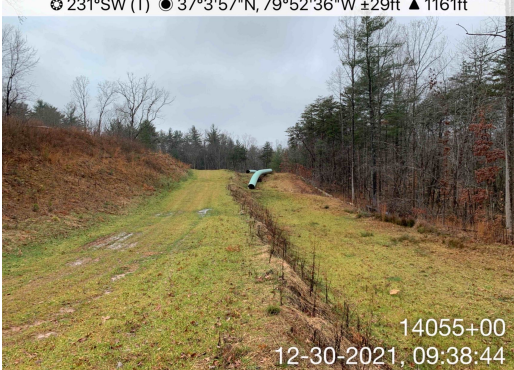
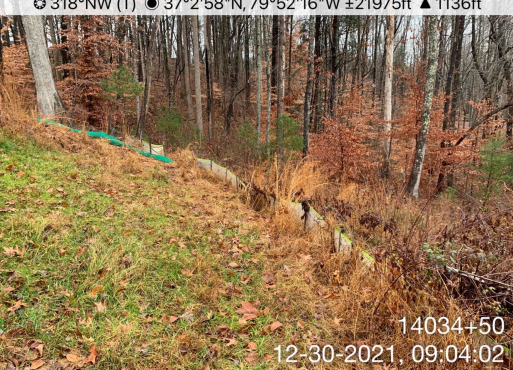
<p>14034+50 12-30-2021, 09:04:02</p>			
GPS Location	0	GPS Location	0		
Field Station#	14055+00	Field Station#	14034+50		
Pic 5 Desc.	Temporary vegetative stabilization in acceptable condition		Pic 6 Desc.	P1 silt fence in acceptable condition

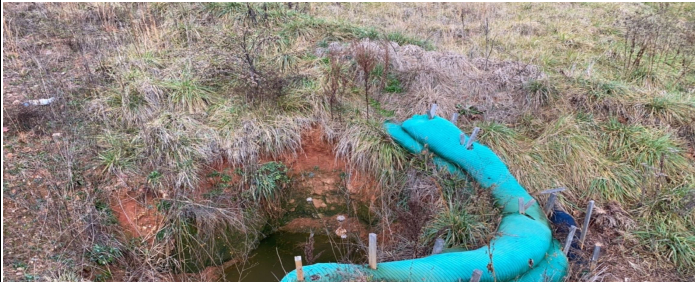
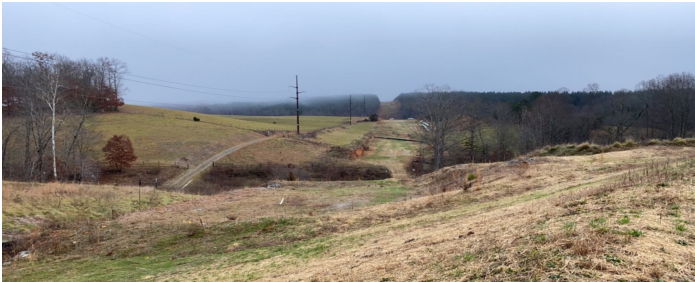
36°58'4" N 79°38'16" W 304°NW COURSE 3° GPS 2066-2156 Ramsey Memorial Rd, Penhook, VA 24137, United States 12.31.2021 10:50:46 Accur +/-15.4 Ft ALT 854 Ft			36°58'4" N 79°38'16" W 53°NE COURSE 62° GPS 2066-2156 Ramsey Memorial Rd, Penhook, VA 24137, United States 12.31.2021 10:50:32 Accur +/-15.4 Ft ALT 850 Ft		
GPS Location	1	GPS Location	2		
Field Station#	14929+50	Field Station#	14935+00		
Pic 1 Desc.	Sump pit and CFS end treatment performing intended functions.	Pic 2 Desc.	Perimeter controls in place and functional.

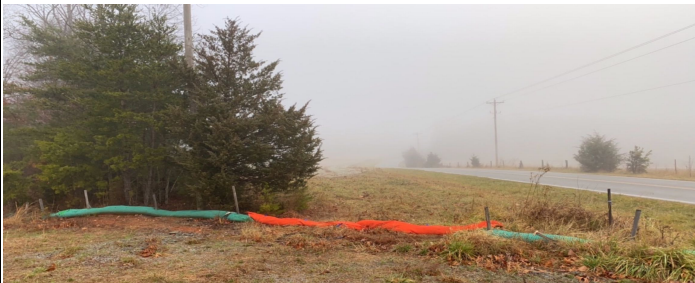
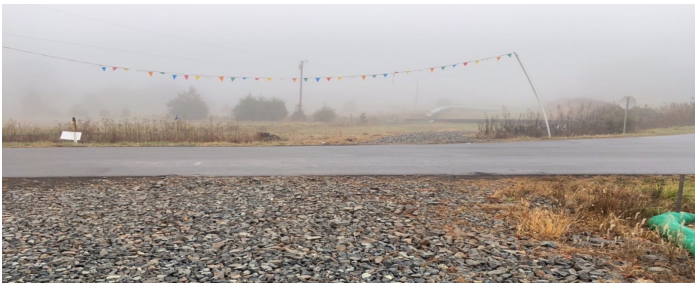
GPS Location	3	GPS Location	4		
Field Station#	14981+00	Field Station#	14981+55		
Pic 3 Desc.	Contractor replaced perimeter CFS with wattles.	Pic 4 Desc.	RCE at Snow Creek Rd in good condition.

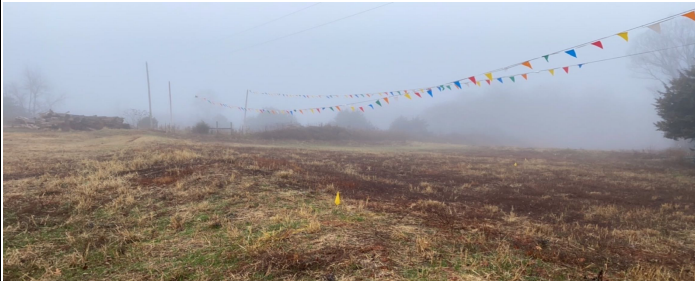
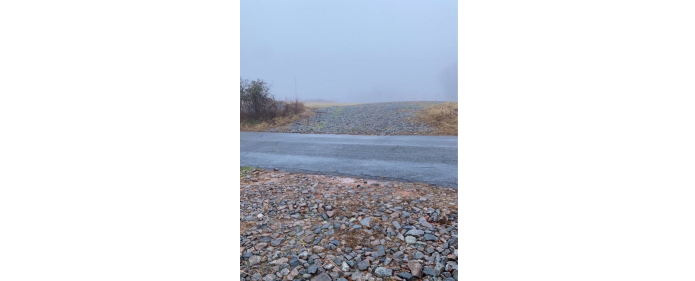
36°57'48" N 79°35'37" W 265°W COURSE 310° GPS 1923-2165 Armstrong Rd, Penhook, VA 24137, United States 12.31.2021 08:20:46 Accur +/-15.4 Ft ALT 922 Ft			36°57'47" N 79°35'36" W 385°NW COURSE 123° GPS 1923-2165 Armstrong Rd, Penhook, VA 24137, United States 12.31.2021 08:19:42 Accur +/-15.4 Ft ALT 922 Ft		
GPS Location	5	GPS Location	6		
Field Station#	15060+00	Field Station#	15063+85		
Pic 5 Desc.	Water bar performing intended function; ROW stabilized and vegetated in temporary area.	Pic 6 Desc.	RCE at Armstrong Rd in good condition.

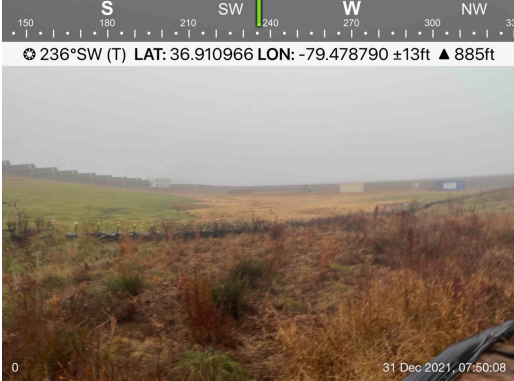
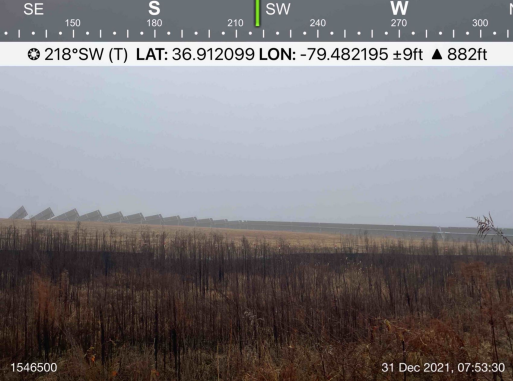
GPS Location	See photo		GPS Location	See photo	
Field Station#	15475+00		Field Station#	15465+00	
Pic 1 Desc.	3rd party rock outlet appears to be in good condition.		Pic 2 Desc.	No evidence of sedimentation from 3rd party disturbance.

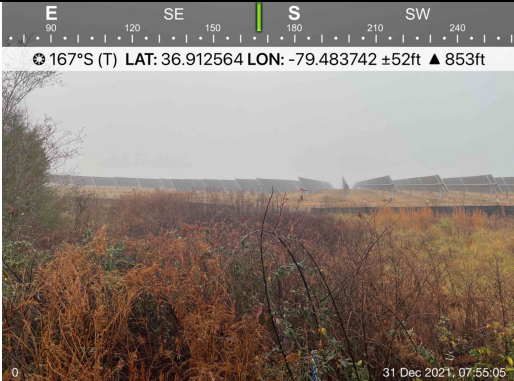
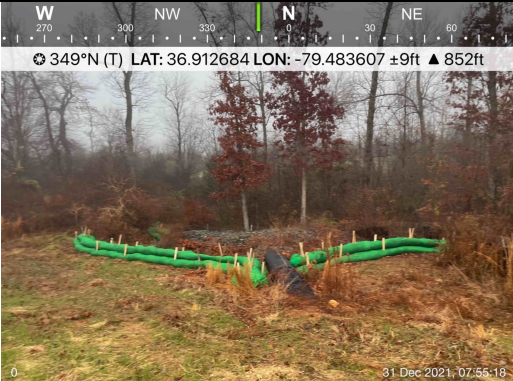
GPS Location	See photo		GPS Location	See photo	
Field Station#	15460+81		Field Station#	15460+81	
Pic 3 Desc.	No evidence of sedimentation from 3rd party disturbance into CWD inlet.		Pic 4 Desc.	CWD remains in good condition.

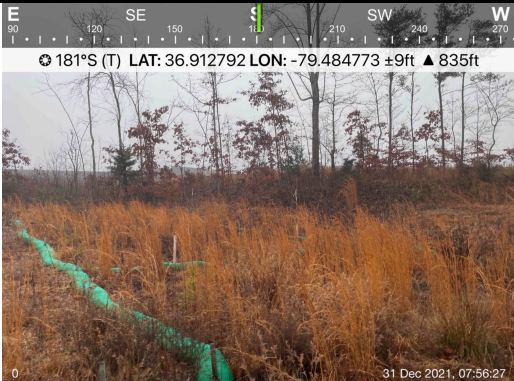
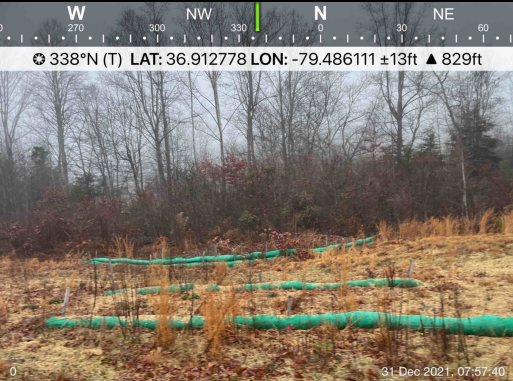
GPS Location	See photo		GPS Location	See photo	
Field Station#	15457+00		Field Station#	15453+00	
Pic 5 Desc.	No evidence of sedimentation within drainage feature.		Pic 6 Desc.	CWD remains in good condition.

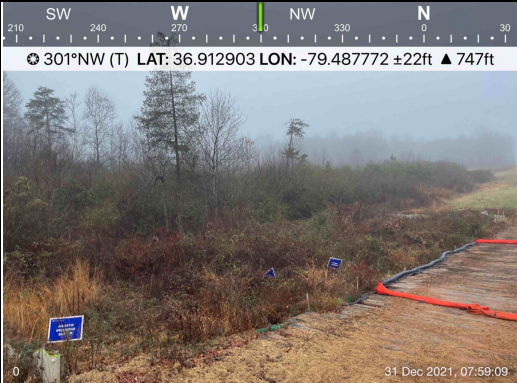
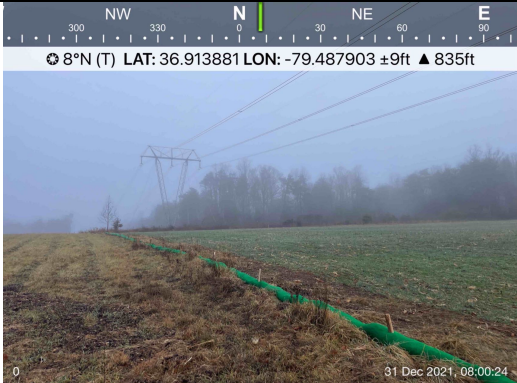
GPS Location	See photo		GPS Location	See photo	
Field Station#	15447+73		Field Station#	15445+00	
Pic 7 Desc.	Resource buffers remain in good condition.		Pic 8 Desc.	Perimeter CFS is in good condition.

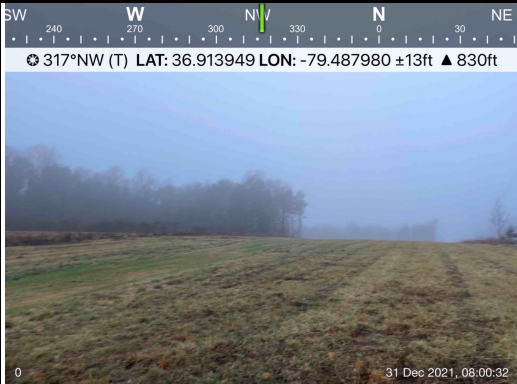
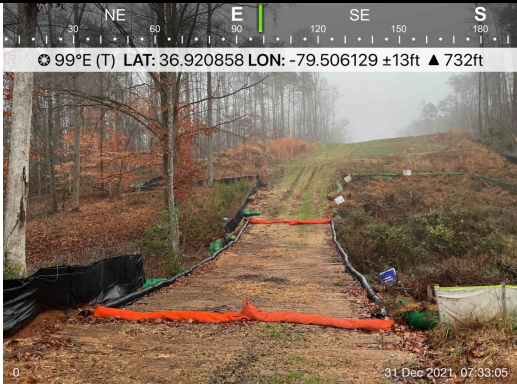
GPS Location	See photo		GPS Location	See photo	
Field Station#	15444+00		Field Station#	15384+74	
Pic 9 Desc.	Vegetation continues to fill in throughout this section.		Pic 10 Desc.	Equipment bridge ECDs are in place and functioning.

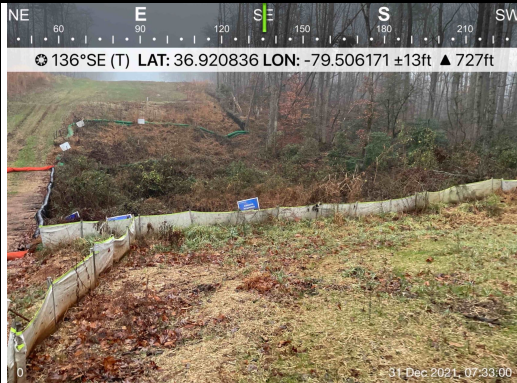
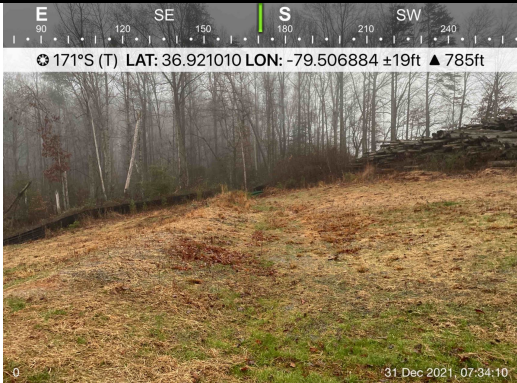
GPS Location	See photo		GPS Location	See photo	
Field Station#	15384+50		Field Station#	15380+00	
Pic 11 Desc.	P1 is in good condition at all stream and wetland buffers.		Pic 12 Desc.	Waterbars are in good condition and functioning.
