# Visual Site Inspection Report

<b>Project Name</b>	H-600 Pipeline Spread I	<b>AFE</b>	124300139	<b>Spread</b>	H-600 Pipeline Spread I
<b>Contractor</b>	Precision			<b>Report #</b>	31937
<b>Inspector</b>	Justin Burch			<b>Date/Time</b>	12/6/2021 10:56 AM
<b>Permit #</b>	TBD	<b>Inspection Type</b>	VA SWPP	<b>Station Begin</b>	14171+36
<b>State</b>	VA	<b>Inspection Area</b>	Full	<b>Station End</b>	14311+57
<b>County</b>	Franklin	<b>Ground</b>	Dry	<b>Temperature (°F)</b>	67.00
<b>Municipality</b>	N/A	<b>Weather</b>	Sunny	<b>Rain Gauge (in)</b>	0.00
				<b>Rain Accumulation Time (days)</b>	6.00

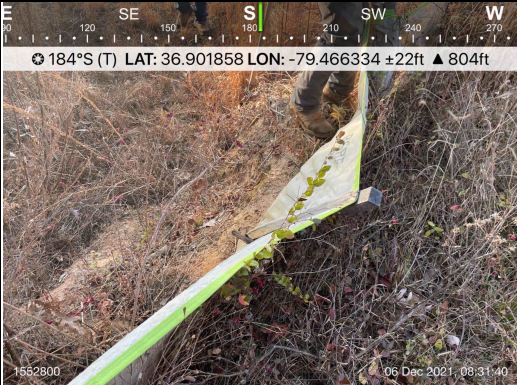
GPS Location	See photo		GPS Location	See photo	
Field Station#	15528+00		Field Station#	15528+00	
Pic 7 Desc.	P1 is degraded and needs to be replaced.		Pic 8 Desc.	Environmental crew has corrected this issue.

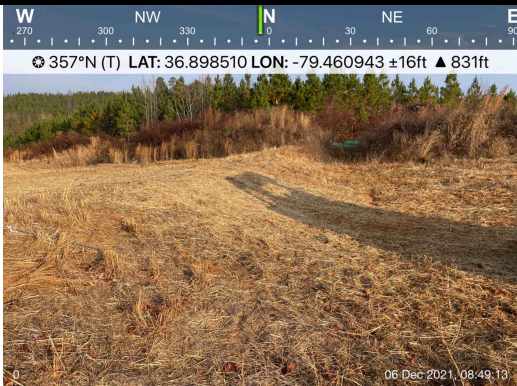
GPS Location	See photo		GPS Location	See photo	
Field Station#	15540+00		Field Station#	15549+00	
Pic 9 Desc.	Equipment bridge ECDs are in place and functioning.		Pic 10 Desc.	Waterbars are in good condition.

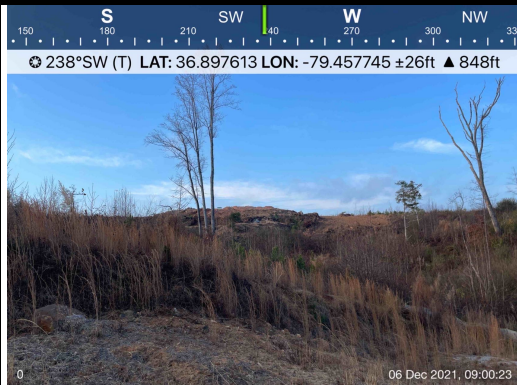
GPS Location	See photo		GPS Location	See photo	
Field Station#	15556+83		Field Station#	15575+00	
Pic 11 Desc.	No evidence of sedimentation from 3rd party disturbance.		Pic 12 Desc.	Slope drain remains in good condition and functioning.

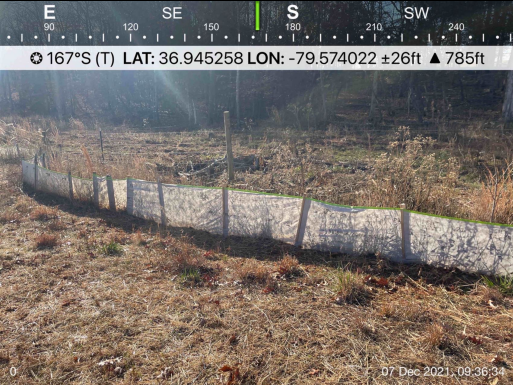
<b>GPS Location</b>	See photo		<b>GPS Location</b>	See photo	
<b>Field Station#</b>	15142+66		<b>Field Station#</b>	15160+00	
<b>Pic 1 Desc.</b>	RCE is in good condition at Rockcreek Rd.		<b>Pic 2 Desc.</b>	Perimeter P1 is in good condition throughout this section.

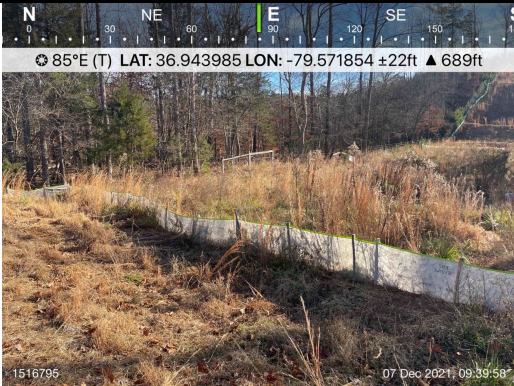
<b>GPS Location</b>	See photo		<b>GPS Location</b>	See photo	
<b>Field Station#</b>	15167+95		<b>Field Station#</b>	15167+95	
<b>Pic 5 Desc.</b>	P1 is in good condition at stream buffer.		<b>Pic 6 Desc.</b>	Equipment bridge ECDs are in place and functioning.

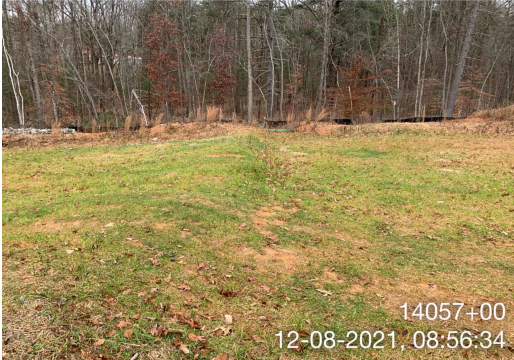
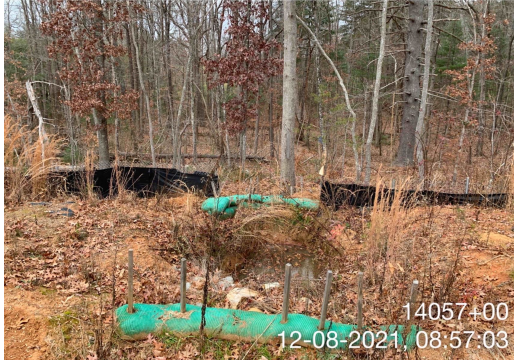
14057+00 12-08-2021, 08:57:03			
<b>GPS Location</b>	0	<b>GPS Location</b>	0		
<b>Field Station#</b>	14057+00	<b>Field Station#</b>	14057+00		
<b>Pic 1 Desc.</b>	Waterbar in acceptable condition	<b>Pic 2 Desc.</b>	Waterbar end treatment in acceptable condition		
⚙ 13°N (T) ● 37°3'55"N, 79°52'39"W ±1253ft ▲ 1212ft

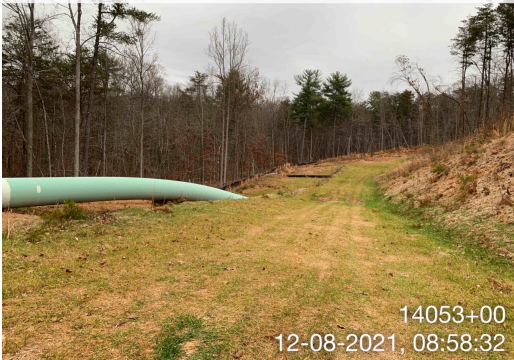
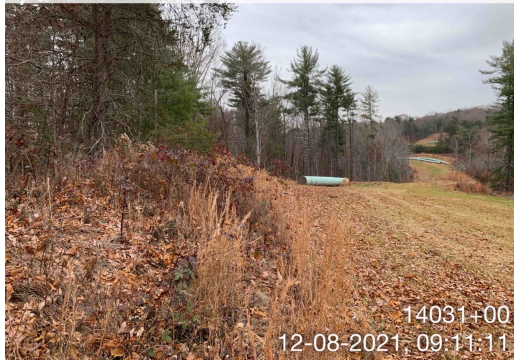
14031+00 12-08-2021, 09:11:11			
<b>GPS Location</b>	0	<b>GPS Location</b>	0		
<b>Field Station#</b>	14053+00	<b>Field Station#</b>	14031+00		
<b>Pic 3 Desc.</b>	Temporary vegetative stabilization in acceptable condition	<b>Pic 4 Desc.</b>	Clean water diversion berm and temporary vegetative stabilization in acceptable conditions

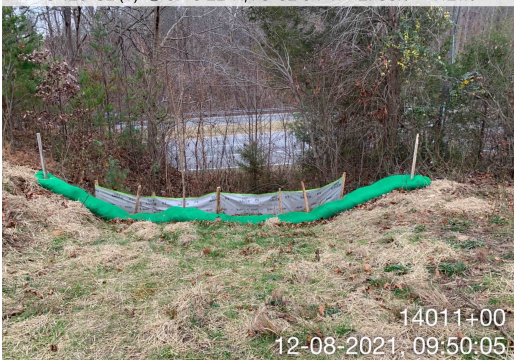
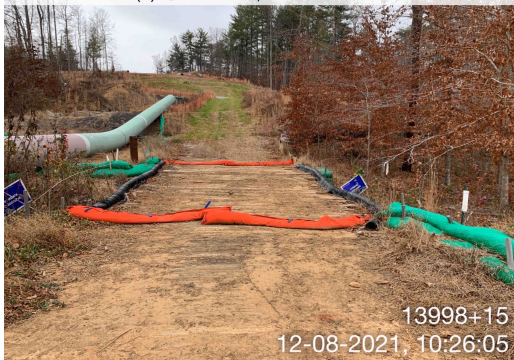
13998+15 12-08-2021, 10:26:05			
<b>GPS Location</b>	0	<b>GPS Location</b>	0		
<b>Field Station#</b>	14011+00	<b>Field Station#</b>	13998+15		
<b>Pic 5 Desc.</b>	CFS and P1 silt fence in acceptable conditions	<b>Pic 6 Desc.</b>	Equipment bridge in acceptable condition

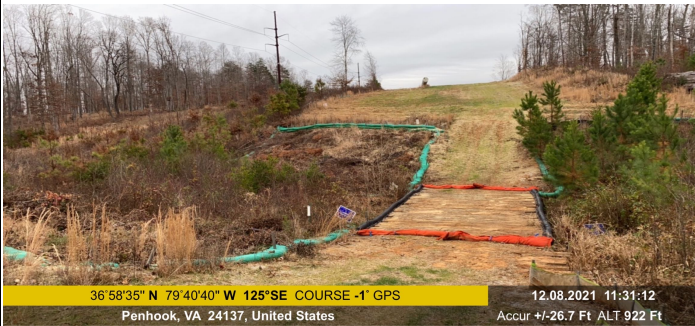
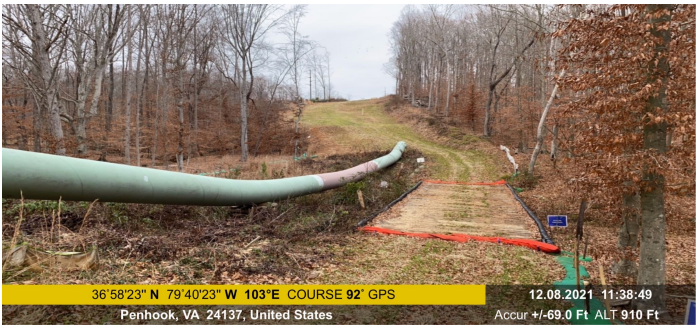
GPS Location			1	GPS Location		2					
Field Station#			14804+99	Field Station#		14823+54					
Pic 1 Desc.			Equipment bridge and surrounding ECDs in place and functional at stream crossing and resource buffer; signage visible and intact.			Pic 2 Desc.			Equipment bridge and surrounding ECDs in place and functional at stream crossing and resource buffer; signage visible and intact.

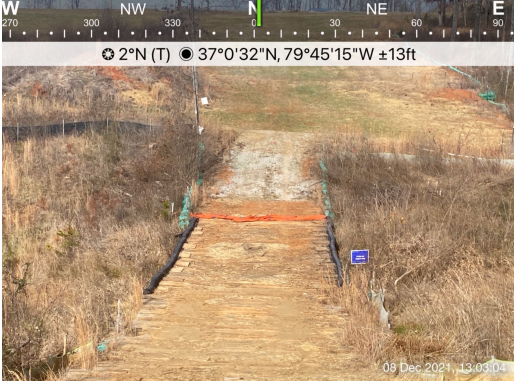
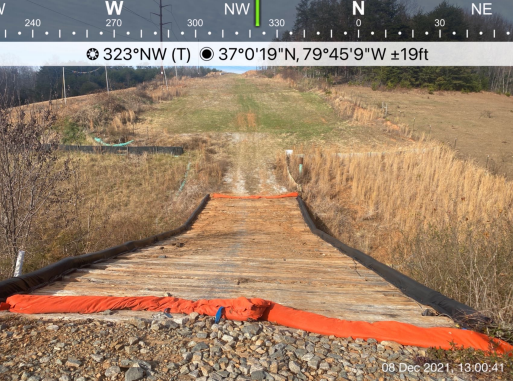
<b>GPS Location</b>	0	<b>GPS Location</b>	0		
<b>Field Station#</b>	14531+58	<b>Field Station#</b>	14546+33		
<b>Pic 1 Desc.</b>	Approximately 14531+58. Overview of stream crossing, equipment bridge and ECDs at stream S-G18.		<b>Pic 2 Desc.</b>	Approximately 14546+33. Overview of stream crossing, equipment bridge and ECDs at stream S-G17.

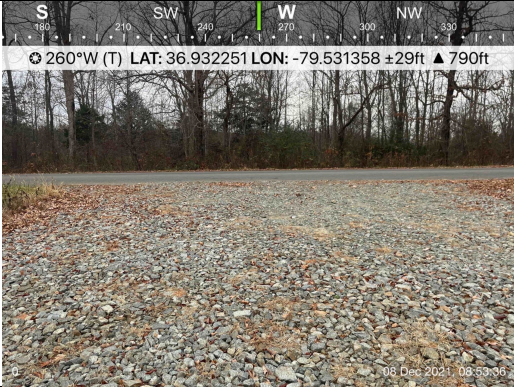
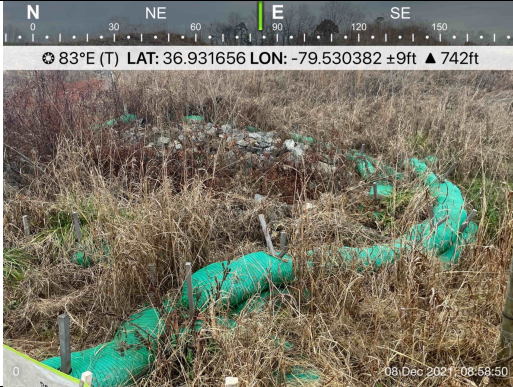
<b>GPS Location</b>	See photo		<b>GPS Location</b>	See photo	
<b>Field Station#</b>	15296+00		<b>Field Station#</b>	15299+00	
<b>Pic 1 Desc.</b>	RCEs are in good condition at all road crossings.		<b>Pic 2 Desc.</b>	CWD is in good condition and functioning.

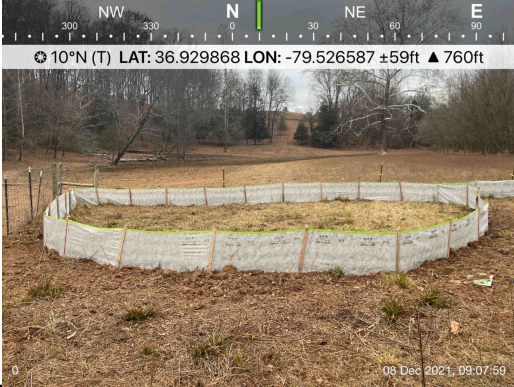
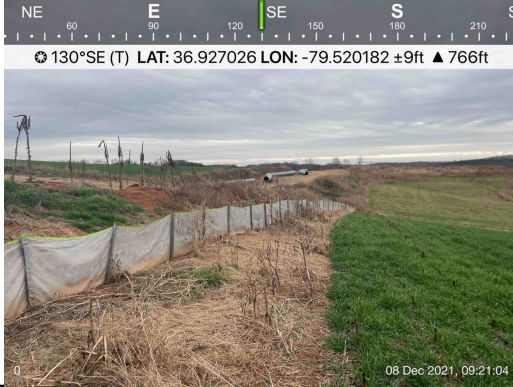
<b>GPS Location</b>	See photo		<b>GPS Location</b>	See photo	
<b>Field Station#</b>	15311+78		<b>Field Station#</b>	15337+00	
<b>Pic 3 Desc.</b>	Wetland buffer P1 remains in good condition.		<b>Pic 4 Desc.</b>	Perimeter P1 is in good condition.

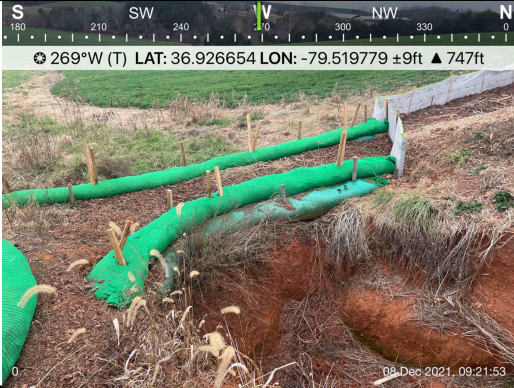
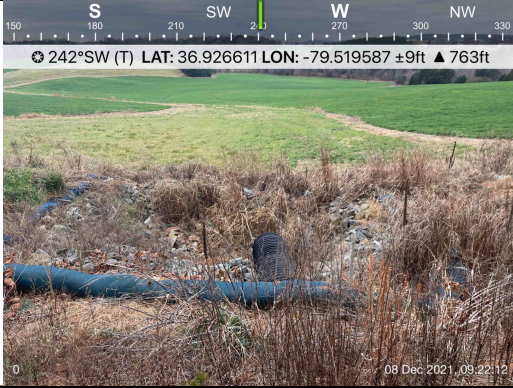
<b>GPS Location</b>	See photo		<b>GPS Location</b>	See photo	
<b>Field Station#</b>	15338+00		<b>Field Station#</b>	15338+00	
<b>Pic 5 Desc.</b>	Waterbar end treatments are in good condition throughout this section.		<b>Pic 6 Desc.</b>	CWD is in good condition and functioning.

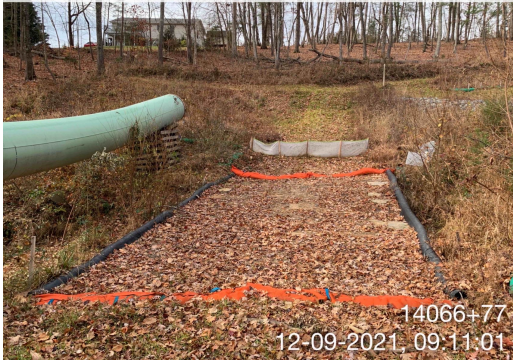
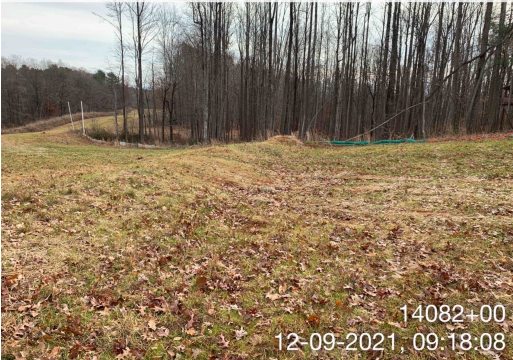
GPS Location		0		GPS Location		0	
Field Station#		14066+77		Field Station#		14082+00	
Pic 1 Desc.		Equipment bridge and P1 silt fence in acceptable conditions		Pic 2 Desc.		Waterbar in acceptable condition

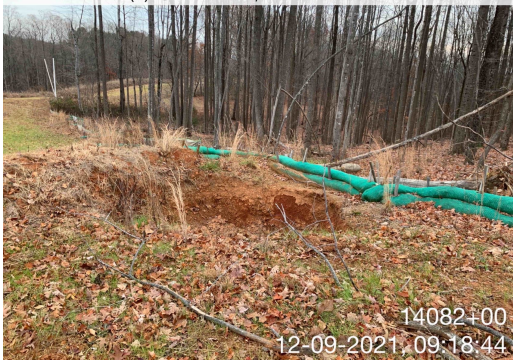
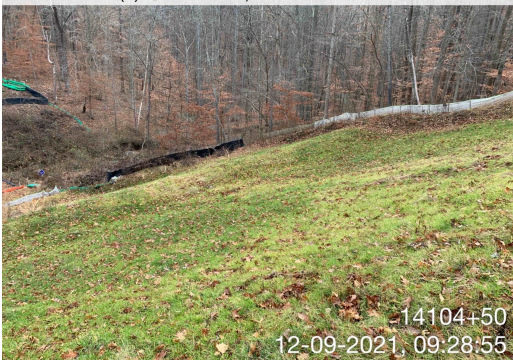
GPS Location		0		GPS Location		0	
Field Station#		14082+00		Field Station#		14104+50	
Pic 3 Desc.		Waterbar end treatment in acceptable condition		Pic 4 Desc.		Temporary vegetative stabilization and waterbar in acceptable conditions

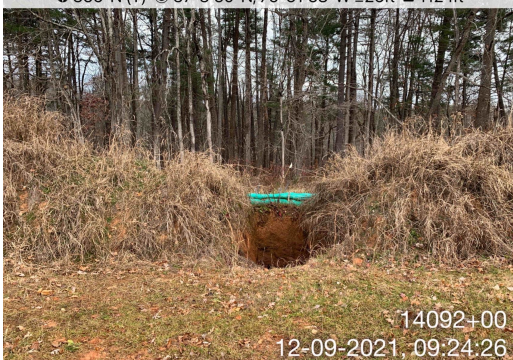
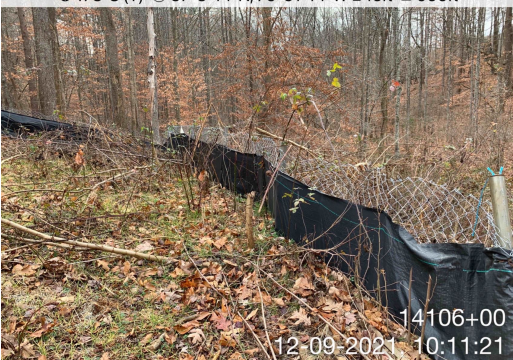
GPS Location		0		GPS Location		0	
Field Station#		14092+00		Field Station#		14106+00	
Pic 5 Desc.		Sump pit in acceptable condition		Pic 6 Desc.		Super silt fence in acceptable condition

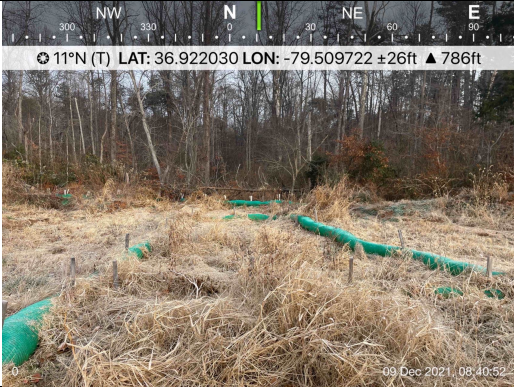
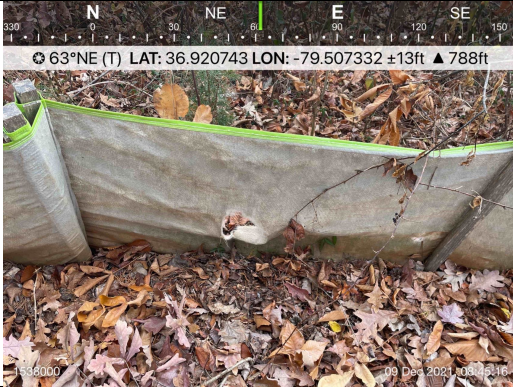
<b>GPS Location</b>	See photo	<b>GPS Location</b>	See photo		
<b>Field Station#</b>	15375+00	<b>Field Station#</b>	15380+00		
<b>Pic 1 Desc.</b>	Drainage ECDs are in good condition and functioning.	<b>Pic 2 Desc.</b>	P1 is damaged and needs to be replaced.

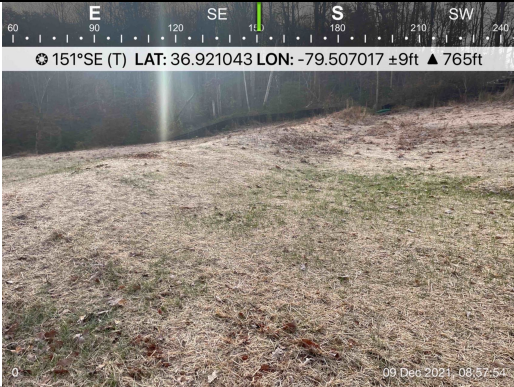
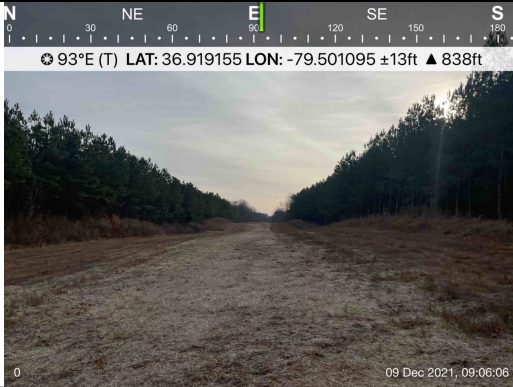
<b>GPS Location</b>	See photo	<b>GPS Location</b>	See photo		
<b>Field Station#</b>	15381+00	<b>Field Station#</b>	15400+00		
<b>Pic 3 Desc.</b>	Waterbars are in good condition throughout this section.	<b>Pic 4 Desc.</b>	Vegetation continues to fill in throughout this section.

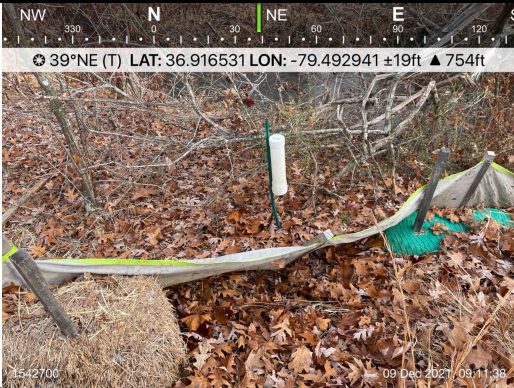
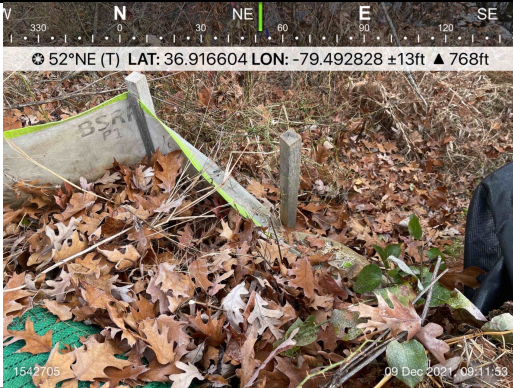
<b>GPS Location</b>	See photo	<b>GPS Location</b>	See photo		
<b>Field Station#</b>	15427+00	<b>Field Station#</b>	15427+05		
<b>Pic 5 Desc.</b>	P1 needs to be restaked.	<b>Pic 6 Desc.</b>	P1 needs to be restaked

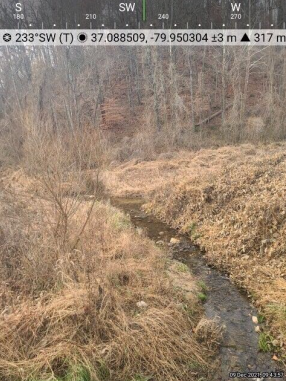
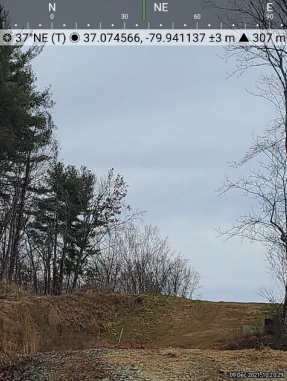
<b>GPS Location</b>	0000	<b>GPS Location</b>	0000		
<b>Field Station#</b>	13678+71	<b>Field Station#</b>	13748+04		
<b>Pic 1 Desc.</b>	Stream observation photo facing downstream during routine inspection today, no environmental issues observed at the time of inspection I		<b>Pic 2 Desc.</b>	Row photo stabilization on hill side at road crossing, no environmental issues observed at the time of inspection I

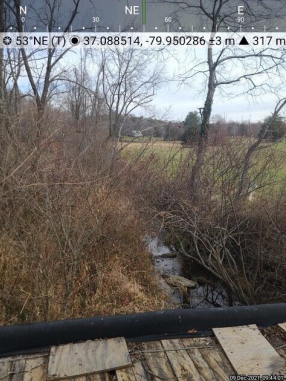
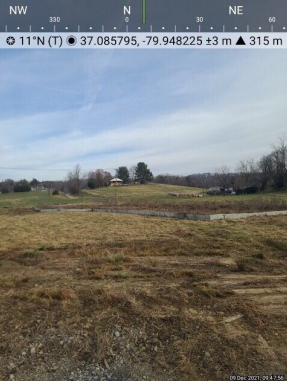
<b>GPS Location</b>	0000	<b>GPS Location</b>	00000		
<b>Field Station#</b>	13678+71	<b>Field Station#</b>	13691+30		
<b>Pic 3 Desc.</b>	Stream observation photo facing upstream during routine inspection today, no environmental issues observed at the time of inspection I		<b>Pic 4 Desc.</b>	Observed ECDs around wetland area and vegetation, no environmental issues observed at the time of inspection I

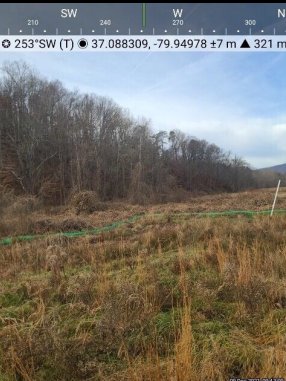
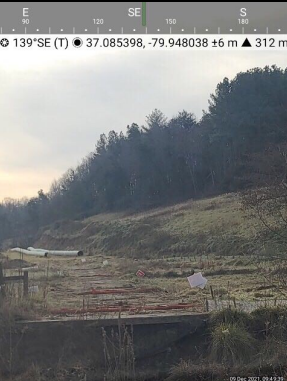
<b>GPS Location</b>	0000	<b>GPS Location</b>	00000		
<b>Field Station#</b>	13679+00	<b>Field Station#</b>	13692+64		
<b>Pic 5 Desc.</b>	Monitored ECDs along the LOD during routine inspection today. No environmental issues observed at the time of inspection I		<b>Pic 6 Desc.</b>	Monitored stream banks and ECDs, no environmental issues observed at the time of inspection.

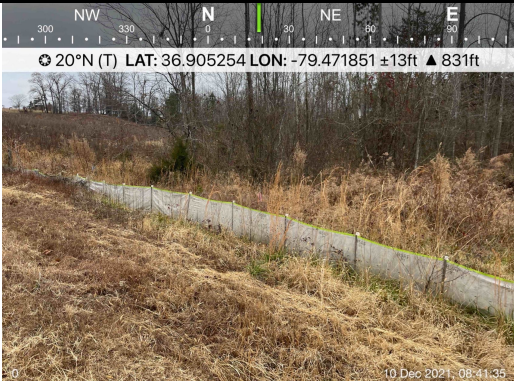
<b>GPS Location</b>	See photo		<b>GPS Location</b>	See photo	
<b>Field Station#</b>	15507+77		<b>Field Station#</b>	15510+00	
<b>Pic 5 Desc.</b>	P1 is in good condition at all stream and wetland buffers.		<b>Pic 6 Desc.</b>	3rd party ECDs appear to be in good condition.

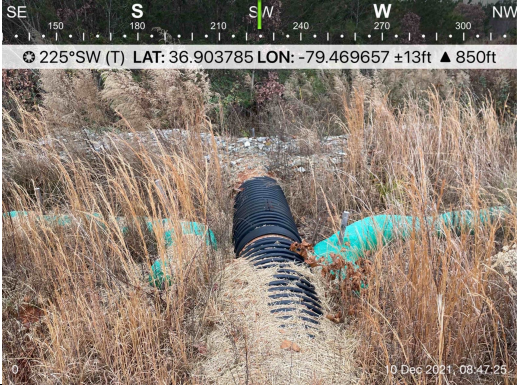
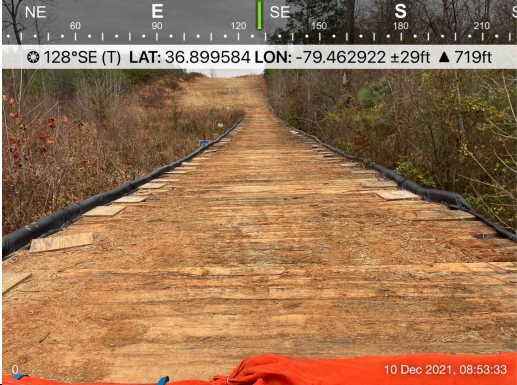
<b>GPS Location</b>	See photo	<b>GPS Location</b>	See photo		
<b>Field Station#</b>	15515+00	<b>Field Station#</b>	15540+00		
<b>Pic 7 Desc.</b>	CWDs are functioning as intended.	<b>Pic 8 Desc.</b>	Equipment bridge ECDs are in place and functioning.

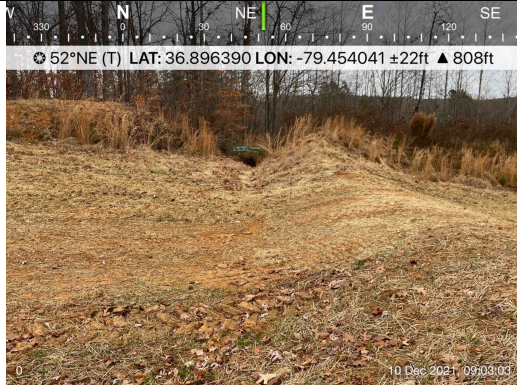
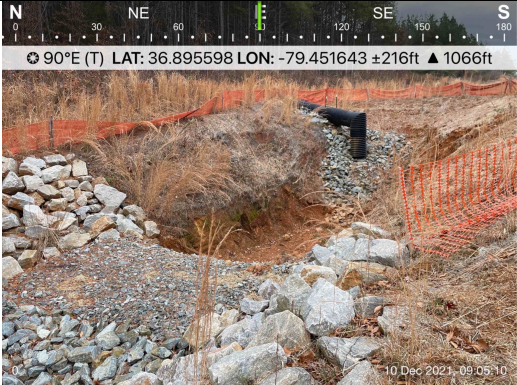
<b>GPS Location</b>	See photo	<b>GPS Location</b>	See photo		
<b>Field Station#</b>	15560+00	<b>Field Station#</b>	15574+87		
<b>Pic 11 Desc.</b>	Waterbars are functioning as intended.	<b>Pic 12 Desc.</b>	Slope drain is in good condition and functioning.

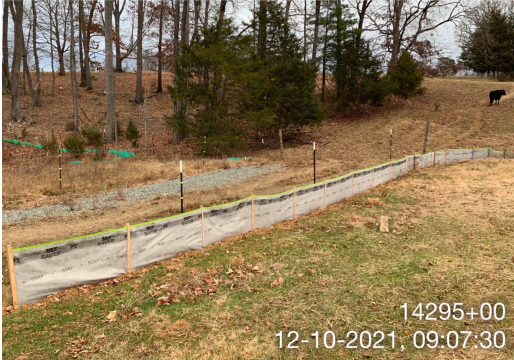
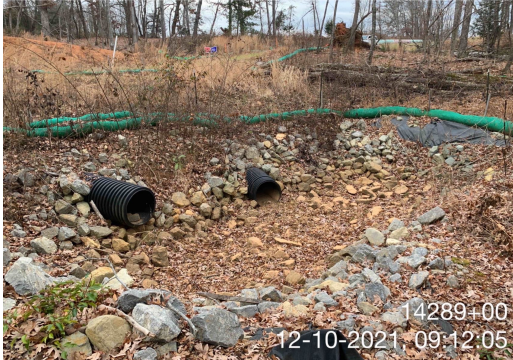
<p>14289+00 12-10-2021, 09:12:05</p>			
<b>GPS Location</b>	0	<b>GPS Location</b>	0		
<b>Field Station#</b>	14295+00	<b>Field Station#</b>	14289+00		
<b>Pic 1 Desc.</b>	P1 silt fence in acceptable condition	<b>Pic 2 Desc.</b>	Clean water diversion pipe and plunge pool in acceptable conditions

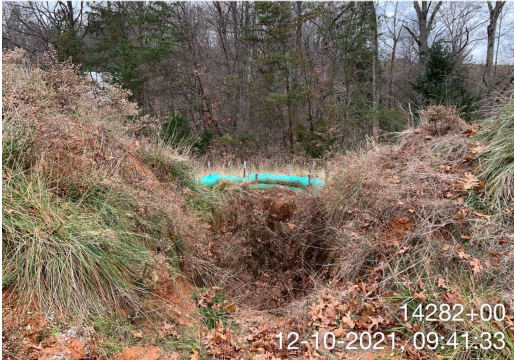
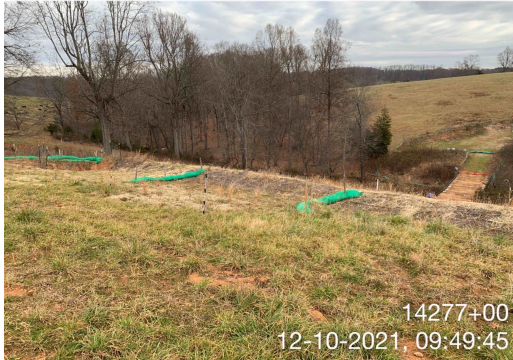
<p>14277+00 12-10-2021, 09:49:45</p>			
<b>GPS Location</b>	0	<b>GPS Location</b>	0		
<b>Field Station#</b>	14282+00	<b>Field Station#</b>	14277+00		
<b>Pic 3 Desc.</b>	Sump pit in acceptable condition	<b>Pic 4 Desc.</b>	Waterbar in acceptable condition

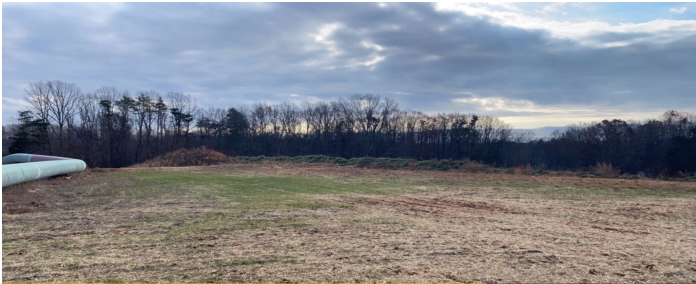
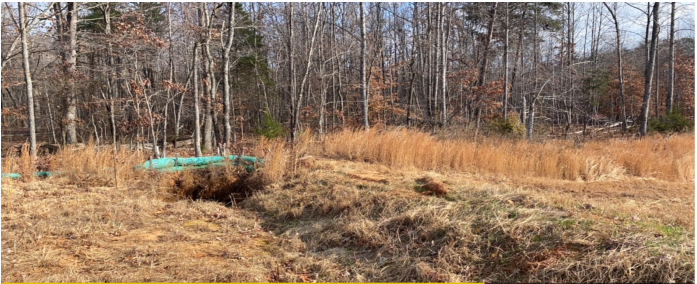
36°57'47" N 79°35'35" W 301°NW COURSE 138' GPS 1918-2164 Armstrong Rd, Penhook, VA 24137, United States 12.10.2021 10:43:38 Accur +/-40.7 Ft ALT 0 Ft			36°57'46" N 79°35'30" W 257°W COURSE 147' GPS Penhook, VA 24137, United States 12.10.2021 10:45:47 Accur +/-135.4 Ft ALT 914 Ft		
<b>GPS Location</b>	1	<b>GPS Location</b>	2		
<b>Field Station#</b>	15065+00	<b>Field Station#</b>	15069+00		
<b>Pic 1 Desc.</b>	ROW stabilized and vegetated in temporary area.	<b>Pic 2 Desc.</b>	Sump pit and CFS end treatment performing intended functions.

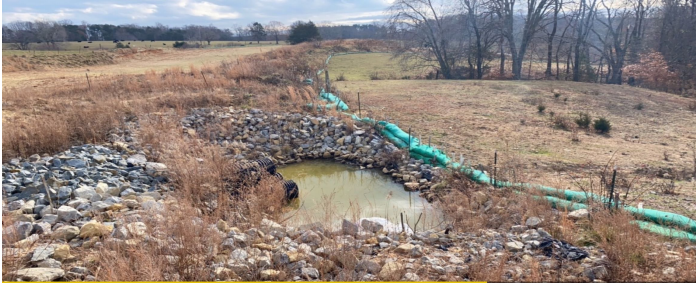
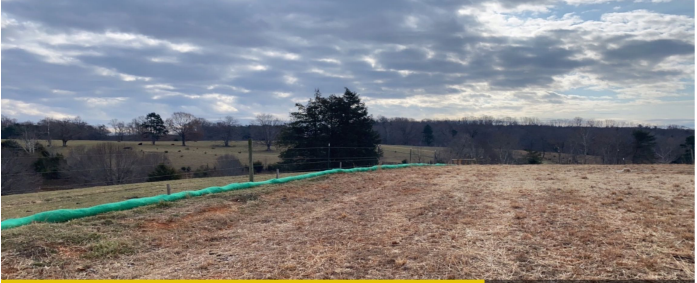
36°57'40" N 79°35'13" W 148°SE COURSE -1' GPS Sandy Level, VA 24161, United States 12.10.2021 10:54:40 Accur +/-122.7 Ft ALT 892 Ft			36°57'38" N 79°35'10" W 207°SW COURSE -1' GPS Sandy Level, VA 24161, United States 12.10.2021 10:56:45 Accur +/-60.6 Ft ALT 868 Ft		
<b>GPS Location</b>	5	<b>GPS Location</b>	6		
<b>Field Station#</b>	15084+00	<b>Field Station#</b>	15088+00		
<b>Pic 5 Desc.</b>	Plunge pool performing intended function.	<b>Pic 6 Desc.</b>	Perimeter CFS in place and functional.

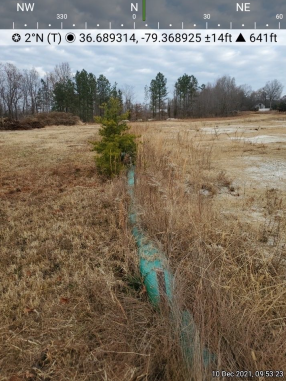
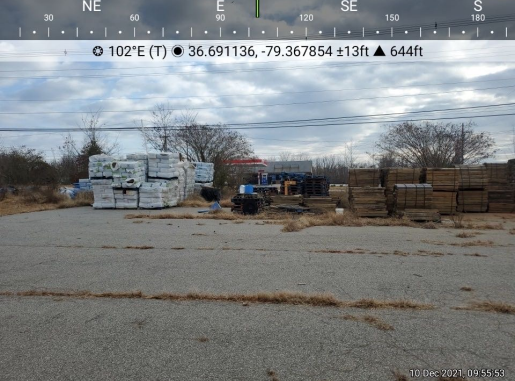
<b>GPS Location</b>	0	<b>GPS Location</b>	0		
<b>Field Station#</b>	0+00	<b>Field Station#</b>	0+00		
<b>Pic 1 Desc.</b>	LY-048 West perimeter CFS	<b>Pic 2 Desc.</b>	LY-048 Housekeeping

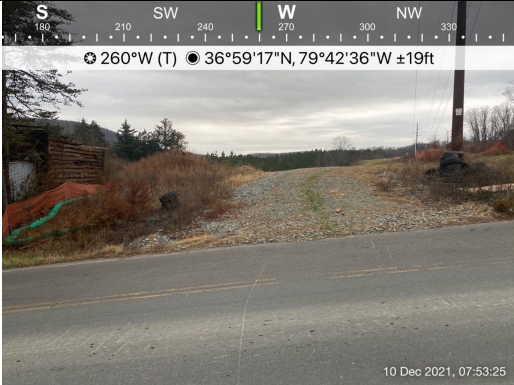
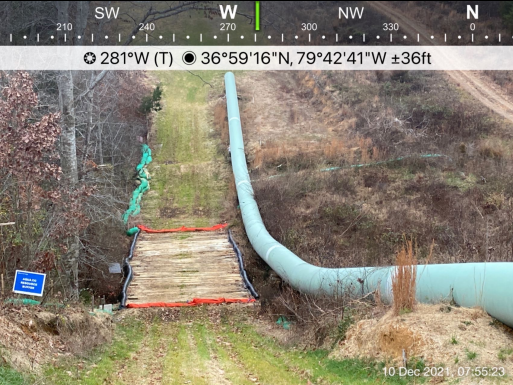
<b>GPS Location</b>	0	<b>GPS Location</b>	0		
<b>Field Station#</b>	14694+50	<b>Field Station#</b>	14689+36		
<b>Pic 1 Desc.</b>	Approximately 14694+50. Overview of road crossing and RCE.		<b>Pic 2 Desc.</b>	Approximately 14689+36. Overview of stream crossing, equipment bridge and ECDs at stream S-H34.

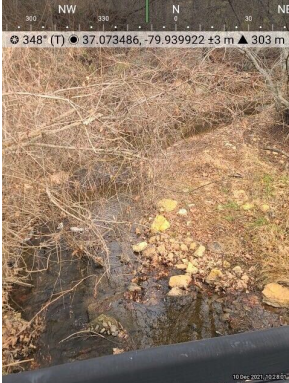
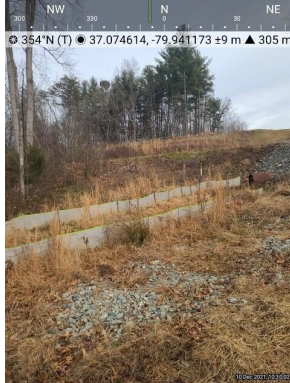
<b>GPS Location</b>	0000	<b>GPS Location</b>	0000		
<b>Field Station#</b>	13755+49	<b>Field Station#</b>	13748+97		
<b>Pic 1 Desc.</b>	Stream observation photo facing downstream during routine inspection today No environmental issues observed at the time of inspection I		<b>Pic 2 Desc.</b>	Monitored ECDs at stream crossing at Green Level rd.

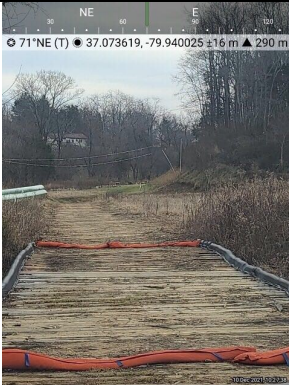
<b>GPS Location</b>	0000	<b>GPS Location</b>	0000		
<b>Field Station#</b>	13755+49	<b>Field Station#</b>	13850+00		
<b>Pic 3 Desc.</b>	Monitored equipment bridge and protection, checked all ECDs in the area. No environmental issues observed at the time of inspection.		<b>Pic 4 Desc.</b>	Vegetation observation photo showing good coverage

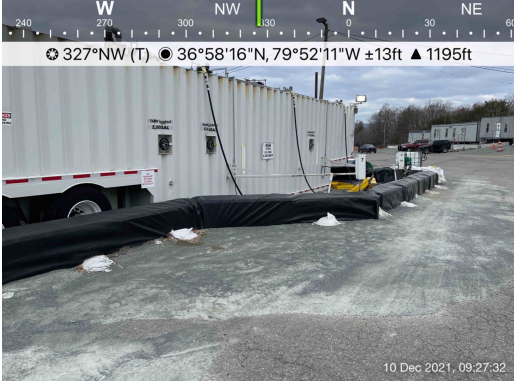
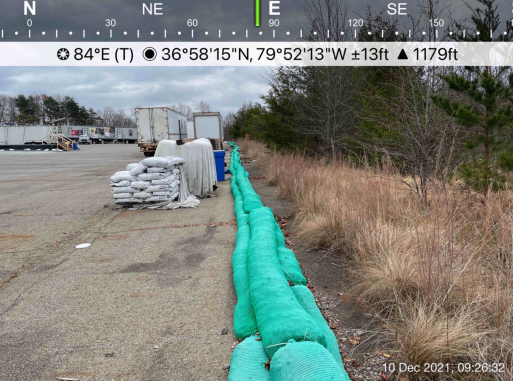
<b>GPS Location</b>	See picture	<b>GPS Location</b>	See picture		
<b>Field Station#</b>	0000+00	<b>Field Station#</b>	0000+00		
<b>Pic 1 Desc.</b>	Secondary containment structure for fuel cell at LY-046 in good condition.	<b>Pic 2 Desc.</b>	Perimeter ECD's on south end of LY-046 in good condition.

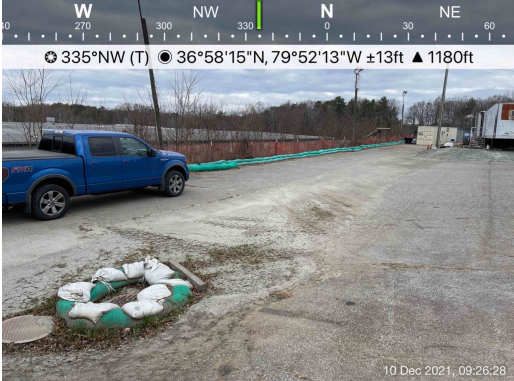
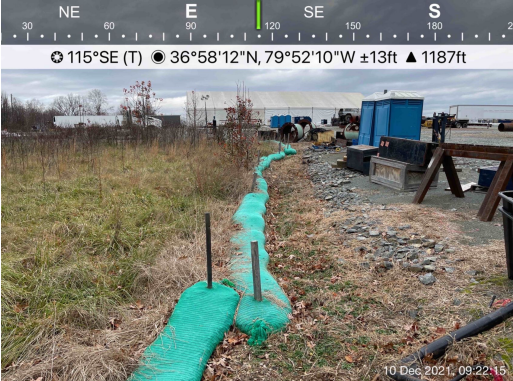
<b>GPS Location</b>	See picture	<b>GPS Location</b>	See picture		
<b>Field Station#</b>	0000+00	<b>Field Station#</b>	0000+00		
<b>Pic 3 Desc.</b>	Perimeter ECD's and inlet protection for catch basin on west side of LY-046 in acceptable condition.	<b>Pic 4 Desc.</b>	Perimeter ECD's on north end of LY-045 in good condition.

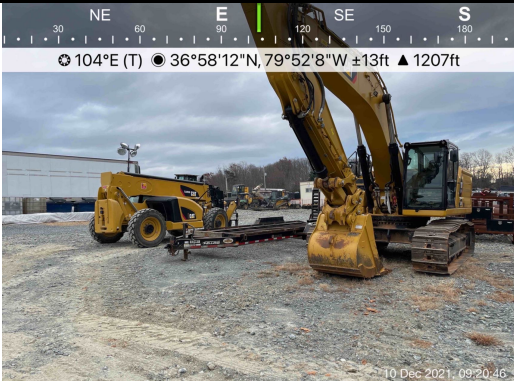
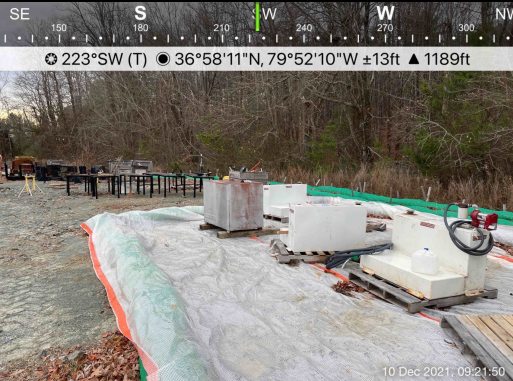
<b>GPS Location</b>	See picture	<b>GPS Location</b>	See picture		
<b>Field Station#</b>	0000+00	<b>Field Station#</b>	0000+00		
<b>Pic 5 Desc.</b>	Equipment at LY-045 inspected and no leaks observed at time of inspection.	<b>Pic 6 Desc.</b>	Secondary containment structure and perimeter ECD's on northwest corner of LY-045 in good condition.
