Visual Site Inspection Report

Project Name	H-600 Pipeline Spread I	AFE	124300139	Spread	H-600 Pipeline Spread I
Contractor	Precision	Report #	34359		
Inspector	Justin Burch	Date/Time	2/14/2022 12:09 PM		
Permit #	TBD	Inspection Type	VA SWPP	Station Begin	13958+31
State	VA	Inspection Area	Full	Station End	14062+17
County	Franklin	Ground	Wet	Temperature (°F)	41.00
Municipality	N/A	Weather	Sunny	Rain Gauge (in)	0.10
			Rain Accumulation Time (days)	6.00

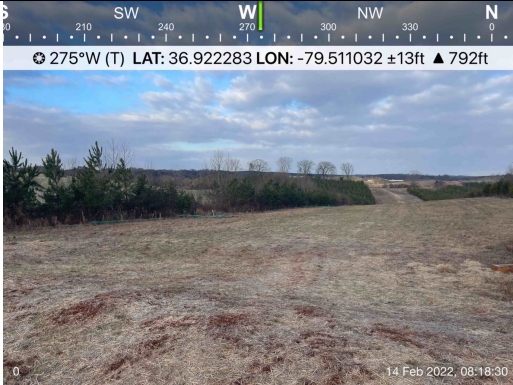
GPS Location	See photo		GPS Location	See photo	
Field Station#	15370+62		Field Station#	15370+00	
Pic 1 Desc.	RCEs are in good condition at all road crossings.		Pic 2 Desc.	Vegetation continues to fill in throughout this section.

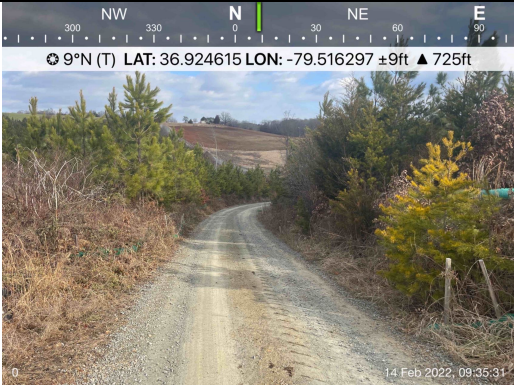
GPS Location	See photo		GPS Location	See photo	
Field Station#	15350+00		Field Station#	15348+21	
Pic 3 Desc.	MVP-PI-332 remains in good condition with controls in place.		Pic 4 Desc.	P1 is in good condition at all stream and wetland buffers.

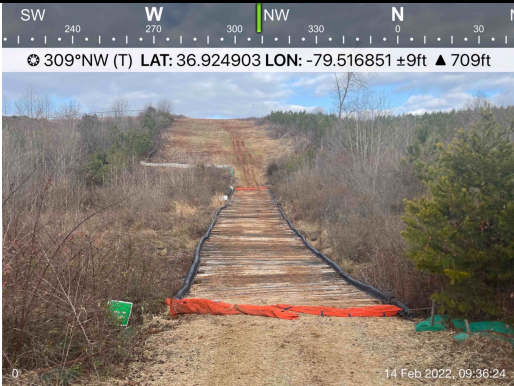
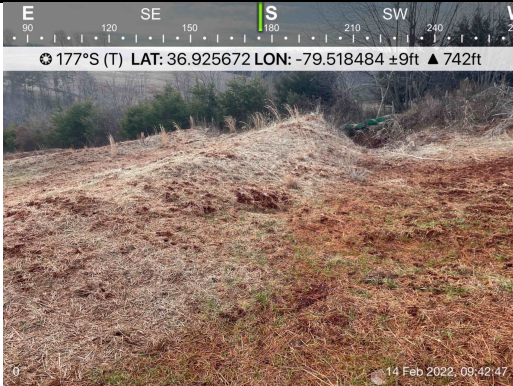
GPS Location	See photo		GPS Location	See photo	
Field Station#	15346+70		Field Station#	15335+00	
Pic 5 Desc.	Equipment bridge ECDs are in place and functioning.		Pic 6 Desc.	Waterbars are functioning as intended.

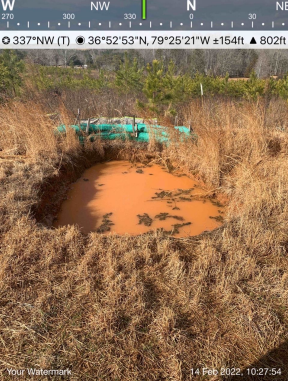
GPS Location	O	GPS Location	O		
Field Station#	15690+00	Field Station#	15679+30		
Pic 1 Desc.	Observing temporary stabilization, sump and end treatment	Pic 2 Desc.	Observing temporary stabilization, CWD outlet and ECD's

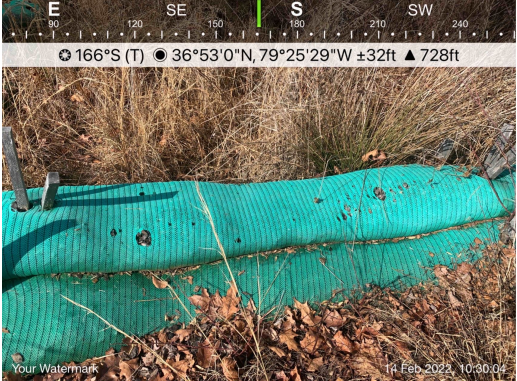
GPS Location	O	GPS Location	O		
Field Station#	15679+10	Field Station#	15694+20		
Pic 3 Desc.	Observing CFS that requires maintenance	Pic 4 Desc.	Observing CFS that requires maintenance

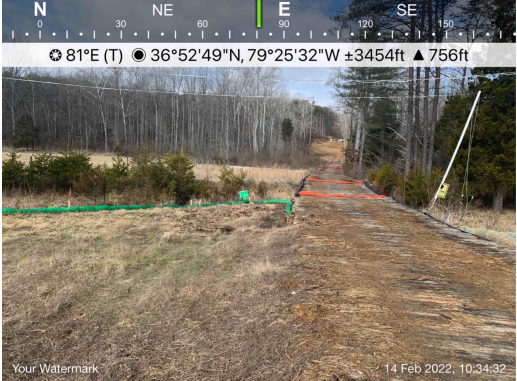
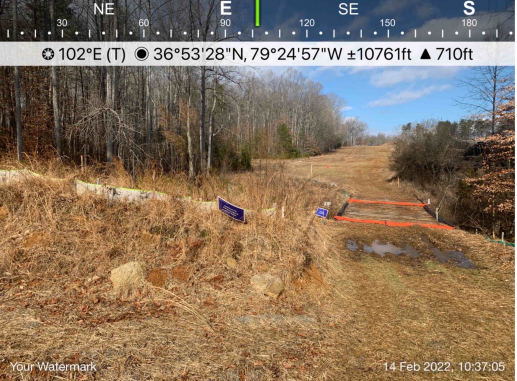
GPS Location	O	GPS Location	O		
Field Station#	15671+93	Field Station#	15658+43		
Pic 5 Desc.	Observing temporary stabilization, signage, buffer, equipment crossing and ECD's	Pic 6 Desc.	Observing temporary stabilization, signage, buffer, equipment crossing and ECD's

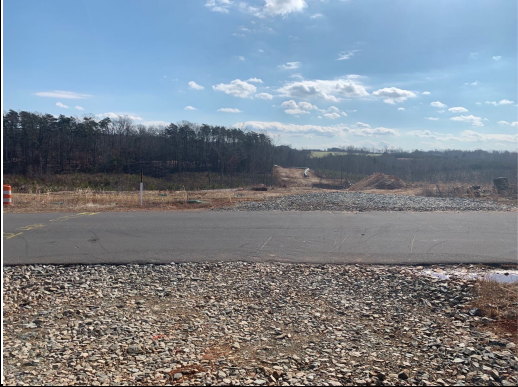
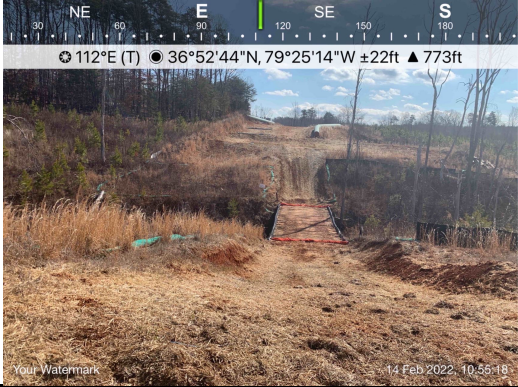
GPS Location	O	GPS Location	O		
Field Station#	15693+89	Field Station#	15700+35		
Pic 7 Desc.	Observing road crossing and RCE's	Pic 8 Desc.	Observing temporary stabilization, signage, buffer, equipment crossing and ECD's		
Insert image here		Insert image here			
GPS Location		GPS Location			
Field Station#		Field Station#			
Pic 9 Desc.		Pic 10 Desc.			
Insert image here		Insert image here			
GPS Location		GPS Location			
Field Station#		Field Station#			
Pic 11 Desc.		Pic 12 Desc.

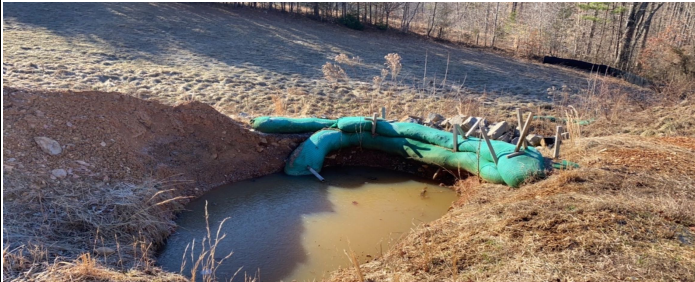
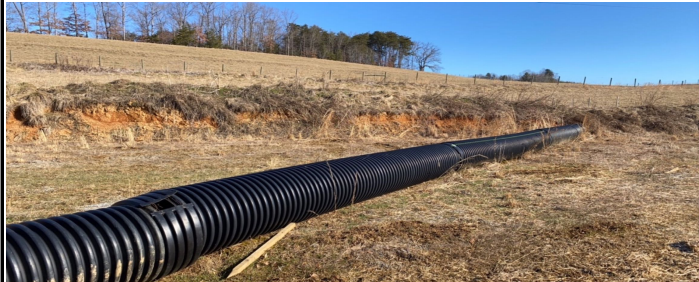
36°58'3" N 79°38'11" W 172°S COURSE 132° GPS 2082 Ramsey Memorial Rd, Penhook, VA 24137, United States 02.15.2022 09:40:53 Accur +/-196.0 Ft ALT 826 Ft			36°58'2" N 79°38'6" W 22°N COURSE 281° GPS Sorry no results found 02.15.2022 09:51:32 Accur +/-20.5 Ft ALT 824 Ft		
GPS Location	1	GPS Location	2		
Field Station#	14935+00	Field Station#	14937+00		
Pic 1 Desc.	Routine maintenance. CFS end treatment falling into sump pit.		Pic 2 Desc.	Routine maintenance. Properly install CWD pipe. Spacing in drain tile not diverting water off ROW.

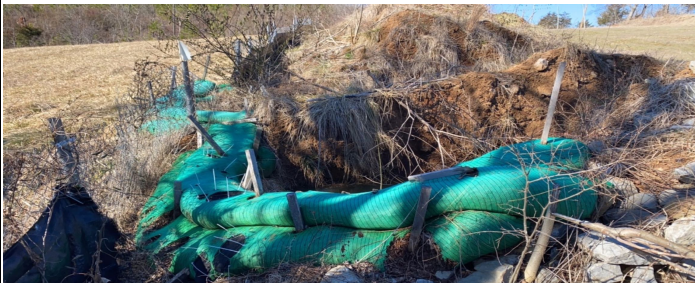
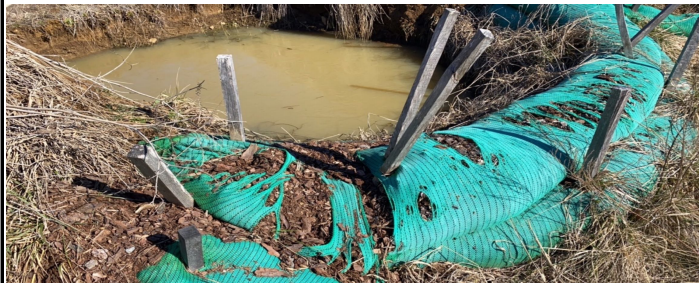
Field Station#	14999+00	Field Station#	15006+00		
Pic 3 Desc.	Routine maintenance. Replace damaged CFS end treatment beyond effective lifespan. End treatment is not at edge of ROW and water is filtering back into ROW.		Pic 4 Desc.	Routine maintenance. Replace damaged CFS end treatment beyond effective lifespan.

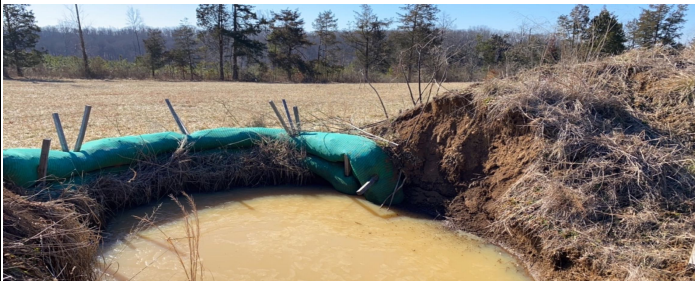
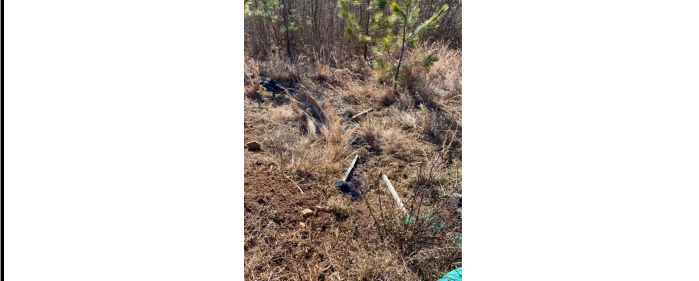
36°57'54" N 79°36'41" W 178°S COURSE 17° GPS Penhook, VA 24137, United States 02.15.2022 10:34:29 Accur +/-128.6 Ft ALT 918 Ft			36°57'55" N 79°36'37" W 186°S COURSE 89° GPS Penhook, VA 24137, United States 02.15.2022 10:36:37 Accur +/-43.0 Ft ALT 912 Ft		
GPS Location	5	GPS Location	6		
Field Station#	15007+00	Field Station#	15008+00		
Pic 5 Desc.	Routine maintenance. CFS end treatment falling into sump pit.		Pic 6 Desc.	Routine maintenance. Replace perimeter CFS beyond effective lifespan. Worn/disintegrated.

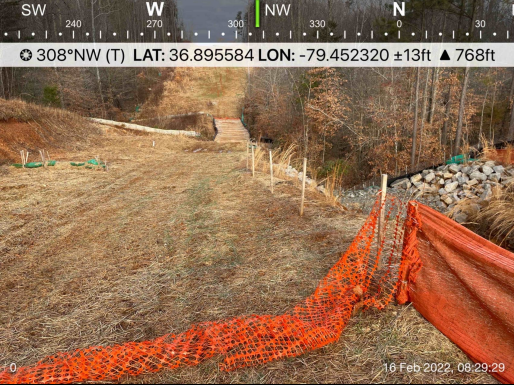
GPS Location	See photo		GPS Location	See photo	
Field Station#	15521+00		Field Station#	15575+00	
Pic 9 Desc.	Resource buffers remain well vegetated		Pic 10 Desc.	Safety fence needs to be reattached around slope drain sump

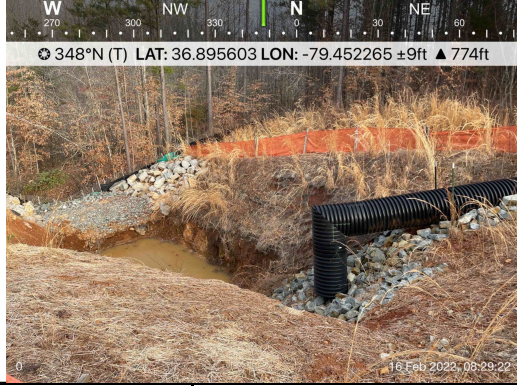
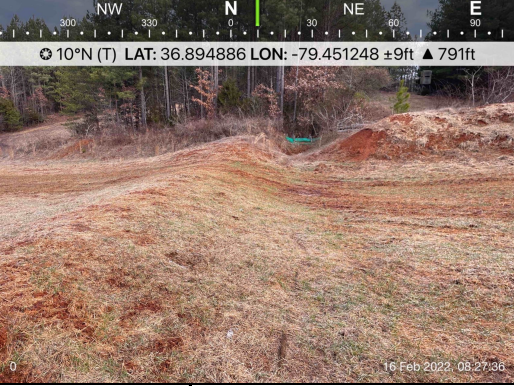
GPS Location	See photo		GPS Location	See photo	
Field Station#	15575+00		Field Station#	15580+00	
Pic 11 Desc.	Slope drain is in good condition and functioning		Pic 12 Desc.	Waterbars are in good condition throughout this section.

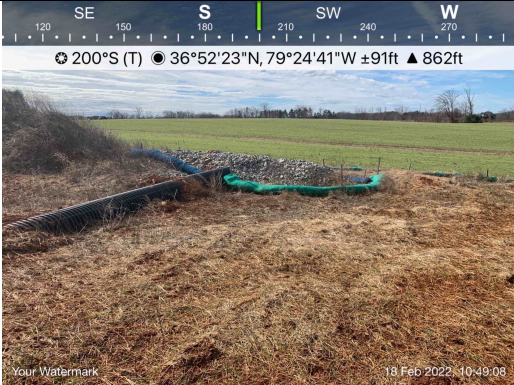
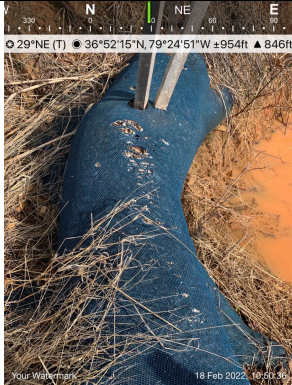
GPS Location	O	GPS Location	O		
Field Station#	15735+50	Field Station#	15735+00		
Pic 1 Desc.	Observing temporary stabilization,CWD outlet and ECD's		Pic 2 Desc.	Observing CFS that requires maintenance

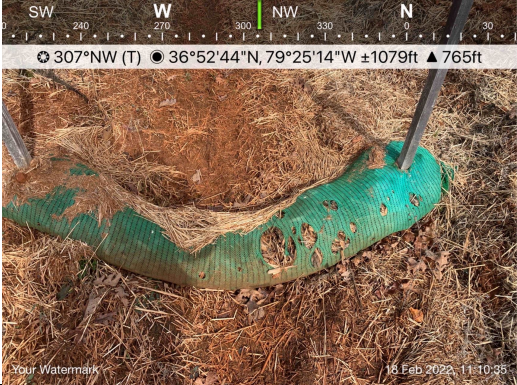
Insert image here			
GPS Location	O	GPS Location			
Field Station#	15698+50	Field Station#			
Pic 7 Desc.	Observing CFS check that requires maintenance	Pic 8 Desc.			
Insert image here		Insert image here			
GPS Location		GPS Location			
Field Station#		Field Station#			
Pic 9 Desc.		Pic 10 Desc.			
Insert image here		Insert image here			
GPS Location		GPS Location			
Field Station#		Field Station#			
Pic 11 Desc.		Pic 12 Desc.

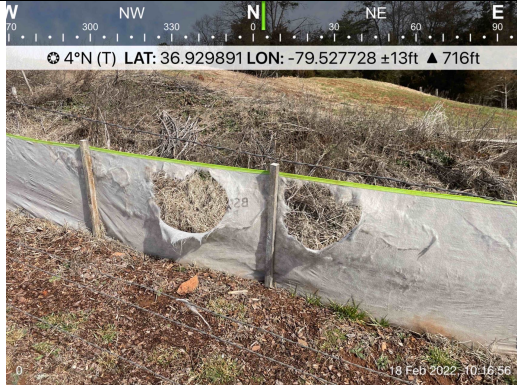
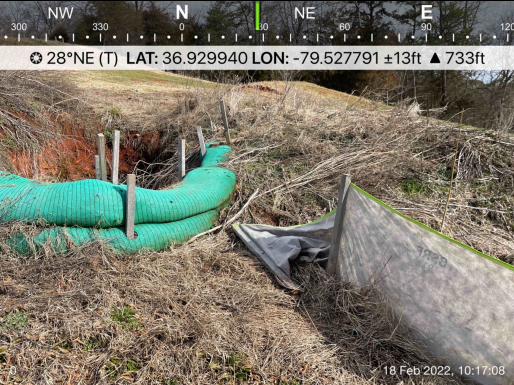
GPS Location	See photo		GPS Location	See photo	
Field Station#	15311+00		Field Station#	15310+50	
Pic 11 Desc.	P1 has been damaged by livestock and needs to be replaced.		Pic 12 Desc.	P1 needs to be restaked.
