Visual Site Inspection Report

Project Name	H-600 Pipeline Spread I	AFE	124300139	Spread	H-600 Pipeline Spread I
Contractor	Precision			Report #	34654
Inspector	Ben Farmer			Date/Time	2/21/2022 2:45 PM
Permit #	TBD	Inspection Type	VA SWPP	Station Begin	15772+27
State	VA	Inspection Area	Partial	Station End	15947+64
County	Pittsylvania	Ground	Dry	Temperature (°F)	40.00
Municipality	Chatham	Weather	Sunny	Rain Gauge (in)	0.00
				Rain Accumulation Time (days)	0.00

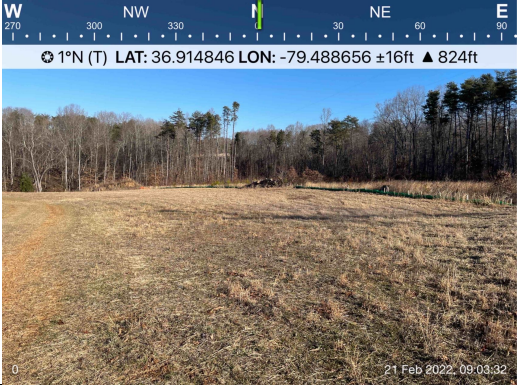
GPS Location	See photo		GPS Location	See photo	
Field Station#	15439+00		Field Station#	15445+00	
Pic 7 Desc.	Vegetation continues to fill in throughout this section		Pic 8 Desc.	Perimeter CFS is in good condition

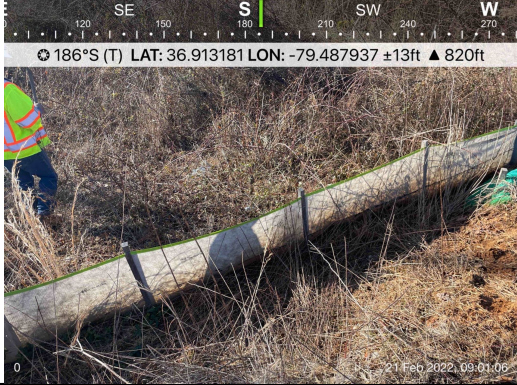
GPS Location	See photo		GPS Location	See photo	
Field Station#	15447+50		Field Station#	15448+00	
Pic 9 Desc.	P1 is degraded and needs to be replaced		Pic 10 Desc.	P1 is degraded and needs to be replaced

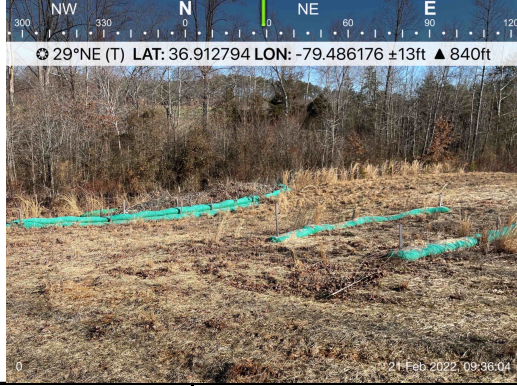
GPS Location	See photo		GPS Location	See photo	
Field Station#	15453+00		Field Station#	15457+00	
Pic 11 Desc.	CWD remains in good condition		Pic 12 Desc.	No evidence of sedimentation from 3rd party disturbance within drainage feature

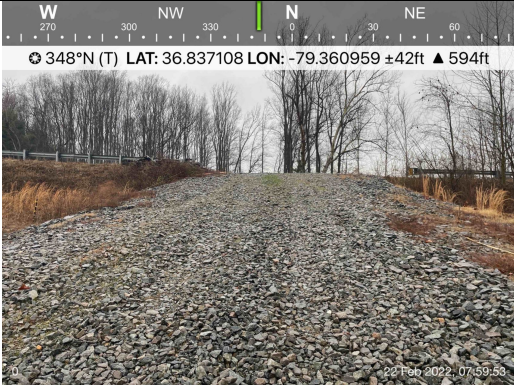
GPS Location	See photo	GPS Location	See photo		
Field Station#	15947+65	Field Station#	15950+00		
Pic 1 Desc.	RCEs are in good condition at all road crossings	Pic 2 Desc.	P1 is in good condition

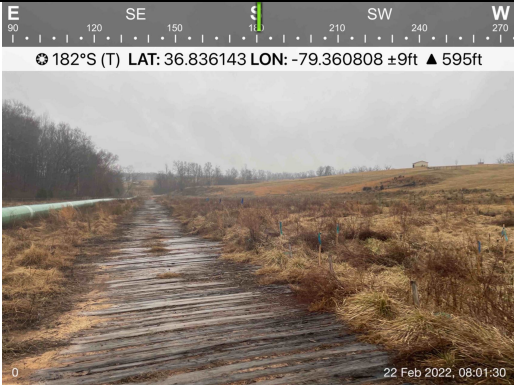
GPS Location	See photo	GPS Location	See photo		
Field Station#	15955+00	Field Station#	15962+00		
Pic 3 Desc.	Wetland buffer ECDs are in place and functioning	Pic 4 Desc.	P1 is in good condition at resource buffer

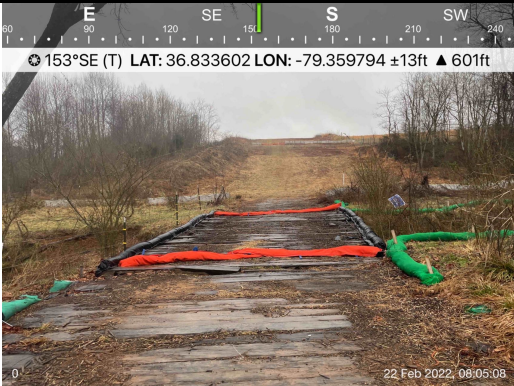
GPS Location	See photo	GPS Location	See photo		
Field Station#	15962+00	Field Station#	15962+00		
Pic 5 Desc.	Equipment bridge ECDs are in place and functioning	Pic 6 Desc.	CFS is in good condition

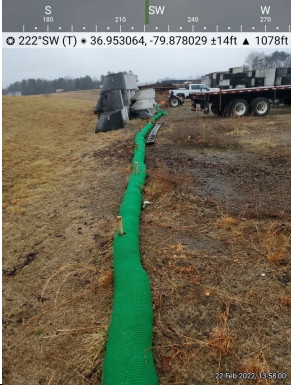
GPS Location	0	GPS Location	0		
Field Station#	0+00	Field Station#	0+00		
Pic 7 Desc.	ANC-006 Southeast perimeter CFS	Pic 8 Desc.	ANC-006 Secondary containment		
Insert image here		Insert image here			
GPS Location		GPS Location			
Field Station#		Field Station#			
Pic 9 Desc.		Pic 10 Desc.			
Insert image here		Insert image here			
GPS Location		GPS Location			
Field Station#		Field Station#			
Pic 11 Desc.		Pic 12 Desc.

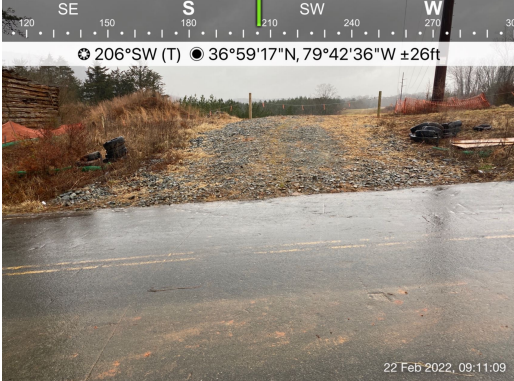
GPS Location	0	GPS Location	0		
Field Station#	14694+50	Field Station#	14689+36		
Pic 1 Desc.	Approximately 14694+50. Overview of road crossing and RCE.	Pic 2 Desc.	Approximately 14689+36. Overview of stream crossing, equipment bridge and ECDs at stream S-H34.

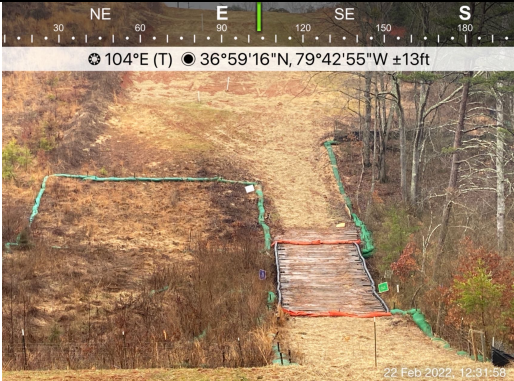
GPS Location	0	GPS Location	0		
Field Station#	14680+30	Field Station#	14675+00		
Pic 3 Desc.	Approximately 14680+30. Overview of stream crossing, equipment bridge and ECDs at stream S-H36.	Pic 4 Desc.	Approximately 14675+00. Overview of ROW.

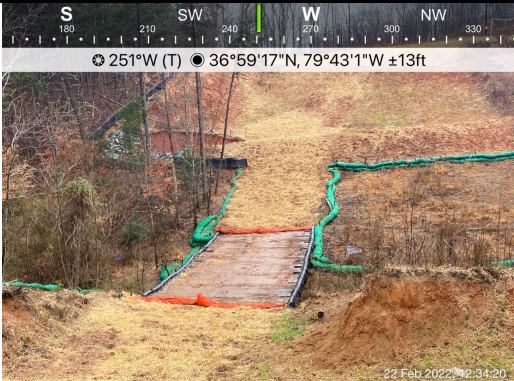
GPS Location	0	GPS Location	0		
Field Station#	14673+10	Field Station#	14655+00		
Pic 5 Desc.	Approximately 14673+10. Overview of stream crossing, equipment bridge and ECDs at stream S-H37.	Pic 6 Desc.	Approximately 14655+00. Overview of ROW. Permanent vegetation.

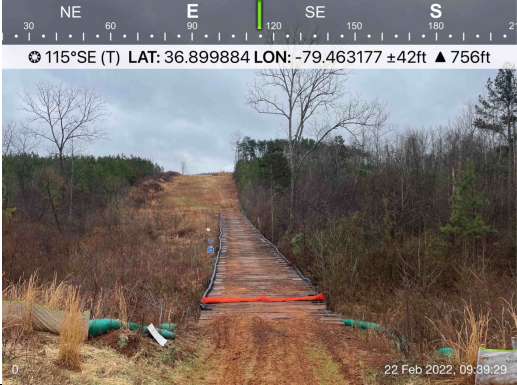
GPS Location	See photo		GPS Location	See photo	
Field Station#	15540+00		Field Station#	15541+50	
Pic 7 Desc.	Equipment bridge ECDs are in place and functioning		Pic 8 Desc.	P1 is degraded and needs to be replaced

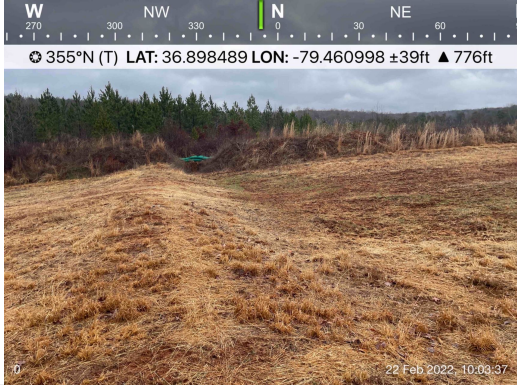
GPS Location	See photo		GPS Location	See photo	
Field Station#	15547+00		Field Station#	15556+83	
Pic 9 Desc.	Waterbars are in good condition		Pic 10 Desc.	Resource buffers remain well vegetated

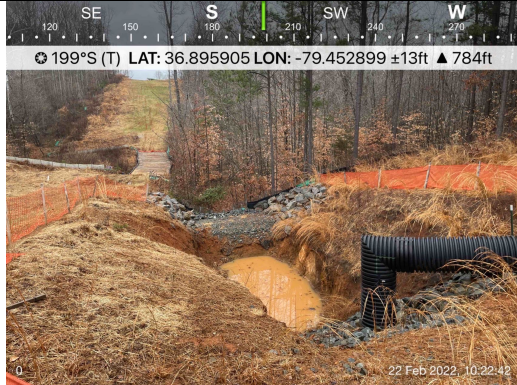
GPS Location	See photo		GPS Location	See photo	
Field Station#	15575+00		Field Station#	15584+00	
Pic 11 Desc.	Slope drain is in good condition and functioning		Pic 12 Desc.	P1 is in good condition at road pipe outlet

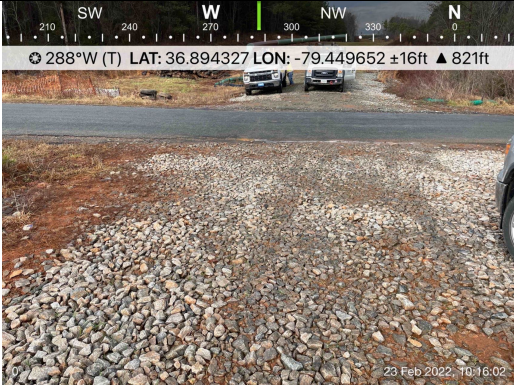
GPS Location	See photo	GPS Location	See photo		
Field Station#	15584+23	Field Station#	15584+50		
Pic 1 Desc.	RCEs are in good condition at all road crossings	Pic 2 Desc.	Perimeter P1 is in good condition

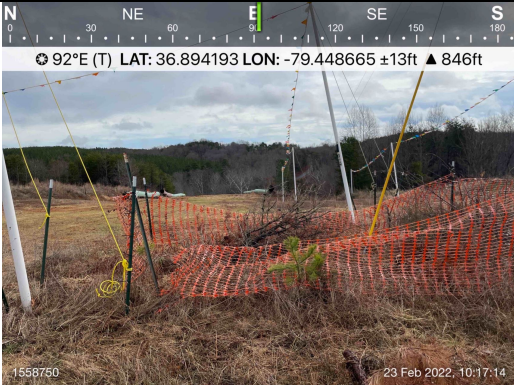
GPS Location	See photo	GPS Location	See photo		
Field Station#	15587+50	Field Station#	15595+50		
Pic 3 Desc.	Safety fence needs to be reattached	Pic 4 Desc.	CWDs are functioning as intended

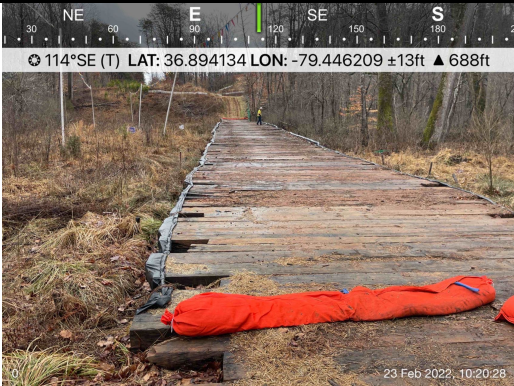
GPS Location	See photo	GPS Location	See photo		
Field Station#	15596+00	Field Station#	15596+70		
Pic 5 Desc.	Equipment bridge ECDs are in place and functioning	Pic 6 Desc.	Resource buffers remain well vegetated

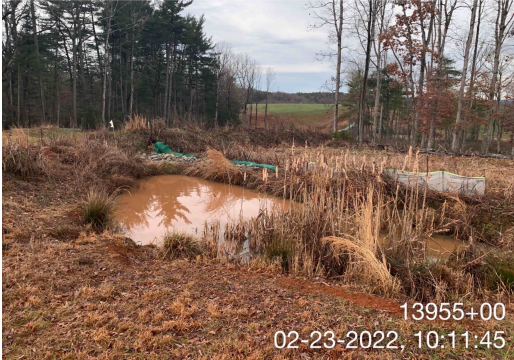
GPS Location	0	GPS Location	0		
Field Station#	13955+00	Field Station#	13954+00		
Pic 1 Desc.	Sump pit in acceptable condition	Pic 2 Desc.	Waterbar in acceptable condition

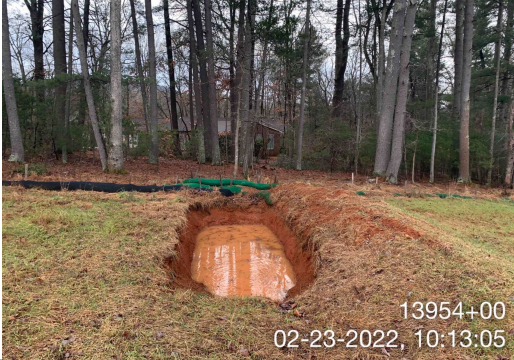
GPS Location	0	GPS Location	0		
Field Station#	13954+00	Field Station#	13942+00		
Pic 3 Desc.	Waterbar end treatment in acceptable condition	Pic 4 Desc.	Clean water diversion berm and temporary vegetative stabilization in acceptable conditions

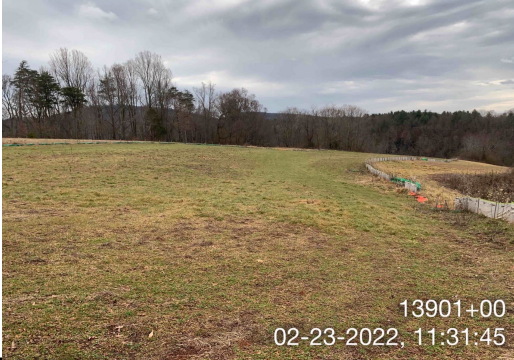
GPS Location	0	GPS Location	0		
Field Station#	13901+00	Field Station#	13887+00		
Pic 5 Desc.	Permanent vegetative stabilization and perimeter P1 silt fence in acceptable conditions	Pic 6 Desc.	Slope drain crushed by fallen tree

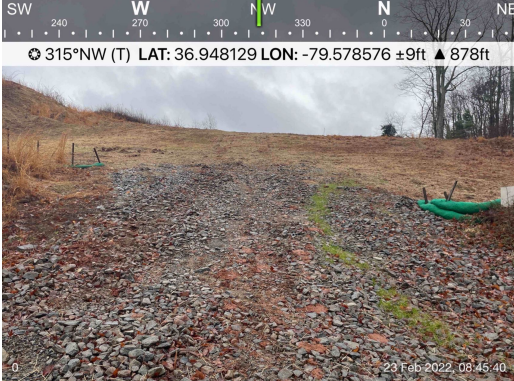
GPS Location	See photo		GPS Location	See photo	
Field Station#	15142+66		Field Station#	15160+00	
Pic 1 Desc.	RCE is in good condition		Pic 2 Desc.	Perimeter P1 is in good condition

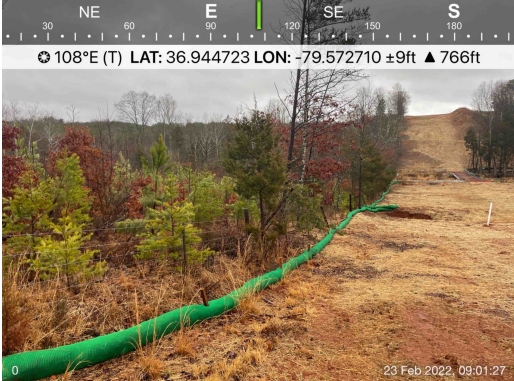
GPS Location	See photo		GPS Location	See photo	
Field Station#	15164+00		Field Station#	15165+57	
Pic 3 Desc.	Perimeter CFS is in good condition		Pic 4 Desc.	Rock filter remains in good condition

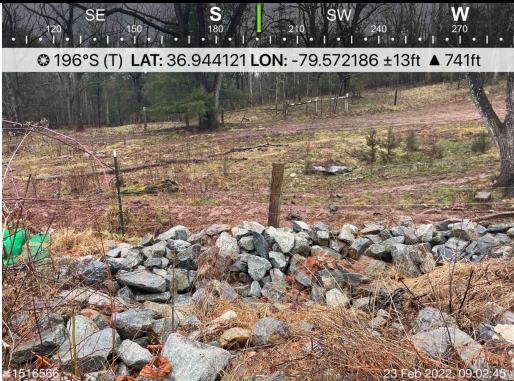
GPS Location	See photo		GPS Location	See photo	
Field Station#	15166+00		Field Station#	15168+00	
Pic 5 Desc.	Rock outlet remains in good condition		Pic 6 Desc.	P1 is in good condition at stream buffer

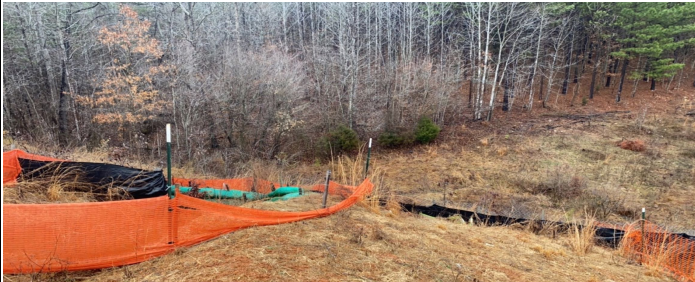
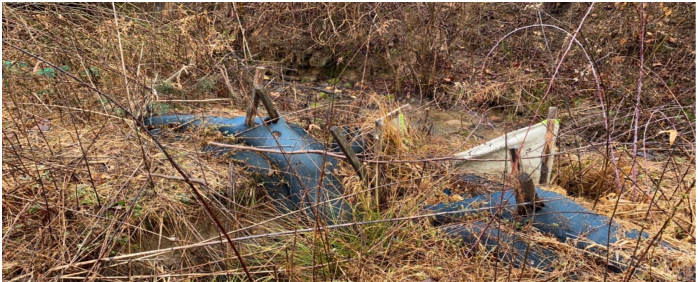
36°58'57" N 79°41'17" W 84°E COURSE -1' GPS Sorry no results found 02.23.2022 10:08:03 Accur +/-43.8 Ft ALT 942 Ft			36°58'57" N 79°41'16" W 258°W COURSE 0' GPS Sorry no results found 02.23.2022 09:32:23 Accur +/-92.6 Ft ALT 0 Ft		
GPS Location	1	GPS Location	2		
Field Station#	14764+00	Field Station#	14766+15		
Pic 1 Desc.	Routine maintenance. Repair safety fence around sump pit.	Pic 2 Desc.	Ineffective ESC measure. CFS triple stack undermining in resource buffer.

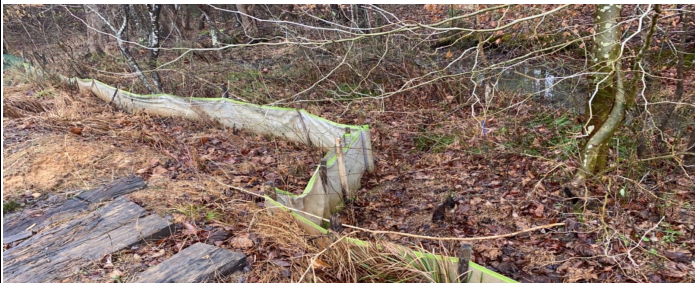
Pic 3 Desc.	Routine maintenance. Replace perimeter P1 silt fence beyond effective lifespan.	Pic 4 Desc.	Routine maintenance. Repair safety fence around sump pit.

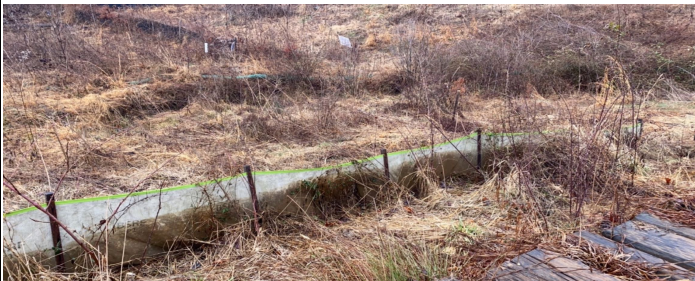
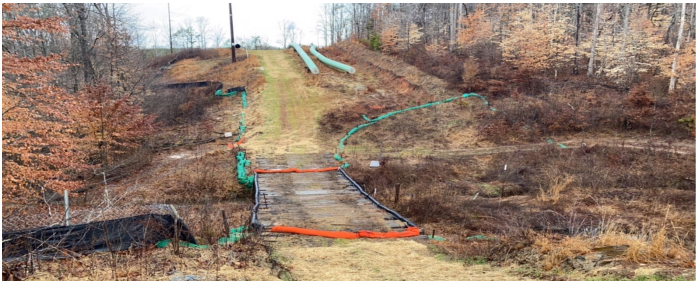
36°58'44" N 79°41'2" W 264°W COURSE -1' GPS 245 Zeigler Ln, Union Hall, VA 24176, United States 02.23.2022 09:44:09 Accur +/-25.3 Ft ALT 864 Ft			36°58'42" N 79°40'55" W 306°NW COURSE 283' GPS Penhook, VA 24137, United States 02.23.2022 09:55:25 Accur +/-38.2 Ft ALT 857 Ft		
GPS Location	5	GPS Location	6		
Field Station#	14782+35	Field Station#	14788+77		
Pic 5 Desc.	Routine maintenance. Replace perimeter P1 silt fence beyond effective lifespan.	Pic 6 Desc.	Equipment bridge and surrounding ECDs in place and functional at stream crossing and resource buffer.

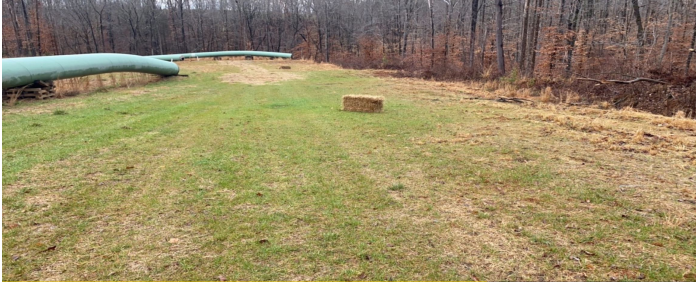
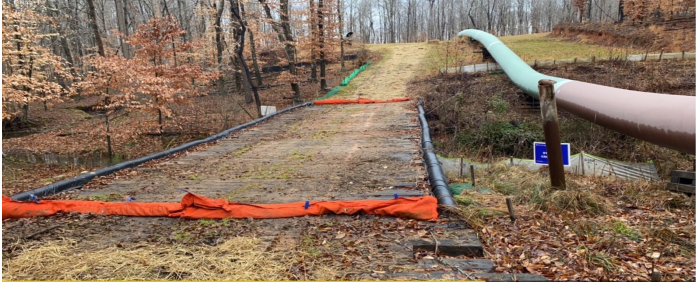
<small>36°58'26" N 79°40'26" W 226°SW COURSE 247' GPS Sorry no results found</small>			<small>36°58'23" N 79°40'22" W 297°NW COURSE 244' GPS Accur +/-35.6 Ft ALT 872 Ft</small>		
GPS Location	1		GPS Location	2	
Field Station#	14818+00		Field Station#	14823+54	
Pic 1 Desc.	ROW stabilized and vegetated in temporary area. No signs of erosion observed.		Pic 2 Desc.	Equipment bridge and surrounding ECDs in place and functional at stream crossing and resource buffer.

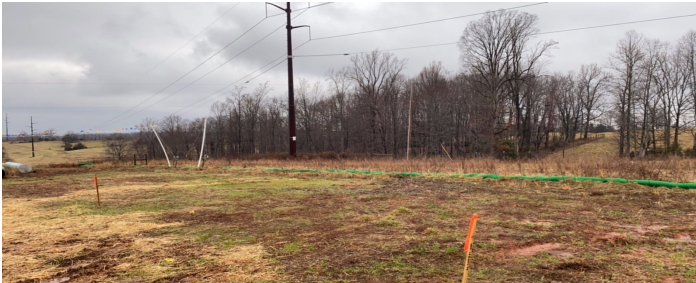
Field Station#	14861+00		Field Station#	14859+00	
Pic 3 Desc.	Portajon properly contained on ROW.		Pic 4 Desc.	ROW stabilized and vegetated in temporary area. Perimeter CFS in good condition.

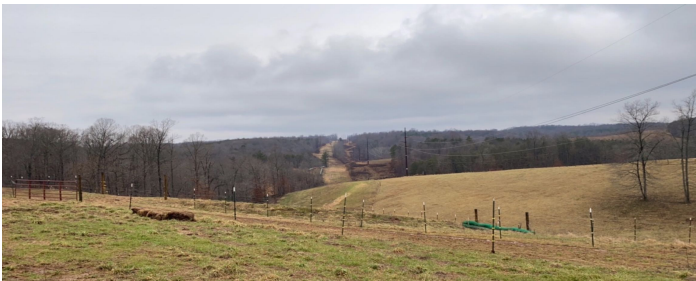
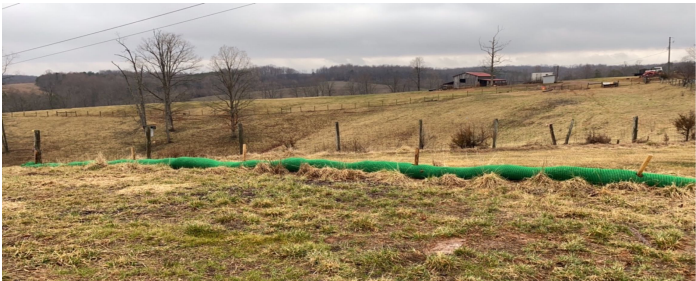
<small>36°58'4" N 79°38'18" W 321°NW COURSE 302' GPS 2019 Ramsey Memorial Rd, Penhook, VA 24137, United States 02.24.2022 10:47:34 Accur +/-15.4 Ft ALT 876 Ft</small>			<small>36°58'4" N 79°38'18" W 59°NE COURSE 49' GPS 2019 Ramsey Memorial Rd, Penhook, VA 24137, United States 02.24.2022 10:47:49 Accur +/-15.3 Ft ALT 876 Ft</small>		
GPS Location	5		GPS Location	6	
Field Station#	14920+00		Field Station#	14926+00	
Pic 5 Desc.	ROW stabilized and vegetated in final cleanup area.		Pic 6 Desc.	Perimeter CFS in place and functional.
