Visual Site Inspection Report

Project Name	H-600 Pipeline Spread I	AFE	124300139	Spread	H-600 Pipeline Spread I	
Contractor	Precision			Report #	34942	
Inspector	Glenn Mike Renfro			Date/Time	2/28/2022 1:33 PM	
Permit #	TBD	Inspection Type	VA SWPP	Station Begin	0000+00	
State	VA	Inspection Area	Full	Station End	0000+00	
County	Franklin	Ground	Dry	Temperature (°F)	56.00	
Municipality	N/A	Weather	Sunny	Rain Gauge (in)	1.20	
				Rain Accumulation Time (days)	6.00

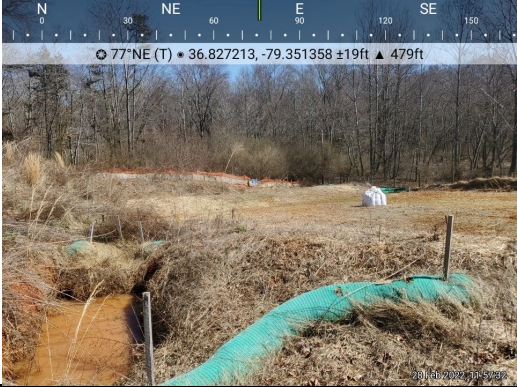
GPS Location	0	GPS Location	0		
Field Station#	15996+00	Field Station#	15989+00		
Pic 7 Desc.	Sump and ECDs	Pic 8 Desc.	GAS S-002 Buffer zone ECDs

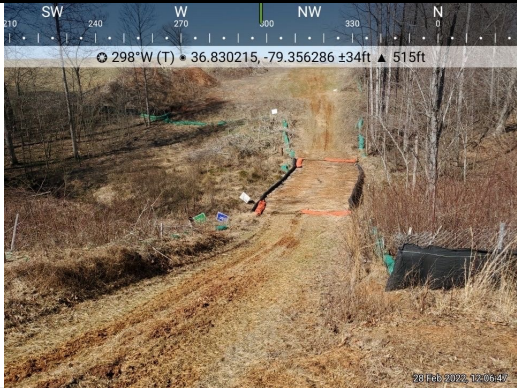
GPS Location	0	GPS Location	0		
Field Station#	15978+00	Field Station#	15957+00		
Pic 9 Desc.	GAS S-001 Travel lane and ECDs	Pic 10 Desc.	Clean water diversion outlet

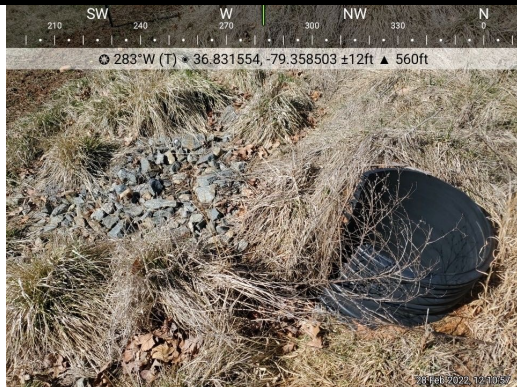
GPS Location	0	GPS Location	0		
Field Station#	15957+00	Field Station#	15963+50		
Pic 11 Desc.	Clean water diversion inlet	Pic 12 Desc.	GAS S-H5 Silt fence

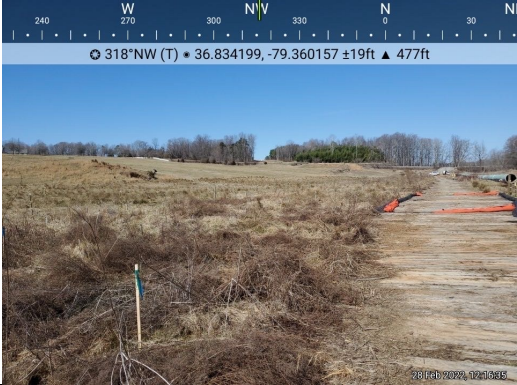
GPS Location	0	GPS Location			
Field Station#	15954+00	Field Station#			
Pic 13 Desc.	W-H2	Pic 14 Desc.			
Insert image here		Insert image here			
GPS Location		GPS Location			
Field Station#		Field Station#			
Pic 15 Desc.		Pic 16 Desc.			
Insert image here		Insert image here			
GPS Location		GPS Location			
Field Station#		Field Station#			
Pic 17 Desc.		Pic 18 Desc.

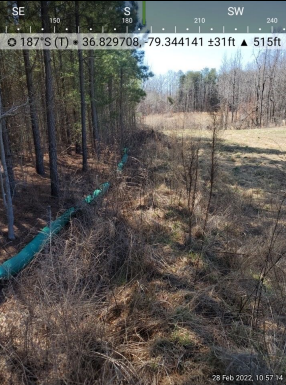
GPS Location	0	GPS Location	0		
Field Station#	18+00	Field Station#	13+25		
Pic 1 Desc.	Perimeter CFS	Pic 2 Desc.	GAS S-H42 Buffer zone ECDs

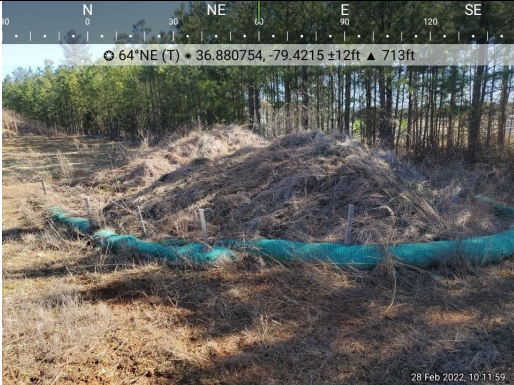
GPS Location	0	GPS Location	0		
Field Station#	5+00	Field Station#	12+50		
Pic 1 Desc.	Soil stockpile stabilization	Pic 2 Desc.	CIS Transco Rd Sump and ECDs

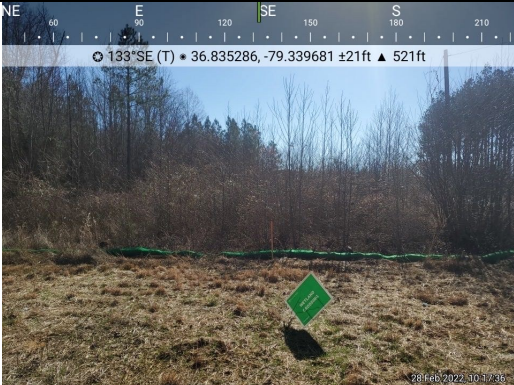
GPS Location	0	GPS Location	0		
Field Station#	15+00	Field Station#	19+50		
Pic 3 Desc.	CIS W-EF6 Buffer zone	Pic 4 Desc.	GAS W-IJ21 Perimeter CFS

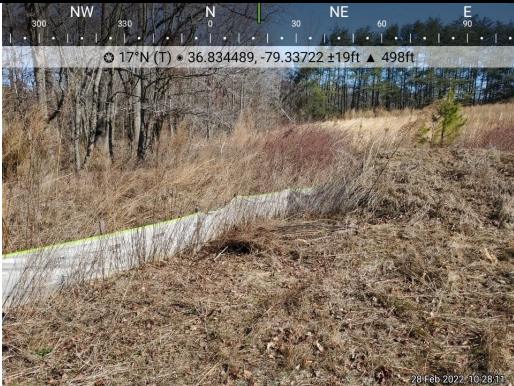
GPS Location	0	GPS Location	0		
Field Station#	20+66	Field Station#	20+66		
Pic 5 Desc.	Silt fence	Pic 6 Desc.	Damaged CFS

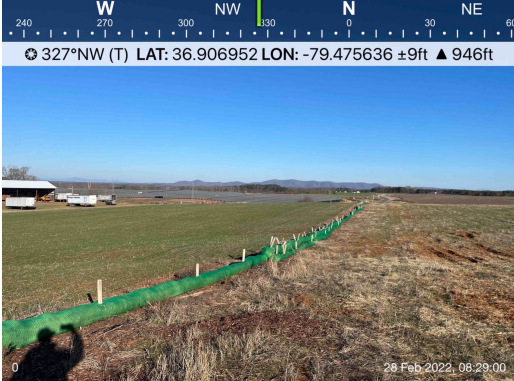
GPS Location	See photo	GPS Location	See photo		
Field Station#	15490+00	Field Station#	15493+00		
Pic 1 Desc.	Perimeter CFS is in good condition	Pic 2 Desc.	Vegetation continues to fill in throughout this section

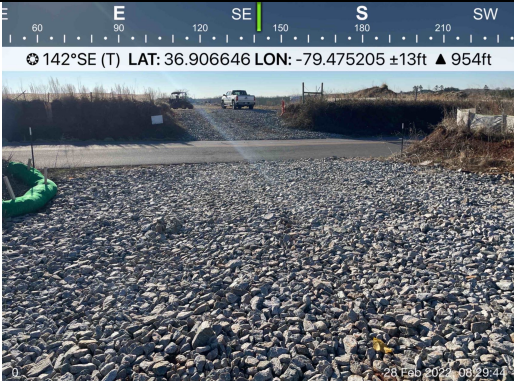
GPS Location	See photo	GPS Location	See photo		
Field Station#	15496+70	Field Station#	15501+00		
Pic 3 Desc.	RCEs are in good condition at all road crossings	Pic 4 Desc.	No evidence of sedimentation from 3rd party disturbance

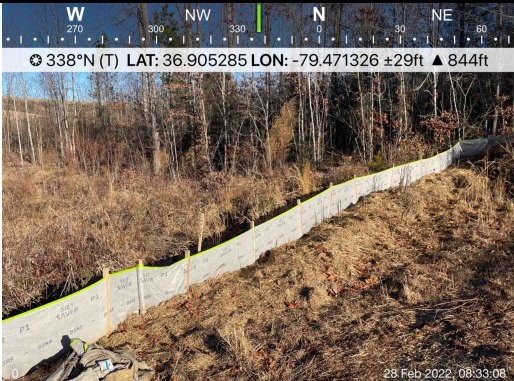
GPS Location	See photo	GPS Location	See photo		
Field Station#	15508+02	Field Station#	15510+00		
Pic 5 Desc.	P1 is in good condition at all stream and wetland buffers	Pic 6 Desc.	3rd party ECDs appear to be in good condition.

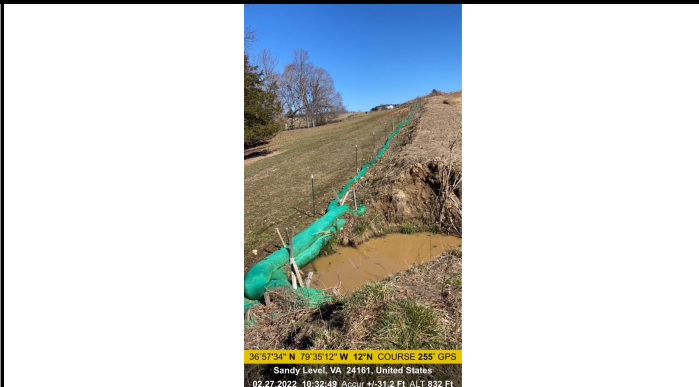
Field Station#	15085+93	Field Station#	15091+00		
Pic 3 Desc.	Plunge pool performing intended function.		Pic 4 Desc.	Sump pit and CFS end treatment performing intended functions; perimeter CFS in good condition.

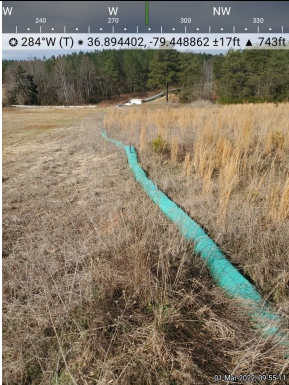
GPS Location	0	GPS Location	0		
Field Station#	15588+00	Field Station#	15592+00		
Pic 1 Desc.	GAS Anderson Mill Rd #1 Perimeter CFS		Pic 2 Desc.	Sump

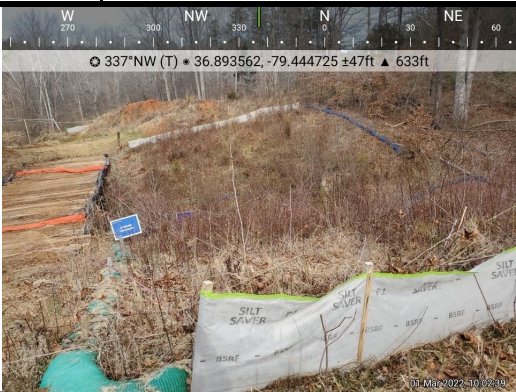
GPS Location	0	GPS Location	0		
Field Station#	15601+00	Field Station#	15632+00		
Pic 5 Desc.	GAS S-CC3 Buffer zone and ECDs		Pic 6 Desc.	Clean water diversion inlet

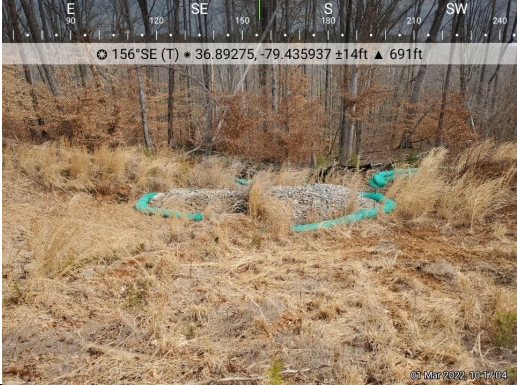
GPS Location	0		GPS Location	0	
Field Station#	15632+00		Field Station#	15637+00	
Pic 7 Desc.	Clean water diversion outlet		Pic 8 Desc.	GAS S-IJ35-INT Buffer zone	
 		Insert image here

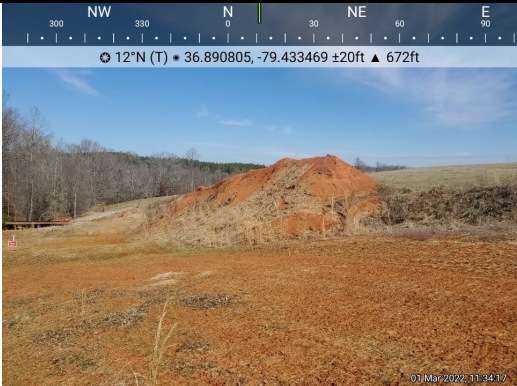
GPS Location	0		GPS Location	0	
Field Station#	15643+00		Field Station#	15638+00	
Pic 9 Desc.	CIS Anderson Mill Rd #3 Perimeter CFS		Pic 10 Desc.	Soil stockpile needs stabilization	
Insert image here			Insert image here		
GPS Location			GPS Location		
Field Station#			Field Station#		
Pic 11 Desc.			Pic 12 Desc.

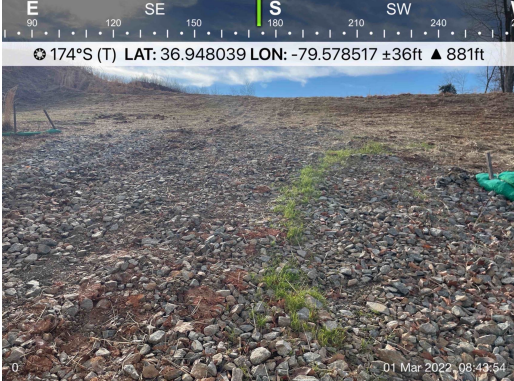
GPS Location	See photo		GPS Location	See photo	
Field Station#	15142+66		Field Station#	15152+84	
Pic 1 Desc.	RCE is in good condition at Rockcreek Rd.		Pic 2 Desc.	-CFS has been damaged by livestock along MVP-PI-326 and needs to be replaced.

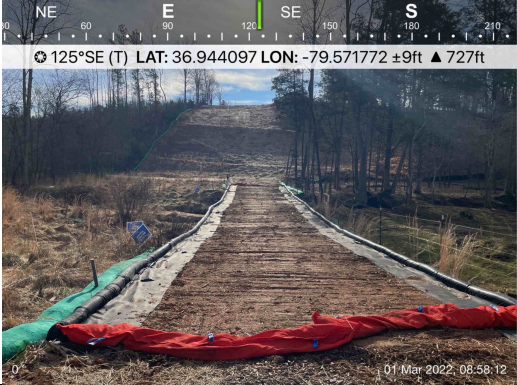
GPS Location	See photo	GPS Location	See photo		
Field Station#	15168+49	Field Station#	15170+00		
Pic 7 Desc.	Equipment bridge ECDs are in place and functioning	Pic 8 Desc.	Waterbars are in good condition

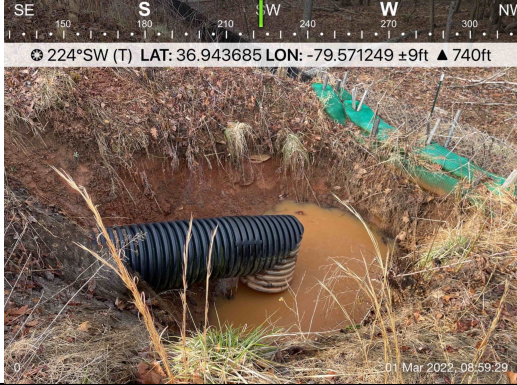
GPS Location	See photo	GPS Location	See photo		
Field Station#	15170+00	Field Station#	15195+00		
Pic 9 Desc.	Slope drain is functioning as intended	Pic 10 Desc.	Drainage ECDs are in place and functioning

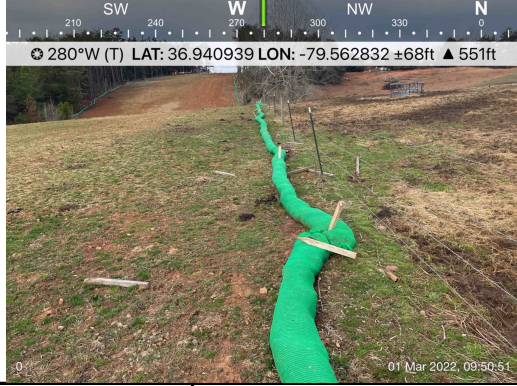
GPS Location	See photo	GPS Location	See photo		
Field Station#	15202+00	Field Station#	15230+00		
Pic 11 Desc.	Perimeter CFS has been displaced and needs to be restaked	Pic 12 Desc.	Vegetation continues to fill in throughout this section.

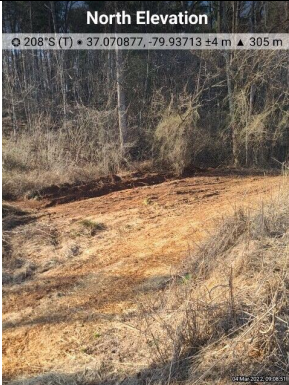
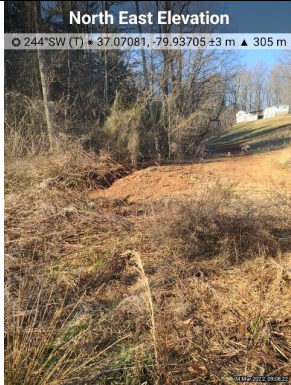
GPS Location	0000	GPS Location	0000		
Field Station#	13770+69	Field Station#	13770+69		
Pic 1 Desc.	Land owner disturbance to S-MM42 , land owner has cleaned out the stream channel inside part of the buffer zone, documented as non project related activities		Pic 2 Desc.	Land owner disturbance to S-MM42 , land owner has cleaned out the stream channel inside part of the buffer zone, documented as non project related activities	
	West Elevation

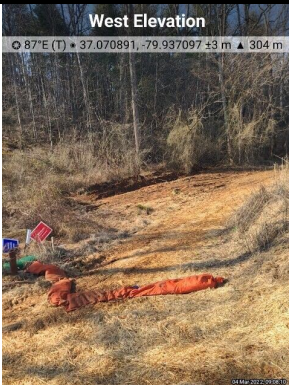
North West Elevation  	
GPS Location	0000	GPS Location	0000		
Field Station#	13770+69	Field Station#	13755+49		
Pic 3 Desc.	Land owner disturbance to S-MM42 , land owner has cleaned out the stream channel inside part of the buffer zone, documented as non project related activities		Pic 4 Desc.	Stream observation photo facing upstream during routine inspection today, no environmental issues observed at the time of inspection

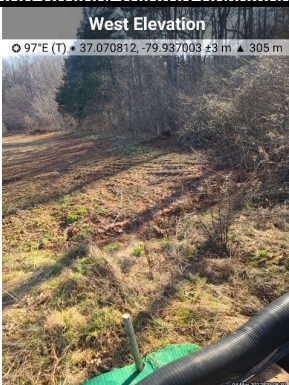
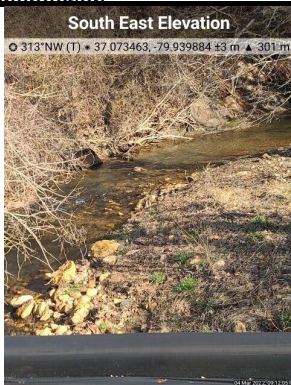
GPS Location	0000	GPS Location	0000		
Field Station#	13770+69	Field Station#	13755+49		
Pic 5 Desc.	Additional photo showing land owner disturbance to S-MM42 on the neck done side of row, documented as non project related activities		Pic 6 Desc.	Stream observation photo facing downstream during routine inspection today, no environmental issues observed at the time of inspection

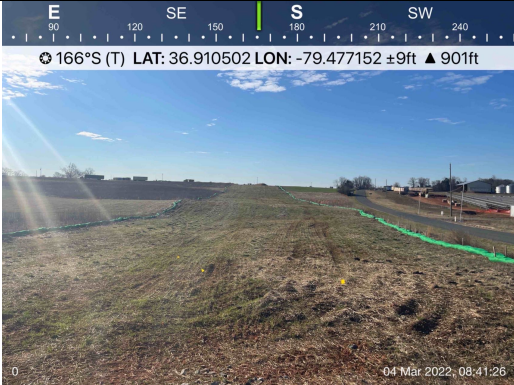
GPS Location	See photo		GPS Location	See photo	
Field Station#	15481+00		Field Station#	15483+00	
Pic 1 Desc.	Vegetation continues to fill in throughout this section		Pic 2 Desc.	Perimeter CFS is in good condition.

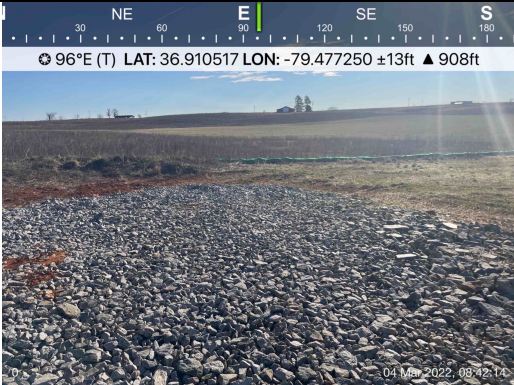
GPS Location	See photo		GPS Location	See photo	
Field Station#	15480+67		Field Station#	15501+00	
Pic 3 Desc.	RCEs are in good condition at all road crossings		Pic 4 Desc.	No evidence of sedimentation from 3rd party disturbance

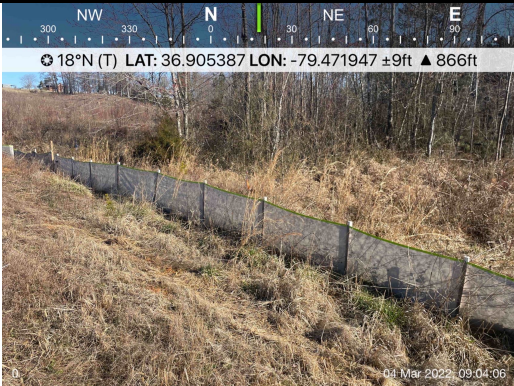
GPS Location	See photo		GPS Location	See photo	
Field Station#	15507+00		Field Station#	15510+00	
Pic 5 Desc.	P1 is in good condition at all stream and wetland buffers		Pic 6 Desc.	3rd party ECDs appear to be in good condition

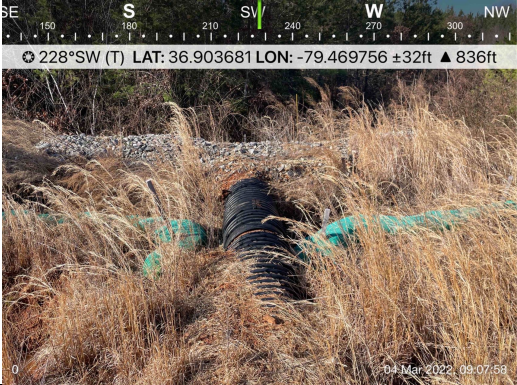
GPS Location	See photo		GPS Location	See photo	
Field Station#	15515+00		Field Station#	15542+00	
Pic 7 Desc.	CWDs are functioning as intended		Pic 8 Desc.	Resource buffers remain well vegetated

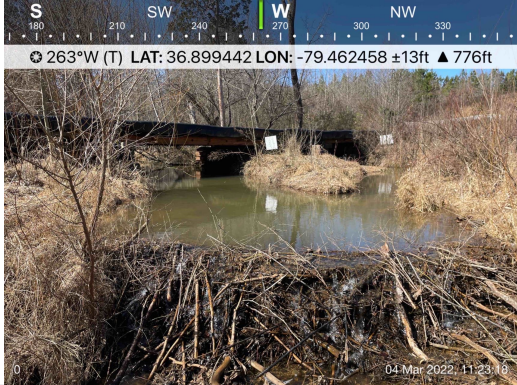
GPS Location	See photo		GPS Location	See photo	
Field Station#	15542+20		Field Station#	15543+00	
Pic 9 Desc.	Beaver dam located within ROW down stream of equipment bridge at S-CC5. EI will continue to monitor this area for potential backwater conditions and equipment bridge.		Pic 10 Desc.	Equipment bridge ECDs are in good condition and functioning

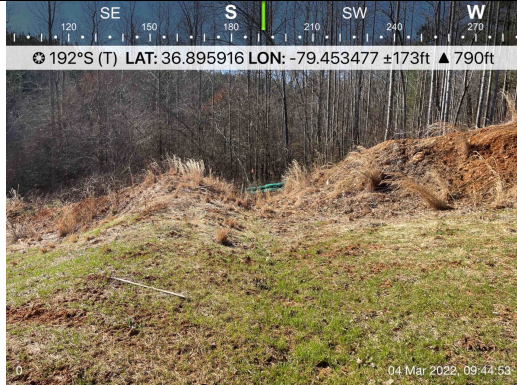
GPS Location	See photo		GPS Location	See photo	
Field Station#	15570+00		Field Station#	15575+00	
Pic 11 Desc.	Waterbars remain in good condition		Pic 12 Desc.	Slope drain is in good condition and functioning

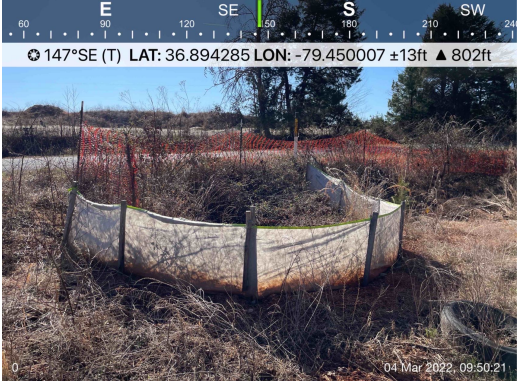
GPS Location	See photo	GPS Location			
Field Station#	15584+00	Field Station#			
Pic 13 Desc.	P1 remains in good condition at road pipe outlet.	Pic 14 Desc.			
Insert image here		Insert image here			
GPS Location		GPS Location			
Field Station#		Field Station#			
Pic 15 Desc.		Pic 16 Desc.			
Insert image here		Insert image here			
GPS Location		GPS Location			
Field Station#		Field Station#			
Pic 17 Desc.		Pic 18 Desc.
