Visual Site Inspection Report

Project Name	H-600 Pipeline Spread I	AFE	124300139	Spread	H-600 Pipeline Spread I
Contractor	Precision			Report #	34118
Inspector	John White			Date/Time	2/7/2022 11:05 AM
Permit #	TBD	Inspection Type	VA SWPP	Station Begin	15584+23
State	VA	Inspection Area	Full	Station End	15647+03
County	Pittsylvania	Ground	Frozen	Temperature (°F)	32.00
Municipality	Chatham	Weather	Snow/Sleet	Rain Gauge (in)	0.50
				Rain Accumulation Time (days)	6.00

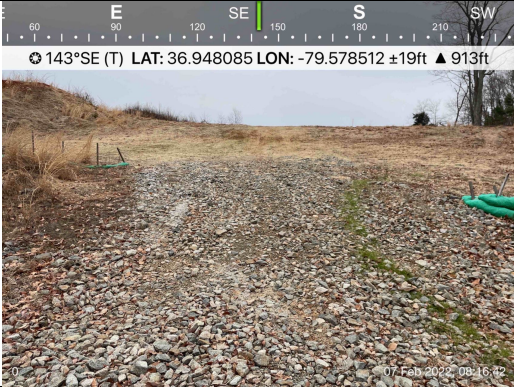
GPS Location	See photo		GPS Location	See photo	
Field Station#	15142+66		Field Station#	15160+00	
Pic 1 Desc.	RCE is in good condition at Rockcreek Rd.		Pic 2 Desc.	Perimeter P1 is degraded and needs to be replaced.

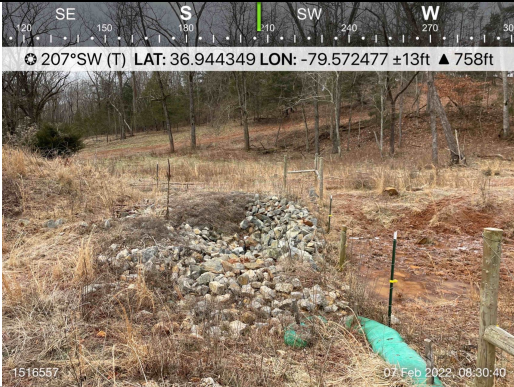
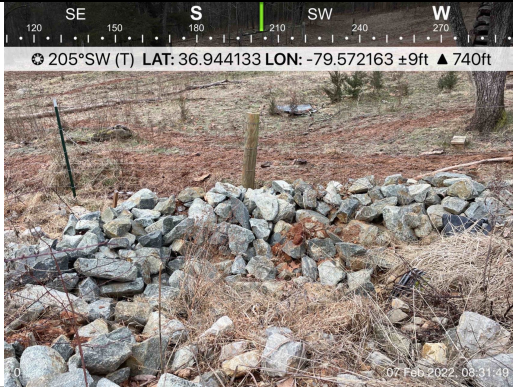
GPS Location	See photo		GPS Location	See photo	
Field Station#	15165+57		Field Station#	15166+00	
Pic 3 Desc.	Rock inlet remains in good condition.		Pic 4 Desc.	Rock outlet remains in good condition.

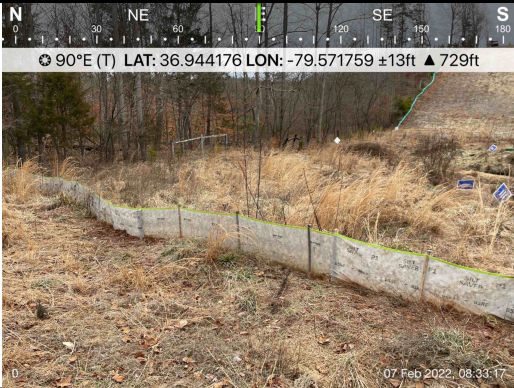
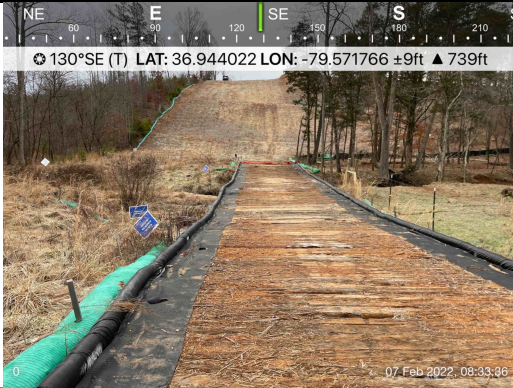
GPS Location	See photo		GPS Location	See photo	
Field Station#	15168+49		Field Station#	15168+49	
Pic 5 Desc.	P1 is in good condition at stream buffer.		Pic 6 Desc.	Equipment bridge ECDs are in place and functioning.

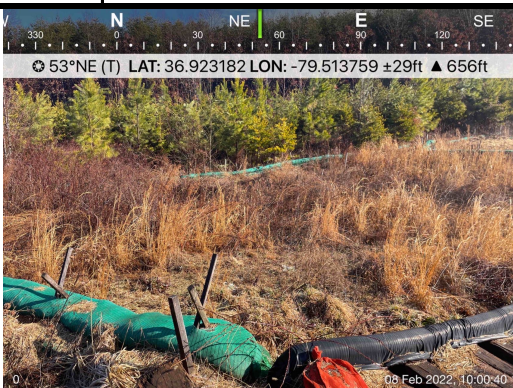
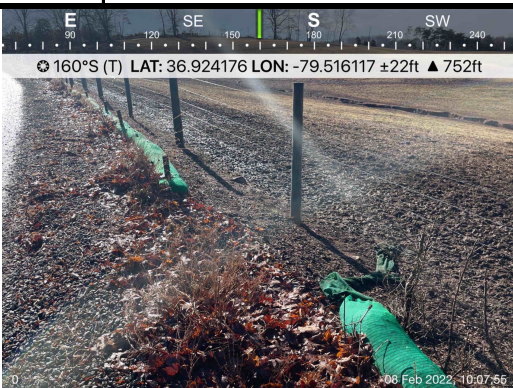
GPS Location	See photo		GPS Location	See photo	
Field Station#	15365+00		Field Station#	15350+00	
Pic 3 Desc.	Drainage ECDs are in good condition and functioning.		Pic 4 Desc.	CFS has been damaged by livestock and needs to be replaced.

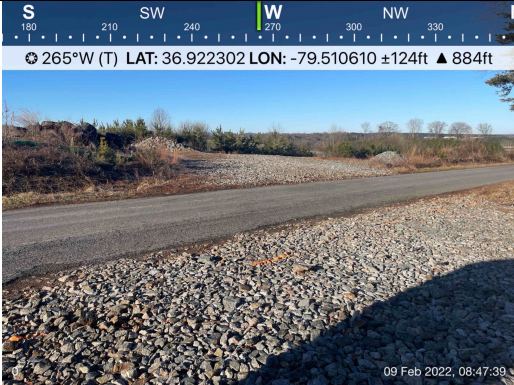
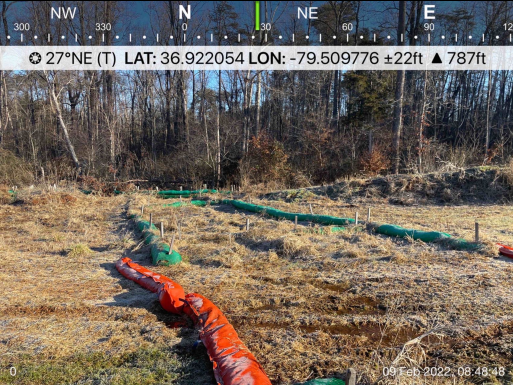
GPS Location	See photo	GPS Location	See photo		
Field Station#	15370+62	Field Station#	15375+00		
Pic 1 Desc.	RCEs are in good condition at all road crossings.	Pic 2 Desc.	Drainage ECDs are in good condition and functioning.

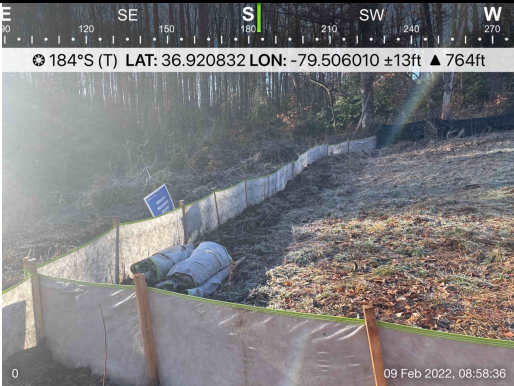
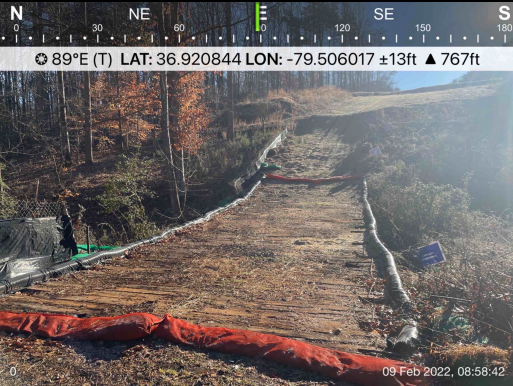
GPS Location	See photo	GPS Location	See photo		
Field Station#	15384+50	Field Station#	15384+73		
Pic 5 Desc.	P1 is in good condition at all stream and wetland buffers	Pic 6 Desc.	Equipment bridge ECDs are in place and functioning.

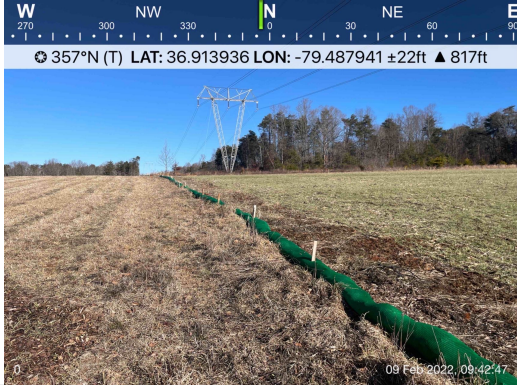
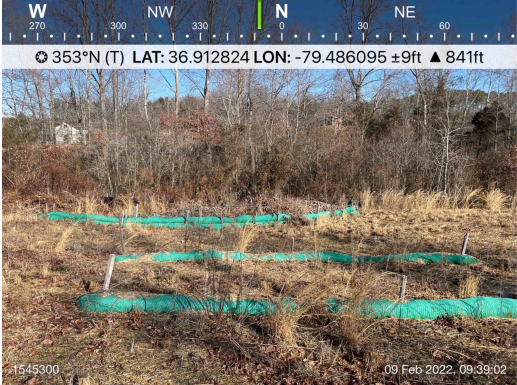
GPS Location	See photo		GPS Location	See photo	
Field Station#	15444+00		Field Station#	15453+00	
Pic 9 Desc.	Perimeter CFS is in good condition		Pic 10 Desc.	CWD is functioning as intended.

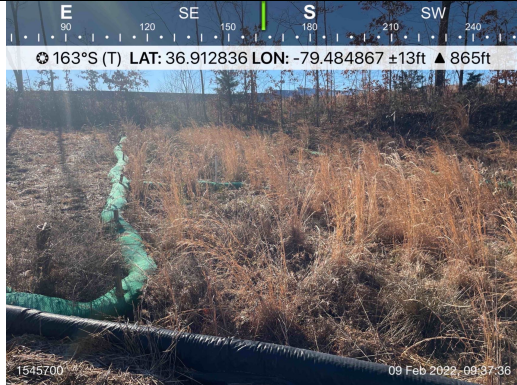
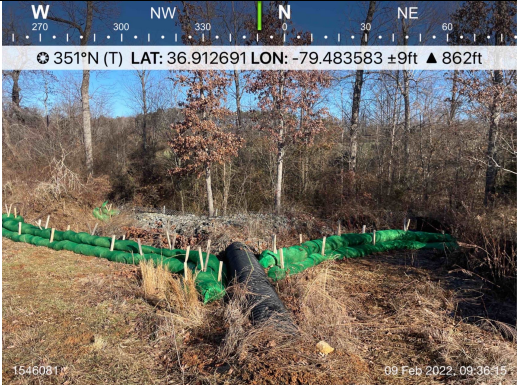
GPS Location	See photo		GPS Location	See photo	
Field Station#	15457+00		Field Station#	15460+81	
Pic 11 Desc.	No evidence of sedimentation from 3rd party disturbance within drainage feature.		Pic 12 Desc.	CWD remains in good condition

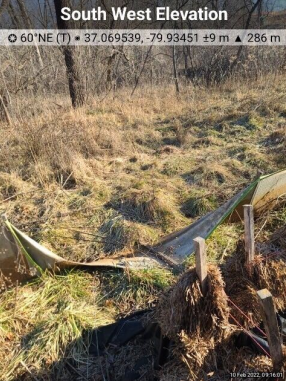
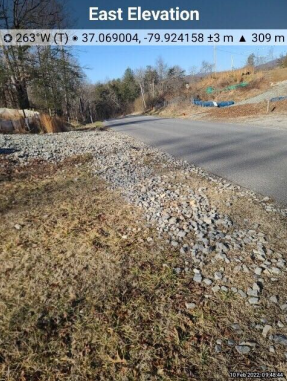
GPS Location	00000	GPS Location	0000		
Field Station#	13780+25	Field Station#	13811+91		
Pic 1 Desc.	P1 requires maintenance due to being weathered and torn, documented and added to the punch list for repair.		Pic 2 Desc.	Rock pushed into a land owners yard during snow plow activities, added to the punch list to have the rock removed.	
	East Elevation

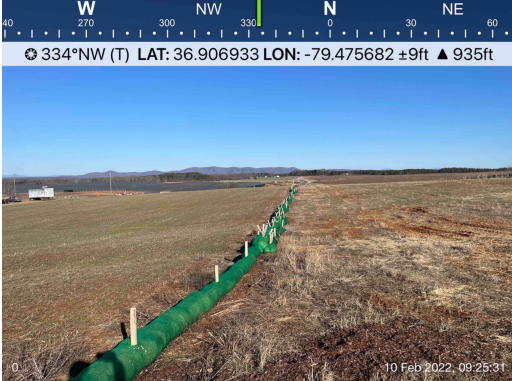
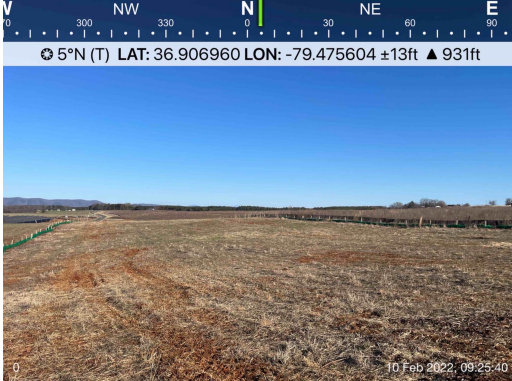
GPS Location	See photo		GPS Location	See photo	
Field Station#	15490+00		Field Station#	15493+00	
Pic 1 Desc.	CFS is in good condition.		Pic 2 Desc.	Vegetation continues to fill in throughout this section.

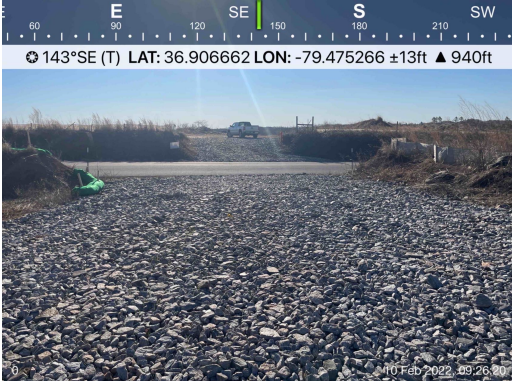
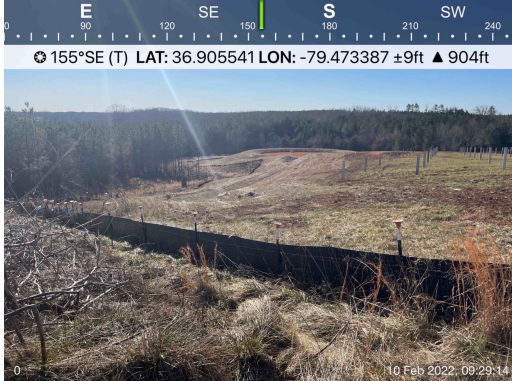
GPS Location	See photo		GPS Location	See photo	
Field Station#	15496+70		Field Station#	15501+00	
Pic 3 Desc.	RCEs are in good condition at all road crossings.		Pic 4 Desc.	No evidence of sedimentation from 3rd party disturbance.

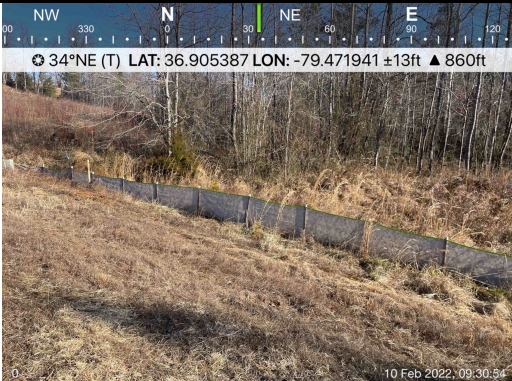
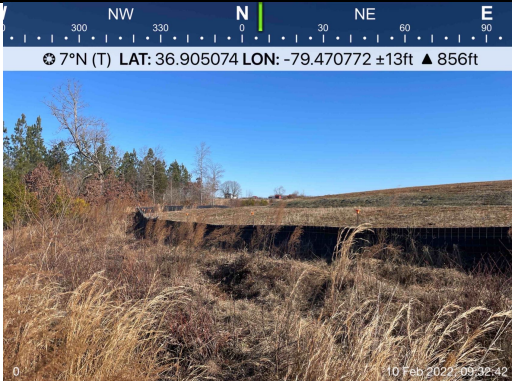
GPS Location	See photo		GPS Location	See photo	
Field Station#	15507+00		Field Station#	15510+00	
Pic 5 Desc.	P1 is in good condition at all stream and wetland buffers.		Pic 6 Desc.	3rd party ECDs appear to be in good condition.

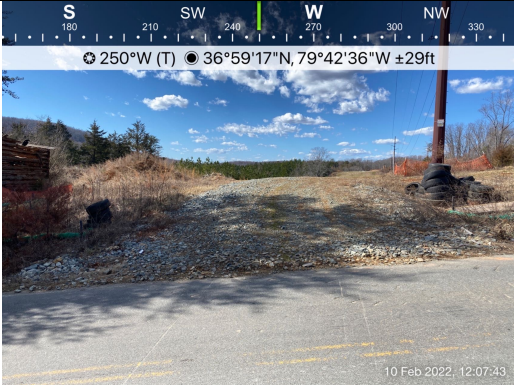
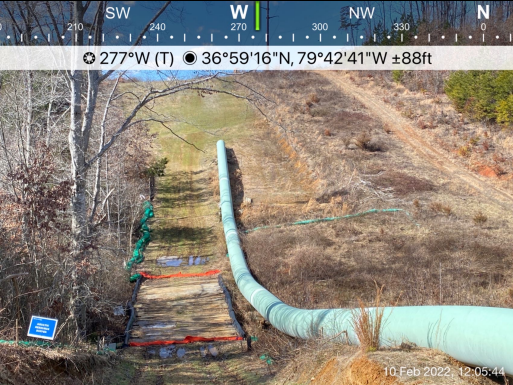
GPS Location	0	GPS Location	0		
Field Station#	14694+50	Field Station#	14689+36		
Pic 1 Desc.	Approximately 14694+50. Overview of road crossing and RCE.		Pic 2 Desc.	Approximately 14689+36. Overview of stream crossing, equipment bridge and ECDs at stream S-H34.

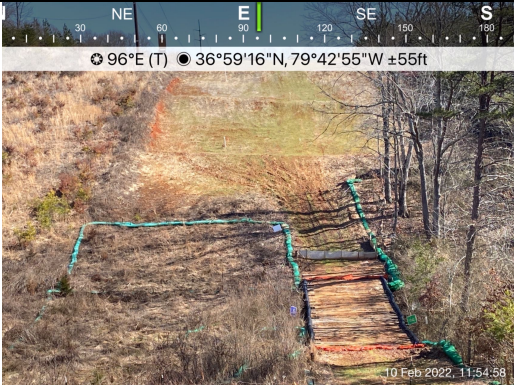
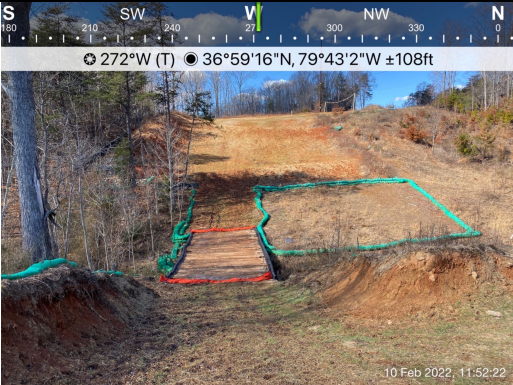
GPS Location	0	GPS Location	0		
Field Station#	14680+30	Field Station#	14673+10		
Pic 3 Desc.	Approximately 14680+30. Overview of stream crossing, equipment bridge and ECDs at stream S-H36.		Pic 4 Desc.	Approximately 14673+10. Overview of stream crossing, equipment bridge and ECDs at stream S-H37.

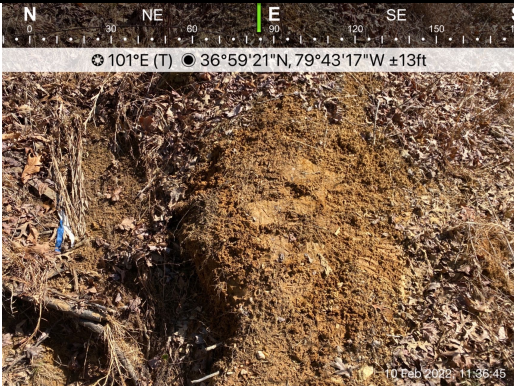
GPS Location	0	GPS Location	0		
Field Station#	14658+75	Field Station#	14654+00		
Pic 5 Desc.	Approximately 14658+75. Maintenance item. Install erosion control blanket on CWD dike and channel.		Pic 6 Desc.	Approximately 14654+00. Overview of ROW.

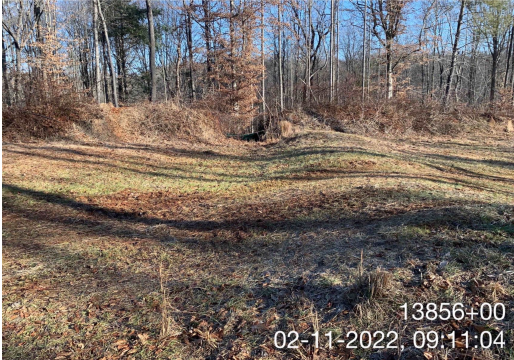
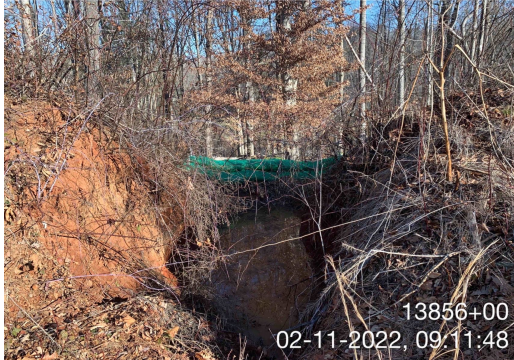
13856+00 02-11-2022, 09:11:48			
GPS Location	0	GPS Location	0		
Field Station#	13856+00	Field Station#	13856+00		
Pic 1 Desc.	Waterbar in acceptable condition	Pic 2 Desc.	Waterbar end treatment in acceptable condition		
244°SW (T) 37°3'27"N, 79°54'54"W ±1925ft ▲1042ft

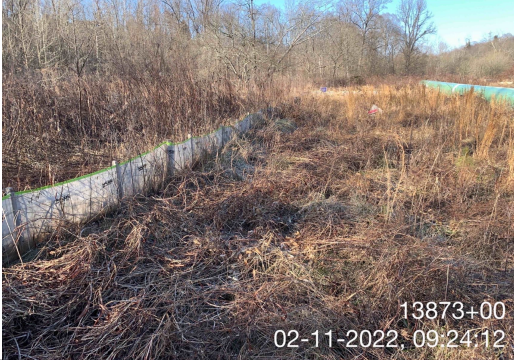
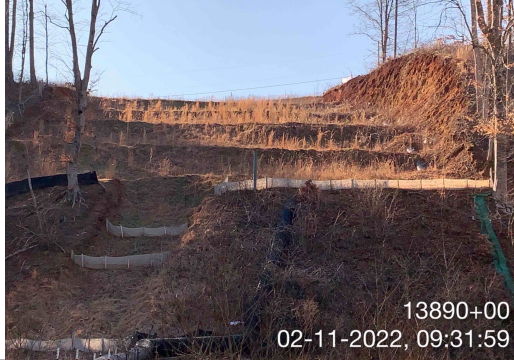
13890+00 02-11-2022, 09:31:59			
GPS Location	0	GPS Location	0		
Field Station#	13873+00	Field Station#	13890+00		
Pic 3 Desc.	P1 silt fence and temporary vegetative stabilization in acceptable conditions	Pic 4 Desc.	Watbars and temporary vegetative stabilization in acceptable conditions		
333°NW (T) 37°3'29"N, 79°55'3"W ±656ft ▲1067ft

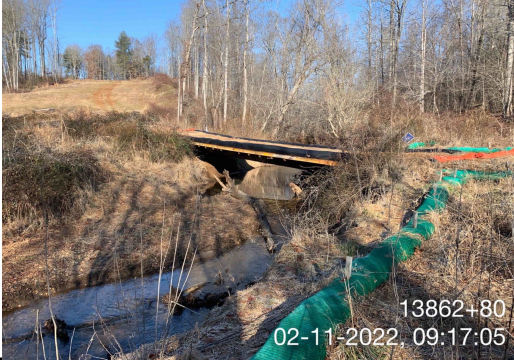
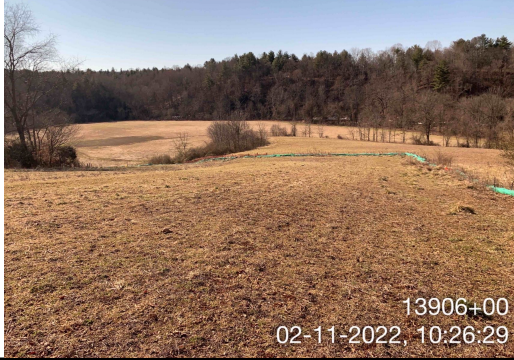
GPS Location	0	GPS Location	0		
Field Station#	13862+80	Field Station#	13906+00		
Pic 5 Desc.	CFS and equipment bridge in acceptable conditions	Pic 6 Desc.	Permanent vegetative stabilization in acceptable condition

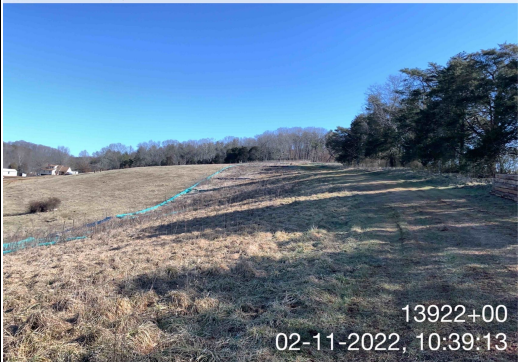
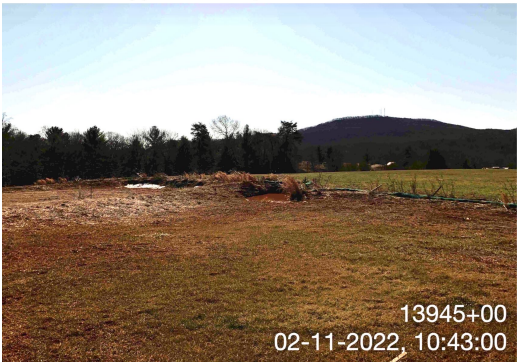
GPS Location	0	GPS Location	0		
Field Station#	13922+00	Field Station#	13945+00		
Pic 7 Desc.	Permanent vegetative stabilization in acceptable condition		Pic 8 Desc.	Waterbar and waterbar end treatment in acceptable conditions	
Insert image here			Insert image here		
GPS Location		GPS Location			
Field Station#		Field Station#			
Pic 9 Desc.			Pic 10 Desc.		
Insert image here			Insert image here		
GPS Location		GPS Location			
Field Station#		Field Station#			
Pic 11 Desc.			Pic 12 Desc.

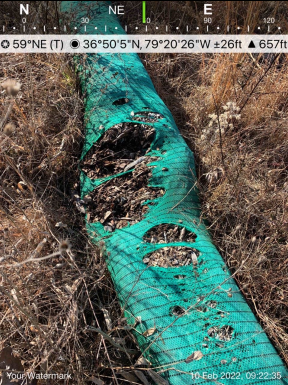
GPS Location	O	GPS Location	O		
Field Station#	00+00	Field Station#	00+00		
Pic 1 Desc.	Observing CFS that requires maintenance		Pic 2 Desc.	Observing lay down yard

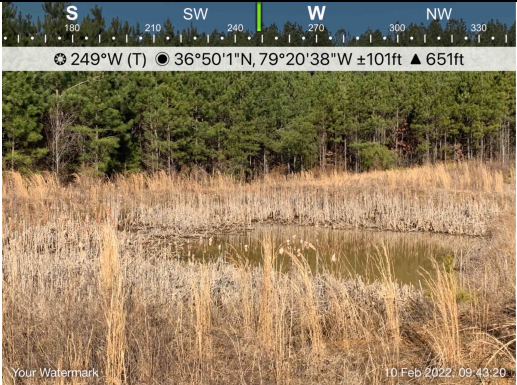
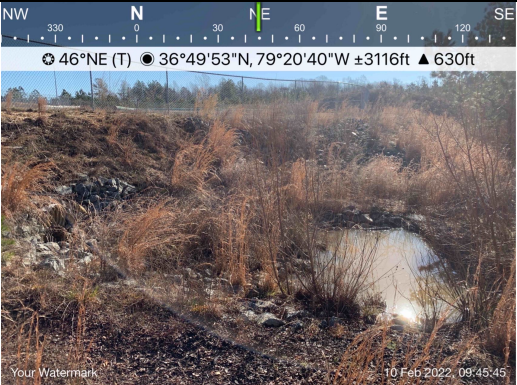
GPS Location	O	GPS Location	O		
Field Station#	00+00	Field Station#	00+00		
Pic 3 Desc.	Observing temporary stabilization and sediment basin		Pic 4 Desc.	Observing emergency overflow at the storm water pond	
Insert image here			Insert image here		
GPS Location		GPS Location			
Field Station#		Field Station#			
Pic 5 Desc.			Pic 6 Desc.
