Visual Site Inspection Report

Project Name	H-600 Pipeline Spread G	AFE	124300137	Spread	H-600 Pipeline Spread G
Contractor	Precision			Report #	35439
Inspector	Chris Burns			Date/Time	3/14/2022 12:04 PM
Permit #	TBD	Inspection Type	VA SWPP	Station Begin	11023+80
State	VA	Inspection Area	Partial	Station End	11098+47
County	Giles	Ground	Wet	Temperature (°F)	60.00
Municipality	N/A	Weather	Sunny	Rain Gauge (in)	0.00
				Rain Accumulation Time (days)	1.00

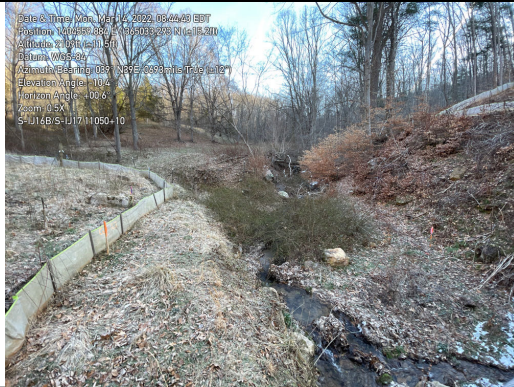
GPS Location	3	GPS Location	4		
Field Station#	11039+00	Field Station#	11050+10		
Pic 3 Desc.	Section of RoW showing conditions and controls.	Pic 4 Desc.	S-IJ16B/S-IJ17.

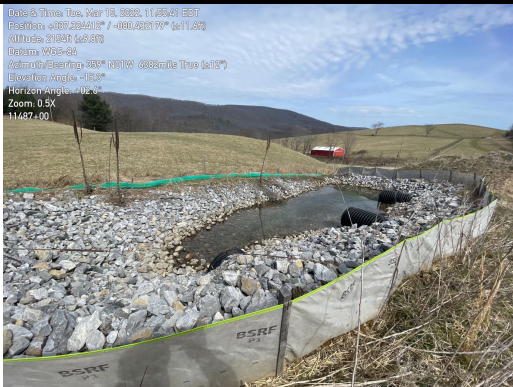
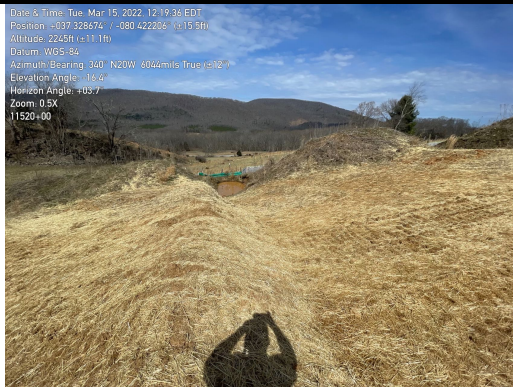
GPS Location		See photo		GPS Location	
Field Station#		11487+00		See photo	
Field Station#		11520+00			
Pic 3 Desc.		Plunge pool and perimeter controls are in acceptable condition		Pic 4 Desc.	
				Water bar and sump pit are in acceptable condition	
<p>Date & Time: Tue Mar 15 2022 11:56:02 EDT Position: +037 224592 / -080 431008 (s10.24) Altitude: 21414 (+11.2ft) Datum: WGS-84 Azimuth/Bearing: 060° N45E 1007mils True (+12°) Elevation Angle: -12.6° Horizon Angle: -00.8° Zoom: 0.5X 11490+00</p>

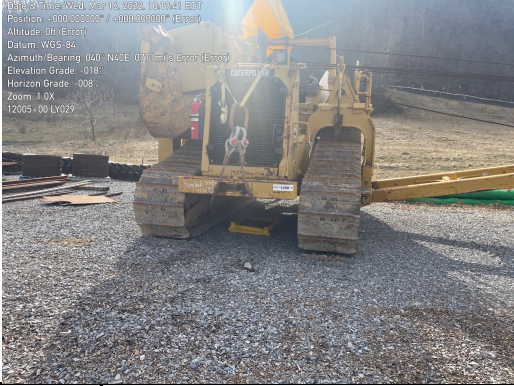
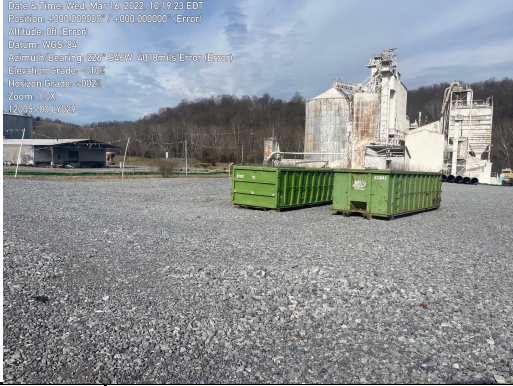
GPS Location	See Photo	GPS Location	See Photo		
Field Station#	12005+00	Field Station#	12005+00		
Pic 1 Desc.	Equipment storage with no spills observed.	Pic 2 Desc.	Debris free areas around trash receptacles.

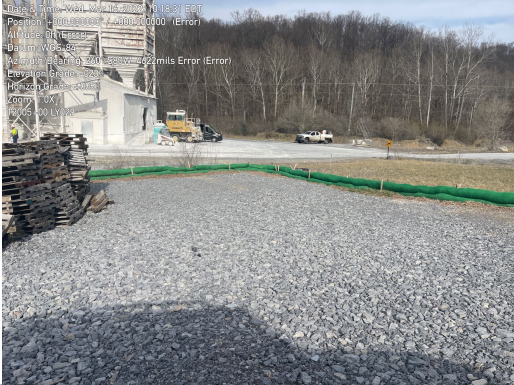
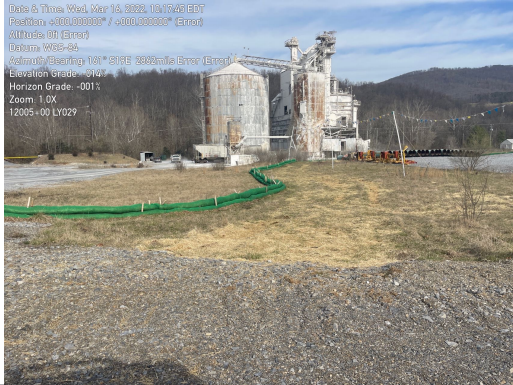
GPS Location	See Photo	GPS Location	See Photo		
Field Station#	12005+00	Field Station#	12005+00		
Pic 3 Desc.	RCE conditions.	Pic 4 Desc.	Previously stabilized disturbances.

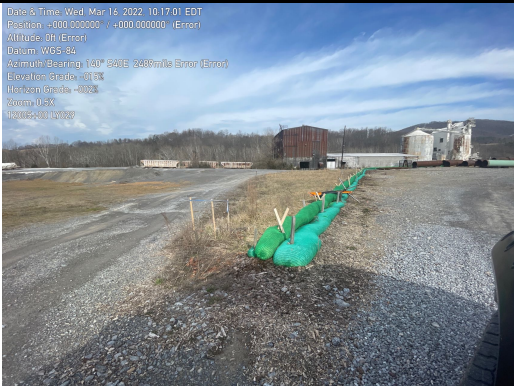
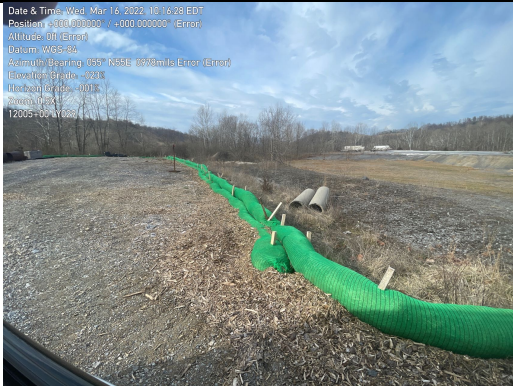
GPS Location	See Photo	GPS Location	See Photo		
Field Station#	12005+00	Field Station#	12005+00		
Pic 5 Desc.	Perimeter CFS	Pic 6 Desc.	Perimeter CFS. Pre-cast culverts not placed by Precision contractor.

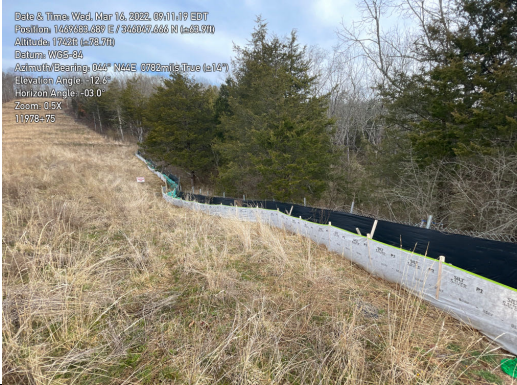
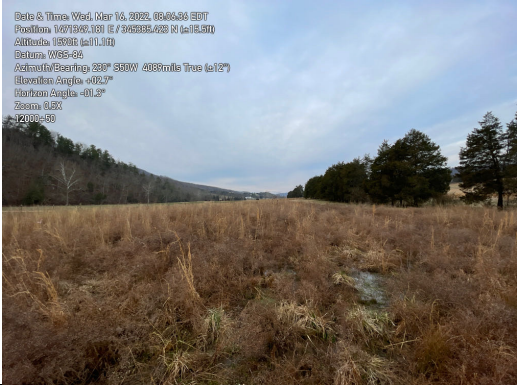
GPS Location	7	GPS Location	8		
Field Station#	11978+75	Field Station#	12000+50		
Pic 7 Desc.	Karst feature protection functional.		Pic 8 Desc.	Section of restored RoW showing conditions and controls.

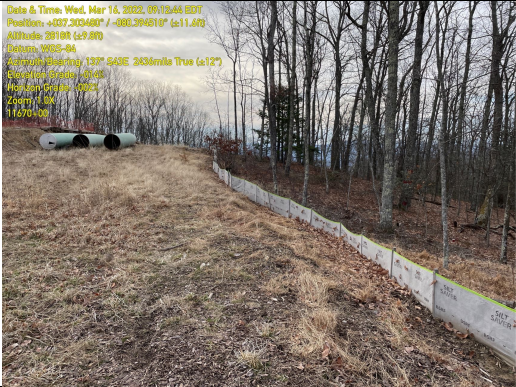
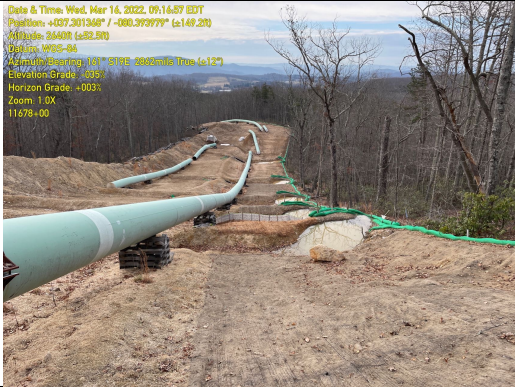
GPS Location	See photo	GPS Location	See photo		
Field Station#	11670+00	Field Station#	11678+00		
Pic 1 Desc.	P1 silt fence perimeter control in place	Pic 2 Desc.	End treatments in place

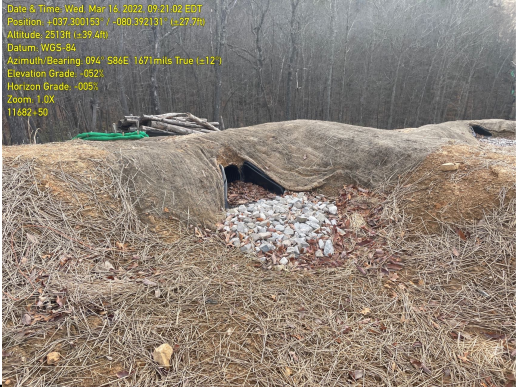
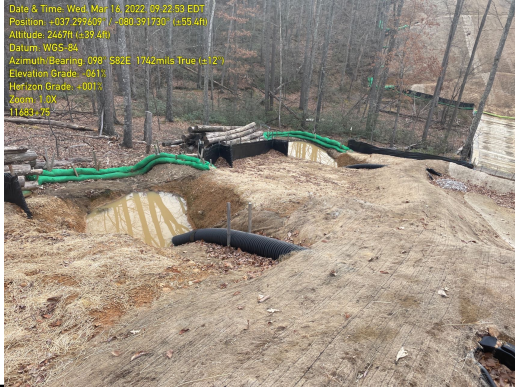
GPS Location	See photo	GPS Location	See photo		
Field Station#	11682+50	Field Station#	11683+75		
Pic 3 Desc.	Stone inlet protection in place	Pic 4 Desc.	Slope drain in place

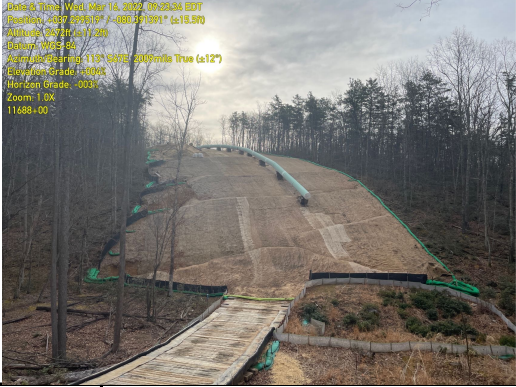
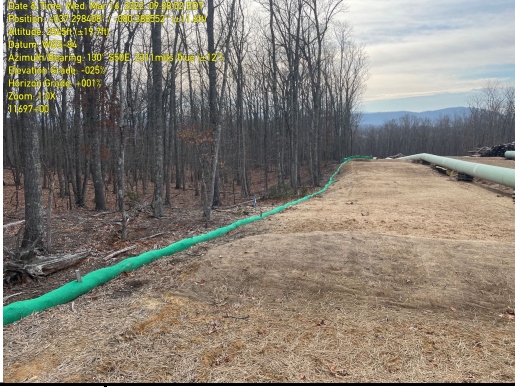
GPS Location	See photo	GPS Location	See photo		
Field Station#	11688+00	Field Station#	11697+00		
Pic 5 Desc.	Erosion control blanket in place	Pic 6 Desc.	CFS perimeter control in place

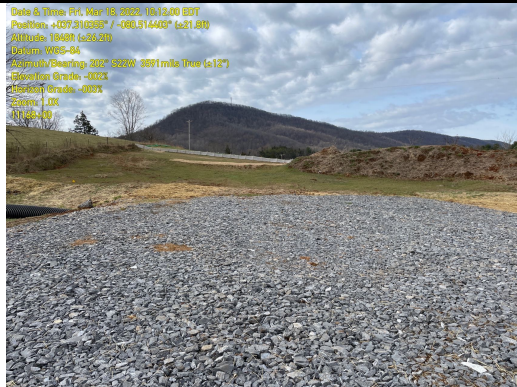
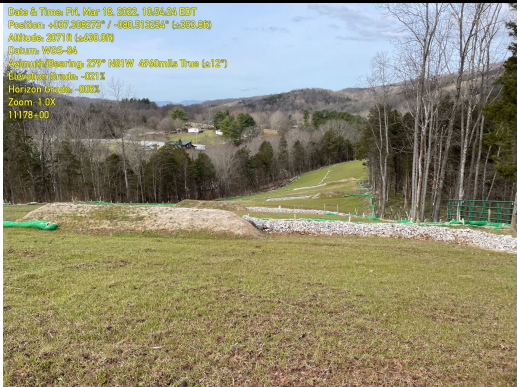
GPS Location	See photo	GPS Location	See photo		
Field Station#	11168+00	Field Station#	11178+00		
Pic 11 Desc.	RCE in place	Pic 12 Desc.	Level spreader in place
