Visual Site Inspection Report

Project Name	H-600 Pipeline Spread G	AFE	124300137	Spread	H-600 Pipeline Spread G
Contractor	Precision			Report #	35666
Inspector	Clint Sears			Date/Time	3/21/2022 10:31 AM
Permit #	TBD	Inspection Type	VA SWPP	Station Begin	11471+56
State	VA	Inspection Area	Partial	Station End	11524+16
County	Giles	Ground	Damp	Temperature (°F)	50.00
Municipality	N/A	Weather	Sunny	Rain Gauge (in)	0.00
				Rain Accumulation Time (days)	1.00

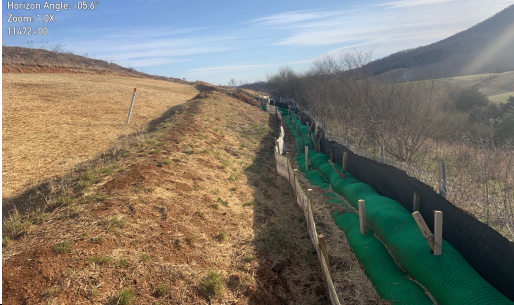
GPS Location	See photo	GPS Location	see photo		
Field Station#	11472+00	Field Station#	11475+00		
Pic 1 Desc.	Karst ECD's are in acceptable condition	Pic 2 Desc.	Section of Row showing conditions and controls		
<p>Date & Time: Mon, Mar 21, 2022 09:15:09 EDT Position: +037.22679° / -080.52822° (±0.3m) Altitude: 2183ft (±6.2ft) Datum: WGS 84 Azimuth/Bearing: 058 N58E 102mils True (±16.1) Elevation Angle: -14.8 Horizon Angle: -02.5 Zoom: 1.0X 11487+24</p>

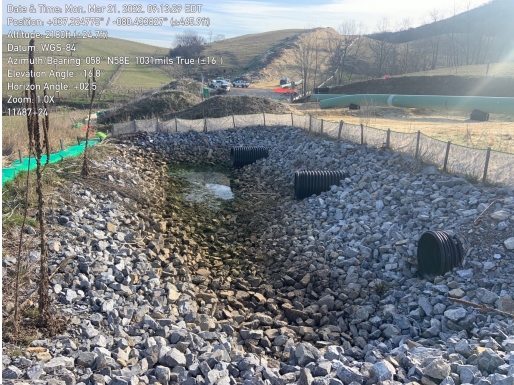
GPS Location	See photo	GPS Location	See photo		
Field Station#	11487+24	Field Station#	11488+75		
Pic 3 Desc.	Plunge pool is in acceptable condition	Pic 4 Desc.	Section of Row showing conditions and controls		
<p>Date & Time: Mon, Mar 21, 2022 09:18:35 EDT Position: +037.22628° / -080.42251° (±15.4ft) Altitude: 2235ft (±11.2ft) Datum: WGS 84 Azimuth/Bearing: 051 N51E 300mils True (±16.1) Elevation Grade: -020.1 Horizon Grade: -004.1 Zoom: 1.0X 11518+00</p>

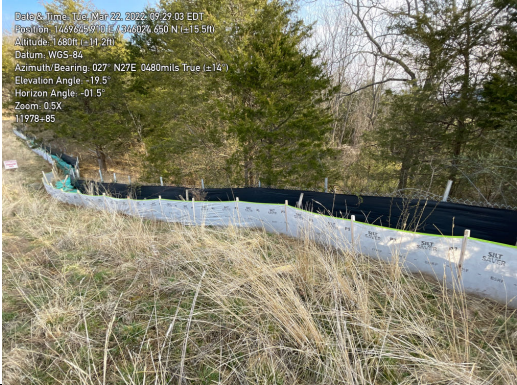
GPS Location	7	GPS Location	8		
Field Station#	11962+25	Field Station#	11978+85		
Pic 7 Desc.	P-1 perimeter controls functional.		Pic 8 Desc.	Karst feature protection functional.

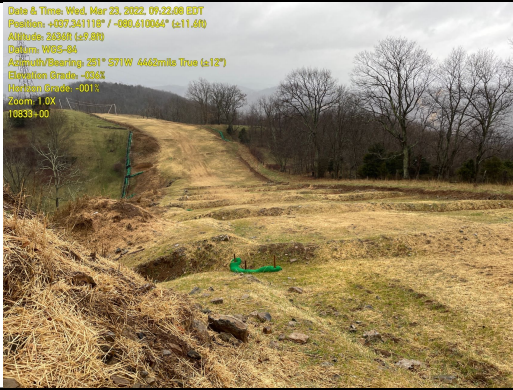
GPS Location	See photo	GPS Location	See photo		
Field Station#	10830+50	Field Station#	10833+00		
Pic 5 Desc.	Triple protection ECDs in place at karst feature	Pic 6 Desc.	Waterbars in place

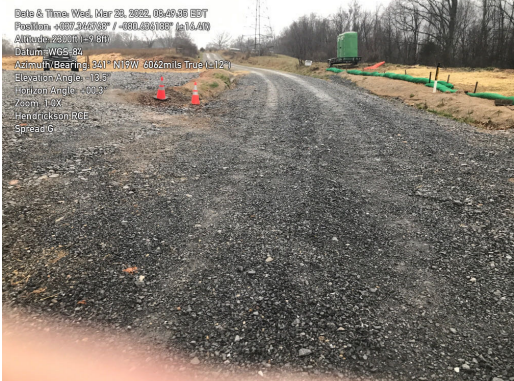
GPS Location	See photo		GPS Location	see photo	
Field Station#	10749+92		Field Station#	10733+00	
Pic 1 Desc.	Hendrickson RCE.		Pic 2 Desc.	Sump that was cleaned out

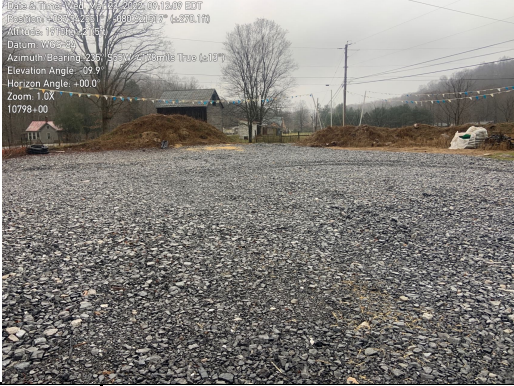
GPS Location	See photo	GPS Location	See photo		
Field Station#	10798+99	Field Station#	10797+00		
Pic 1 Desc.	RCE is maintained and in acceptable condition	Pic 2 Desc.	Temporary vegetation and stabilization are in acceptable condition		
<p>Date & Time: Wed Mar 23, 2022 09:58:40 EDT Position: +037 343113 / -080 623567 (+46.1ft) Altitude: 1965ft (+48.0ft) Datum: WGS-84 Azimuth Bearing: 138° S42E 2453mits True (±13) Elevation Angle: -15.8 Horizon Angle: -01.6 Zoom: 1.0X 10790+75</p>

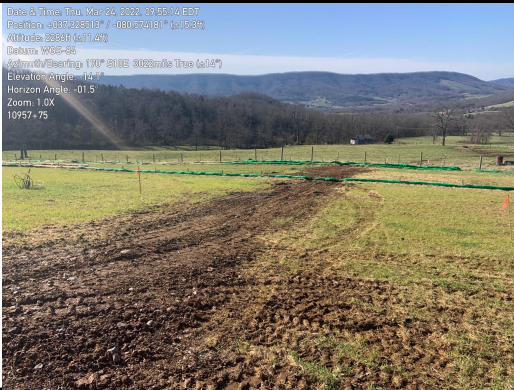
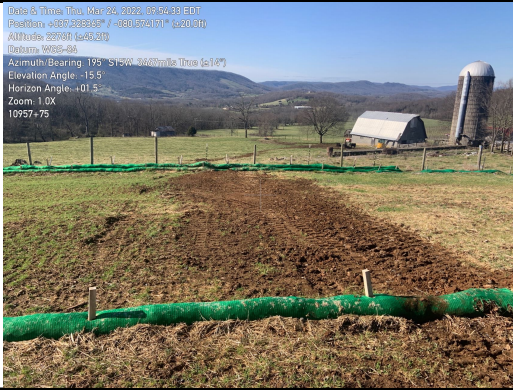
GPS Location	See photo	GPS Location	See photo		
Field Station#	10957+75	Field Station#	10957+75		
Pic 5 Desc.	Ground disturbance where land owner installed water line	Pic 6 Desc.	Disturbed are of ROW caused by land owner during installation of water line

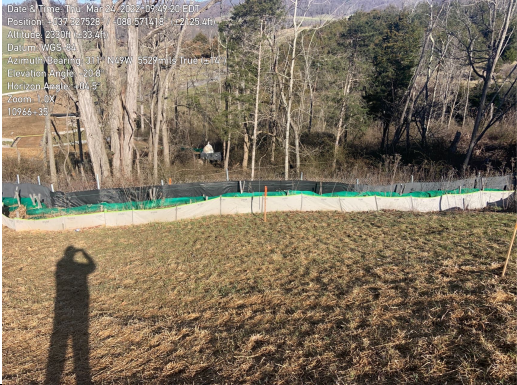
<p>Date & Time: Thu, Mar 24, 2022 10:58:01 EDT Position: +037 326649 -080 568339 (±27.3ft) Altitude: 2366ft (±35.3ft) Datum: WGS-84 Azimuth: Bearing: 113° S67E 2009/mils True (±13°) Elevation Angle: -03°5' Horizon Angle: -03°5' Zoom: 1.0X 10974-05</p>

GPS Location	See photo	GPS Location	See photo		
Field Station#	10966+35	Field Station#	10976+05		
Pic 7 Desc.	Karst ECD's are in acceptable condition	Pic 8 Desc.	Section of Row showing conditions and controls		
<p>Date & Time: Thu, Mar 24, 2022 10:57:55 EDT Position: +037 326649 -080 568339 (±27.3ft) Altitude: 2366ft (±35.3ft) Datum: WGS-84 Azimuth: Bearing: 015° N15E 0267/mils True (±12°) Elevation Angle: -02°8' Horizon Angle: -00°0' Zoom: 1.0X 10985-68</p>
