Visual Site Inspection Report

Project Name	H-600 Pipeline Spread G	AFE	124300137	Spread	H-600 Pipeline Spread G
Contractor	Precision			Report #	35927
Inspector	Clint Sears			Date/Time	3/28/2022 10:47 AM
Permit #	TBD	Inspection Type	VA SWPP	Station Begin	11788+52
State	VA	Inspection Area	Partial	Station End	11899+89
County	Montgomery	Ground	Frozen	Temperature (°F)	33.00
Municipality	N/A	Weather	Sunny	Rain Gauge (in)	0.00
				Rain Accumulation Time (days)	1.00

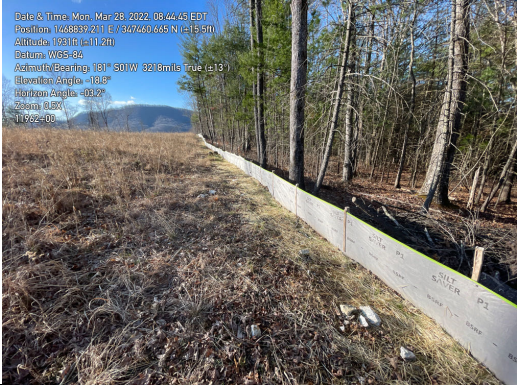
GPS Location	7	GPS Location	8		
Field Station#	11962+00	Field Station#	11978+85		
Pic 7 Desc.	P-1 perimeter controls functional.		Pic 8 Desc.	Karst feature protection functional.

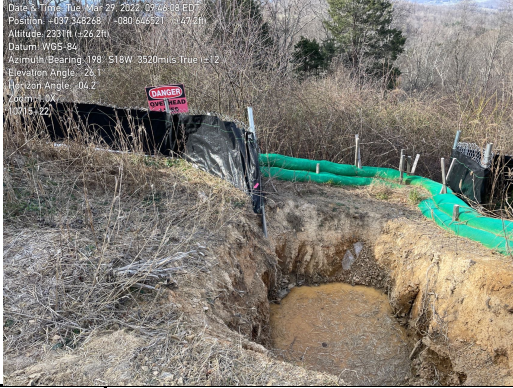
<p>Date & Time: Tue, Mar 29, 2022 07:28:00 EDT Position: +037 342469 / -080 653754 (+19.4ft) Altitude: 2261ft (+26.2ft) Datum: WGS-84 Azimuth: Bearing: 198 S18W 3520mils True (+12) Elevation Angle: -26.1 Horizon Angle: -04.2 Zoom: 1.0X 10715+22</p>			
GPS Location	See photo	GPS Location	See photo		
Field Station#	10712+83	Field Station#	10715+22		
Pic 1 Desc.	Resource buffers in place	Pic 2 Desc.	SSF falling in sump needs repaired

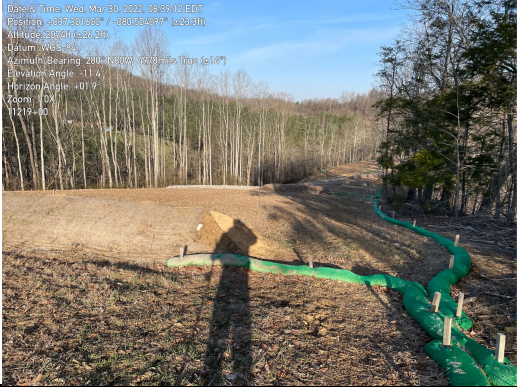
GPS Location	See photo	GPS Location	See photo		
Field Station#	11219+00	Field Station#	11227+00		
Pic 7 Desc.	Permanent water bars and level spreader in place	Pic 8 Desc.	RCE functional		
Insert image here		Insert image here			
GPS Location		GPS Location			
Field Station#		Field Station#			
Pic 9 Desc.		Pic 10 Desc.			
Insert image here		Insert image here			
GPS Location		GPS Location			
Field Station#		Field Station#			
Pic 11 Desc.		Pic 12 Desc.

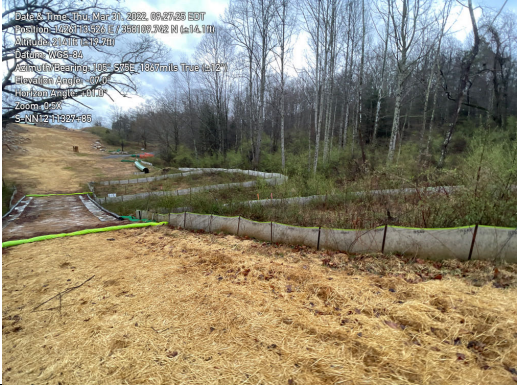
GPS Location	7	GPS Location	8		
Field Station#	11327+85	Field Station#	11347+50		
Pic 7 Desc.	Overview of S-NN12.	Pic 8 Desc.	P-1 perimeter controls functional.

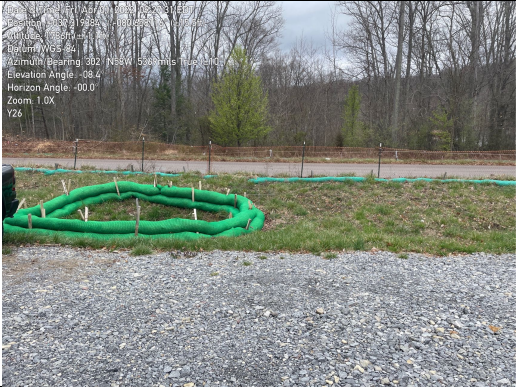
GPS Location	See photo	GPS Location	See photo		
Field Station#	12005+00	Field Station#	12005+00		
Pic 1 Desc.	CFS in place Y26	Pic 2 Desc.	Housekeeping in good condition y26

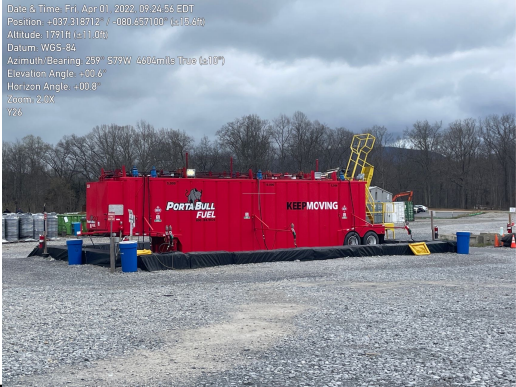
GPS Location	See photo	GPS Location	See photo		
Field Station#	12005+00	Field Station#	12005+00		
Pic 3 Desc.	Secondary containment in place y26	Pic 4 Desc.	Secondary containment in place y26

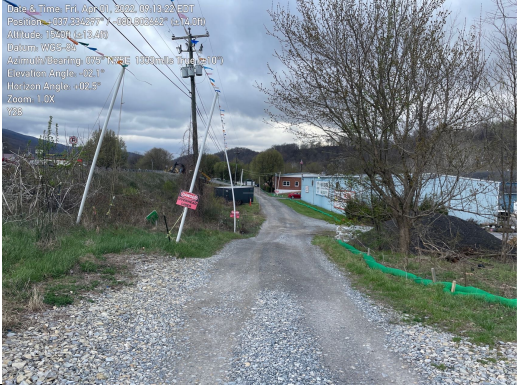
GPS Location	See photo	GPS Location	See photo		
Field Station#	12005+00	Field Station#	12005+00		
Pic 7 Desc.	Permanent stabilization in place y28	Pic 8 Desc.	Housekeeping in good condition y28

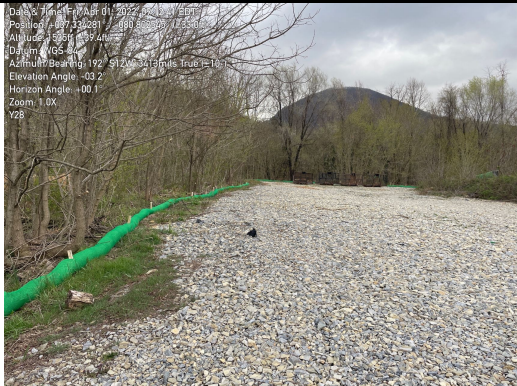
GPS Location	See photo	GPS Location	See photo		
Field Station#	12005+00	Field Station#	12005+00		
Pic 9 Desc.	CFS perimeter controls functional y28	Pic 10 Desc.	RCE functional y28

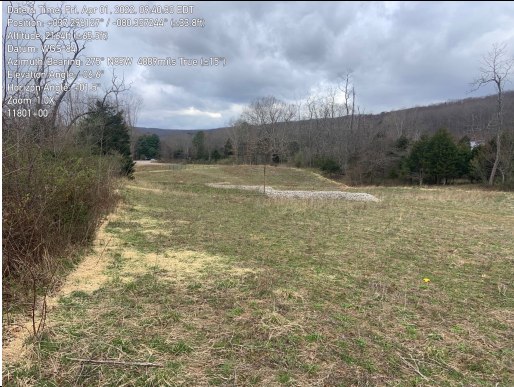
GPS Location	See photo		GPS Location	See photo	
Field Station#	11801+00		Field Station#	11821+00	
Pic 1 Desc.	Representational photo of water bar and level spreader		Pic 2 Desc.	Section of Row showing permanent vegetation and temporary vegetation.
