Visual Site Inspection Report

Project Name	H-600 Pipeline Spread G	AFE	124300137	Spread	H-600 Pipeline Spread G
Contractor	Precision			Report #	35184
Inspector	Patrick Shields			Date/Time	3/7/2022 11:29 AM
Permit #	TBD	Inspection Type	VA SWPP	Station Begin	10798+92
State	VA	Inspection Area	Full	Station End	10859+46
County	Giles	Ground	Dry	Temperature (°F)	68.00
Municipality	N/A	Weather	Sunny	Rain Gauge (in)	0.00
				Rain Accumulation Time (days)	1.00

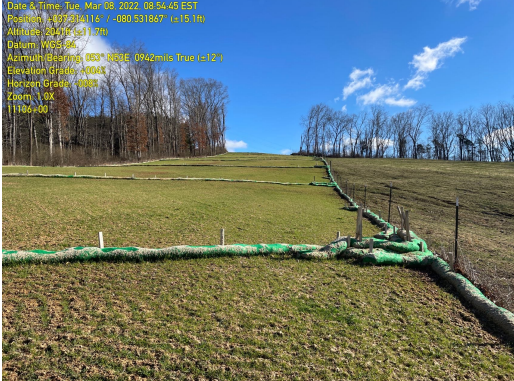
GPS Location	See photo		GPS Location	See photo	
Field Station#	11106+00		Field Station#	11112+00	
Pic 1 Desc.	CFS end treatments in place		Pic 2 Desc.	CFS triple stack perimeter control in place

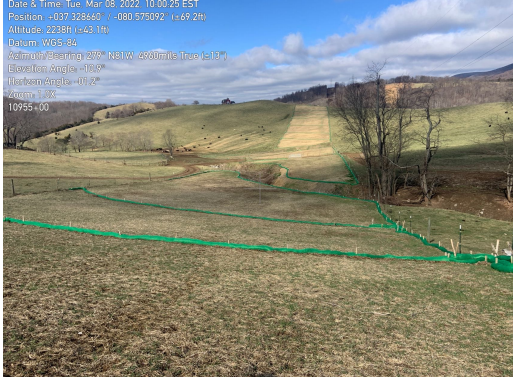
GPS Location				See photo							
Field Station#				10955+00							
Pic 1 Desc.				Permanently restored Row with CFS water bars							
<p>Date & Time: Tue Mar 08 2022 09:56:29 EST Position: +037.328145° / -080.572949° (+25.5ft) Altitude: 2275ft (+66.1ft) Datum: WGS-84 Azimuth/Bearing: 281° N79°W 499mils True (±13°) Elevation Angle: -02.5° Horizon Angle: -00.7° Zoom: 1.0x 10961+00</p>

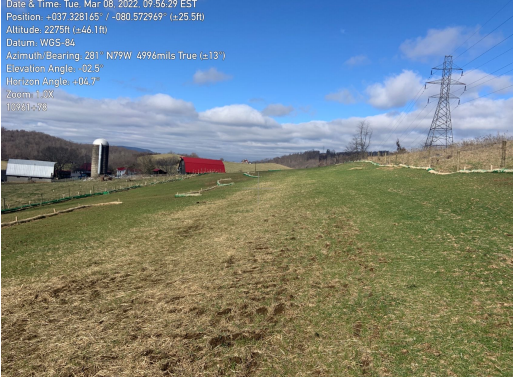
GPS Location				See photo							
Field Station#				10961+78							
Pic 2 Desc.				Section of Row showing conditions and controls							
<p>Date & Time: Tue Mar 08 2022 09:57:01 EST Position: +037.328333° / -080.575100° (+67.4ft) Altitude: 2280ft (+63.3ft) Datum: WGS-84 Azimuth/Bearing: 285° N51°W 510mils True (±13°) Elevation Angle: -06.7° Horizon Angle: -00.3° Zoom: 1.0x 10966+30</p>

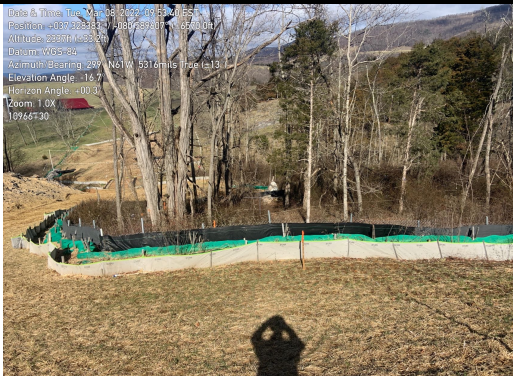
GPS Location				see photo							
Field Station#				10966+30							
Pic 3 Desc.				Karst ECD's are in acceptable condition							
<p>Date & Time: Tue Mar 08 2022 09:57:01 EST Position: +037.328333° / -080.575100° (+67.4ft) Altitude: 2280ft (+63.3ft) Datum: WGS-84 Azimuth/Bearing: 285° N51°W 510mils True (±13°) Elevation Angle: -06.7° Horizon Angle: -00.3° Zoom: 1.0x 10969+00</p>

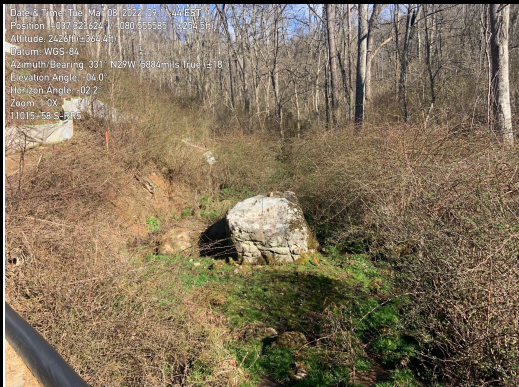
GPS Location	See photo		GPS Location	See photo	
Field Station#	11015+58		Field Station#	10987+51	
Pic 7 Desc.	S-RR5		Pic 8 Desc.	Conditions and controls at S-E25

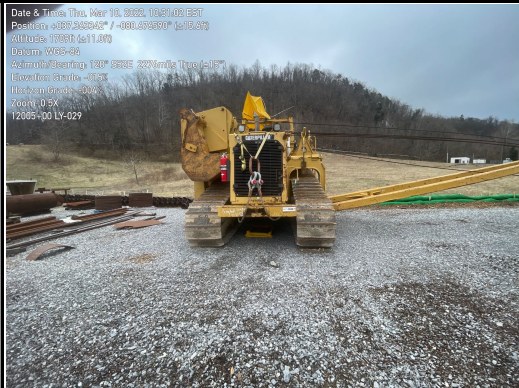
GPS Location	See Photo		GPS Location	See Photo	
Field Station#	12005+00		Field Station#	12005+00	
Pic 15 Desc.	Additional stabilization		Pic 16 Desc.	Equipment location. No issues or spills.

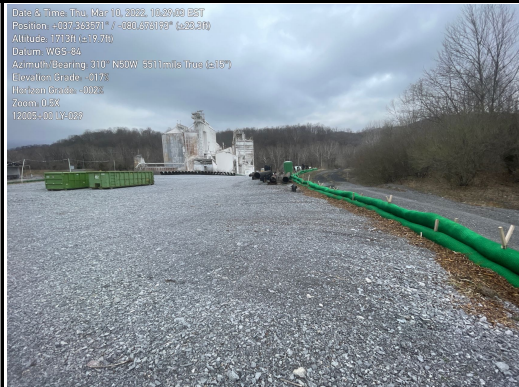
GPS Location	See Photo		GPS Location	See Photo	
Field Station#	12005+00		Field Station#	12005+00	
Pic 17 Desc.	Perimeter CFS conditions		Pic 18 Desc.	RCE and trash receptacles. No Issues.

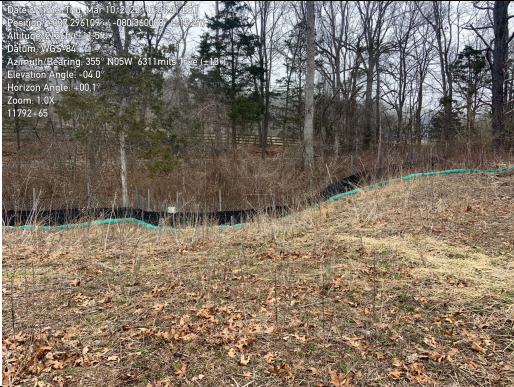
GPS Location	See photo	GPS Location	See photo		
Field Station#	11792+65	Field Station#	11798+00		
Pic 1 Desc.	ECD's are in acceptable condition	Pic 2 Desc.	Section of Row showing conditions and controls

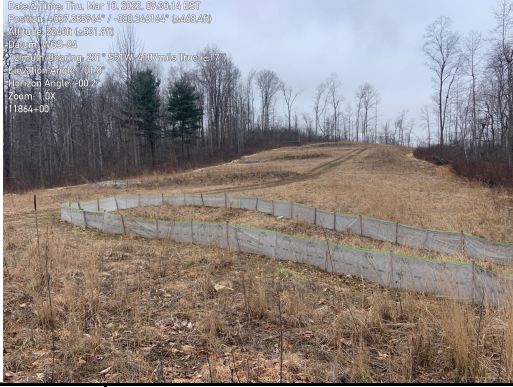
GPS Location	See photo	GPS Location	See photo		
Field Station#	11753+00	Field Station#	11864+00		
Pic 5 Desc.	Section of Row showing conditions and controls	Pic 6 Desc.	ECD's are in place at P-K12

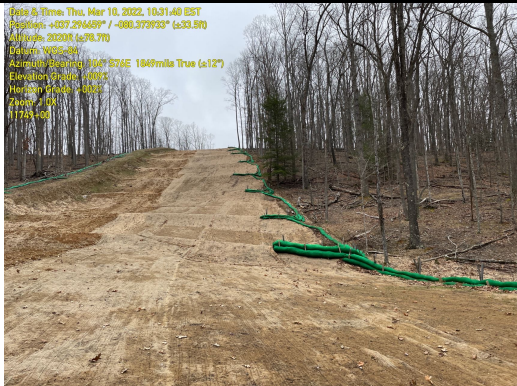
GPS Location	See photo		GPS Location	See photo	
Field Station#	11749+00		Field Station#	11758+00	
Pic 9 Desc.	End treatments in place		Pic 10 Desc.	Supersilt fence perimeter control in place
