Visual Site Inspection Report

Project Name	H-600 Pipeline Spread H	AFE	124300138	Spread	H-600 Pipeline Spread H
Contractor	Precision			Report #	35694
Inspector	Norm Kitchen			Date/Time	3/21/2022 3:30 PM
Permit #	TBD	Inspection Type	VA SWPP	Station Begin	12119+17
State	VA	Inspection Area	Partial	Station End	12284+75
County	Montgomery	Ground	Dry	Temperature (°F)	65.00
Municipality	N/A	Weather	Sunny	Rain Gauge (in)	0.00
				Rain Accumulation Time (days)	1.00

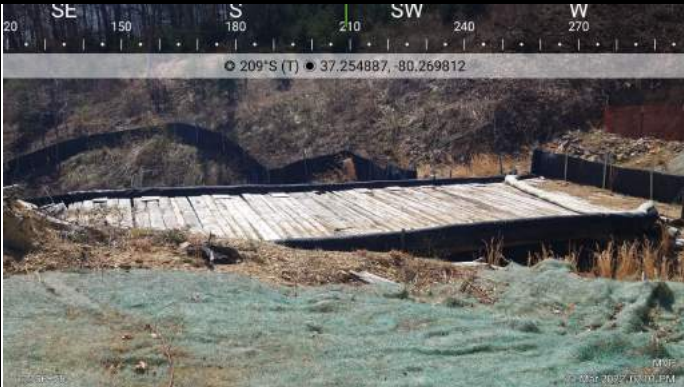
GPS Location	See Above		GPS Location	See Above	
Field Station#	12156+75		Field Station#	12158+50	
Pic 7 Desc.	ROW Overview. ECDs functional and in good condition and ROW is stable.		Pic 8 Desc.	ROW Overview. ECDs functional and in good condition and ROW is stable.

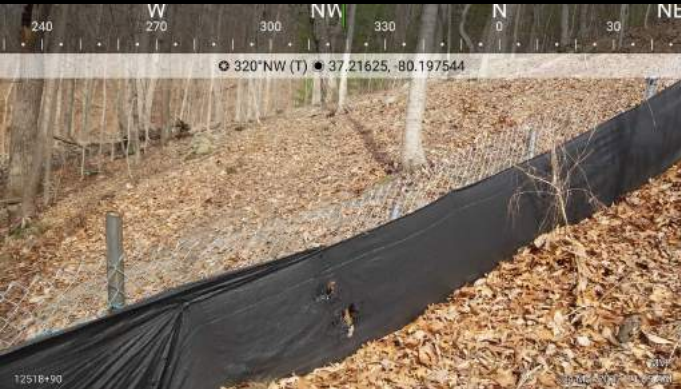
GPS Location	See Above		GPS Location	See Above	
Field Station#	12518+90		Field Station#	12519+00	
Pic 13 Desc.	Punchlist Item: Repair Super Silt Fence Fabric		Pic 14 Desc.	Punchlist Item: Repair Super Silt Fence Fabric

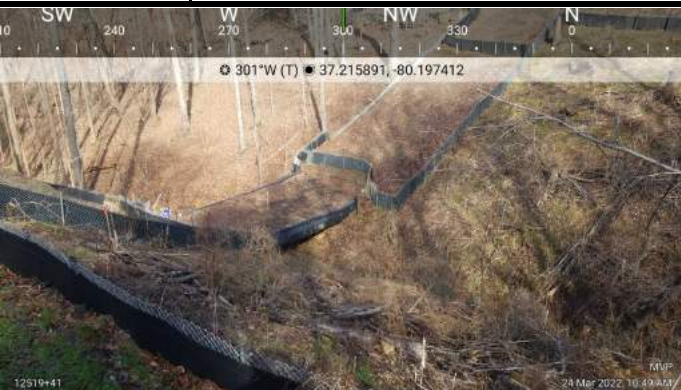
GPS Location	See Above		GPS Location	See Above	
Field Station#	12519+41		Field Station#	12530+00	
Pic 15 Desc.	Overview of Waterbody S-EF19. ECDs are functional and ROW is stable.		Pic 16 Desc.	ROW Overview (temporary stabilization). ECDs are functional and ROW is stable.

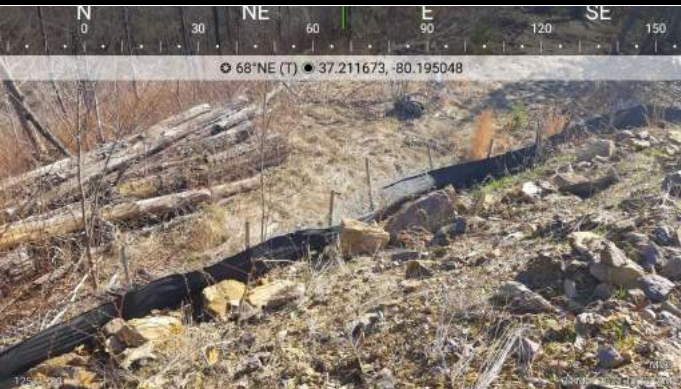
GPS Location	See Above		GPS Location	See Above	
Field Station#	12541+00		Field Station#	12544+06	
Pic 17 Desc.	Punchlist Item: Repair Super Silt Fence Fabric		Pic 18 Desc.	ECDs are functional and Access road MN-278.01 (Yellow Finch Road) area is stable.

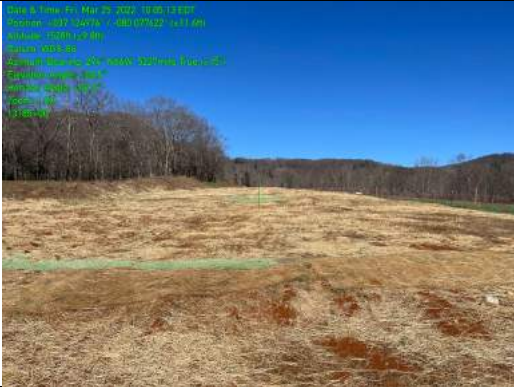
GPS Location	0	GPS Location	0		
Field Station#	13185+00	Field Station#	13175+00		
Pic 1 Desc.	ROW and ECDs In good condition and stable	Pic 2 Desc.	Sump pit in good condition

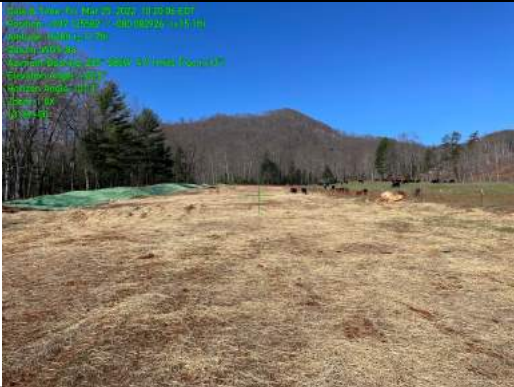
GPS Location	0	GPS Location	0		
Field Station#	13169+00	Field Station#	13169+00		
Pic 3 Desc.	ROW and ECDs In good condition and stable	Pic 4 Desc.	ROW and ECDs In good condition and stable

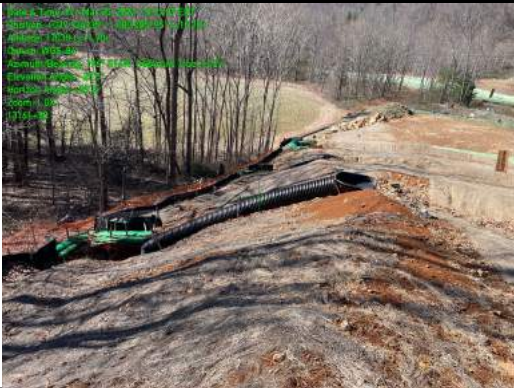
GPS Location	0	GPS Location	0		
Field Station#	13161+50	Field Station#	13159+50		
Pic 5 Desc.	Slope drain pipe in good condition and functioning properly	Pic 6 Desc.	ROW and ECDs In good condition and stable

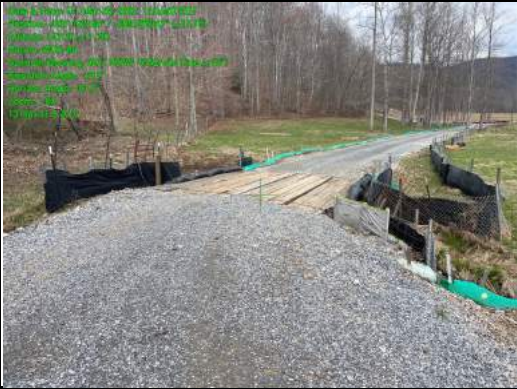
GPS Location	0		GPS Location	0	
Field Station#	13196+31		Field Station#	13262+62	
Pic 13 Desc.	MVP-S-D10 and corresponding buffer zone in good condition		Pic 14 Desc.	Flanders Road Crossing in good condition

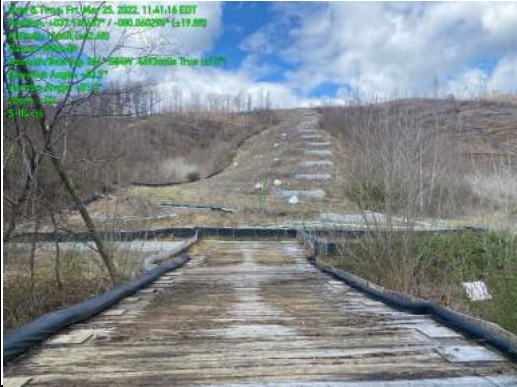
GPS Location	0		GPS Location	0	
Field Station#	13260+66		Field Station#	13309+09	
Pic 15 Desc.	MVP-S-II4 and corresponding buffer zone in good condition		Pic 16 Desc.	MVP-S-GH7 and corresponding buffer zone in good condition

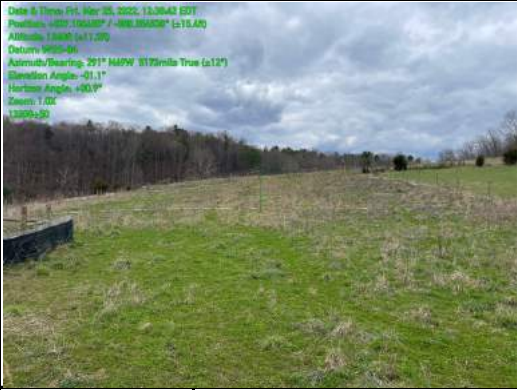
GPS Location	0		GPS Location	0	
Field Station#	13308+50		Field Station#	13314+00	
Pic 17 Desc.	ROW and ECDs In good condition and stable		Pic 18 Desc.	ROW and ECDs In good condition and stable
