Visual Site Inspection Report

Project Name	H-600 Pipeline Spread H	AFE	124300138	Spread	H-600 Pipeline Spread H
Contractor	Precision			Report #	35942
Inspector	Jordan Davis			Date/Time	3/28/2022 3:15 PM
Permit #	TBD	Inspection Type	VA SWPP	Station Begin	12005+00
State	VA	Inspection Area	Partial	Station End	12119+17
County	Montgomery	Ground	Damp	Temperature (°F)	45.00
Municipality	N/A	Weather	Sunny	Rain Gauge (in)	0.00
				Rain Accumulation Time (days)	0.00

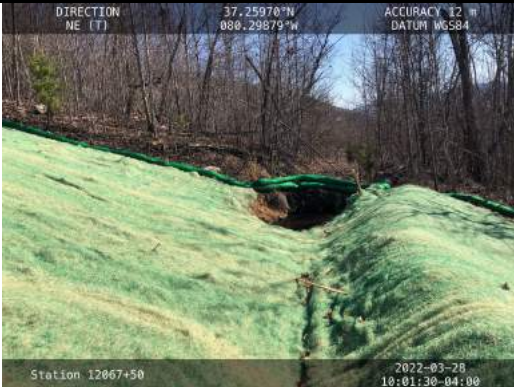
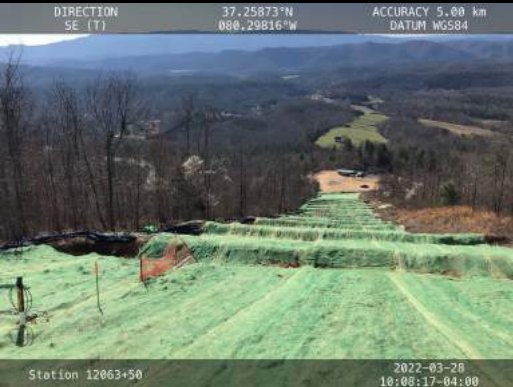
GPS Location	Please see photo for details.		GPS Location	Please see photo for details.	
Field Station#	12067+50		Field Station#	12063+50	
Pic 1 Desc.	Photo shows stabilized ROW, water bar, sump and end treatment functioning as designed.		Pic 2 Desc.	Photo shows stabilized ROW, water bar, sump and end treatment functioning as designed.

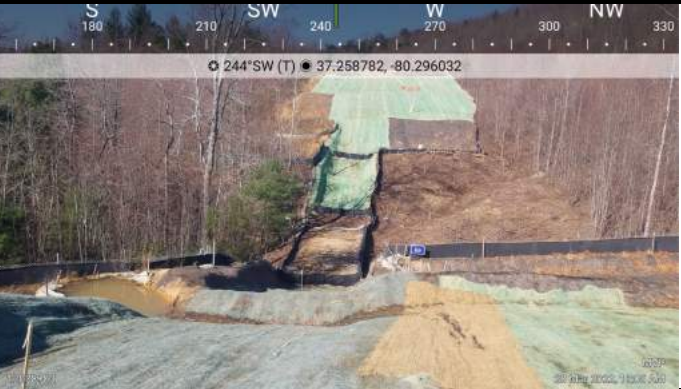
GPS Location	Please see photo for details.		GPS Location	Please see photo for details.	
Field Station#	12073+00		Field Station#	1207+80	
Pic 13 Desc.	Photo shows stabilized ROW conditions and installed ECDs functioning as designed.		Pic 14 Desc.	Photo shows stabilized ROW conditions with water bar, sump and end treatment functioning as designed.

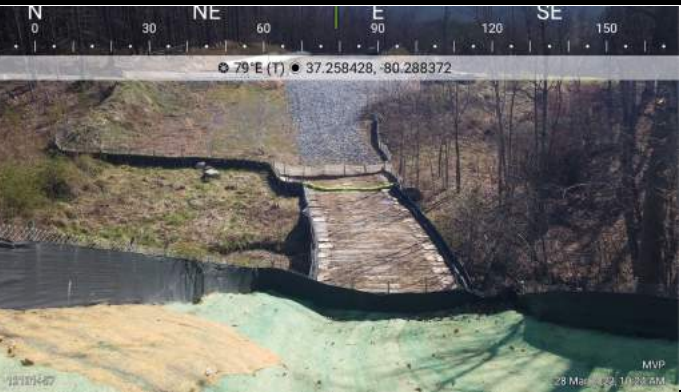
GPS Location	Please see photo for details.		GPS Location	Please see photo for details.	
Field Station#	12098+44		Field Station#	12101+57	
Pic 15 Desc.	Photo shows view of Stream S-MM13 and its buffer zone.		Pic 16 Desc.	Photo shows view of Stream S-MM11 and its buffer zone.

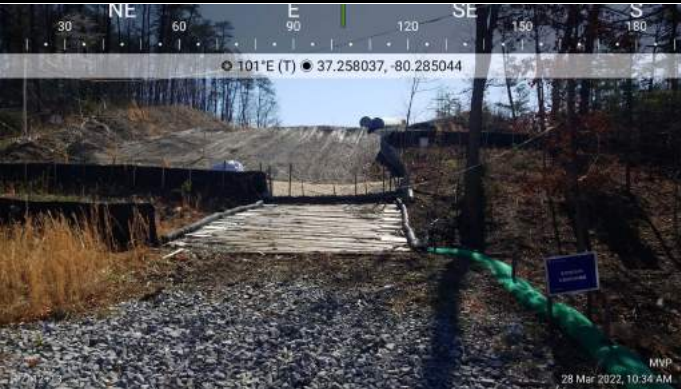
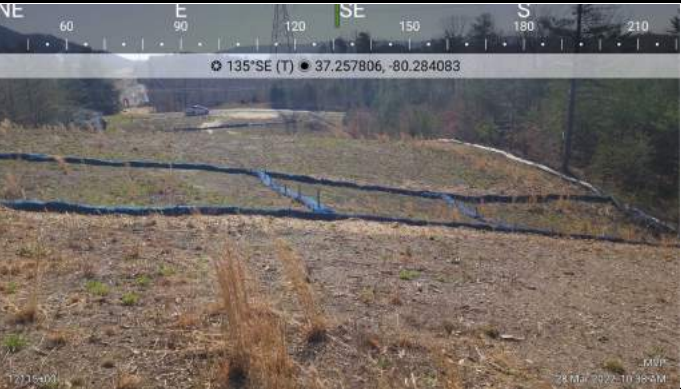
GPS Location	Please see photo for details.		GPS Location	Please see photo for details.	
Field Station#	12112+13		Field Station#	12115+00	
Pic 17 Desc.	Photo shows RCE, coming in the of Stream S-F16A/B and it's buffer zone.		Pic 18 Desc.	Photo shows stabilized ROW conditions with installed ECDs functioning as designed.

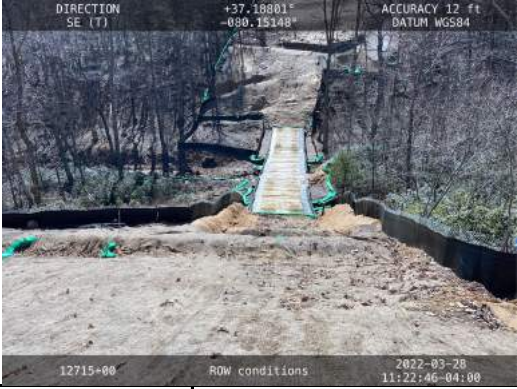
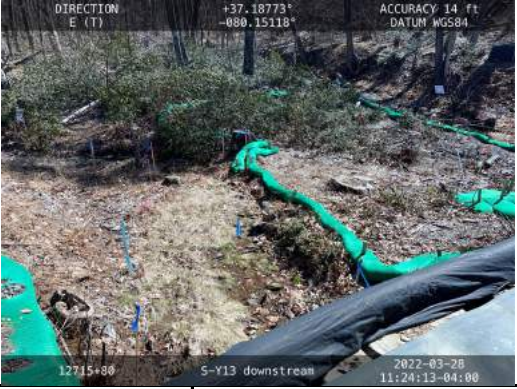
GPS Location	See photo for gps location data.		GPS Location	See photo for gps location data.	
Field Station#	12715+00		Field Station#	12715+80	
Pic 13 Desc.	Photo shows the ROW conditions. ECDs are installed and functioning as designed.		Pic 14 Desc.	Photo shows S-Y13 downstream from the bridge.

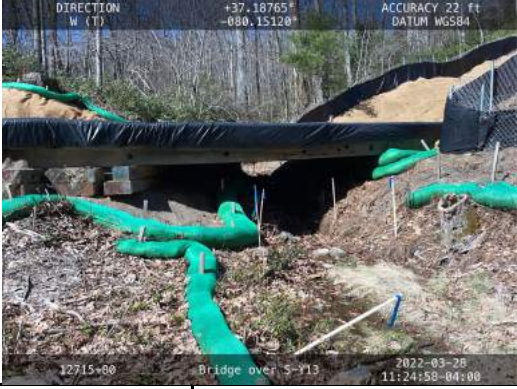
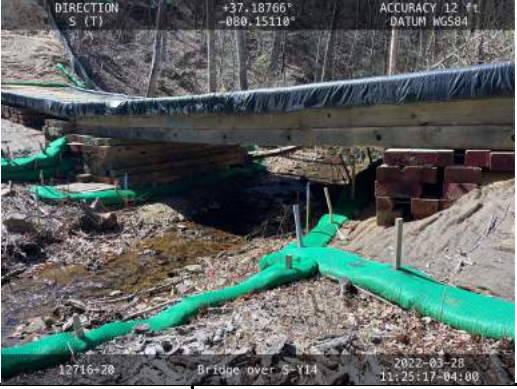
GPS Location	See photo for gps location data.		GPS Location	See photo for gps location data.	
Field Station#	12715+80		Field Station#	12716+20	
Pic 15 Desc.	Photo shows the bridge over stream S-Y13.		Pic 16 Desc.	Photo shows the bridge over stream S-Y14.

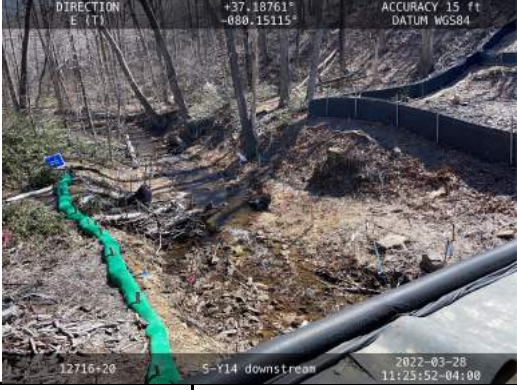
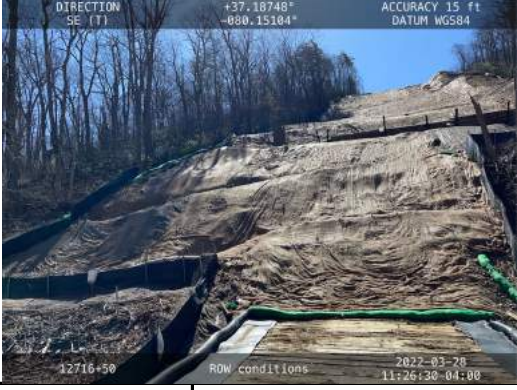
GPS Location	See photo for gps location data.		GPS Location	See photo for gps location data.	
Field Station#	12716+20		Field Station#	12716+50	
Pic 17 Desc.	Photo shows S-Y14 downstream from the bridge.		Pic 18 Desc.	Photo shows the ROW conditions. ECDs are installed and functioning as designed.

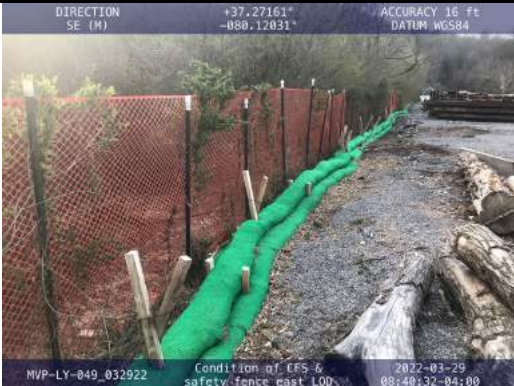
Pic 5 Desc.	Condition of triple stack compost filter sock and safety fence along east LOD. Looking SE.	Pic 6 Desc.	Landowner soil disturbance along triple stack compost filter sock. Area not project related or stabilized. Looking SE.

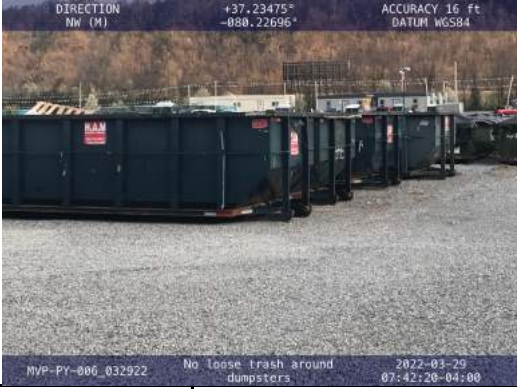
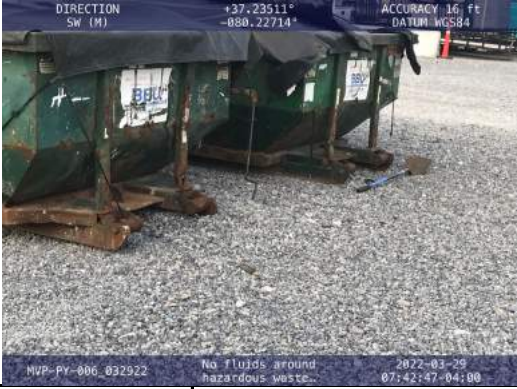
GPS Location	MVP-PY-006 See photo for gps data		GPS Location	MVP-PY-006 See photo for gps data	
Field Station#	+0		Field Station#	+0	
Pic 7 Desc.	No loose trash around dumpsters or in the yard. Looking NW.		Pic 8 Desc.	No fluids or deposits around hazardous waste dumpsters. Looking SW.

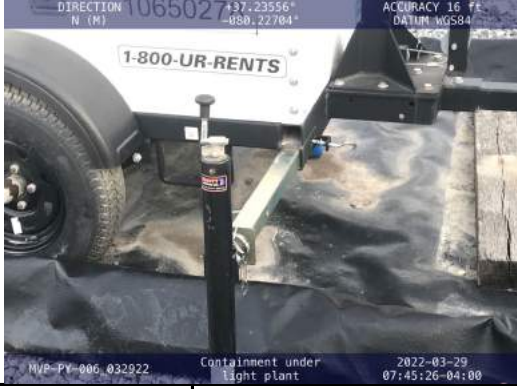
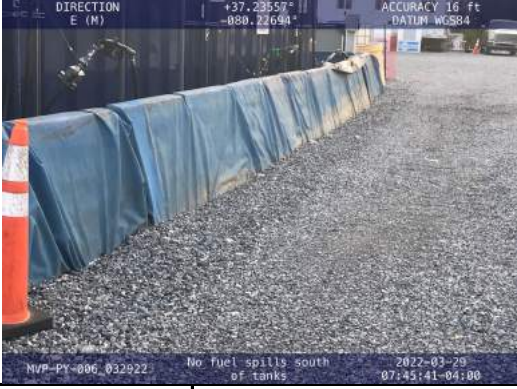
GPS Location	MVP-PY-006 See photo for gps data		GPS Location	MVP-PY-006 See photo for gps data	
Field Station#	+0		Field Station#	+0	
Pic 9 Desc.	Secondary containment under light plants free of fluids. Looking N.		Pic 10 Desc.	Blue Bulk Fuel tanks no fuel spills on the south side of the tanks. Looking E.

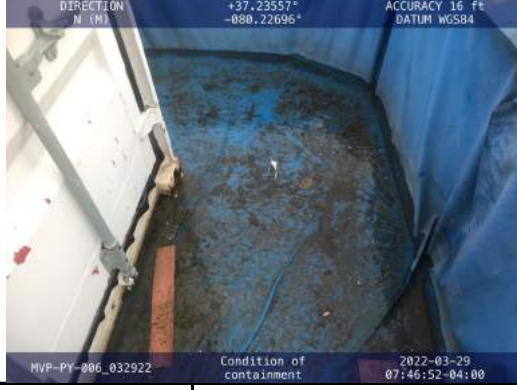
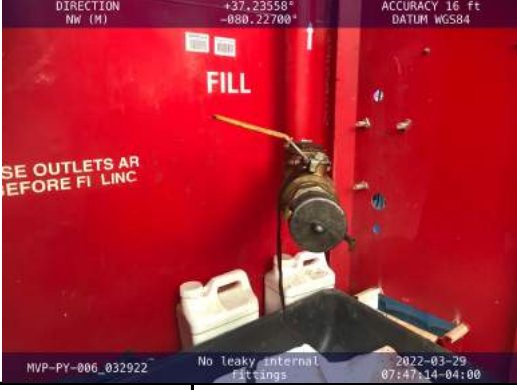
GPS Location	MVP-PY-006 See photo for gps data		GPS Location	MVP-PY-006 See photo for gps data	
Field Station#	+0		Field Station#	+0	
Pic 11 Desc.	Off Road Fuel unit containment holding stormwater. Looking N.		Pic 12 Desc.	Off Road Fuel unit no leaky internal fittings. Looking NW.

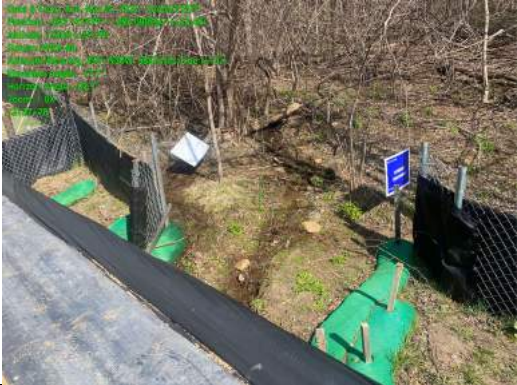
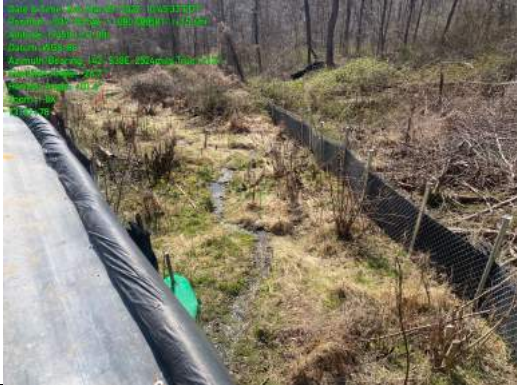
GPS Location	See pic for GPS location.		GPS Location	See pic for GPS location.	
Field Station#	13137+78		Field Station#	13137+78	
Pic 7 Desc.	Upstream side of stream S-D17/14.		Pic 8 Desc.	Downstream side of stream S-D17/14.

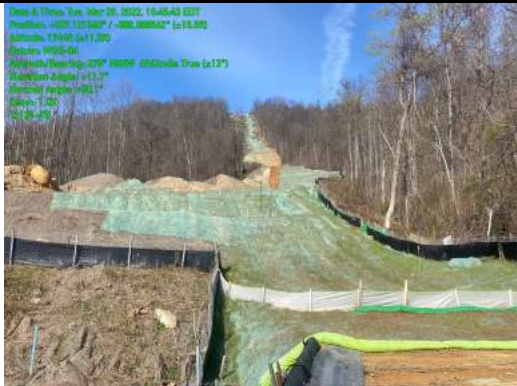
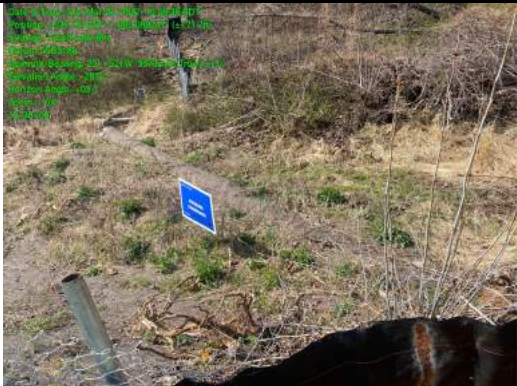
GPS Location	See pic for GPS location.		GPS Location	See pic for GPS location.	
Field Station#	13137+78		Field Station#	13138+00	
Pic 9 Desc.	Current ROW conditions.		Pic 10 Desc.	Downstream side of stream S-D17/14.

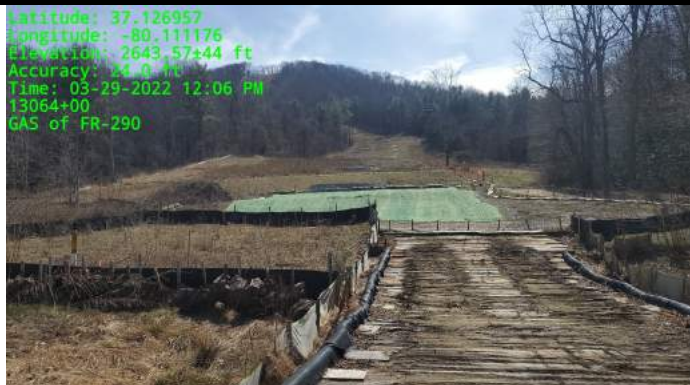
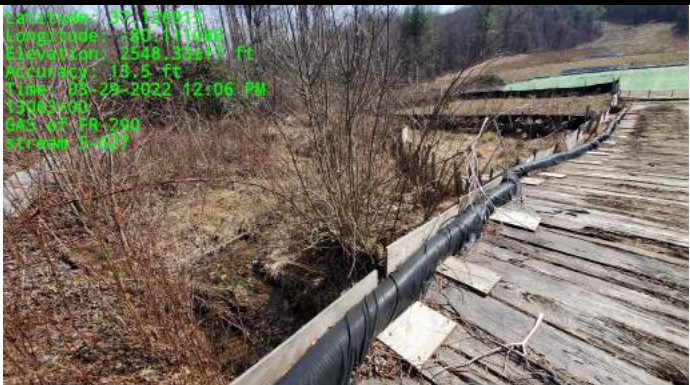
GPS Location	See pic for GPS location.		GPS Location	See pic for GPS location.	
Field Station#	13064+00		Field Station#	13063+00	
Pic 11 Desc.	Current ROW conditions.		Pic 12 Desc.	Upstream side of stream S-G27.

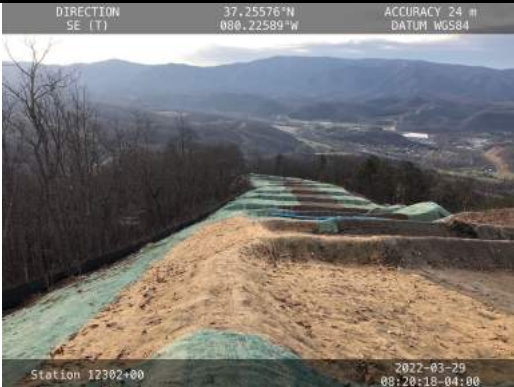
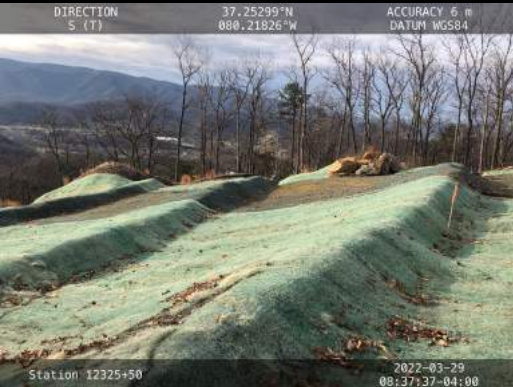
GPS Location	Please see photo for details.		GPS Location	Please see photo for details.	
Field Station#	12302+00		Field Station#	12325+50	
Pic 1 Desc.	Photo shows the stabilized ROW conditions with water bars and that all ECDs are installed and are functioning as designed.		Pic 2 Desc.	Photo shows the stabilized ROW conditions with water bars and that all ECDs are installed and are functioning as designed.

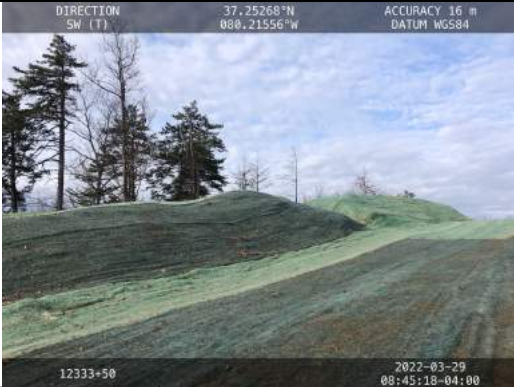
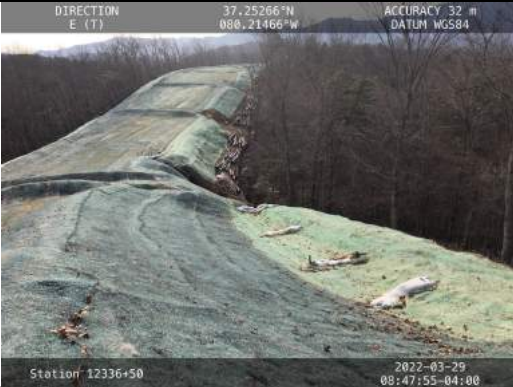
GPS Location	Please see photo for details.		GPS Location	Please see photo for details.	
Field Station#	12333+50		Field Station#	12336+50	
Pic 3 Desc.	Photo shows stabilized ROW conditions and stabilized stock piles.		Pic 4 Desc.	Photo shows stabilized ROW conditions and CFS sock checks.

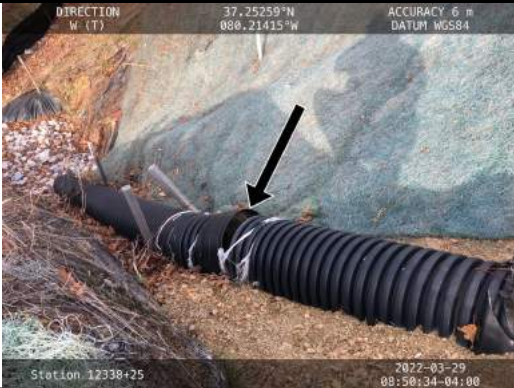
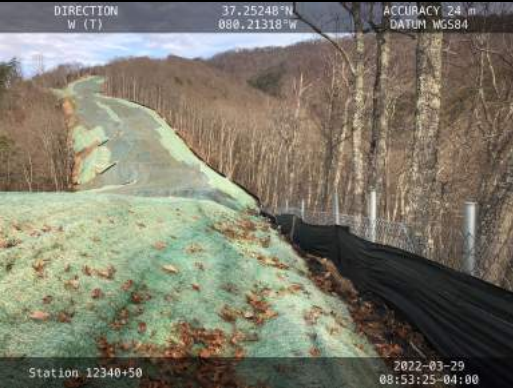
GPS Location	Please see photo for details.		GPS Location	Please see photo for details.	
Field Station#	12338+25		Field Station#	12340+50

Pic 5 Desc.	Photo shows today's punch list item of separated section of slope drain pipe.		Pic 6 Desc.	Photo shows the stabilized ROW conditions with water bars and that all ECDs are installed and are functioning as designed.

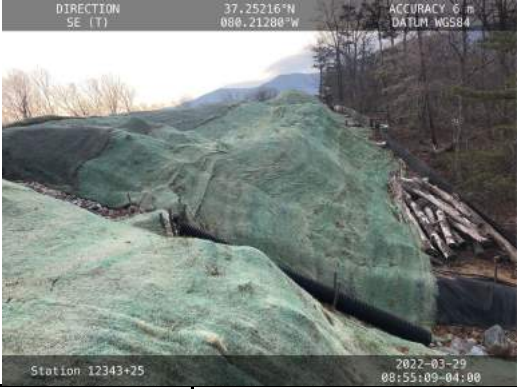
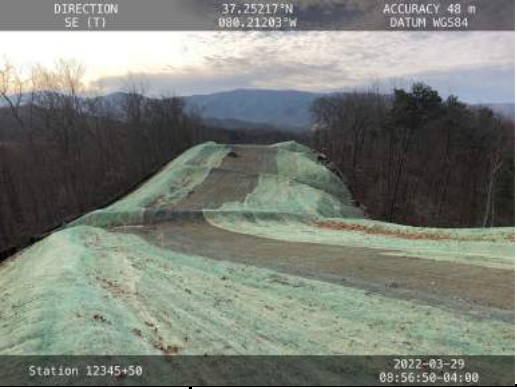
GPS Location	Please see photo for details.		GPS Location	Please see photo for details.	
Field Station#	12343+25		Field Station#	12345+50	
Pic 7 Desc.	Photo shows the stabilized ROW conditions with water bars and that all ECDs are installed and are functioning as designed.		Pic 8 Desc.	Photo shows the stabilized ROW conditions with water bars and that all ECDs are installed and are functioning as designed.

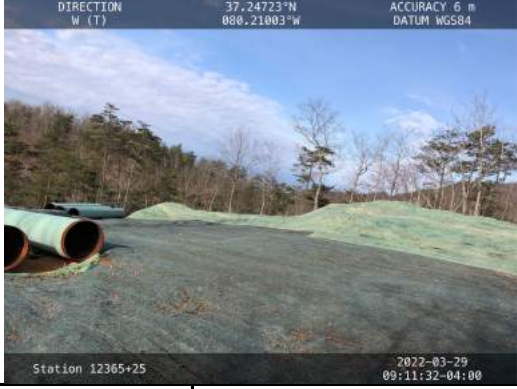
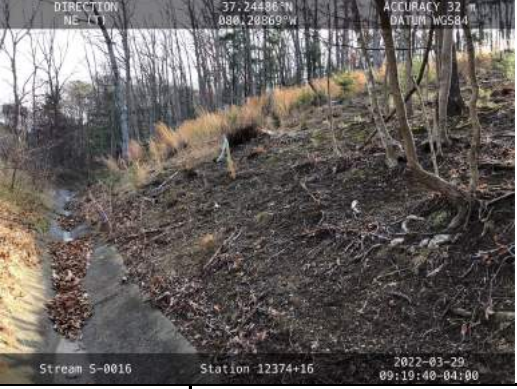
GPS Location	Please see photo for details.		GPS Location	Please see photo for details.	
Field Station#	12365+25		Field Station#	12374+16	
Pic 9 Desc.	Photo shows the stabilized ROW conditions with water bars and that all ECDs are installed and are functioning as designed.		Pic 10 Desc.	Photo shows downstream of Stream S-0016.

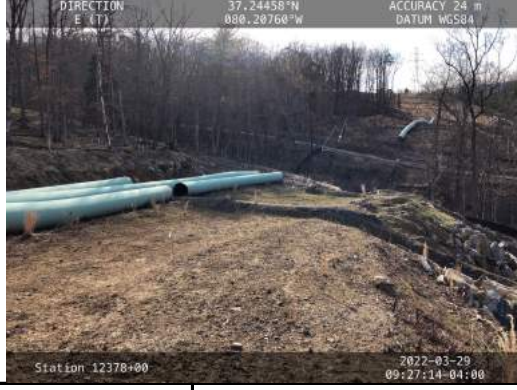
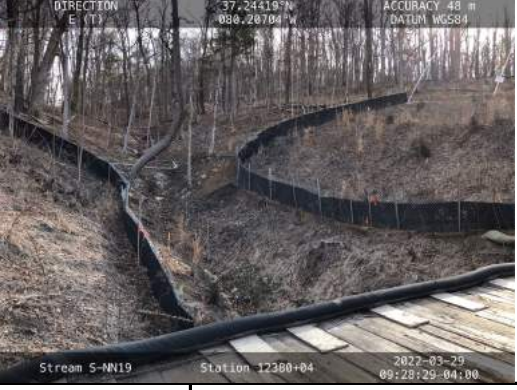
GPS Location	Please see photo for details.		GPS Location	Please see photo for details.

Field Station#	12378+00		Field Station#	12380+04	
Pic 11 Desc.	Photo shows the stabilized ROW conditions with water bars and that all ECDs are installed and are functioning as designed.		Pic 12 Desc.	Photo shows upstream of Stream S-NN19.

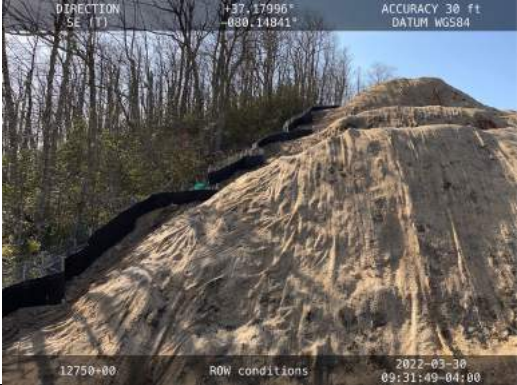
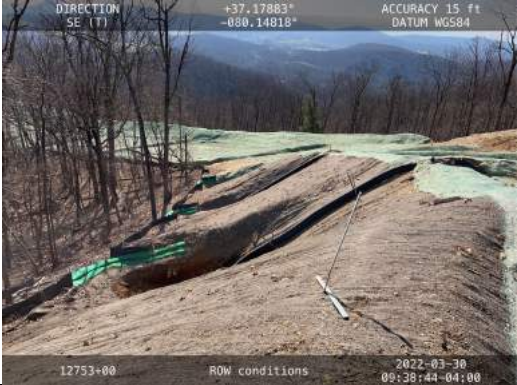
GPS Location	See photo for gps location data		GPS Location	See photo for gps location data	
Field Station#	12750+00		Field Station#	12753+00	
Pic 7 Desc.	Photo shows the ROW condition. ECDs are installed and functioning as designed.		Pic 8 Desc.	Photo shows the ROW condition. ECDs are installed and functioning as designed.

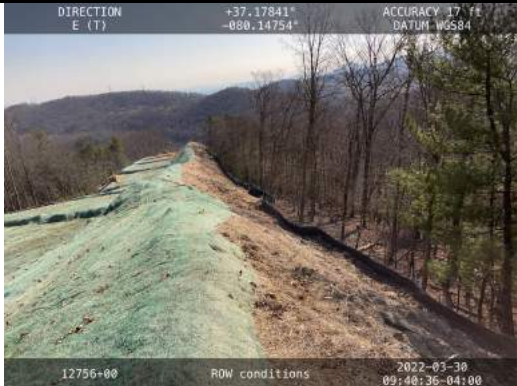
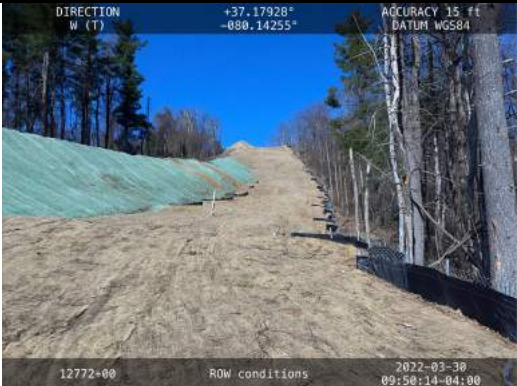
GPS Location	See photo for gps location data		GPS Location	See photo for gps location data	
Field Station#	12756+00		Field Station#	12772+00	
Pic 9 Desc.	Photo shows the ROW condition. ECDs are installed and functioning as designed.		Pic 10 Desc.	Photo shows the ROW condition. ECDs are installed and functioning as designed.

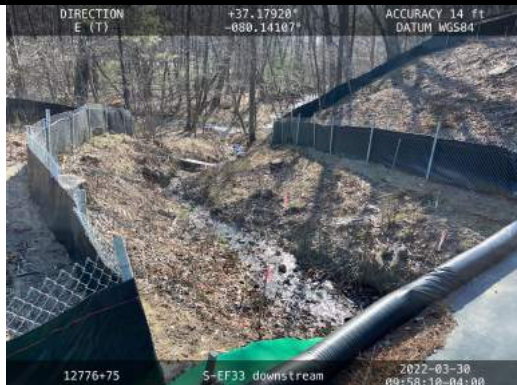
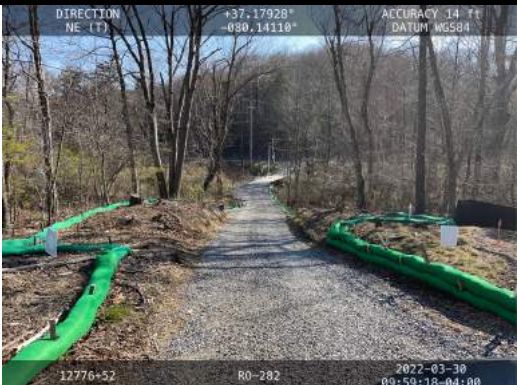
GPS Location	See photo for gps location data		GPS Location	See photo for gps location data	
Field Station#	12776+75		Field Station#	12776+52	
Pic 11 Desc.	Photo shows S-EF33 downstream from the bridge.		Pic 12 Desc.	Photo shows access road RO-282.

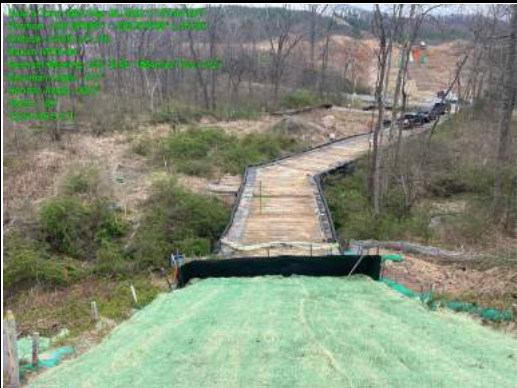
GPS Location	0		GPS Location	0	
Field Station#	13413+05		Field Station#	13415+51	
Pic 15 Desc.	MVP-S-IJ1 and corresponding buffer zone in good condition		Pic 16 Desc.	Cahas Mountain Road Crossing in good condition

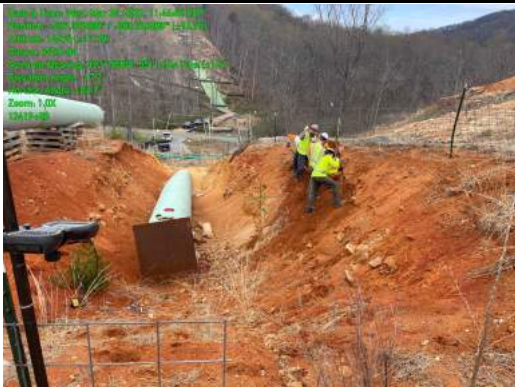
GPS Location	0		GPS Location	0	
Field Station#	13416+00		Field Station#	13419+00	
Pic 17 Desc.	Denuded area needs additional stabilization - 72hr maintenance item		Pic 18 Desc.	Robert's Corrosion installing anode

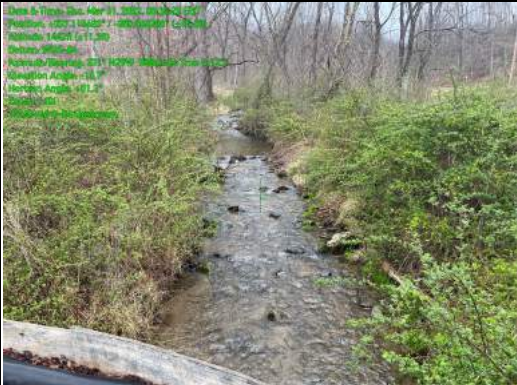
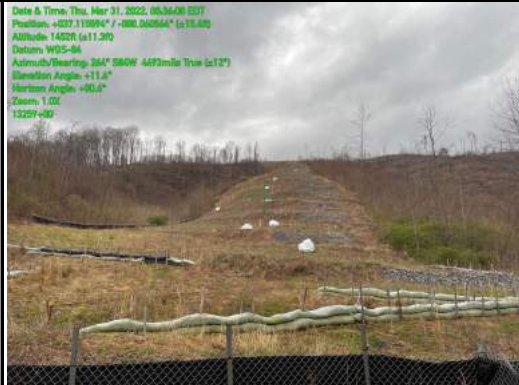
GPS Location			0	GPS Location		0	
Field Station#			13260+66	Field Station#		13259+00	
Pic 7 Desc.			MVP-S-II4 Upstream and corresponding buffer zone in good condition			Pic 8 Desc.	ROW and ECDs In good condition and stable

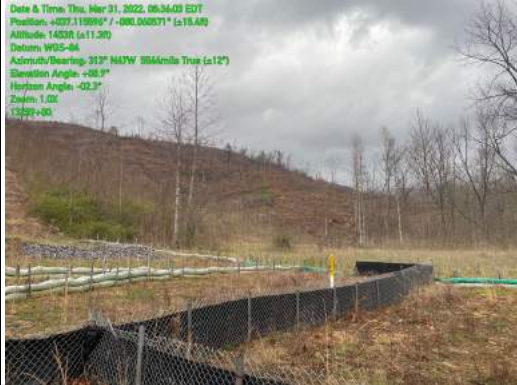
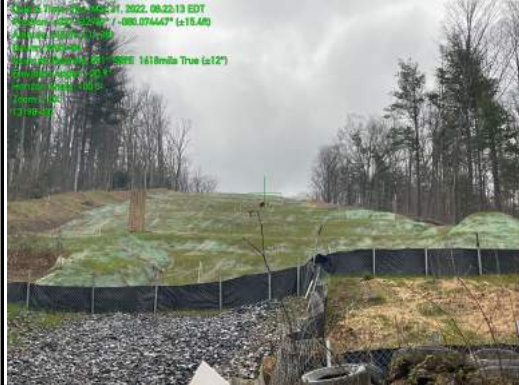
GPS Location			0	GPS Location		0	
Field Station#			13259+00	Field Station#		13198+00	
Pic 9 Desc.			Continuing to monitor logging activity adjacent to row			Pic 10 Desc.	ROW and ECDs In good condition and stable

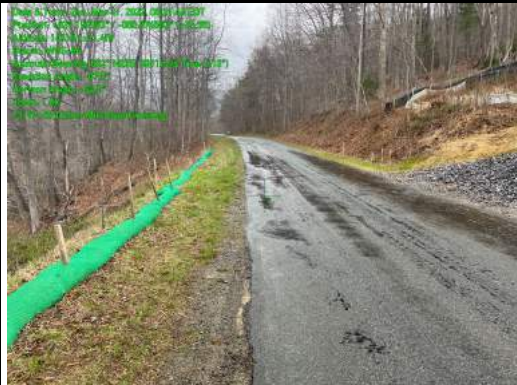
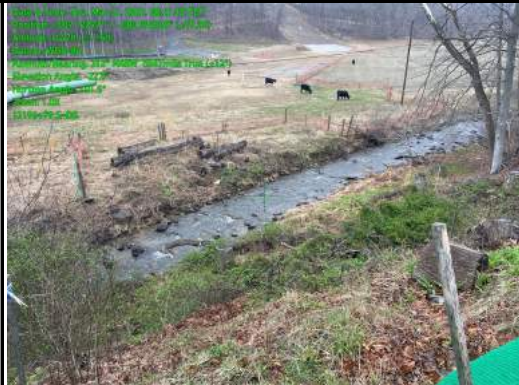
GPS Location			0	GPS Location		0	
Field Station#			13197+55	Field Station#		13196+79	
Pic 11 Desc.			Dillion Mill Road Crossing in good condition			Pic 12 Desc.	MVP-S-D8 and corresponding buffer zone in good condition

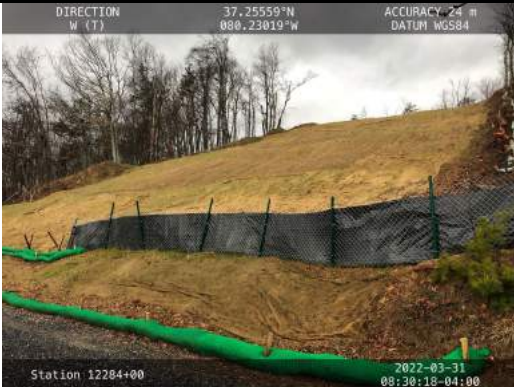
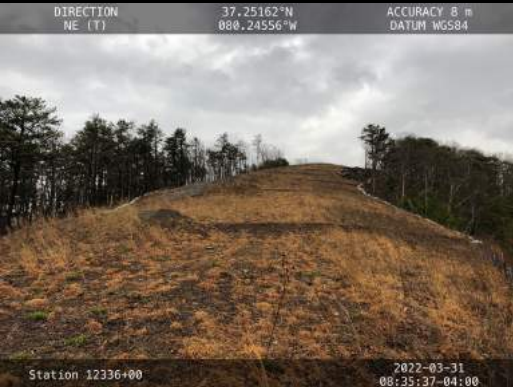
GPS Location	Please see photo for details.		GPS Location	Please see photo for details.	
Field Station#	12284+00		Field Station#	12236+00	
Pic 1 Desc.	Photo shows the stabilized ROW conditions with water bars and that all ECDs are installed and are functioning as designed.		Pic 2 Desc.	Photo shows final restoration area with permanent water bars equipped with level spreaders functioning as designed.

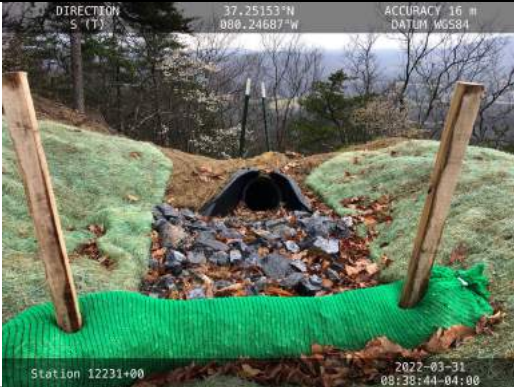
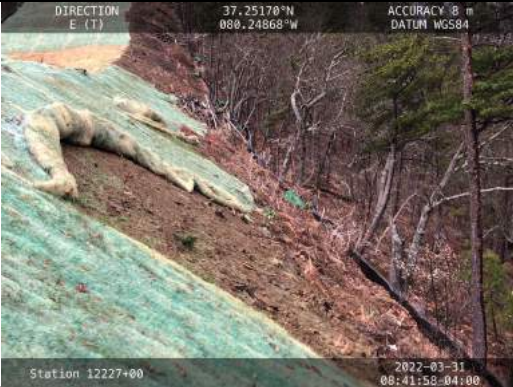
GPS Location	Please see photo for details.		GPS Location	Please see photo for details.	
Field Station#	12231+00		Field Station#	12227+00	
Pic 3 Desc.	Photo shows stone inlet protection on slope drain pipe.		Pic 4 Desc.	Photo shows today's punch list item of erosion control blanket blown out of place by windy weather conditions. (Item resolved 3/31/2022).

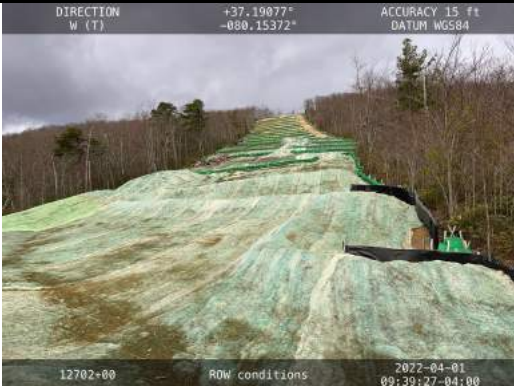
GPS Location	See photo for gps location data.		GPS Location	See photo for gps location data.	
Field Station#	12702+00		Field Station#	12704+00	
Pic 5 Desc.	Photo shows the ROW condition. ECDs are installed and functioning as designed.		Pic 6 Desc.	Photo shows the ROW condition. ECDs are installed and functioning as designed.

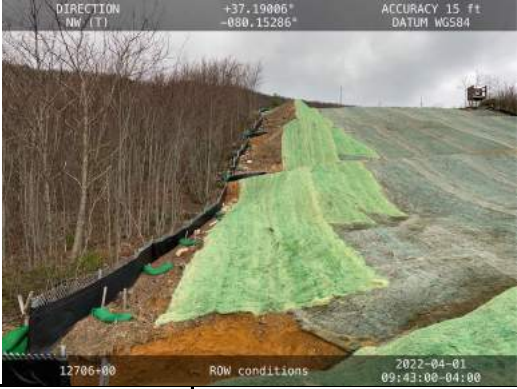
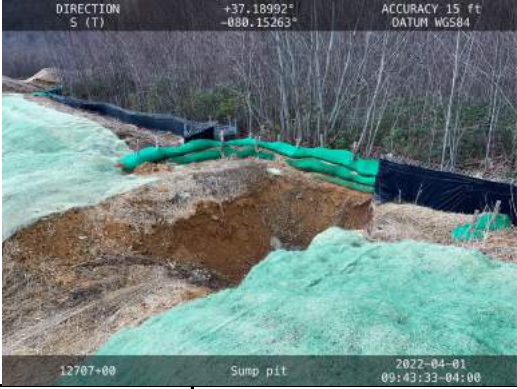
GPS Location	See photo for gps location data.		GPS Location	See photo for gps location data.	
Field Station#	12706+00		Field Station#	12707+00	
Pic 7 Desc.	Photo shows the ROW condition. ECDs are installed and functioning as designed.		Pic 8 Desc.	Photo shows the sump pit and end treatment.

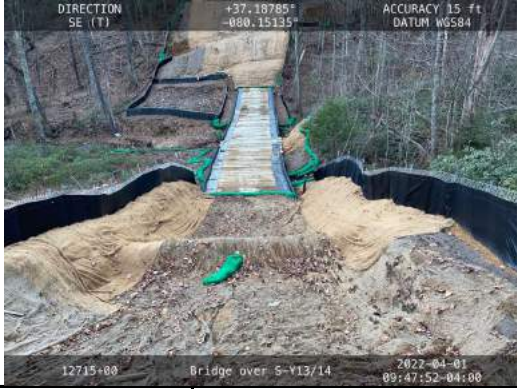
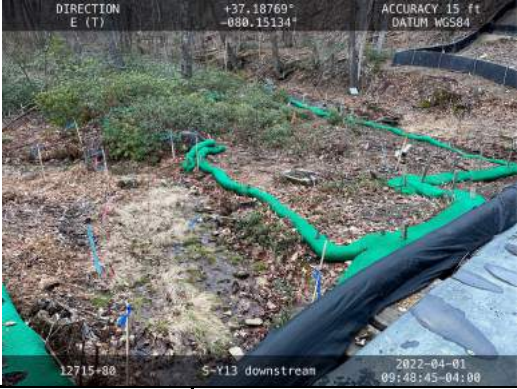
GPS Location	See photo for gps location data.		GPS Location	See photo for gps location data.	
Field Station#	12715+00		Field Station#	12715+80	
Pic 9 Desc.	Photo shows the bridge over streams S-Y13 and S-Y14.		Pic 10 Desc.	Photo shows stream S-Y13 downstream from the bridge.

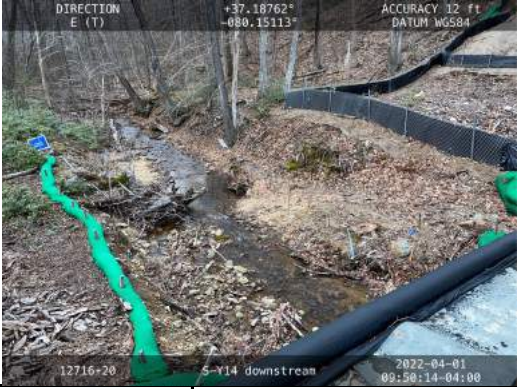
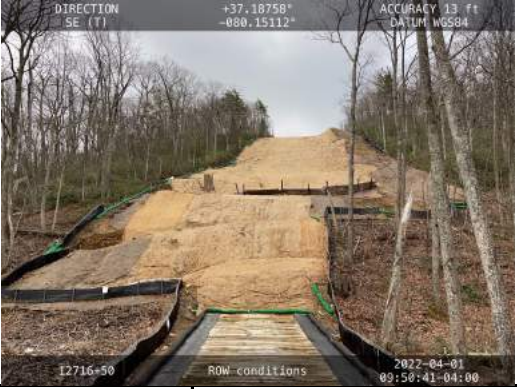
GPS Location	See photo for gps location data.		GPS Location	See photo for gps location data.	
Field Station#	12716+20		Field Station#	12716+50	
Pic 13 Desc.	Photo shows stream S-Y14 downstream from the bridge.		Pic 14 Desc.	Photo shows the ROW condition. ECDs are installed and functioning as designed.

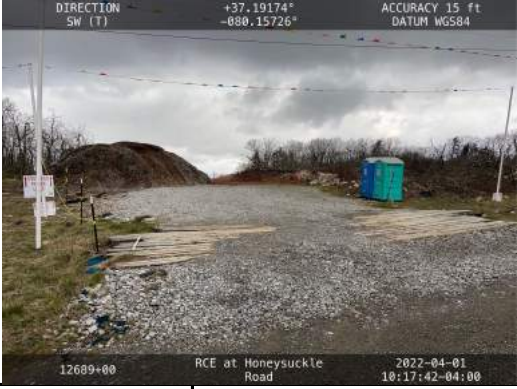
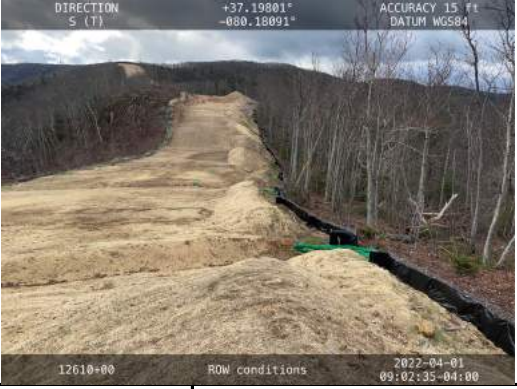
GPS Location	See photo for gps location data.		GPS Location	See photo for gps location data.	
Field Station#	12689+00		Field Station#	12610+00	
Pic 15 Desc.	Photo shows the RCE at Honeysuckle Road.		Pic 16 Desc.	Photo shows the ROW condition. ECDs are installed and functioning as designed.

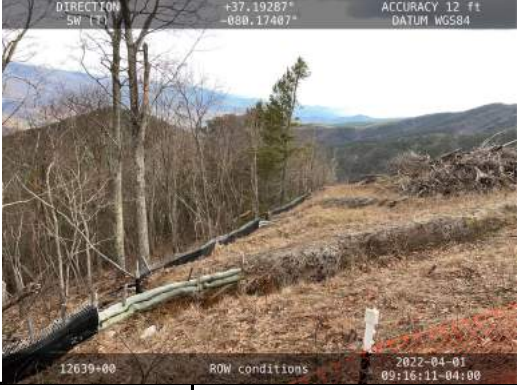
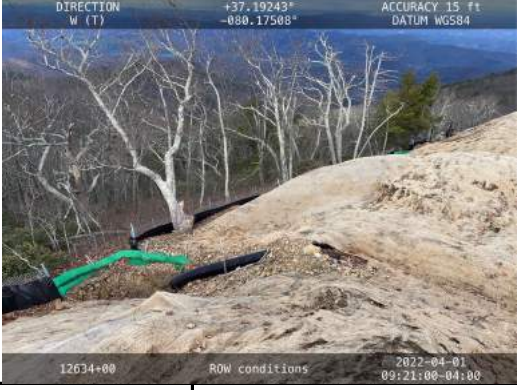
GPS Location	See photo for gps location data.		GPS Location	See photo for gps location data.	
Field Station#	12639+00		Field Station#	12634+00	
Pic 17 Desc.	Photo shows the ROW condition. ECDs are installed and functioning as designed.		Pic 18 Desc.	Photo shows the slope drain.
