# Visual Site Inspection Report

<b>Project Name</b>	H-600 Pipeline Spread I	<b>AFE</b>	124300139	<b>Spread</b>	H-600 Pipeline Spread I
<b>Contractor</b>	Precision			<b>Report #</b>	35391
<b>Inspector</b>	Ben Davenport			<b>Date/Time</b>	3/14/2022 12:21 PM
<b>Permit #</b>	TBD	<b>Inspection Type</b>	VA SWPP	<b>Station Begin</b>	14802+19
<b>State</b>	VA	<b>Inspection Area</b>	Partial	<b>Station End</b>	14928+52
<b>County</b>	Franklin	<b>Ground</b>	Muddy	<b>Temperature (°F)</b>	62.00
<b>Municipality</b>	N/A	<b>Weather</b>	Sunny	<b>Rain Gauge (in)</b>	0.50
				<b>Rain Accumulation Time (days)</b>	1.00

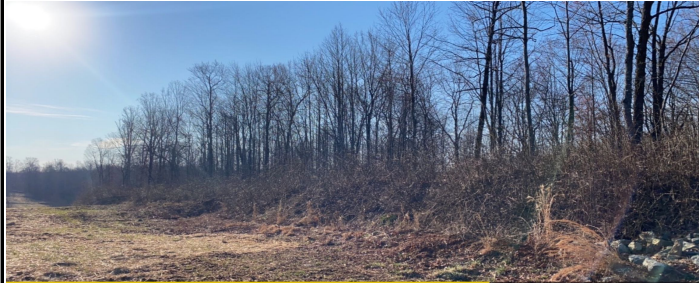
36°58'17" N 79°39'35" W 65°NE COURSE 74' GPS 1592-2298 Bar Ridge Rd, Penhook, VA 24137, United States 03.14.2022 09:04:44 Accur +/-19.6 Ft ALT 987 Ft			36°58'17" N 79°39'36" W 119°SE COURSE 130' GPS 1592-2298 Bar Ridge Rd, Penhook, VA 24137, United States 03.14.2022 09:04:20 Accur +/-32.9 Ft ALT 988 Ft		
<b>GPS Location</b>	5	<b>GPS Location</b>	6		
<b>Field Station#</b>	14861+31	<b>Field Station#</b>	14876+00

<b>Pic 5 Desc.</b>	Water bar performing intended function.		<b>Pic 6 Desc.</b>	Temporary diversion berm stabilized and vegetated.

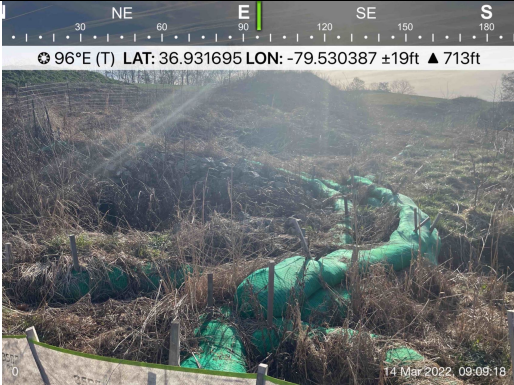
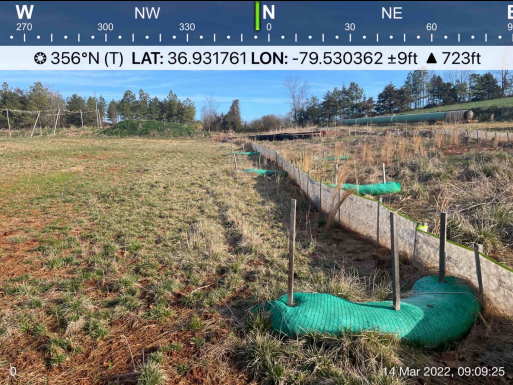
<b>GPS Location</b>	See photo		<b>GPS Location</b>	See photo	
<b>Field Station#</b>	15299+00		<b>Field Station#</b>	15299+00	
<b>Pic 1 Desc.</b>	CWD is in good condition and functioning		<b>Pic 2 Desc.</b>	Drainage feature ECDs are in good condition and functioning

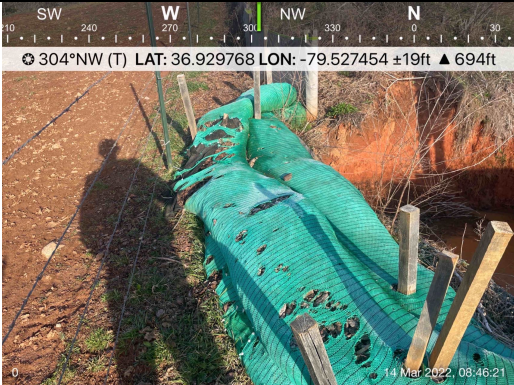
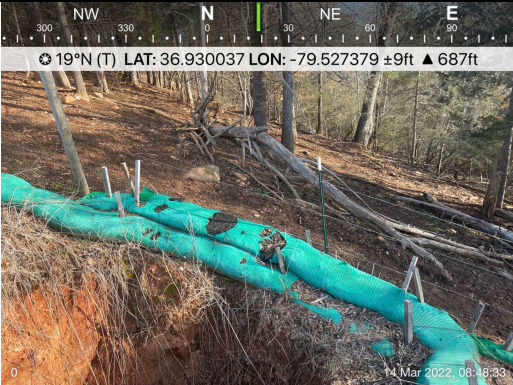
<b>GPS Location</b>	See photo		<b>GPS Location</b>	See photo	
<b>Field Station#</b>	15310+00		<b>Field Station#</b>	15310+15	
<b>Pic 3 Desc.</b>	CFS end treatment is degraded and needs to be replaced		<b>Pic 4 Desc.</b>	CFS end treatment is degraded and needs to be replaced

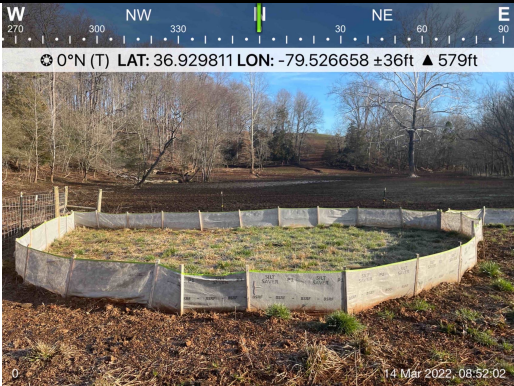
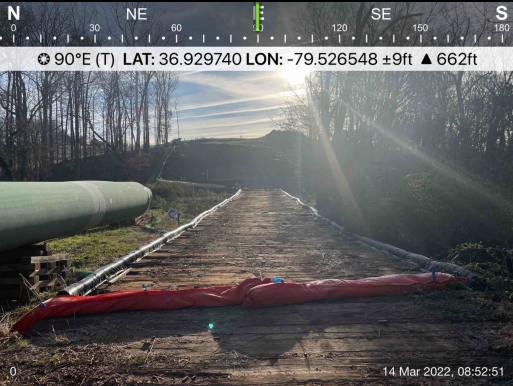
<b>GPS Location</b>	See photo		<b>GPS Location</b>	See photo	
<b>Field Station#</b>	15311+78		<b>Field Station#</b>	15314+25	
<b>Pic 5 Desc.</b>	P1 is in good condition at wetland buffer		<b>Pic 6 Desc.</b>	Equipment bridge ECDs are in good condition and functioning

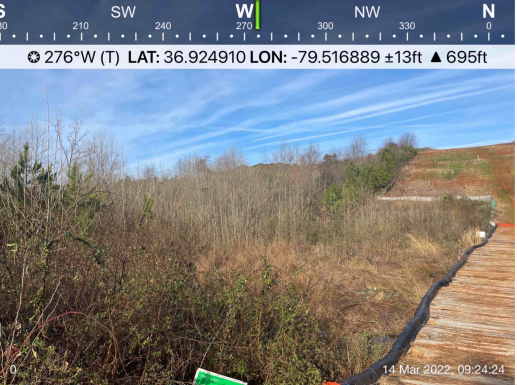
<b>GPS Location</b>	See photo		<b>GPS Location</b>	See photo	
<b>Field Station#</b>	15346+00		<b>Field Station#</b>	15347+00	
<b>Pic 9 Desc.</b>	P1 is degraded and needs to be replaced		<b>Pic 10 Desc.</b>	Resource buffers remain well vegetated

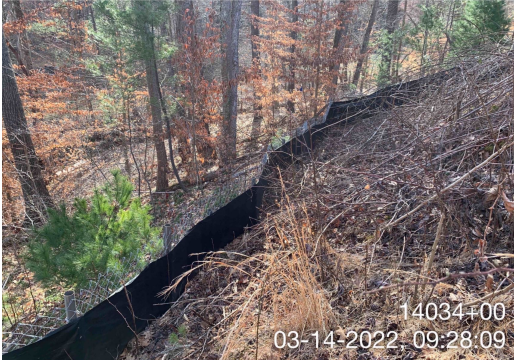
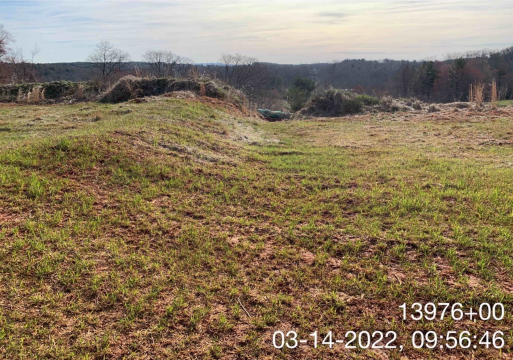
<p>107°E (T) 37°3'6"N, 79°53'27"W ±85ft ▲1132ft 13976+00 03-14-2022 09:56:46</p>			
<b>GPS Location</b>	0	<b>GPS Location</b>	0		
<b>Field Station#</b>	14034+00	<b>Field Station#</b>	13976+00		
<b>Pic 1 Desc.</b>	Super silt fence in acceptable condition		<b>Pic 2 Desc.</b>	Waterbar in acceptable condition

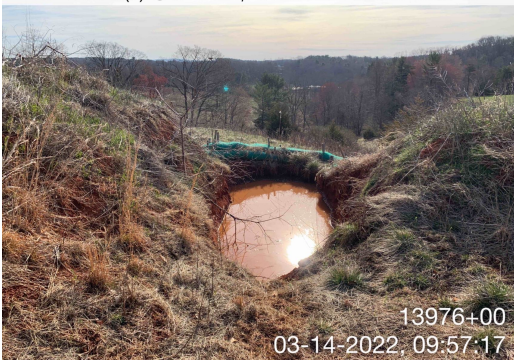
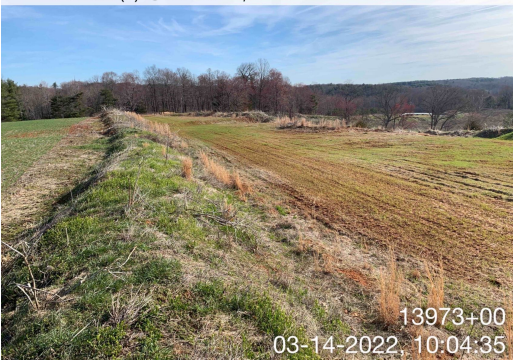
<p>64°NE (T) 37°2'51"N, 79°53'10"W ±728ft ▲1085ft 13973+00 03-14-2022 10:04:35</p>			
<b>GPS Location</b>	0	<b>GPS Location</b>	0		
<b>Field Station#</b>	13976+00	<b>Field Station#</b>	13973+00		
<b>Pic 3 Desc.</b>	Waterbar end treatment in acceptable condition		<b>Pic 4 Desc.</b>	Clean water diversion berm and temporary vegetative stabilization in acceptable conditions

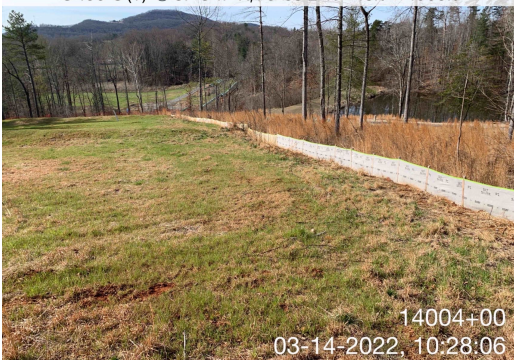
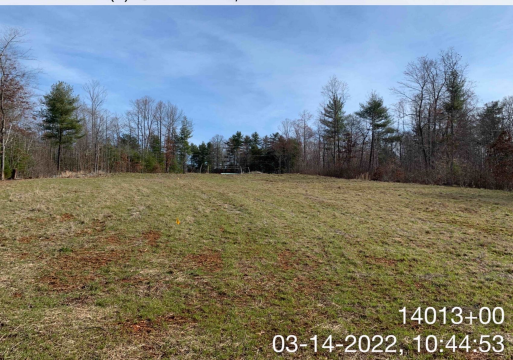
<p>21°N (T) 37°3'22"N, 79°52'55"W ±656ft ▲1023ft 14013+00 03-14-2022 10:44:53</p>			
<b>GPS Location</b>	0	<b>GPS Location</b>	0		
<b>Field Station#</b>	14004+00	<b>Field Station#</b>	14013+00		
<b>Pic 5 Desc.</b>	Perimeter P1 silt fence and temporary vegetative stabilization in acceptable conditions		<b>Pic 6 Desc.</b>	Permanent vegetative stabilization in acceptable condition

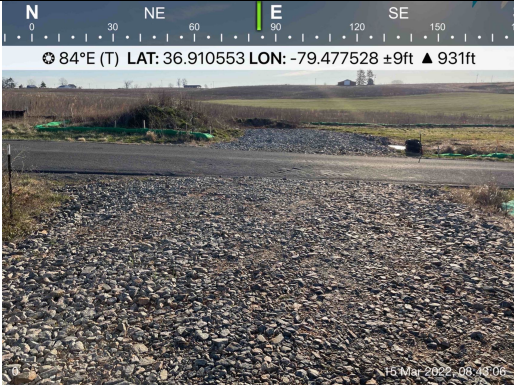
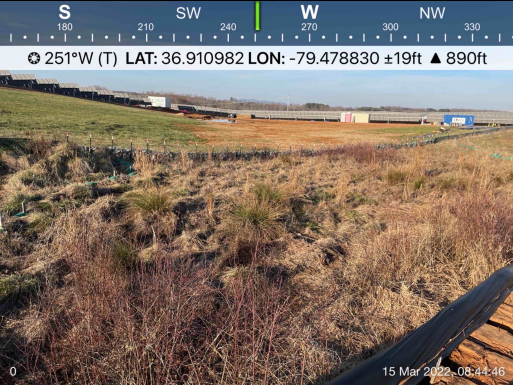
<b>GPS Location</b>	See photo		<b>GPS Location</b>	See photo	
<b>Field Station#</b>	15480+67		<b>Field Station#</b>	15475+00	
<b>Pic 1 Desc.</b>	RCEs are in good condition at all road crossings		<b>Pic 2 Desc.</b>	3rd party rock outlet appears to be in good condition

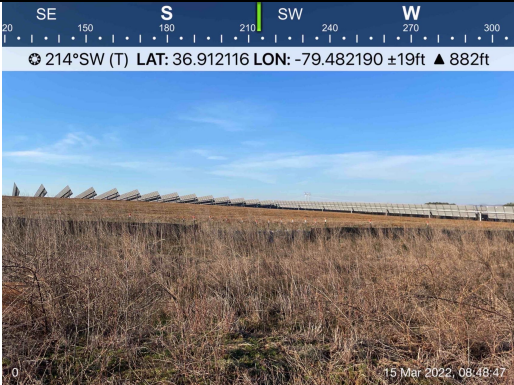
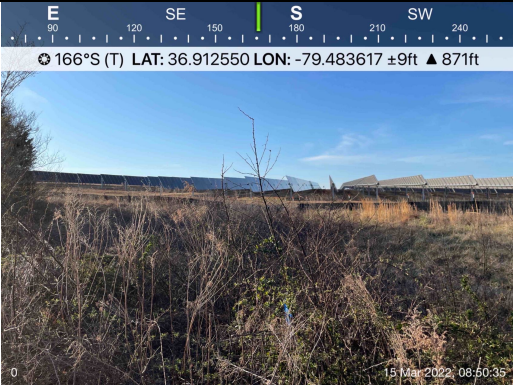
<b>GPS Location</b>	See photo		<b>GPS Location</b>	See photo	
<b>Field Station#</b>	15465+00		<b>Field Station#</b>	15460+81	
<b>Pic 3 Desc.</b>	No evidence of sedimentation from 3rd party disturbance		<b>Pic 4 Desc.</b>	No evidence of sedimentation from 3rd party disturbance into CWD inlet

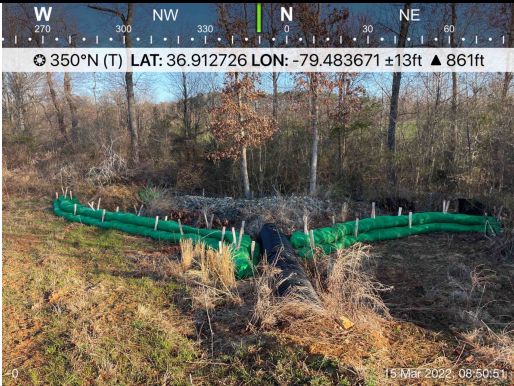
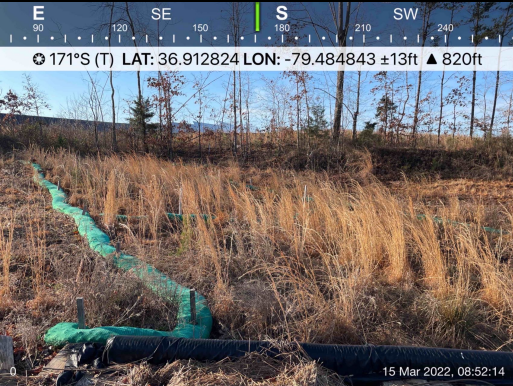
<b>GPS Location</b>	See photo		<b>GPS Location</b>	See photo	
<b>Field Station#</b>	15460+81		<b>Field Station#</b>	15457+00	
<b>Pic 5 Desc.</b>	CWD remains in good condition		<b>Pic 6 Desc.</b>	No evidence of sedimentation from 3rd party disturbance into drainage feature

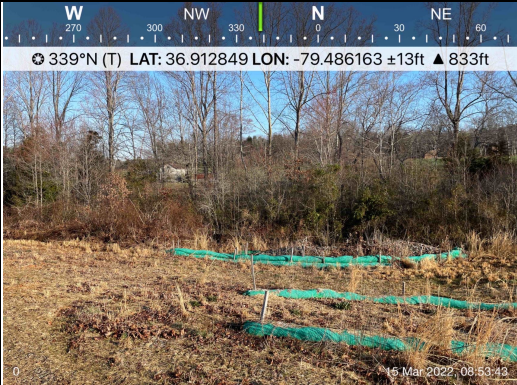
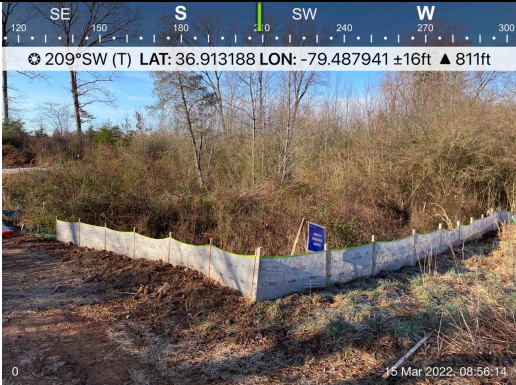
GPS Location	See photo		GPS Location	See photo	
Field Station#	15453+00		Field Station#	15447+61	
Pic 7 Desc.	CWD remains in good condition		Pic 8 Desc.	P1 is in good condition at all stream and wetland buffers

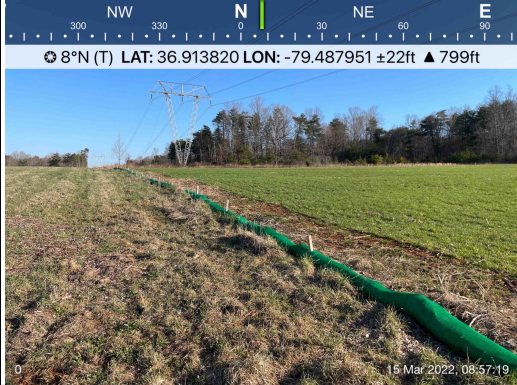
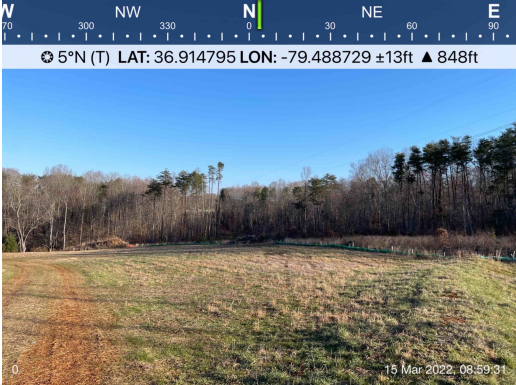
GPS Location	See photo		GPS Location	See photo	
Field Station#	15445+00		Field Station#	15440+00	
Pic 9 Desc.	CFS is in good condition throughout this section		Pic 10 Desc.	Vegetation continues to fill in throughout this section

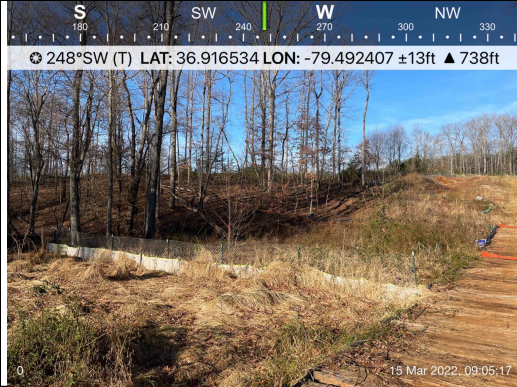
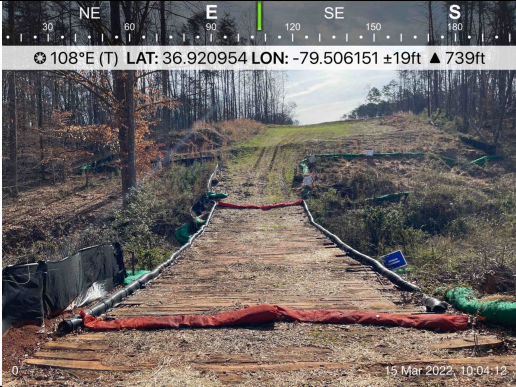
GPS Location	See photo		GPS Location	See photo	
Field Station#	15427+00		Field Station#	15384+74	
Pic 11 Desc.	Resource buffers remain well vegetated		Pic 12 Desc.	Equipment bridge ECDs are in place and functioning

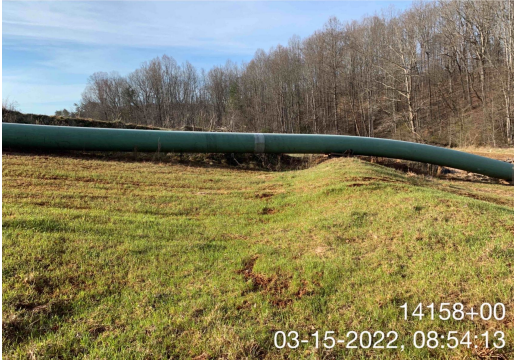
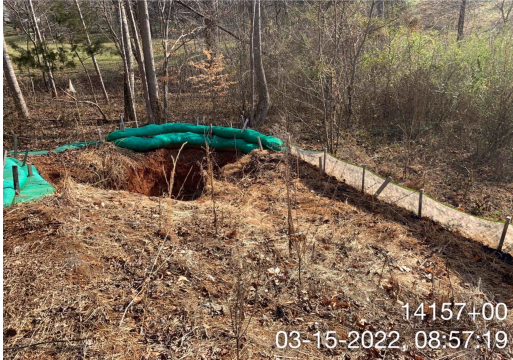
<b>GPS Location</b>	0	<b>GPS Location</b>	0		
<b>Field Station#</b>	14158+00	<b>Field Station#</b>	14157+00		
<b>Pic 1 Desc.</b>	Waterbar in acceptable condition	<b>Pic 2 Desc.</b>	Sump pit and P1 silt fence in acceptable condition

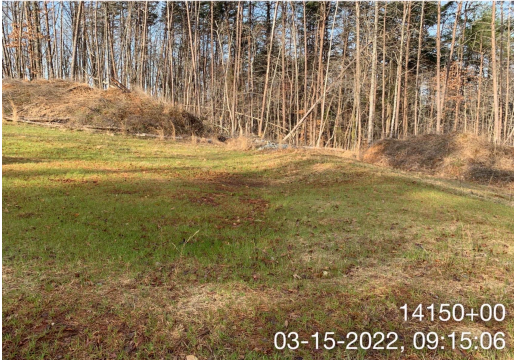
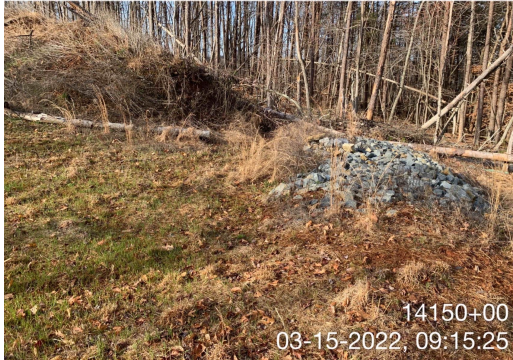
<b>GPS Location</b>	0	<b>GPS Location</b>	0		
<b>Field Station#</b>	14150+00	<b>Field Station#</b>	14150+00		
<b>Pic 3 Desc.</b>	Waterbar in acceptable condition	<b>Pic 4 Desc.</b>	Waterbar end treatment in acceptable condition

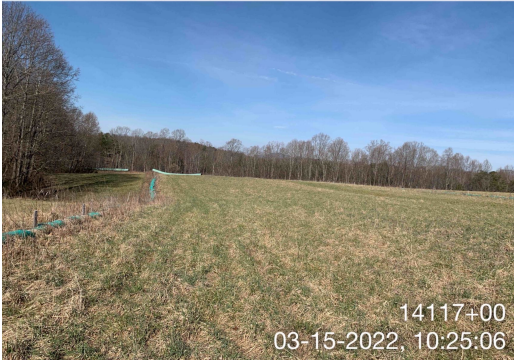
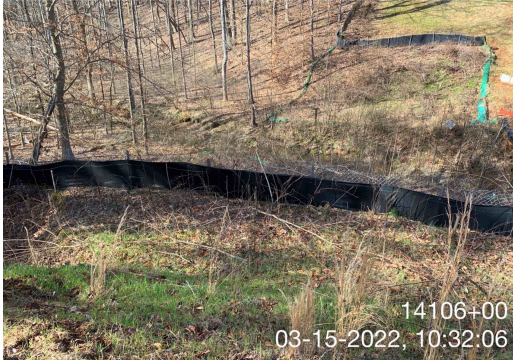
<b>GPS Location</b>	0	<b>GPS Location</b>	0		
<b>Field Station#</b>	14117+00	<b>Field Station#</b>	14106+00		
<b>Pic 5 Desc.</b>	Permanent Vegetative stabilization and perimeter CFS in acceptable conditions	<b>Pic 6 Desc.</b>	Super silt fence in acceptable conditions

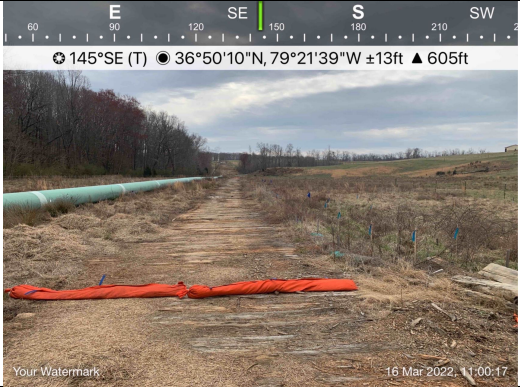
<b>GPS Location</b>	O	<b>GPS Location</b>	O		
<b>Field Station#</b>	15950+00	<b>Field Station#</b>	15951+72		
<b>Pic 1 Desc.</b>	Observing P1 that requires maintenance	<b>Pic 2 Desc.</b>	Observing buffer, equipment crossing and ECD's

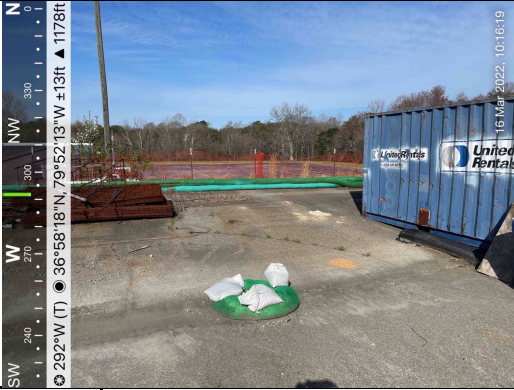
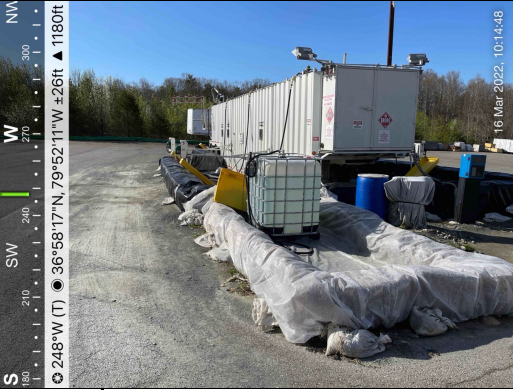
<b>GPS Location</b>	See picture		<b>GPS Location</b>	See picture	
<b>Field Station#</b>	0000+00		<b>Field Station#</b>	00000+00	
<b>Pic 1 Desc.</b>	Inlet protection and perimeter ECD's on west side of LY-046 in acceptable condition.		<b>Pic 2 Desc.</b>	Secondary containment structures for BlueDef and fuel cell at LY-046 in good condition.

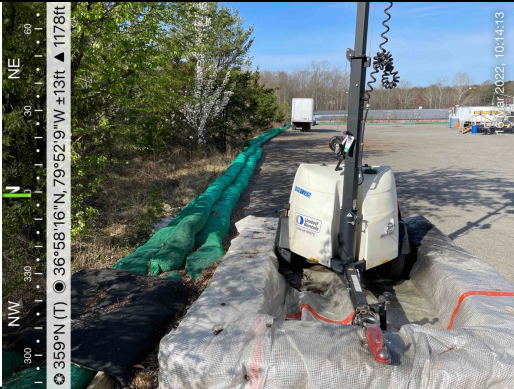
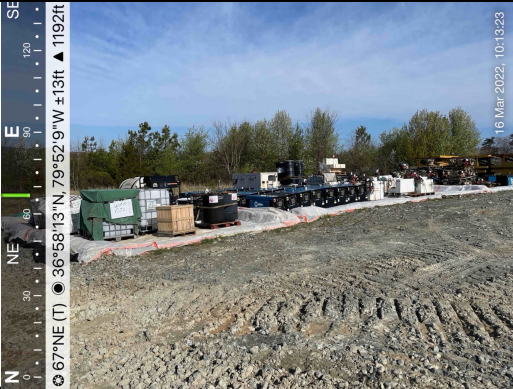
<b>GPS Location</b>	See picture		<b>GPS Location</b>	See picture	
<b>Field Station#</b>	0000+00		<b>Field Station#</b>	0000+00	
<b>Pic 3 Desc.</b>	Secondary containment structure for light plant and perimeter ECD's on south end of LY-046 in good condition.		<b>Pic 4 Desc.</b>	Secondary containment structure on north end of LY-045 in good condition.

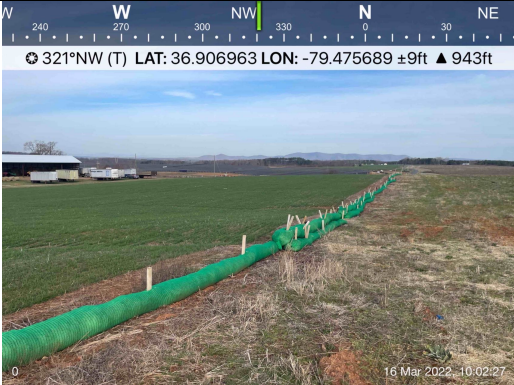
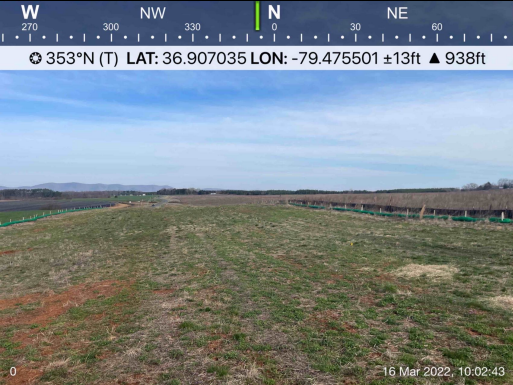
<b>GPS Location</b>	See photo		<b>GPS Location</b>	See photo	
<b>Field Station#</b>	15490+00		<b>Field Station#</b>	15495+00	
<b>Pic 1 Desc.</b>	Perimeter CFS is in good condition		<b>Pic 2 Desc.</b>	Vegetation continues to fill in throughout this section

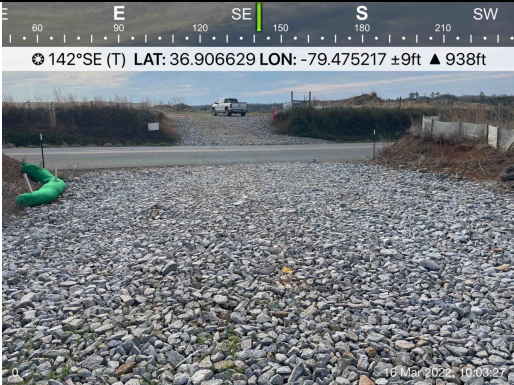
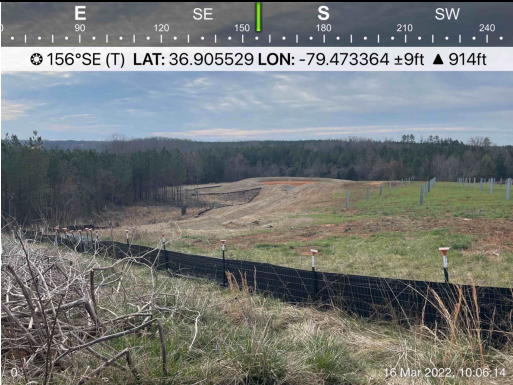
<b>GPS Location</b>	See photo		<b>GPS Location</b>	See photo	
<b>Field Station#</b>	15496+70		<b>Field Station#</b>	15501+00	
<b>Pic 3 Desc.</b>	RCEs are in good condition at all road crossings		<b>Pic 4 Desc.</b>	No evidence of sedimentation from 3rd party disturbance

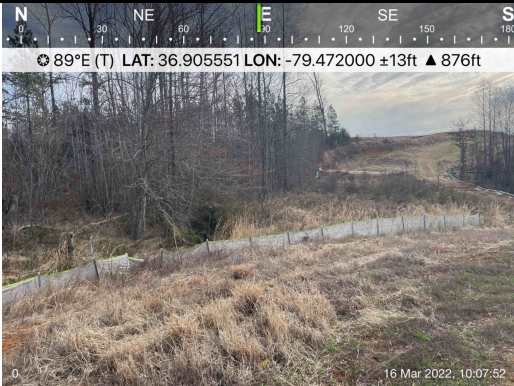
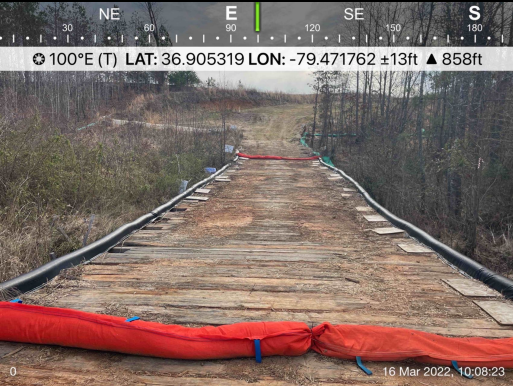
<b>GPS Location</b>	See photo		<b>GPS Location</b>	See photo	
<b>Field Station#</b>	15507+50		<b>Field Station#</b>	15508+00	
<b>Pic 5 Desc.</b>	P1 is in good condition at all stream and wetland buffers		<b>Pic 6 Desc.</b>	Equipment bridge ECDs are in place

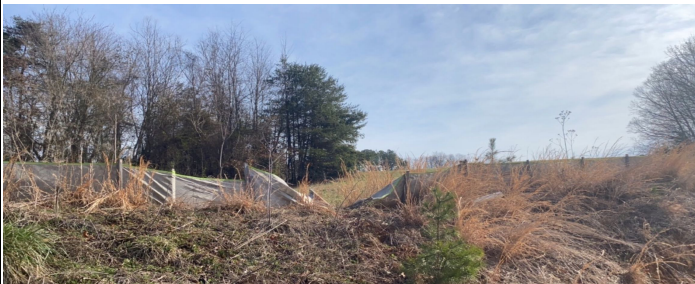
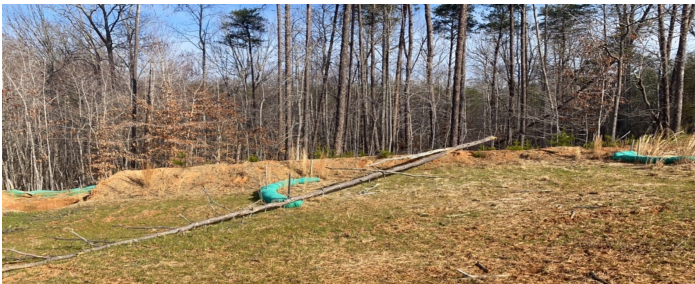
36°57'53" N 79°35'46" W 114°E COURSE 155° GPS Penhook, VA 24137, United States 03.16.2022 09:48:34 Accur +/-70.9 Ft ALT 0 Ft			36°57'44" N 79°35'26" W 55°NE COURSE -1° GPS Sandy Level, VA 24161, United States 03.16.2022 09:59:28 Accur +/-422.8 Ft ALT 865 Ft		
GPS Location	1		GPS Location	2	
Field Station#	15053+00		Field Station#	15076+00	
Pic 1 Desc.	Routine maintenance. Repair/replace damaged perimeter P1 silt fence.		Pic 2 Desc.	Routine maintenance. Fallen tree down on temporary diversion berm and CFS check.

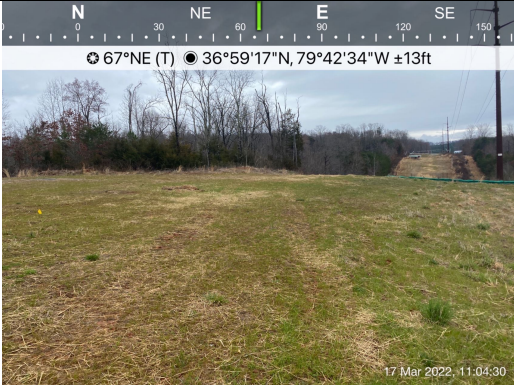
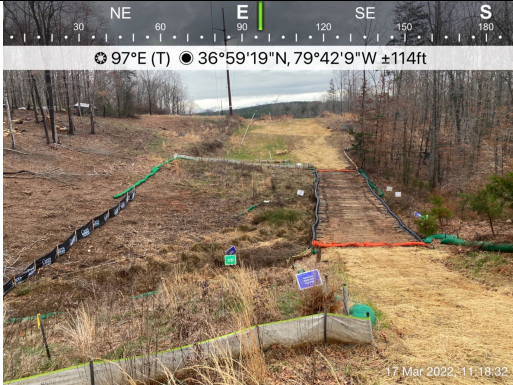
<b>GPS Location</b>	0	<b>GPS Location</b>	0		
<b>Field Station#</b>	14697+00	<b>Field Station#</b>	14716+30		
<b>Pic 1 Desc.</b>	Approximately 14697+00. Overview of ROW.		<b>Pic 2 Desc.</b>	Approximately 14716+30. Overview of stream and wetland crossing, equipment bridge and ECDs at stream S-H30 and wetland W-H11. Black silt fence along northern edge of LOD.

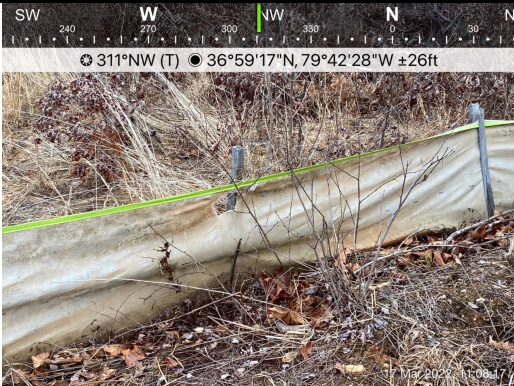
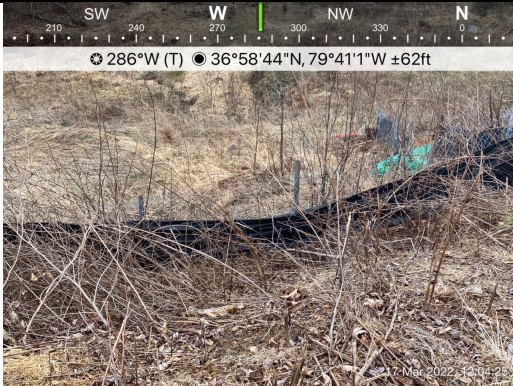
<b>GPS Location</b>	0	<b>GPS Location</b>	0		
<b>Field Station#</b>	14701+30	<b>Field Station#</b>	14783+25		
<b>Pic 5 Desc.</b>	Approximately 14701+30. P-1 requires maintenance. Hole in fabric and stakes weathered and broken.		<b>Pic 6 Desc.</b>	Approximately 14783+25. SSF requires maintenance. Reattach fabric to chain link.

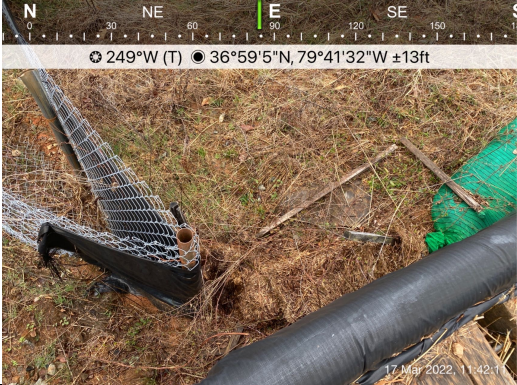
<b>GPS Location</b>	0	<b>GPS Location</b>			
<b>Field Station#</b>	14749+75	<b>Field Station#</b>			
<b>Pic 7 Desc.</b>	Approximately 14749+75. Replace straw bales with CFS.	<b>Pic 8 Desc.</b>			
Insert image here		Insert image here			
<b>GPS Location</b>		<b>GPS Location</b>			
<b>Field Station#</b>		<b>Field Station#</b>			
<b>Pic 9 Desc.</b>		<b>Pic 10 Desc.</b>			
Insert image here		Insert image here			
<b>GPS Location</b>		<b>GPS Location</b>			
<b>Field Station#</b>		<b>Field Station#</b>			
<b>Pic 11 Desc.</b>		<b>Pic 12 Desc.</b>

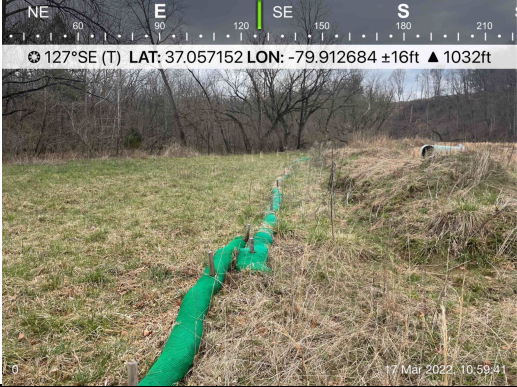
<b>GPS Location</b>	See photo		<b>GPS Location</b>	See photo	
<b>Field Station#</b>	13880+00		<b>Field Station#</b>	13887+00	
<b>Pic 7 Desc.</b>	Perimeter CFS is in good condition		<b>Pic 8 Desc.</b>	Slope drain outlet is in good condition

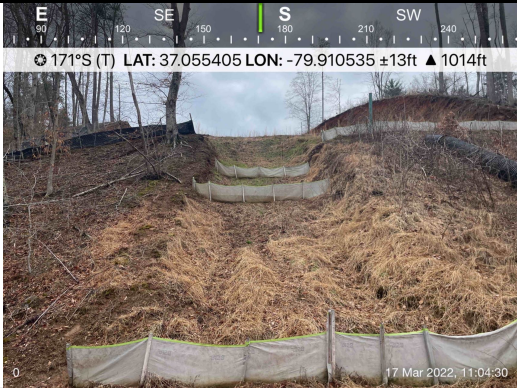
<b>GPS Location</b>	See photo		<b>GPS Location</b>	See photo	
<b>Field Station#</b>	13887+00		<b>Field Station#</b>	13890+00	
<b>Pic 9 Desc.</b>	Slope drain remains in good condition		<b>Pic 10 Desc.</b>	Steep slope above W-CD5 is stabilized with controls in place

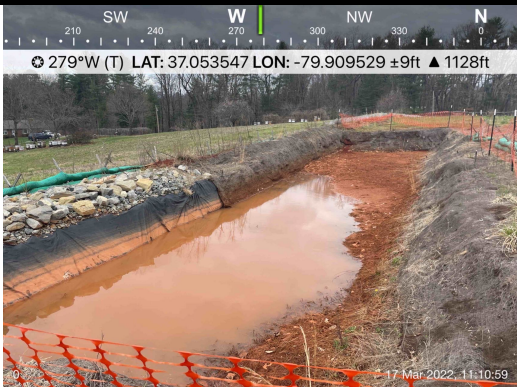
<b>GPS Location</b>	See photo		<b>GPS Location</b>	See photo	
<b>Field Station#</b>	13892+45		<b>Field Station#</b>	13897+00	
<b>Pic 11 Desc.</b>	RCEs are in good condition at all road crossings		<b>Pic 12 Desc.</b>	Sediment trap is in good condition with no evidence of discharge from outlet.

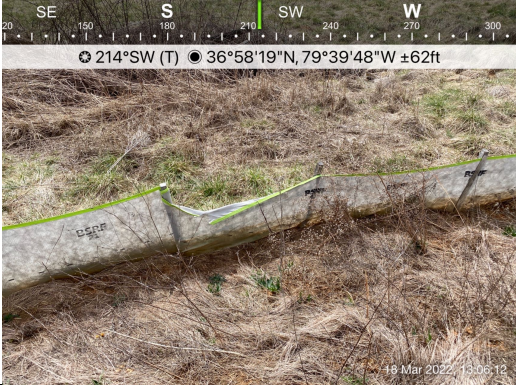
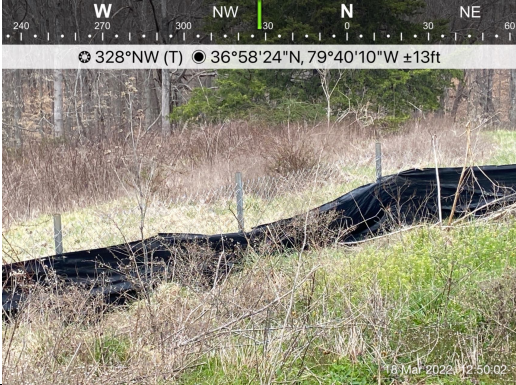
<b>GPS Location</b>	0	<b>GPS Location</b>	0		
<b>Field Station#</b>	14851+00	<b>Field Station#</b>	14833+50		
<b>Pic 7 Desc.</b>	Approximately 14851+00. P-1 requires maintenance. Damaged by wildlife. Contractor on-site and repaired.		<b>Pic 8 Desc.</b>	Approximately 14833+50. SSF requires maintenance. Reattach fabric to chain link. Contractor on-site and repaired.	
Insert image here		Insert image here			
<b>GPS Location</b>		<b>GPS Location</b>			
<b>Field Station#</b>		<b>Field Station#</b>			
<b>Pic 9 Desc.</b>		<b>Pic 10 Desc.</b>			
Insert image here		Insert image here			
<b>GPS Location</b>		<b>GPS Location</b>			
<b>Field Station#</b>		<b>Field Station#</b>			
<b>Pic 11 Desc.</b>		<b>Pic 12 Desc.</b>

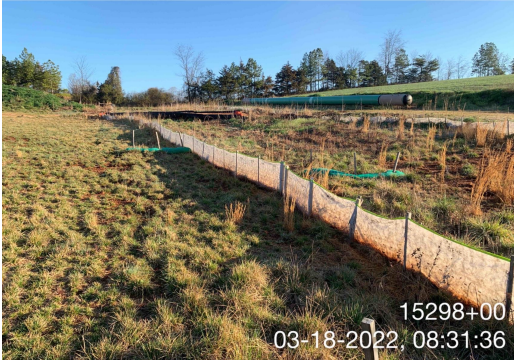
<b>GPS Location</b>	0	<b>GPS Location</b>	0		
<b>Field Station#</b>	15298+00	<b>Field Station#</b>	15303+00		
<b>Pic 1 Desc.</b>	P1 silt fence in acceptable condition	<b>Pic 2 Desc.</b>	Plunge pool in acceptable condition

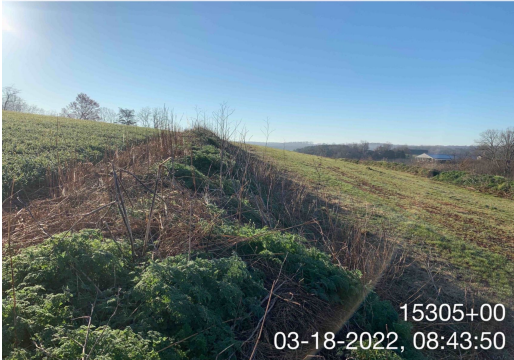
<b>GPS Location</b>	0	<b>GPS Location</b>	0		
<b>Field Station#</b>	15305+00	<b>Field Station#</b>	15316+00		
<b>Pic 3 Desc.</b>	Clean water diversion berm and temporary vegetative stabilization in acceptable conditions	<b>Pic 4 Desc.</b>	Waterbar in acceptable condition

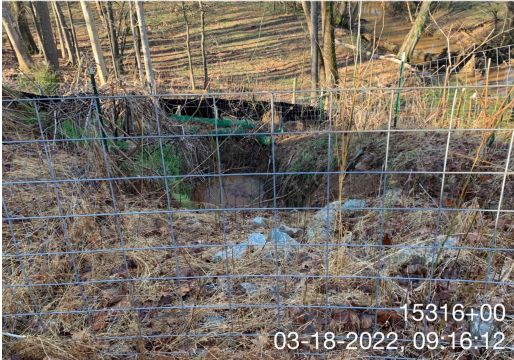
<b>GPS Location</b>	0	<b>GPS Location</b>	0		
<b>Field Station#</b>	15316+00	<b>Field Station#</b>	15316+00		
<b>Pic 5 Desc.</b>	Waterbar end treatment in acceptable condition	<b>Pic 6 Desc.</b>	Super silt fence in acceptable condition

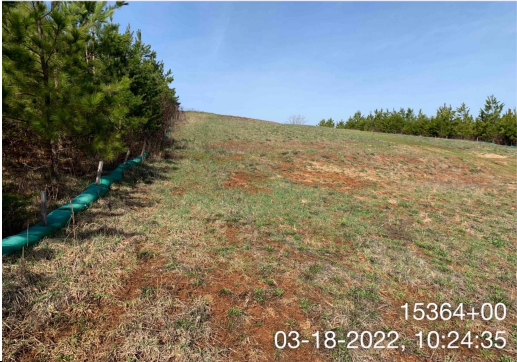
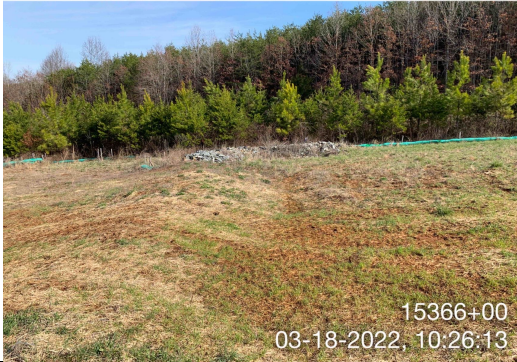
<b>GPS Location</b>	0	<b>GPS Location</b>	0		
<b>Field Station#</b>	15364+00	<b>Field Station#</b>	15366+00		
<b>Pic 7 Desc.</b>	Permanent vegetative stabilization and perimeter CFS in acceptable conditions		<b>Pic 8 Desc.</b>	Waterbar in acceptable condition	
Insert image here			Insert image here		
<b>GPS Location</b>		<b>GPS Location</b>			
<b>Field Station#</b>		<b>Field Station#</b>			
<b>Pic 9 Desc.</b>			<b>Pic 10 Desc.</b>		
Insert image here			Insert image here		
<b>GPS Location</b>		<b>GPS Location</b>			
<b>Field Station#</b>		<b>Field Station#</b>			
<b>Pic 11 Desc.</b>			<b>Pic 12 Desc.</b>
