Visual Site Inspection Report

Project Name	H-600 Pipeline Spread I	AFE	124300139	Spread	H-600 Pipeline Spread I
Contractor	Precision			Report #	35664
Inspector	Justin Burch			Date/Time	3/21/2022 10:18 AM
Permit #	TBD	Inspection Type	VA SWPP	Station Begin	15370+62
State	VA	Inspection Area	Full	Station End	15480+67
County	Pittsylvania	Ground	Damp	Temperature (°F)	72.00
Municipality	Chatham	Weather	Sunny	Rain Gauge (in)	0.90
				Rain Accumulation Time (days)	6.00

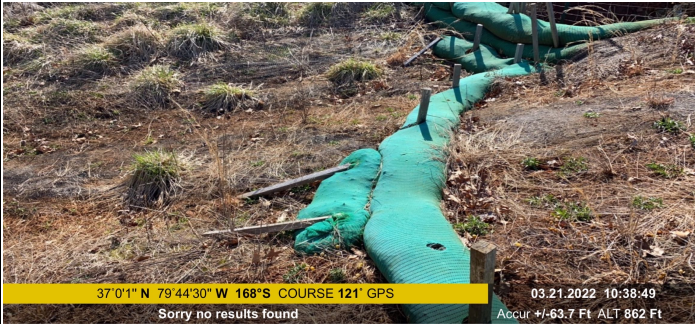
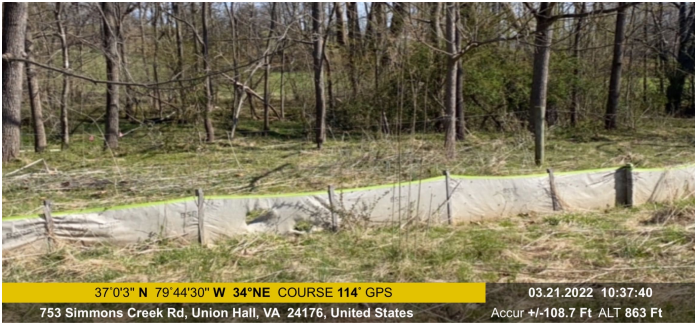
37°0'1" N 79°44'30" W 168°S COURSE 121° GPS 03.21.2022 10:38:49 Sorry no results found Accur +/-63.7 Ft ALT 862 Ft			37°0'3" N 79°44'30" W 34°NE COURSE 114° GPS 03.21.2022 10:37:40 753 Simmons Creek Rd, Union Hall, VA 24176, United States Accur +/-108.7 Ft ALT 863 Ft		
GPS Location	1	GPS Location	2		
Field Station#	14585+00	Field Station#	14584+00		
Pic 1 Desc.	Routine maintenance. Replace damaged/missing stakes in CFS.		Pic 2 Desc.	Routine maintenance. Replace damaged row of P1 silt fence in extra workspace.

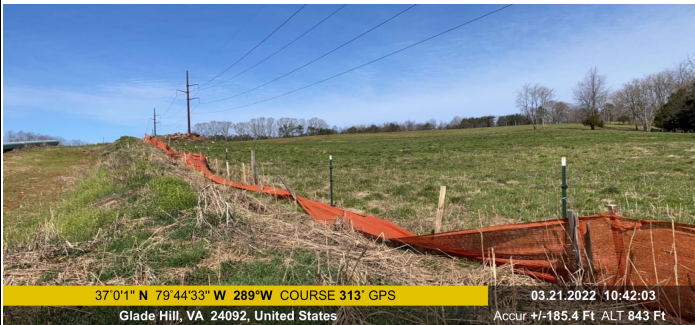
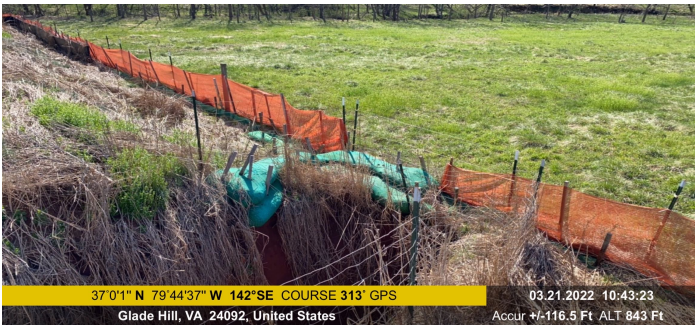
Pic 3 Desc.	Routine maintenance. Repair perimeter safety fence.		Pic 4 Desc.	Routine maintenance. CFS end treatment beginning to fall into sump pit.

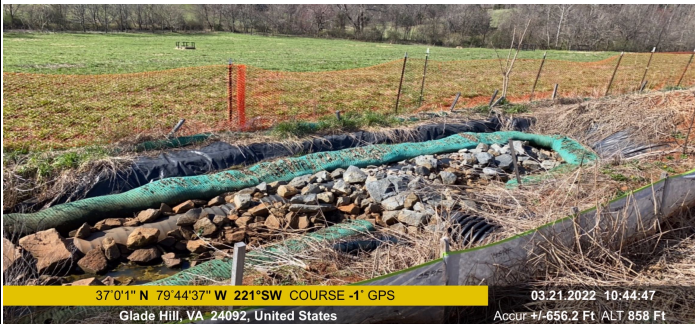
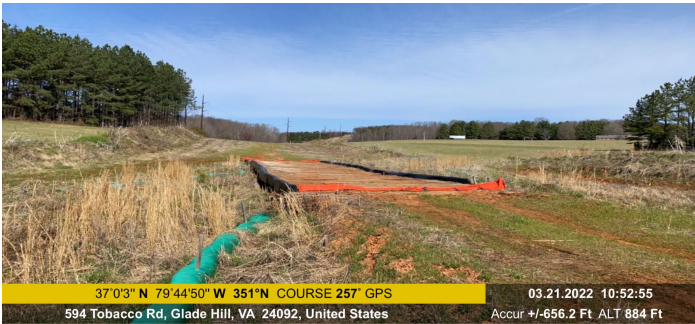
37°0'1" N 79°44'37" W 221°SW COURSE -1° GPS 03.21.2022 10:44:47 Glade Hill, VA 24092, United States Accur +/-656.2 Ft ALT 858 Ft			37°0'3" N 79°44'50" W 351°N COURSE 257° GPS 03.21.2022 10:52:55 594 Tobacco Rd, Glade Hill, VA 24092, United States Accur +/-656.2 Ft ALT 884 Ft		
GPS Location	5	GPS Location	6		
Field Station#	14576+00	Field Station#	14558+01		
Pic 5 Desc.	Routine maintenance. Replace damaged/worn CFS in plunge pool.		Pic 6 Desc.	Natural drainage area and equipment bridge crossing in place and functional.

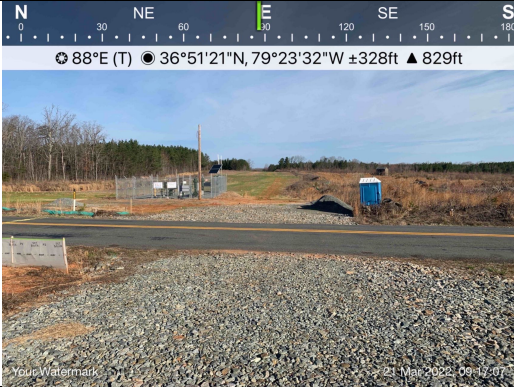
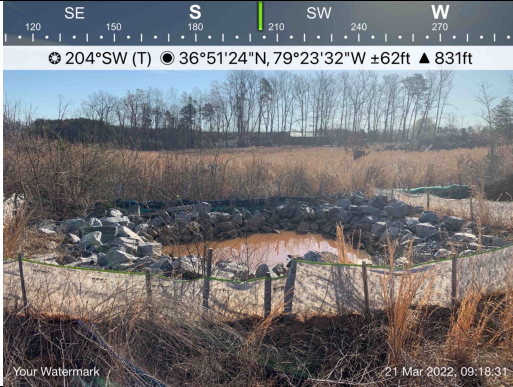
GPS Location	O	GPS Location	O		
Field Station#	15826+77	Field Station#	15825+00		
Pic 1 Desc.	Observing road crossing and RCE's	Pic 2 Desc.	Observing plunge pool and ECD's

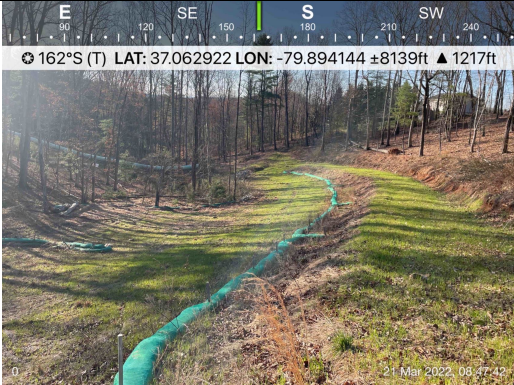
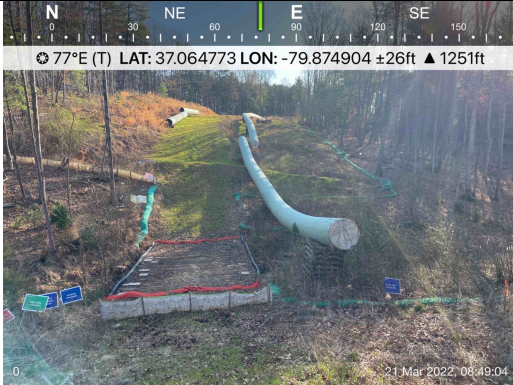
GPS Location	See photo		GPS Location	See photo	
Field Station#	14065+00		Field Station#	14066+77	
Pic 1 Desc.	Vegetation continues to fill in throughout this section		Pic 2 Desc.	Equipment bridge ECDs are in good condition and functioning

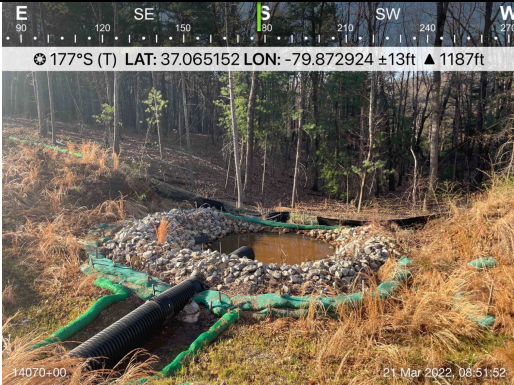
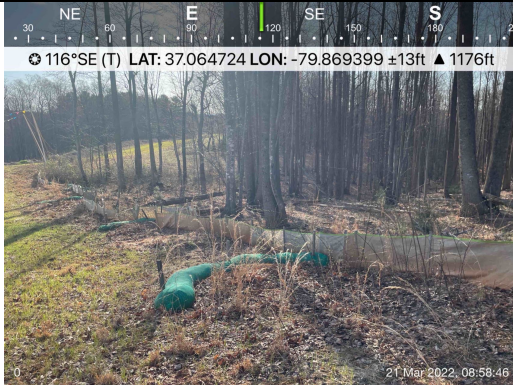
GPS Location	See photo		GPS Location	See photo	
Field Station#	14070+00		Field Station#	14082+00	
Pic 3 Desc.	CWD is functioning as intended		Pic 4 Desc.	Perimeter P1 is in good condition throughout this section

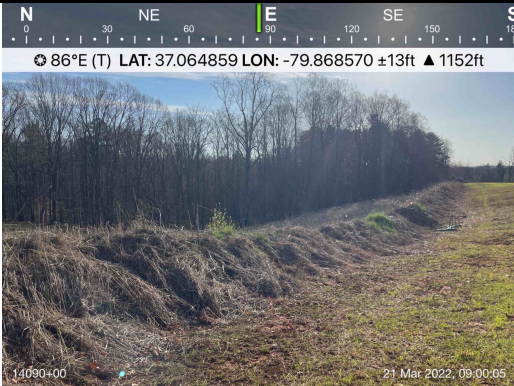
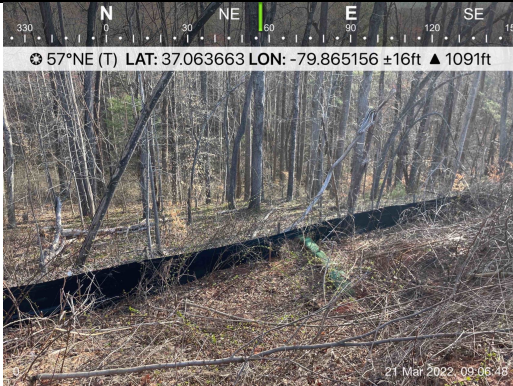
GPS Location	See photo		GPS Location	See photo	
Field Station#	14090+00		Field Station#	14100+00	
Pic 5 Desc.	Topsoil berm remains stabilized		Pic 6 Desc.	SSF is in good condition throughout this section

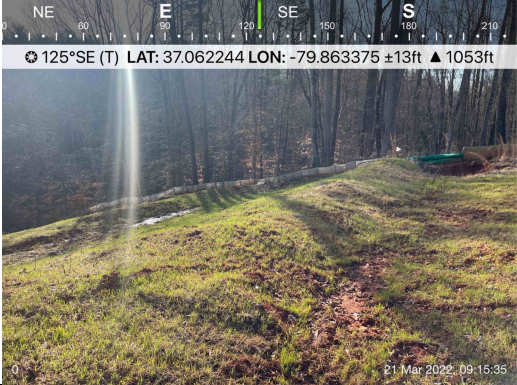
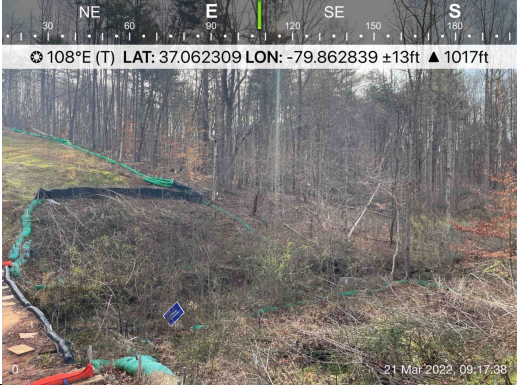
GPS Location	See photo		GPS Location	See photo	
Field Station#	14103+00		Field Station#	14105+32	
Pic 7 Desc.	Waterbars are in good condition		Pic 8 Desc.	Resource buffers remain well vegetated

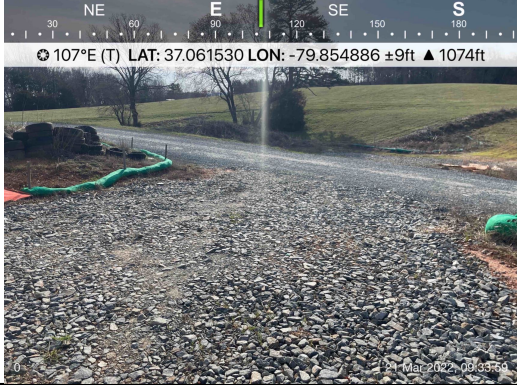
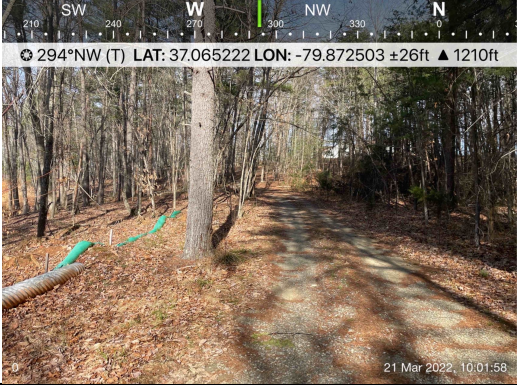
GPS Location	See photo		GPS Location	See photo	
Field Station#	14131+28		Field Station#	14072+70	
Pic 9 Desc.	RCEs are in good condition at all road crossings		Pic 10 Desc.	MVP-FR-309.05 remains in good condition with controls in place.

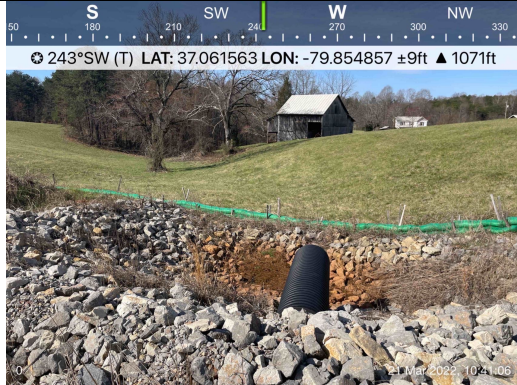
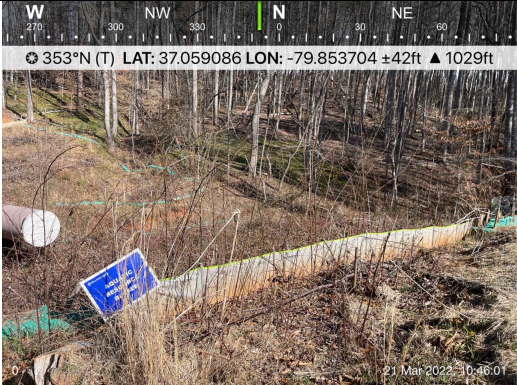
GPS Location	See photo		GPS Location	See photo	
Field Station#	14133+00		Field Station#	14141+62	
Pic 11 Desc.	CWD is functioning as intended		Pic 12 Desc.	P1 is in good condition at all stream and wetland buffers

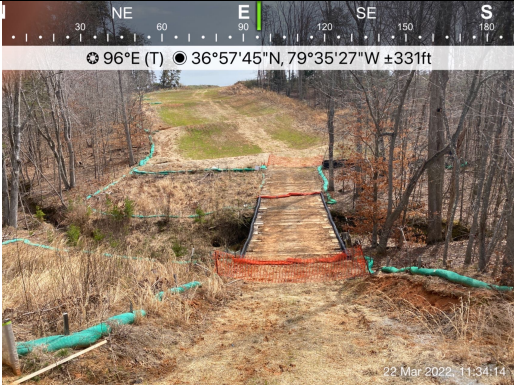
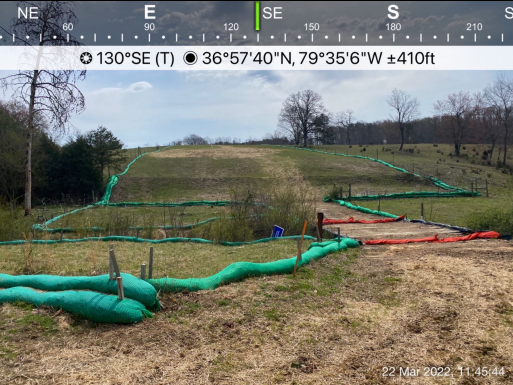
GPS Location	0		GPS Location	0	
Field Station#	15072+86		Field Station#	15092+95	
Pic 1 Desc.	Approximately 15072+86. Overview of stream crossing, equipment bridge and ECDs at stream S-G11.		Pic 2 Desc.	Approximately 15092+95. Overview of stream crossing, equipment bridge and ECDs at stream S-G9.

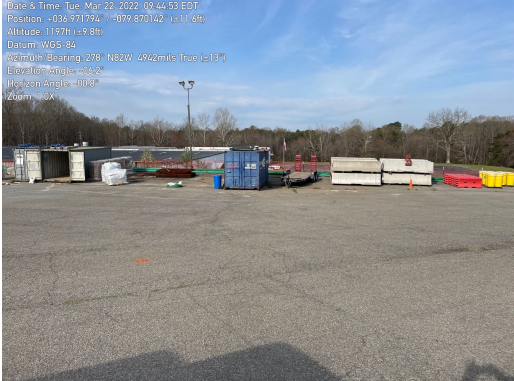
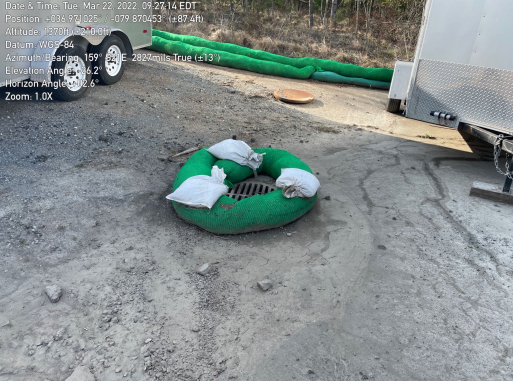
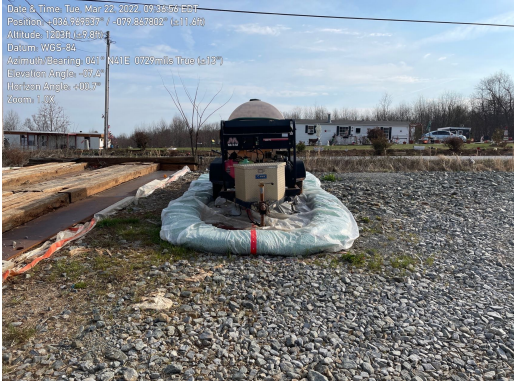
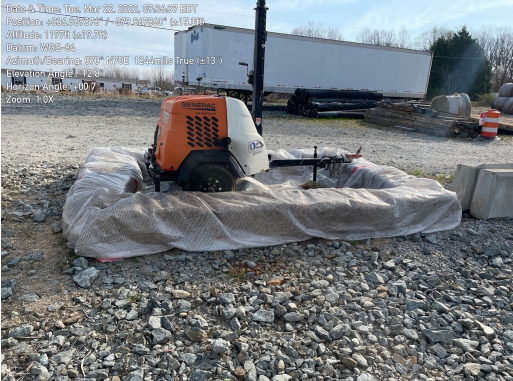
<p><small>Date & Time: Tue Mar 22, 2022 09:27:14 EDT Position: +036°57'07.74" N, -079°57'04.53" W ±11.24ft Altitude: 11197ft ±19.30ft Datum: WGS-84 Azimuth Bearing: 159° S01E 2822mils True ±13 ft Elevation Angle: +0.2° Horizon Angle: +00.3° Zoom: 1.0x</small></p>			
GPS Location	See picture	GPS Location	See picture		
Field Station#	0000+00	Field Station#	00+00		
Pic 1 Desc.	Housekeeping in order at LY-046.	Pic 2 Desc.	Inlet protection and perimeter ECD's in good condition at LY-046.

GPS Location	See picture	GPS Location	See picture		
Field Station#	0000+00	Field Station#	0000+00		
Pic 3 Desc.	Secondary containment structure for near station at LY-045 in good condition.	Pic 4 Desc.	Secondary containment structure for light plant at LY-046 in good condition.

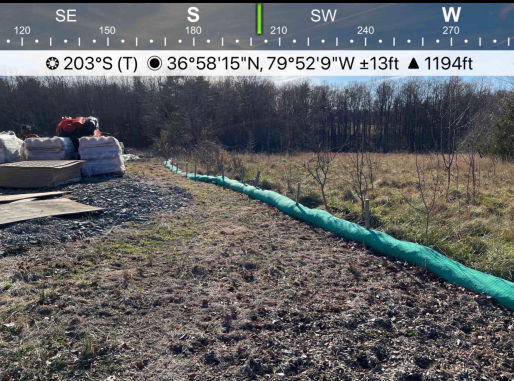
<p><small>SE 120 150 S 180 210 SW 240 W 270 203°S (T) 36°58'15"N, 79°52'9"W ±13ft ▲ 1194ft</small></p>		Insert image here			
GPS Location	See picture	GPS Location			
Field Station#	0000+00	Field Station#			
Pic 5 Desc.	Perimeter ECD's on north end of LY-045 in acceptable condition.	Pic 6 Desc.

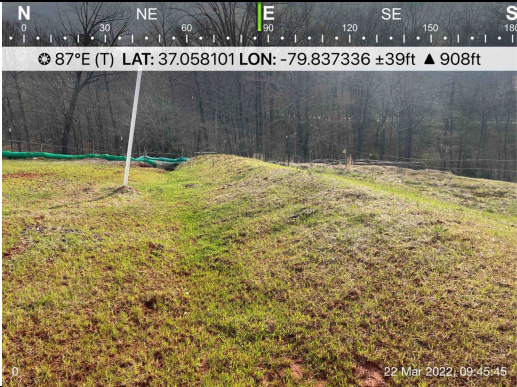
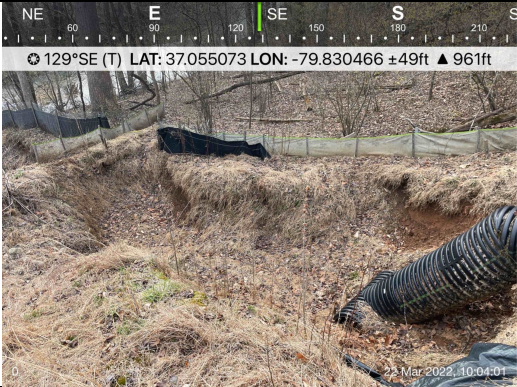
GPS Location	See photo		GPS Location	See photo	
Field Station#	14206+00		Field Station#	14232+00	
Pic 7 Desc.	Waterbars are in good condition		Pic 8 Desc.	Slope drain is in good condition and functioning

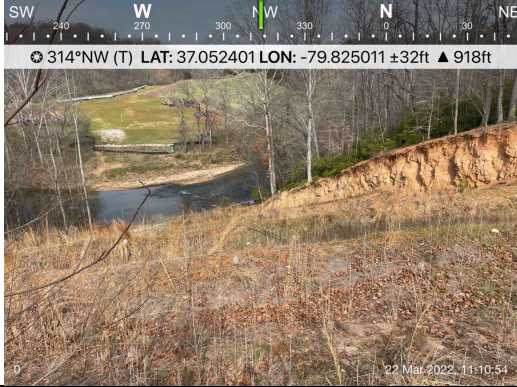
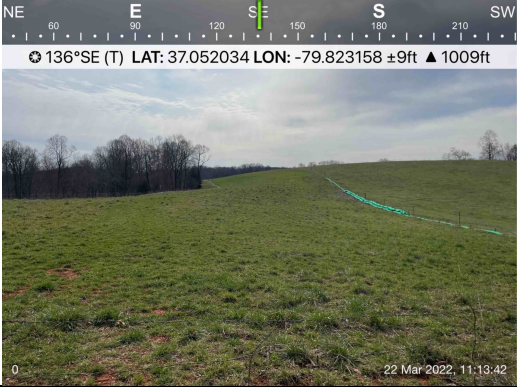
GPS Location	See photo		GPS Location	See photo	
Field Station#	14252+00		Field Station#	14260+00	
Pic 9 Desc.	Slope remains stabilized and ECDs are in good condition.		Pic 10 Desc.	Vegetation continues to fill in throughout this section

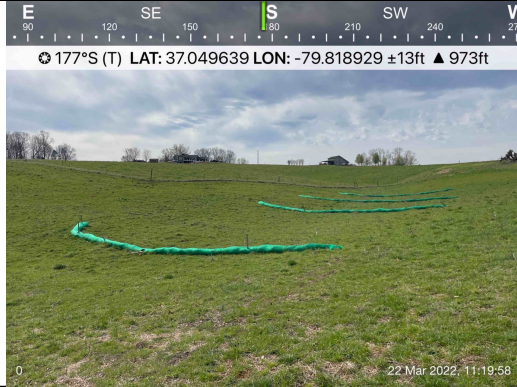
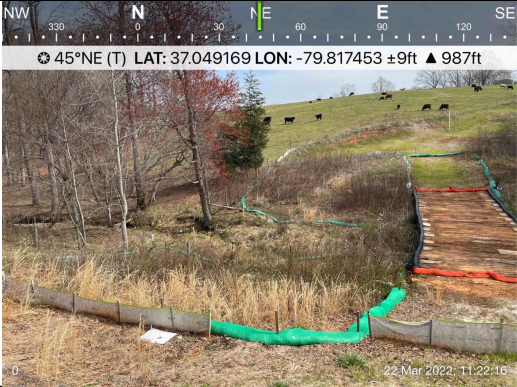
GPS Location	See photo		GPS Location	See photo	
Field Station#	14274+00		Field Station#	14278+93	
Pic 11 Desc.	CFS is in good condition along this drainage.		Pic 12 Desc.	Resource buffers remain well vegetated.

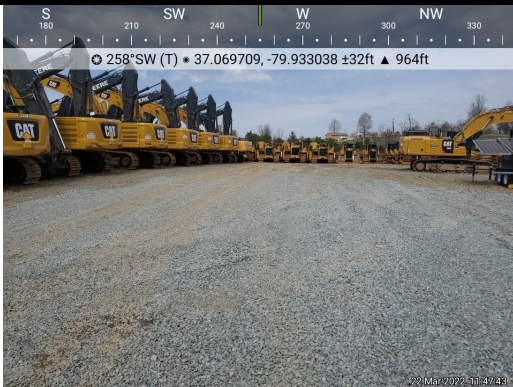
GPS Location	0		GPS Location	0	
Field Station#	0+00		Field Station#	0+00	
Pic 1 Desc.	LY-032 Rock entrance		Pic 2 Desc.	LY-032 Secondary containment needs maintenance

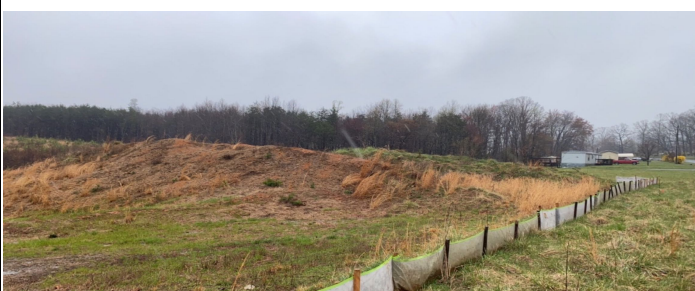
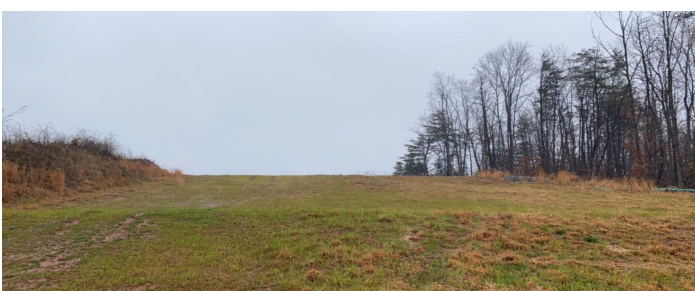
37°2'34" N 79°48'36" W 179°S COURSE 216° GPS 362-532 Farm View Rd, Glade Hill, VA 24092, United States 03.23.2022 12:00:09 Accur +/-15.4 Ft ALT 1059 Ft			37°2'20" N 79°48'19" W 304°NW COURSE 79° GPS 1807 Golden View Rd, Glade Hill, VA 24092, United States 03.23.2022 12:02:56 Accur +/-15.4 Ft ALT 1185 Ft		
GPS Location	1	GPS Location	2		
Field Station#	14313+00	Field Station#	14325+00		
Pic 1 Desc.	Perimeter P1 silt fence in good condition. Spoil pile stabilized and vegetated.		Pic 2 Desc.	ROW stabilized and vegetated in temporary area; perimeter controls and ECDs in place and functional.

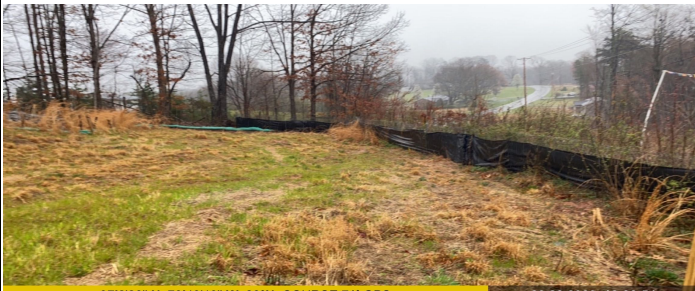
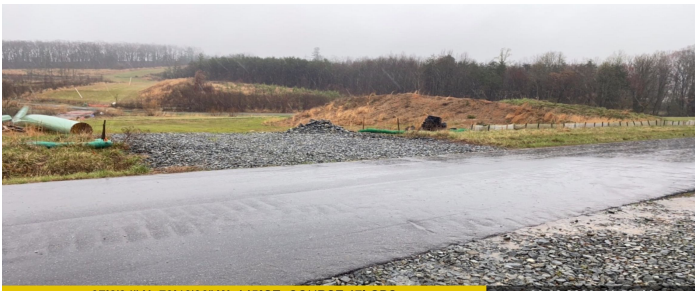
GPS Location	3	GPS Location	4		
Field Station#	14333+00	Field Station#	14311+57		
Pic 3 Desc.	Perimeter SSF and CFS in place and functional.		Pic 4 Desc.	RCE in good condition.

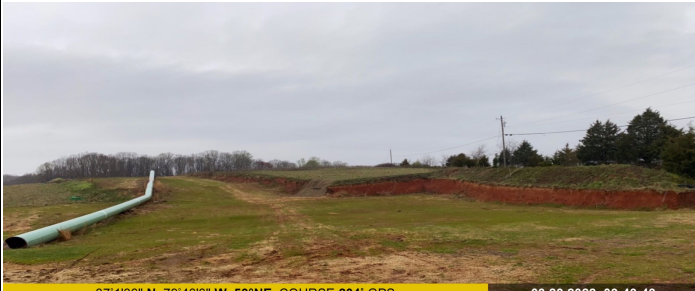
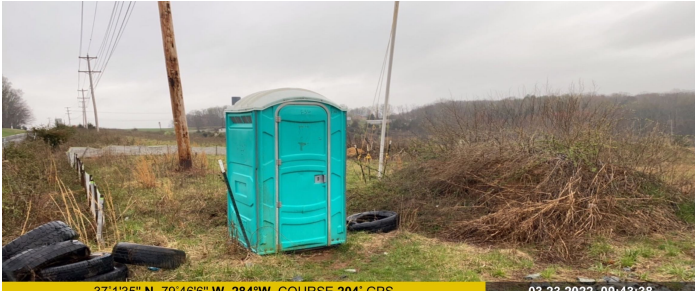
37°1'36" N 79°46'6" W 53°NE COURSE 204° GPS 2753-2799 Webster Rd, Glade Hill, VA 24092, United States 03.23.2022 09:43:49 Accur +/-46.7 Ft ALT 1104 Ft			37°1'35" N 79°46'6" W 284°W COURSE 204° GPS 2753-2799 Webster Rd, Glade Hill, VA 24092, United States 03.23.2022 09:43:38 Accur +/-15.4 Ft ALT 1104 Ft		
GPS Location	5	GPS Location	6		
Field Station#	14450+00	Field Station#	14454+00		
Pic 5 Desc.	ROW stabilized and vegetated in temporary area; perimeter controls and ECDs in place and functional.		Pic 6 Desc.	Portajon properly contained in secondary containment at road crossing.

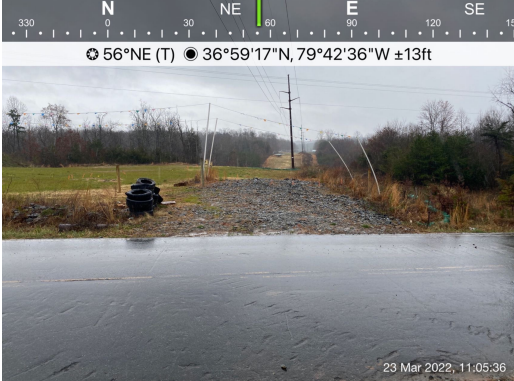
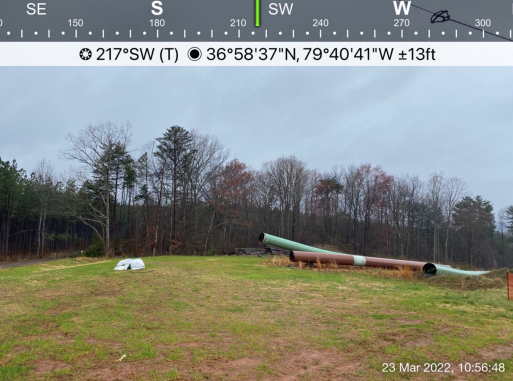
GPS Location	0	GPS Location	0		
Field Station#	14695+00	Field Station#	14801+50		
Pic 1 Desc.	Approximately 14695+00. Overview of road crossing and RCE.	Pic 2 Desc.	Approximately 14801+50. Overview of ROW.

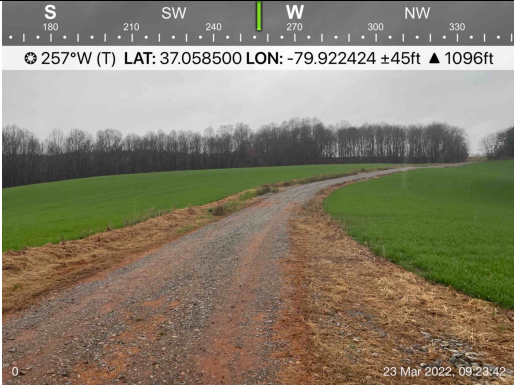
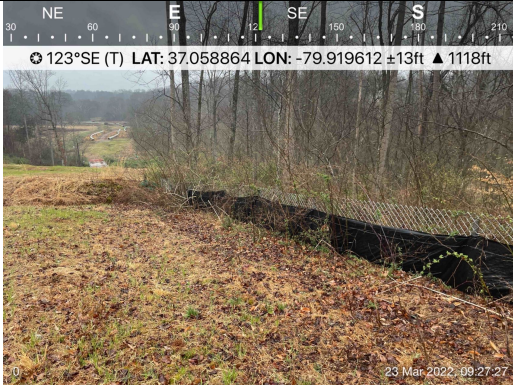
GPS Location	See photo		GPS Location	See photo	
Field Station#	13853+45		Field Station#	13860+00	
Pic 1 Desc.	MVP-FR-303.1 is in good condition with controls in place		Pic 2 Desc.	SSF is in good condition

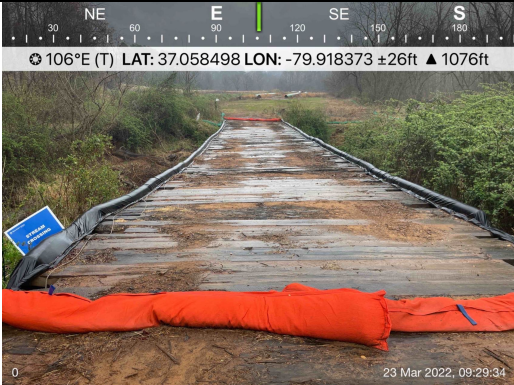
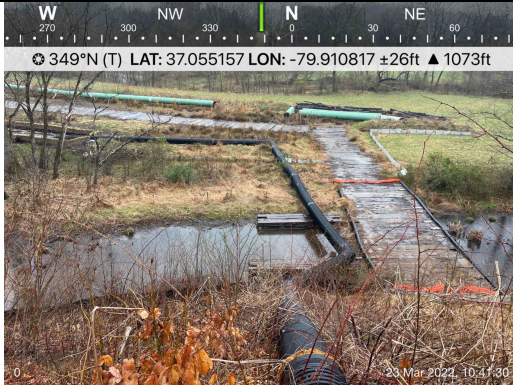
GPS Location	See photo		GPS Location	See photo	
Field Station#	13862+60		Field Station#	13889+00	
Pic 3 Desc.	Equipment bridge ECDs are in good condition and functioning		Pic 4 Desc.	Slope drain is functioning as intended

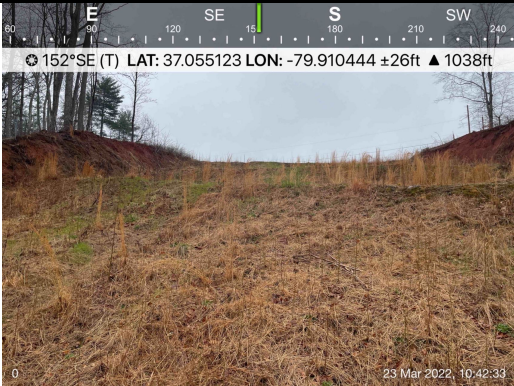
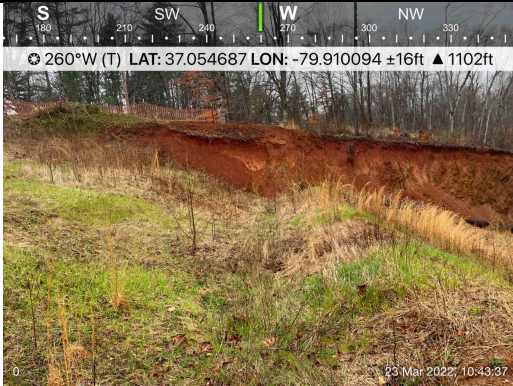
GPS Location	See photo		GPS Location	See photo	
Field Station#	13890+00		Field Station#	13892+00	
Pic 5 Desc.	Slope on the CIS of Iron Ridge Rd. remains stabilized with controls in place		Pic 6 Desc.	Waterbars are functioning as intended

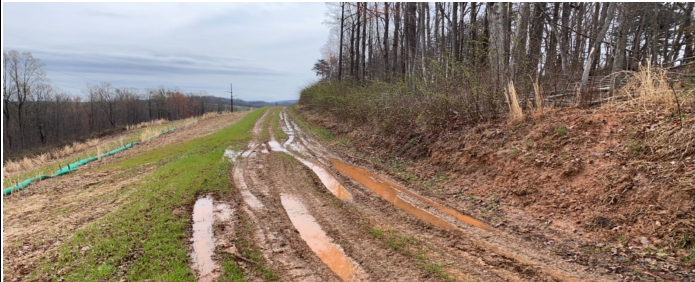
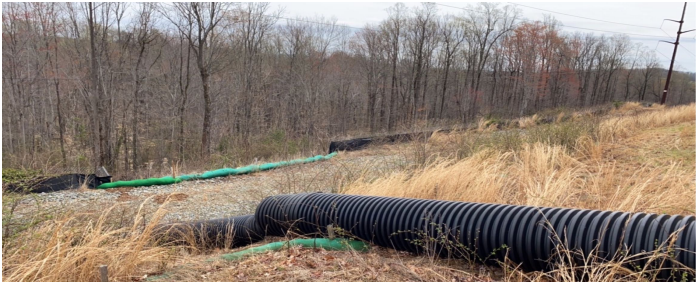
37°13'4" N 79°46'4" W 141°SE COURSE 101' GPS 2750 Webster Rd, Glade Hill, VA 24092, United States 03.24.2022 11:03:46 Accur +/-15.3 Ft ALT 0 Ft			37°13'1" N 79°46'0" W 148°SE COURSE -1' GPS Glade Hill, VA 24092, United States 03.24.2022 11:06:47 Accur +/-87.9 Ft ALT 1101 Ft		
GPS Location	1	GPS Location	2		
Field Station#	14457+00	Field Station#	14460+00		
Pic 1 Desc.	Minor rutting occurring in travel lane. Will monitor for signs of worsening.		Pic 2 Desc.	CWD pipe in good condition; contractor replaced perimeter CFS per punch list item.

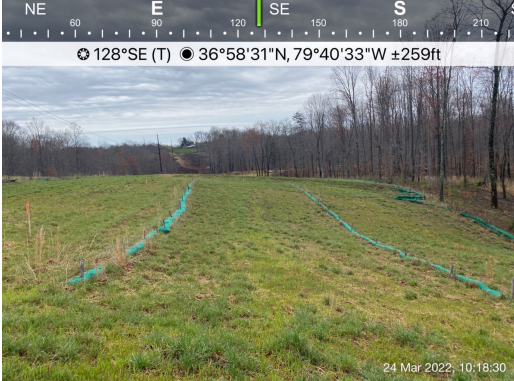
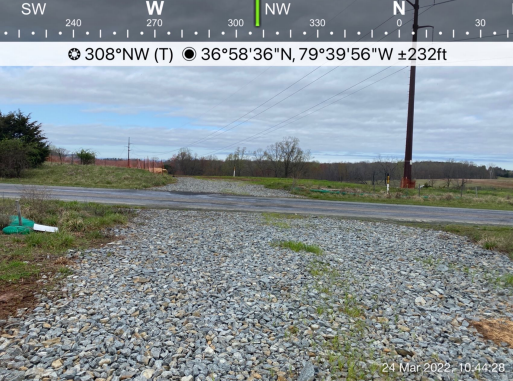
GPS Location	0	GPS Location	0		
Field Station#	14812+00	Field Station#	14845+75		
Pic 1 Desc.	Approximately 14812+00. Overview of ROW.		Pic 2 Desc.	Approximately 14845+75. Overview of road crossing and RCEs.

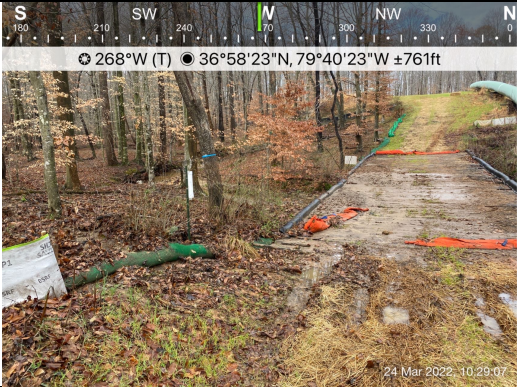
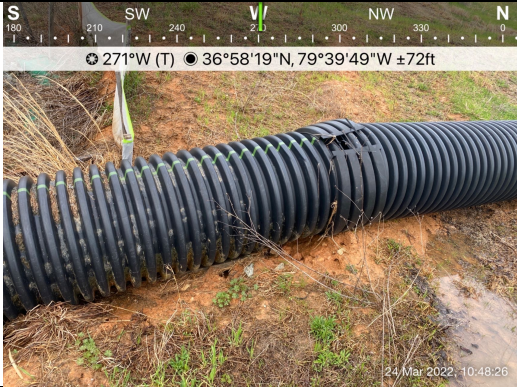
GPS Location	0	GPS Location	0		
Field Station#	14823+50	Field Station#	14850+80		
Pic 7 Desc.	Approximately 14823+50. Sediment from beyond LOD migrated onto LOD and onto equipment bridge. Caused by rain event 03/22/22 and last rain event 03/24/22		Pic 8 Desc.	Approximately 14850+80. CWD piping requires maintenance.

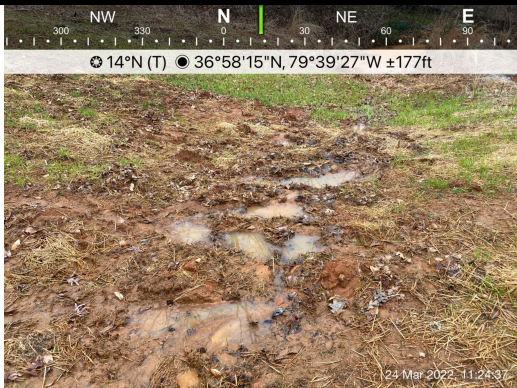
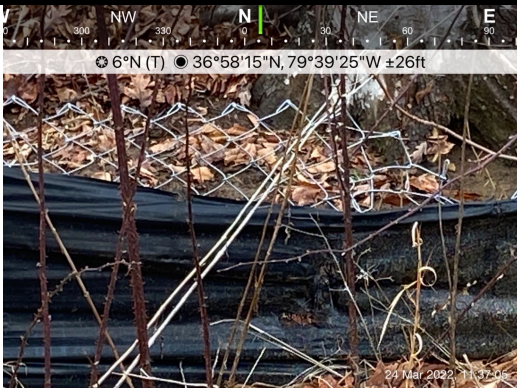
GPS Location	0	GPS Location	0		
Field Station#	14855+40	Field Station#	14871+50		
Pic 9 Desc.	Approximately 14855+40. Breaker trough requires maintenance. Pooling issue. Remove sediment and debris.		Pic 10 Desc.	Approximately 14871+50. SSF requires maintenance. Holes in fabric

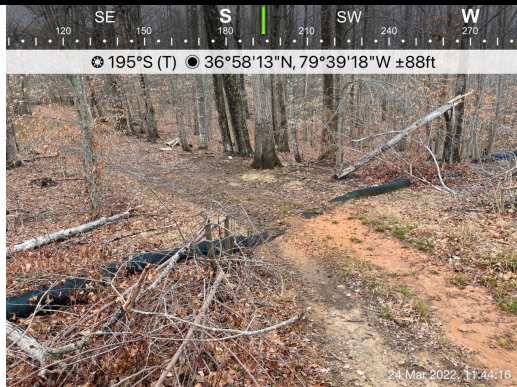
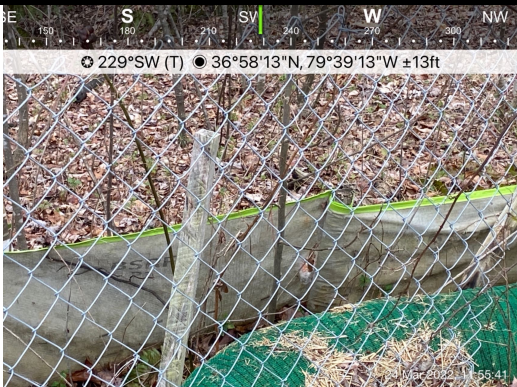
GPS Location	0	GPS Location	0		
Field Station#	14877+00	Field Station#	14881+75		
Pic 11 Desc.	Approximately 14877+00. LOD CFS damaged by third party.		Pic 12 Desc.	Approximately 14881+75. P-1 requires maintenance. Repair/remove. Secondary ECD.

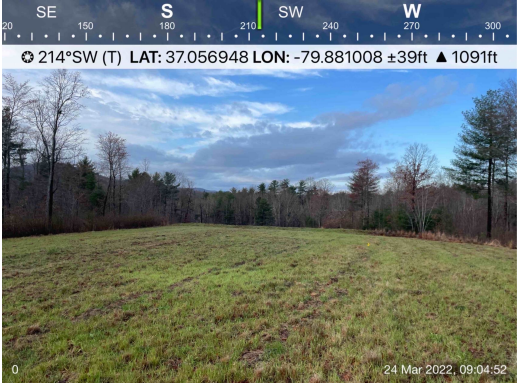
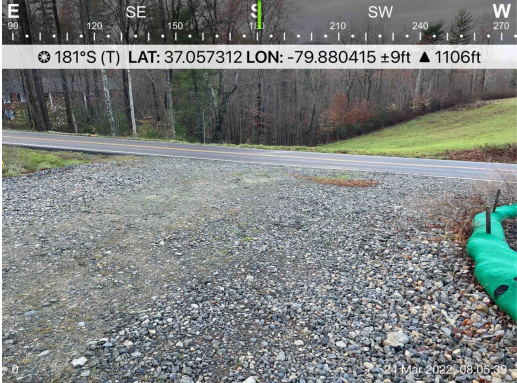
GPS Location	See photo		GPS Location	See photo	
Field Station#	14015+00		Field Station#	14018+47	
Pic 7 Desc.	Vegetation continues to fill in throughout this section		Pic 8 Desc.	RCEs are in good condition at all road crossings.

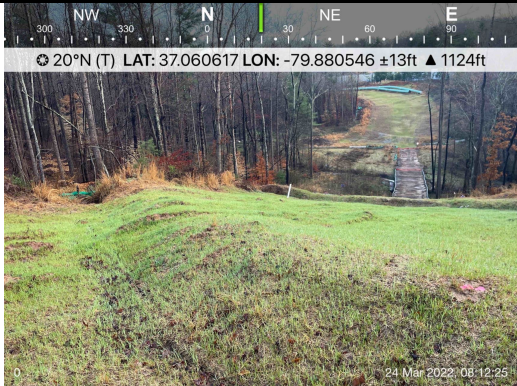
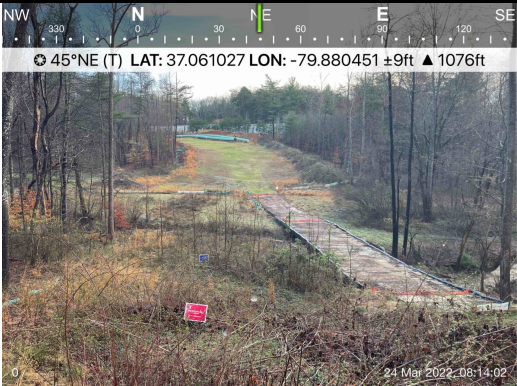
GPS Location	See photo		GPS Location	See photo	
Field Station#	14033+00		Field Station#	14035+28	
Pic 9 Desc.	Waterbars are in good condition and functioning		Pic 10 Desc.	Resource buffers remain well vegetated

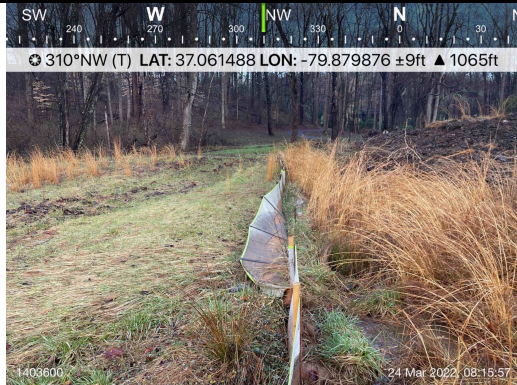
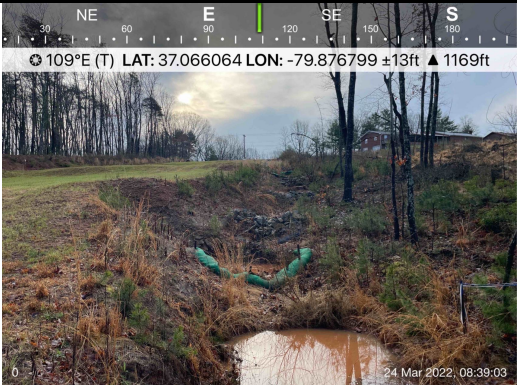
GPS Location	See photo		GPS Location	See photo	
Field Station#	14036+00		Field Station#	14057+50	
Pic 11 Desc.	P1 has been damaged and needs to be replaced		Pic 12 Desc.	Rock check dams are functioning along drainage.

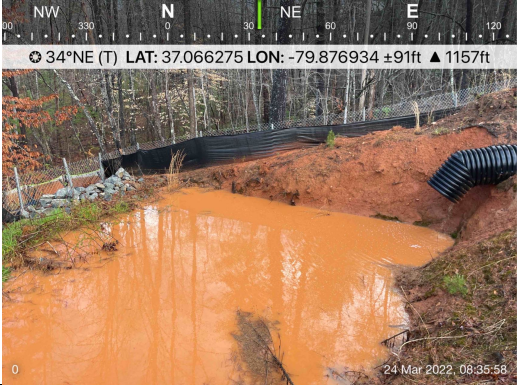
GPS Location	See photo	GPS Location			
Field Station#	14057+50	Field Station#			
Pic 13 Desc.	Slope drain is functioning as intended.	Pic 14 Desc.			
Insert image here		Insert image here			
GPS Location		GPS Location			
Field Station#		Field Station#			
Pic 15 Desc.		Pic 16 Desc.			
Insert image here		Insert image here			
GPS Location		GPS Location			
Field Station#		Field Station#			
Pic 17 Desc.		Pic 18 Desc.

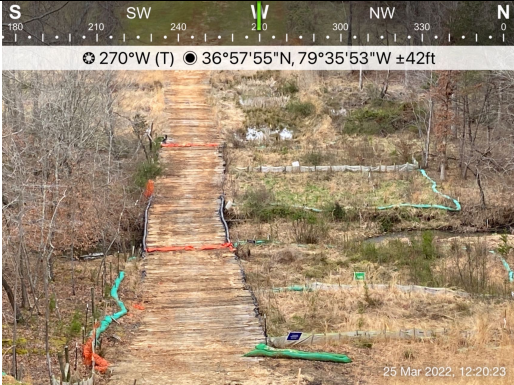
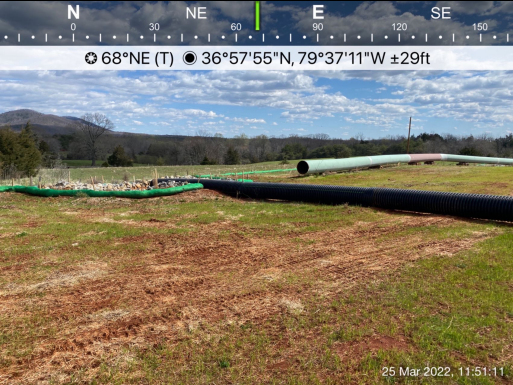
GPS Location	0	GPS Location	0		
Field Station#	15045+00	Field Station#	14984+00		
Pic 1 Desc.	Approximately 15045+00. Overview of stream crossing, equipment bridge and ECDs at stream S-D2.		Pic 2 Desc.	Approximately 14984+00. Overview of ROW.
