Visual Site Inspection Report

Project Name	H-603 Pipeline Spread I		AFE	124300139	Spread	H-603 Pipeline Spread I	
Contractor	Precision				Report #	35929	
Inspector	John White				Date/Time	3/28/2022 11:04 AM	
Permit #	TBD	Inspection Type	VA SWPP		Station Begin	00+00	
State	VA	Inspection Area	Full		Station End	24+53	
County	Pittsylvania	Ground	Damp		Temperature (°F)	44.00	
Municipality	Chatham	Weather	Sunny		Rain Gauge (in)	1.20	
					Rain Accumulation Time (days)	6.00

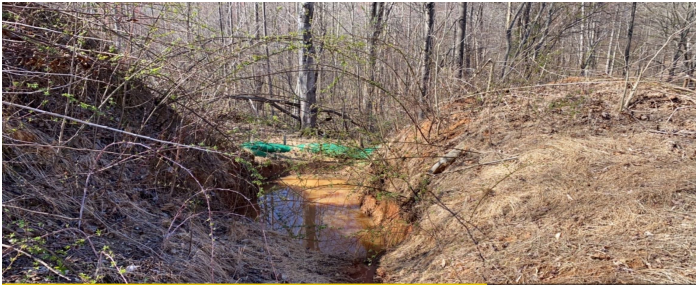
GPS Location	3	GPS Location	4		
Field Station#	14662+00	Field Station#	14672+50		
Pic 3 Desc.	Sump pit and CFS end treatment performing intended functions.	Pic 4 Desc.	Sump pit and perimeter controls performing intended functions.

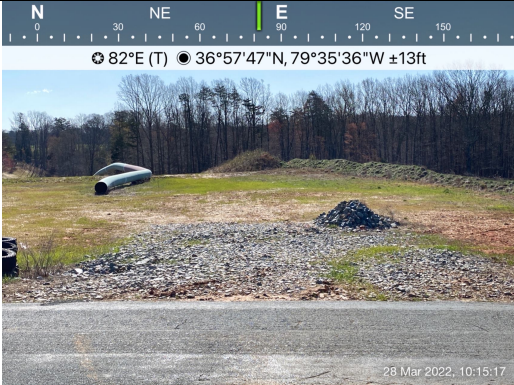
GPS Location	0	GPS Location	0		
Field Station#	15064+00	Field Station#	15084+00		
Pic 1 Desc.	Approximately 15064+00. Overview of road crossing and RCE.		Pic 2 Desc.	Approximately 15084+00. Overview of ROW.

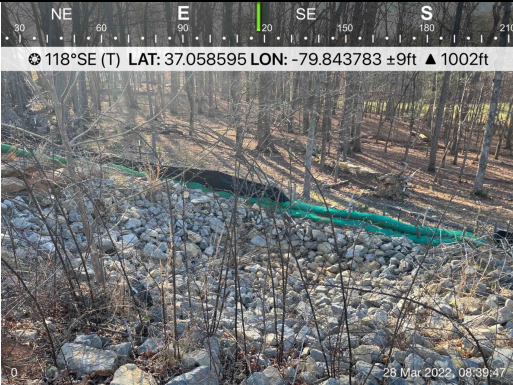
GPS Location	See photo	GPS Location	See photo		
Field Station#	14177+00	Field Station#	14180+00		
Pic 3 Desc.	P1 has been damaged and needs to be replaced	Pic 4 Desc.	CWDs are functioning as intended

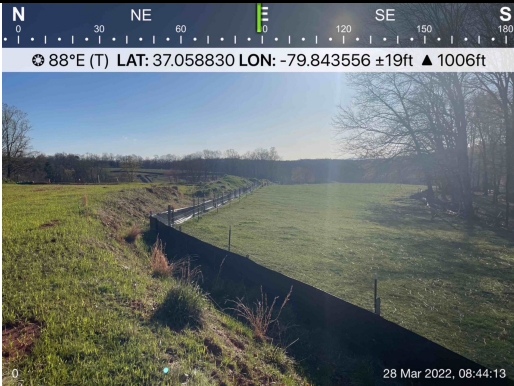
GPS Location	See photo	GPS Location	See photo		
Field Station#	14183+00	Field Station#	14185+00		
Pic 5 Desc.	SSF is in good condition	Pic 6 Desc.	Waterbars are functioning as intended

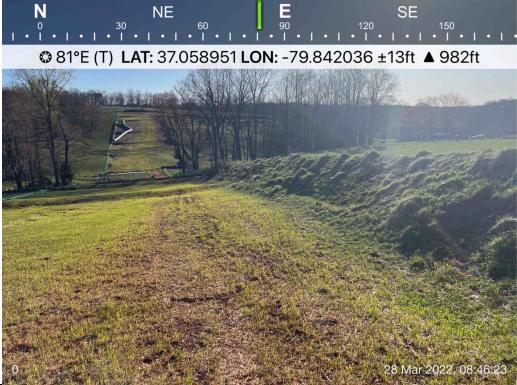
GPS Location	See photo		GPS Location	See photo	
Field Station#	14186+00		Field Station#	14190+00	
Pic 7 Desc.	Topsoil berms remain stabilized		Pic 8 Desc.	Sediment needs to be removed from CFS.

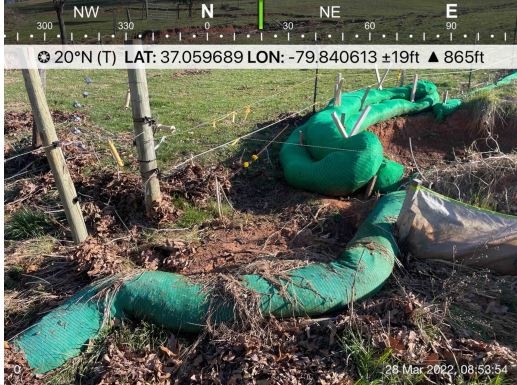
GPS Location	See photo		GPS Location	See photo	
Field Station#	14190+50		Field Station#	14190+50	
Pic 9 Desc.	CFS has been displaced and needs to be restaked		Pic 10 Desc.	P1 has been damaged and needs to be replaced.

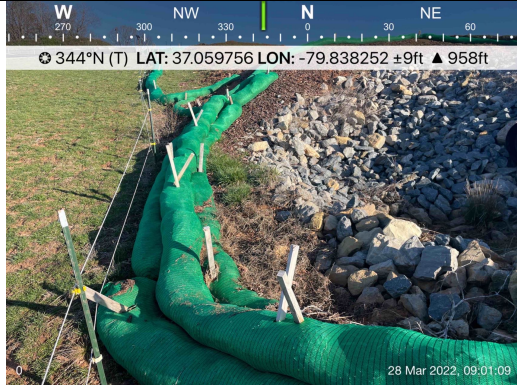
GPS Location	See photo		GPS Location	See photo	
Field Station#	14200+00		Field Station#	14202+00	
Pic 11 Desc.	CFS has been displaced at CWD outlet and needs to be restaked		Pic 12 Desc.	CFS has been displaced and needs to be restaked

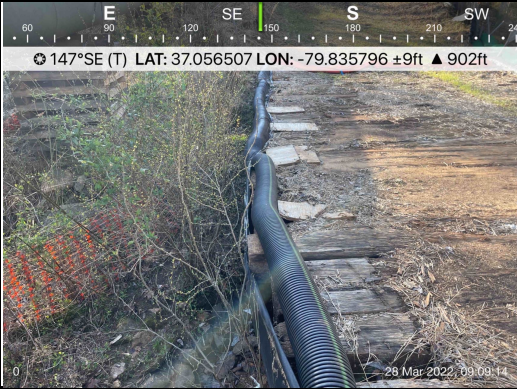
GPS Location	See photo		GPS Location	See photo	
Field Station#	14213+75		Field Station#	14223+41	
Pic 13 Desc.	Equipment bridge fabric needs to be reattached.		Pic 14 Desc.	MVP-FR-311 is in good condition with controls in place.

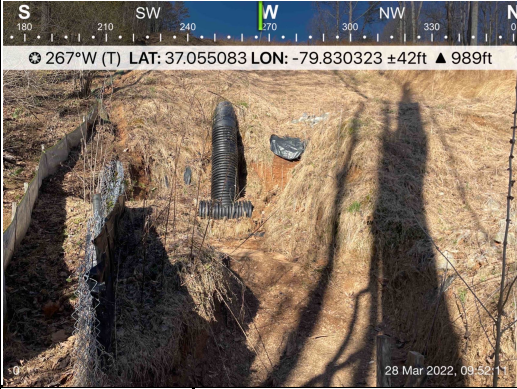
GPS Location	See photo		GPS Location	See photo	
Field Station#	14232+00		Field Station#	14235+19	
Pic 15 Desc.	Slope drain is in good condition		Pic 16 Desc.	CFS has been displaced and needs to be restaked along MVP-MLV-AR-32

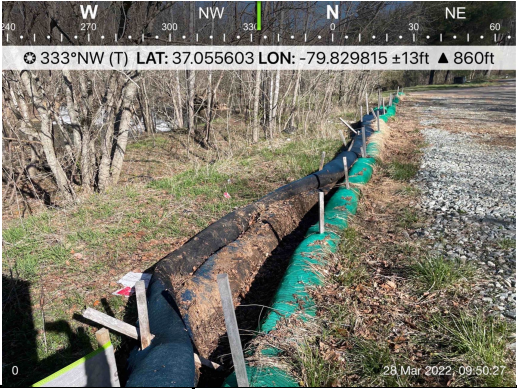
7. Identify all remedial measures that have been taken since the previous inspection was conducted.					
Comments (Reference above questions as appropriate.)					
SWPPP Inspection (Sunny, 35F) Rain Gauge= 0.0" 14171+36-14311+57 -EI began inspection at Angle Plantation Rd. -RCEs are in good condition at all road crossings. -CFS has been displaced and needs to be restaked at 14176+09 -P1 has been damaged and needs to be replaced at 14177+00. -CWD/CWD inlets are in good condition and functioning as intended -SSF is in good condition throughout this section. -Waterbars are in good condition. -Topsoil berms remain stabilized. -Sediment needs to be removed from CFS at 14190+00. (Sediment appears to have been transported by stream and not originating from ROW) -CFS has been displaced and needs to be restaked at 14190+50. -P1 is damaged and needs to be replaced at 14190+50. -CFS needs to be restaked at CWD outlet. (14200+00) -CFS has been displaced and needs to be restaked at 14202+00. -Equipment bridge fabric needs to be reattached at 14213+75. -MVP-FR-311 is in good condition with controls in place. -Slope drain is in good condition and functioning at 14232+00. -CFS has been displaced and needs to be restaked along MVP-MI V-LAP-32

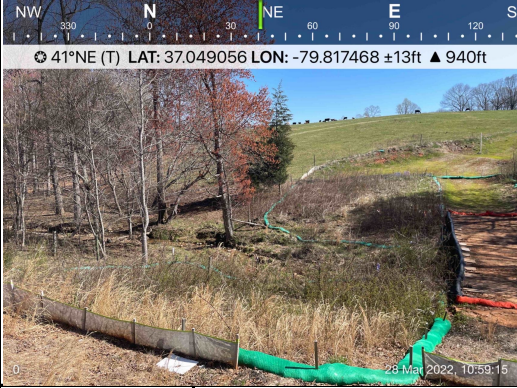
<div>Insert image here</div>			
GPS Location	See photo		GPS Location		
Field Station#	14278+93		Field Station#		
Pic 17 Desc.	Resource buffers remain well vegetated		Pic 18 Desc.

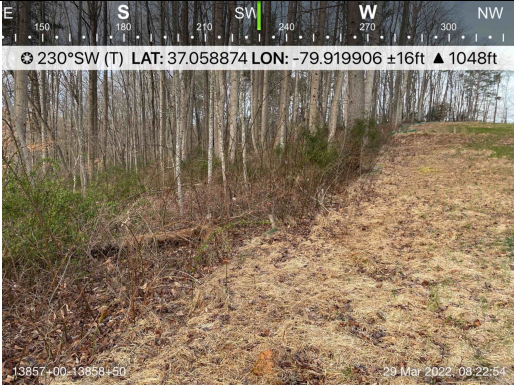
GPS Location	See photo		GPS Location	See photo	
Field Station#	13857+00		Field Station#	13859+00	
Pic 1 Desc.	Perimeter CFS is degraded and needs to be replaced		Pic 2 Desc.	End treatment CFS is degraded and needs to be replaced.

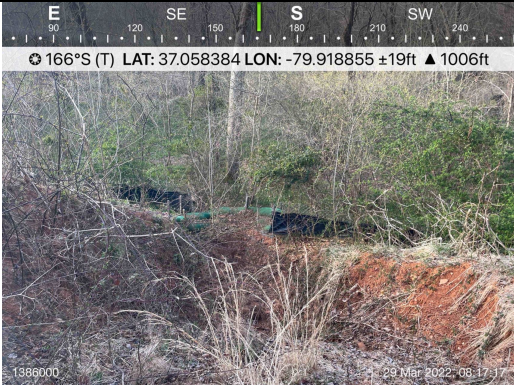
GPS Location	See photo		GPS Location	See photo	
Field Station#	13860+00		Field Station#	13861+78	
Pic 3 Desc.	End treatment CFS is degraded and needs to be replaced.		Pic 4 Desc.	CFS is degraded and needs to be replaced

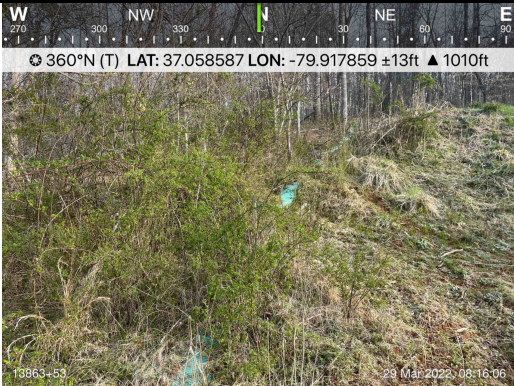
GPS Location	See photo		GPS Location	See photo	
Field Station#	13863+53		Field Station#	13870+12	
Pic 5 Desc.	CFS is degraded and needs to be replaced		Pic 6 Desc.	CFS is degraded and needs to be replaced

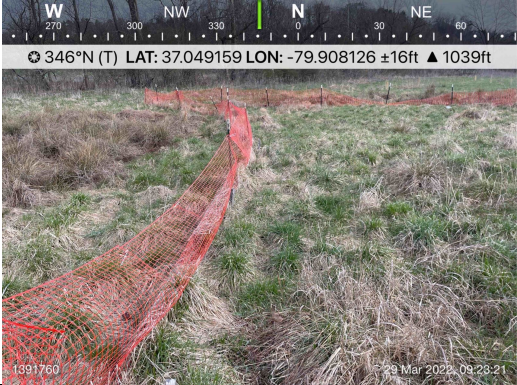
GPS Location	See photo		GPS Location	See photo	
Field Station#	13917+60		Field Station#	13920+00	
Pic 13 Desc.	CFS is degraded and needs to be replaced		Pic 14 Desc.	CFS is degraded and needs to be replaced

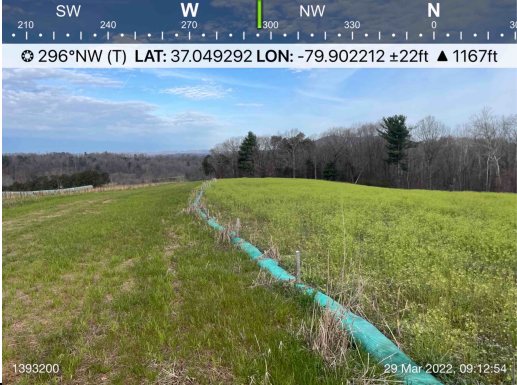
GPS Location	See photo		GPS Location	See photo	
Field Station#	13932+00		Field Station#	13940+00	
Pic 15 Desc.	CFS is degraded and needs to be replaced		Pic 16 Desc.	CFS is degraded and needs to be replaced

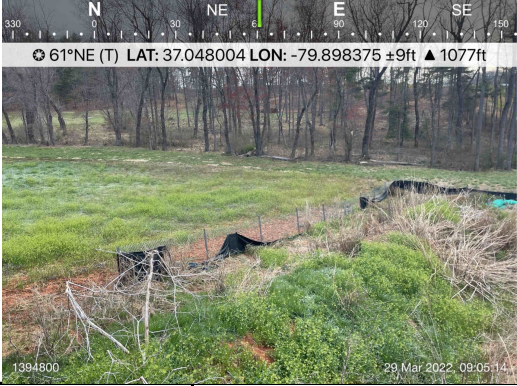
GPS Location	See photo		GPS Location	See photo	
Field Station#	13948+00		Field Station#	13949+24	
Pic 17 Desc.	SSF fabric needs to be reattached		Pic 18 Desc.	CFS is degraded and needs to be replaced

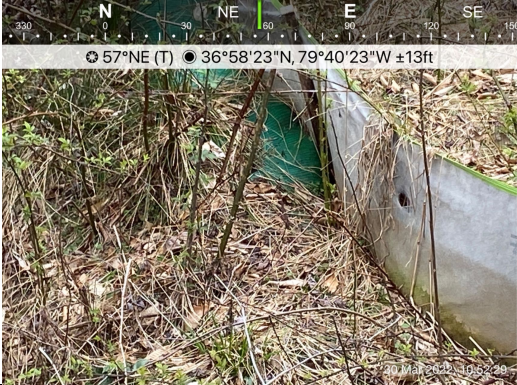
GPS Location	0	GPS Location			
Field Station#	14823+60	Field Station#			
Pic 7 Desc.	Approximately 14823+60. P-1 requires maintenance. Appears to have been damaged by wildlife.	Pic 8 Desc.			
Insert image here		Insert image here			
GPS Location		GPS Location			
Field Station#		Field Station#			
Pic 9 Desc.		Pic 10 Desc.			
Insert image here		Insert image here			
GPS Location		GPS Location			
Field Station#		Field Station#			
Pic 11 Desc.		Pic 12 Desc.

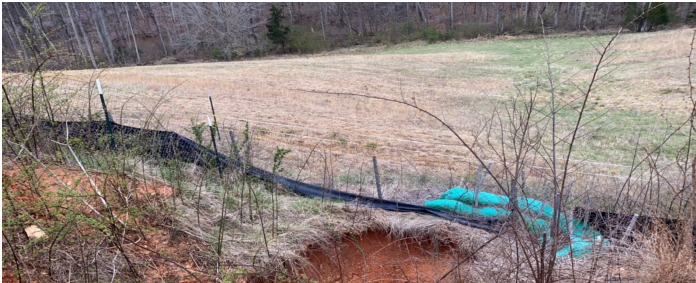
GPS Location	3		GPS Location	4	
Field Station#	14542+00		Field Station#	14524+76	
Pic 3 Desc.	Routine maintenance. Reattach geotextile fabric to SSF fencing.		Pic 4 Desc.	RCE at Timber Ridge Rd in good condition.

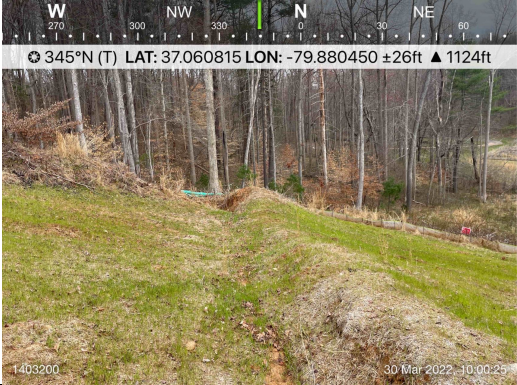
GPS Location	See photo		GPS Location	See photo	
Field Station#	14032+00		Field Station#	14035+28	
Pic 7 Desc.	Waterbars are functioning as intended		Pic 8 Desc.	Equipment bridge ECDs are in good condition and functioning

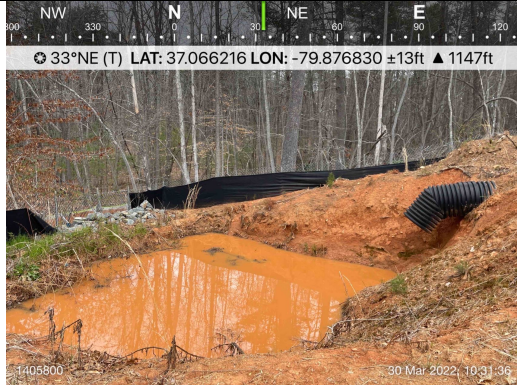
GPS Location	See photo		GPS Location	See photo	
Field Station#	14058+00		Field Station#	14058+00	
Pic 11 Desc.	Slope drain is in good condition and functioning		Pic 12 Desc.	Check dams are functioning as intended

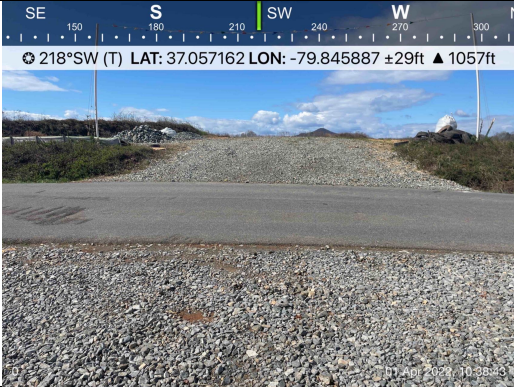
GPS Location	See photo		GPS Location	See photo	
Field Station#	14171+36		Field Station#	14182+00	
Pic 1 Desc.	RCEs are in good condition at all road crossings		Pic 2 Desc.	SSF is in good condition

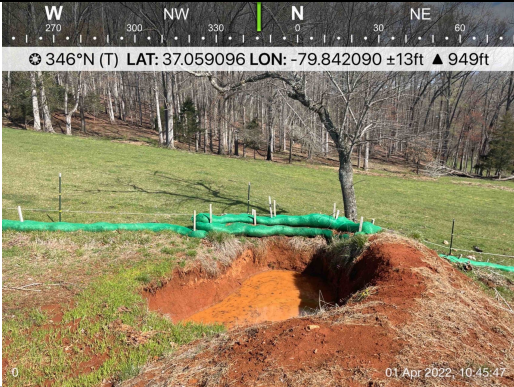
GPS Location	See photo		GPS Location	See photo	
Field Station#	14183+00		Field Station#	14185+00	
Pic 3 Desc.	End treatments are functioning as intended		Pic 4 Desc.	Topsoil berms remain stabilized

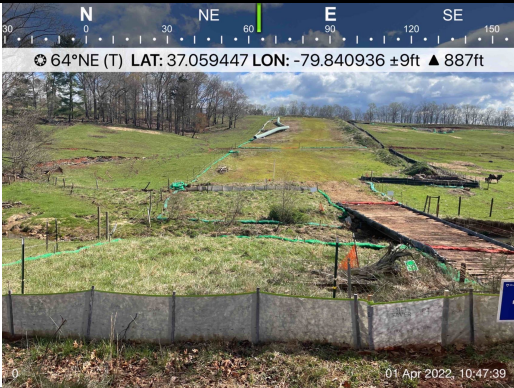
GPS Location	See photo		GPS Location	See photo	
Field Station#	14190+00		Field Station#	14200+00	
Pic 5 Desc.	P1 is in good condition condition at all stream and wetland buffers		Pic 6 Desc.	CWDs are functioning as intended.

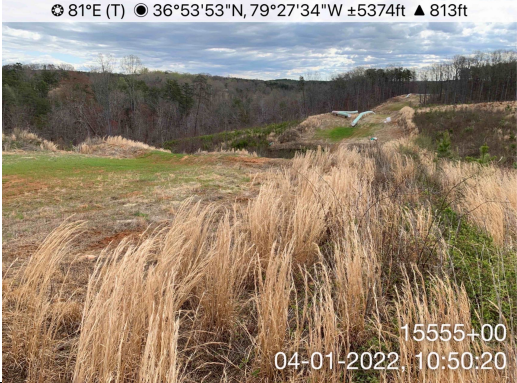
GPS Location	0	GPS Location	0		
Field Station#	15555+00	Field Station#	15584+00		
Pic 7 Desc.	Clean water diversion berm and temporary vegetative stabilization in acceptable conditions	Pic 8 Desc.	Rock construction entrance in acceptable condition

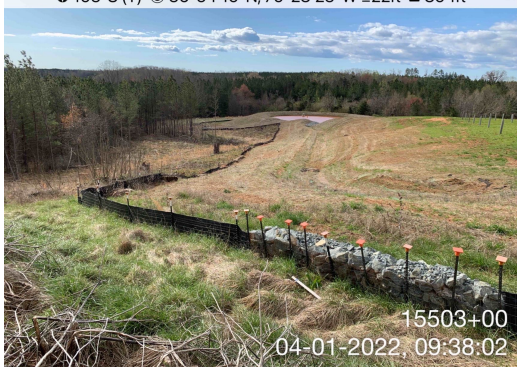
GPS Location	0	GPS Location	0		
Field Station#	15503+00	Field Station#	15514+00		
Pic 9 Desc.	Solar farm ECDs appear to be in acceptable conditions	Pic 10 Desc.	Solar farm ECDs appear to be in acceptable conditions		
Insert image here		Insert image here			
GPS Location		GPS Location			
Field Station#		Field Station#			
Pic 11 Desc.		Pic 12 Desc.

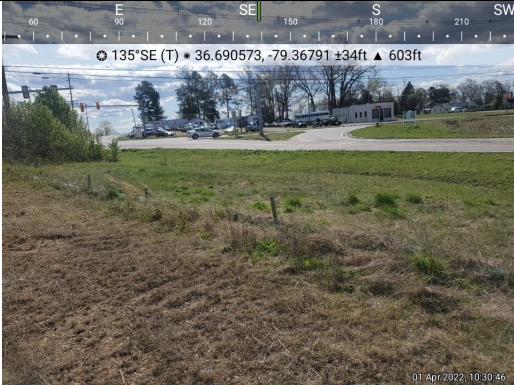
GPS Location	0	GPS Location	0		
Field Station#	0+00	Field Station#	0+00		
Pic 1 Desc.	LY-048 South perimeter CFS		Pic 2 Desc.	LY-048 West perimeter CFS
