Visual Site Inspection Report

Project Name	H-600 Pipeline Spread I		AFE	124300139	Spread	H-600 Pipeline Spread I	
Contractor	Precision				Report #	35192	
Inspector	Ben Davenport				Date/Time	3/7/2022 2:36 PM	
Permit #	TBD	Inspection Type	VA SWPP		Station Begin	14311+57	
State	VA	Inspection Area	Partial		Station End	14454+22	
County	Franklin	Ground	Dry		Temperature (°F)	70.00	
Municipality	N/A	Weather	Cloudy		Rain Gauge (in)	0.00	
					Rain Accumulation Time (days)	0.00

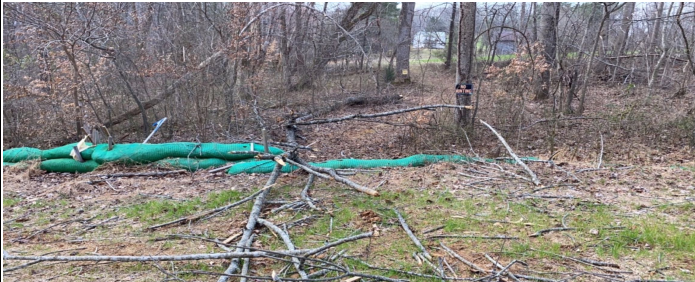
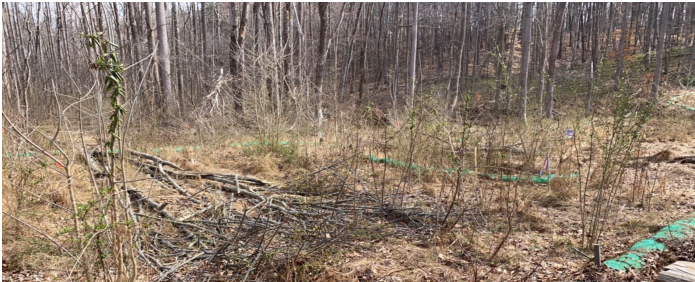
37°15'1" N 79°46'43" W 241°SW COURSE 322° GPS Glade Hill, VA 24092, United States 03.07.2022 10:20:42 Accur +/-140.2 Ft ALT 1012 Ft			37°15'0" N 79°46'40" W 34°NE COURSE 322° GPS Glade Hill, VA 24092, United States 03.07.2022 10:20:10 Accur +/-329.9 Ft ALT 1012 Ft		
GPS Location	1	GPS Location	2		
Field Station#	14419+75	Field Station#	14421+00		
Pic 1 Desc.	Routine maintenance. Fallen tree down on perimeter CFS.		Pic 2 Desc.	Routine maintenance. Multiple fallen trees down on CFS in resource buffer.

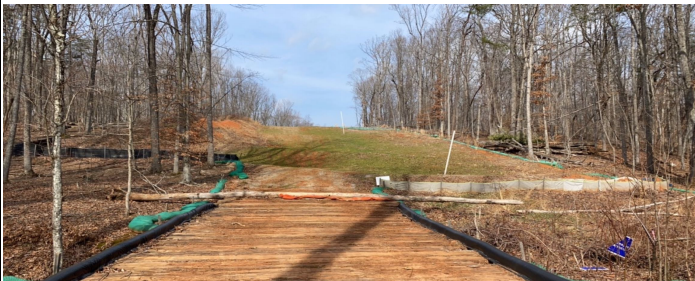
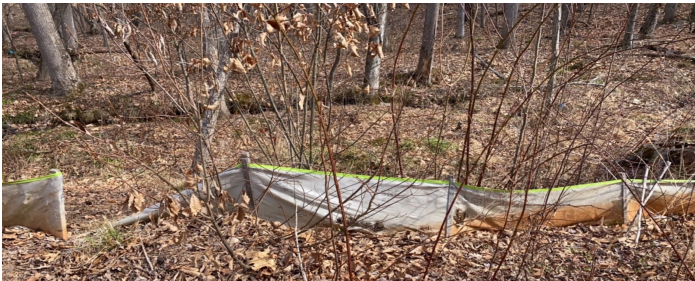
37°143" N 79°46'26" W 337°NW COURSE 182° GPS Glade Hill, VA 24092, United States 03.07.2022 10:13:50 Accur +/-693.7 Ft ALT 1021 Ft			37°143" N 79°46'26" W 44°NE COURSE 16° GPS Glade Hill, VA 24092, United States 03.07.2022 10:10:54 Accur +/-52.8 Ft ALT 1021 Ft		
GPS Location	5	GPS Location	6		
Field Station#	14434+01	Field Station#	14437+00		
Pic 5 Desc.	Routine maintenance. Fallen tree down on equipment bridge of S-GH40.		Pic 6 Desc.	Routine maintenance. Replace damaged row of P1 silt fence.

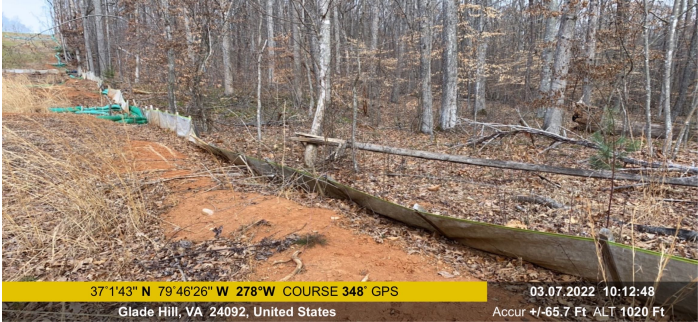
Insert image here			
GPS Location	7	GPS Location			
Field Station#	14445+00	Field Station#			
Pic 7 Desc.	Routine maintenance. Replace damaged P1 silt fence where stakes are broken or fabric is beyond effective lifespan.		Pic 8 Desc.		
Insert image here		Insert image here			
GPS Location		GPS Location			
Field Station#		Field Station#			
Pic 9 Desc.		Pic 10 Desc.			
Insert image here		Insert image here			
GPS Location		GPS Location			
Field Station#		Field Station#			
Pic 11 Desc.		Pic 12 Desc.

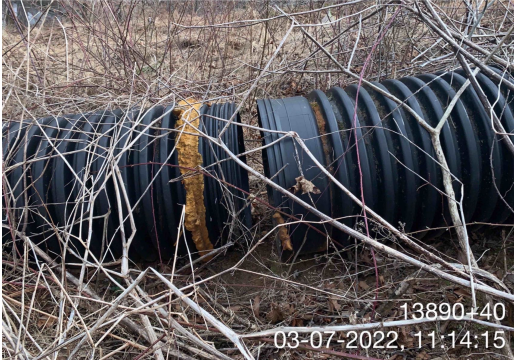
GPS Location	0	GPS Location	0		
Field Station#	13890+40	Field Station#	13941+00		
Pic 1 Desc.	A slope drain pipe with a separated pipe joint		Pic 2 Desc.	Clean water diversion pipe and plunge pool in acceptable conditions

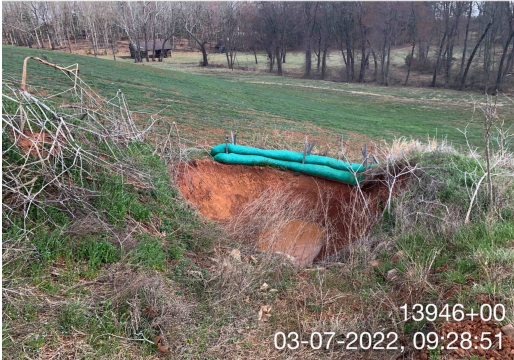
GPS Location	0	GPS Location	0		
Field Station#	13946+00	Field Station#	13930+00		
Pic 3 Desc.	Waterbar end treatment in acceptable condition		Pic 4 Desc.	Permanent vegetative stabilization in acceptable condition

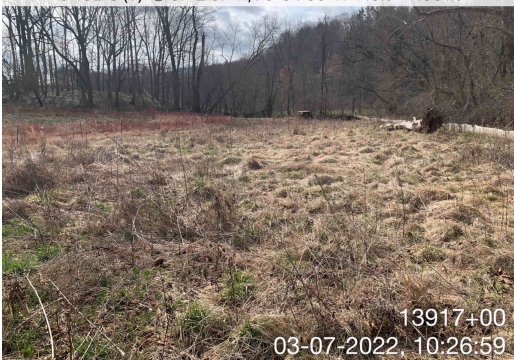
GPS Location	0	GPS Location	0		
Field Station#	13917+00	Field Station#	13918+00		
Pic 5 Desc.	Temporary vegetative stabilization in acceptable condition		Pic 6 Desc.	Waterbar in acceptable condition

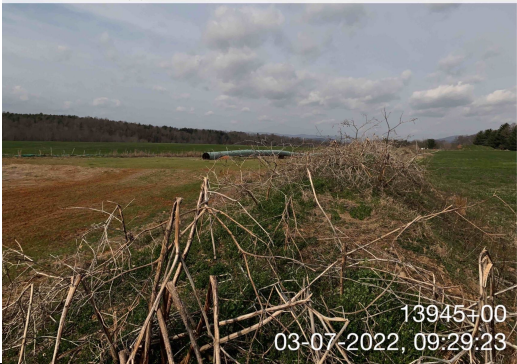
<p>13945+00 03-07-2022, 09:29:23</p>

<p>13854+00 03-07-2022, 10:49:11</p>			
GPS Location	0	GPS Location	0		
Field Station#	13945+00	Field Station#	13854+00		
Pic 7 Desc.	Clean water diversion berm and temporary vegetative stabilization in acceptable conditions		Pic 8 Desc.	P1 silt fence in acceptable condition	
Insert image here			Insert image here		
GPS Location		GPS Location			
Field Station#		Field Station#			
Pic 9 Desc.		Pic 10 Desc.			
Insert image here			Insert image here		
GPS Location		GPS Location			
Field Station#		Field Station#			
Pic 11 Desc.		Pic 12 Desc.

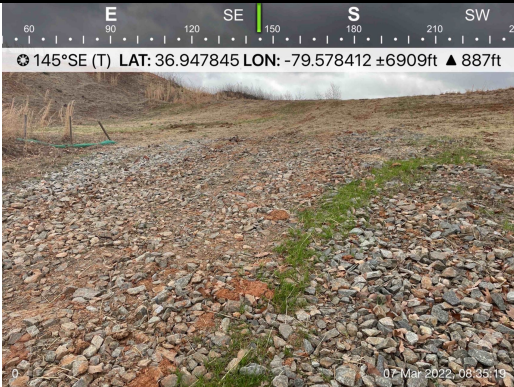
GPS Location	See photo		GPS Location	See photo	
Field Station#	15142+66		Field Station#	15150+00	
Pic 1 Desc.	RCE is in good condition at Rockcreek Rd.		Pic 2 Desc.	Perimeter CFS is in good condition

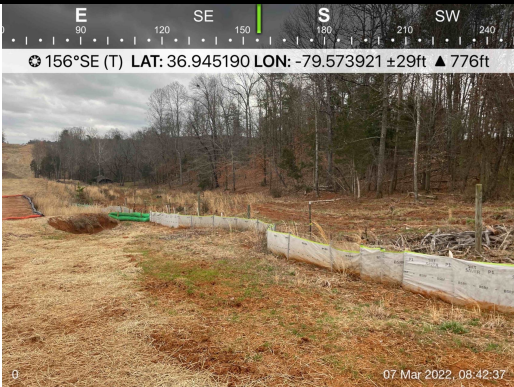
GPS Location	See photo		GPS Location	See photo	
Field Station#	15160+00		Field Station#	15165+57	
Pic 3 Desc.	Perimeter P1 is in good condition		Pic 4 Desc.	Rock outlet is functioning as intended

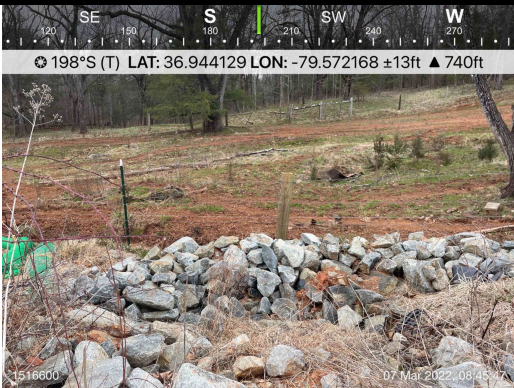
GPS Location	See photo		GPS Location	See photo	
Field Station#	15166+00		Field Station#	15167+00	
Pic 5 Desc.	Rock outlet remains in good condition.		Pic 6 Desc.	P1 is in good condition at stream buffer

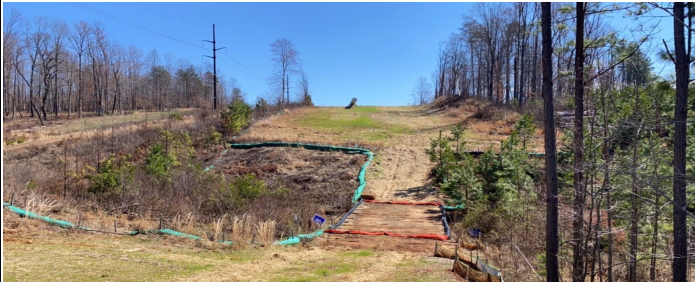
03.08.2022 11:59:37 Accur +/-61.9 Ft ALT 940 Ft			03.08.2022 12:02:08 Accur +/-656.2 Ft ALT 922 Ft		
GPS Location	1		GPS Location	2	
Field Station#	14804+99		Field Station#	14811+00	
Pic 1 Desc.	Equipment bridge and surrounding ECDs in place and functional at stream crossing and resource buffer.		Pic 2 Desc.	Contractor seeded and stabilized disturbed area where anode beds were dug.

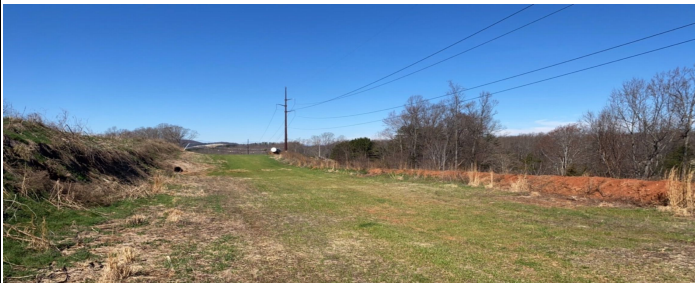
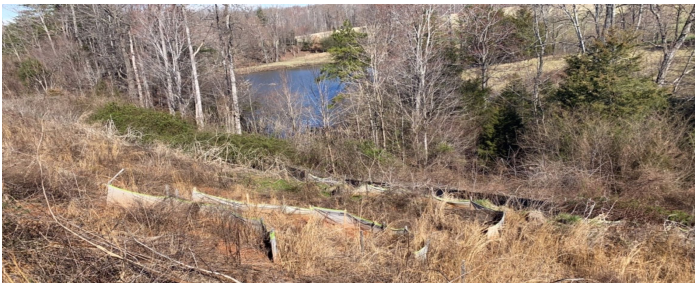
03.08.2022 10:03:54 Accur +/-15.3 Ft ALT 958 Ft			03.08.2022 10:04:26 Accur +/-15.3 Ft ALT 963 Ft		
GPS Location	3		GPS Location	4	
Field Station#	14834+00		Field Station#	14839+00	
Pic 3 Desc.	ROW stabilized and vegetated in temporary area.		Pic 4 Desc.	P1 silt fence on slope in good condition.

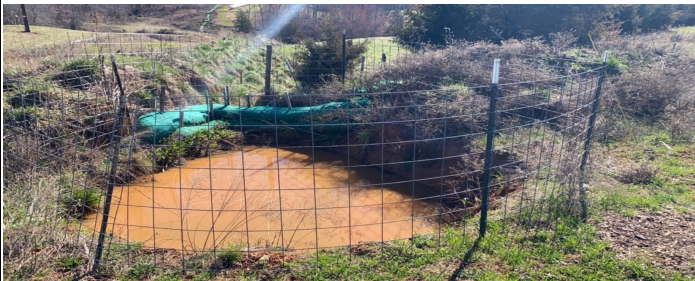
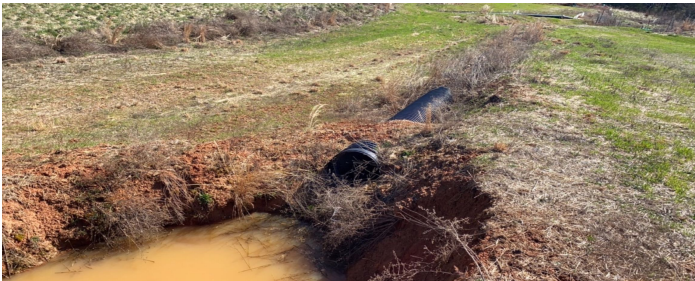
03.08.2022 10:00:24 Accur +/-16.8 Ft ALT 980 Ft			03.08.2022 10:01:05 Accur +/-14.6 Ft ALT 950 Ft		
GPS Location	5		GPS Location	6	
Field Station#	14847+68		Field Station#	14851+00	
Pic 5 Desc.	Sump pit and CFS end treatment performing intended functions.		Pic 6 Desc.	Sump pit and slope drain pipe in place and functional.

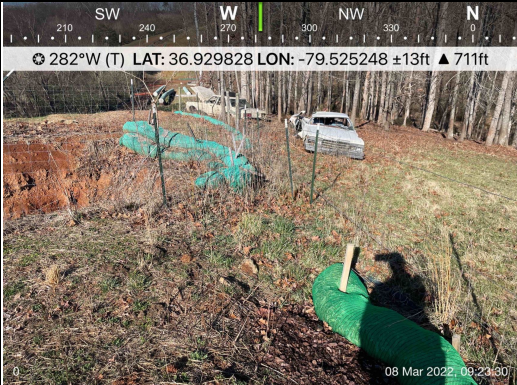
GPS Location	See photo		GPS Location	See photo	
Field Station#	15317+00		Field Station#	15330+00	
Pic 7 Desc.	CFS needs to be extended to end treatment.		Pic 8 Desc.	Drainage feature ECDs are in good condition and functioning

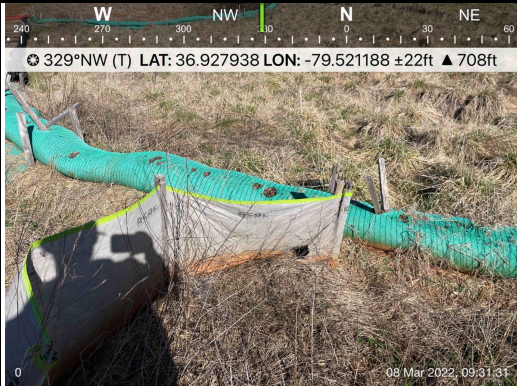
GPS Location	See photo		GPS Location	See photo	
Field Station#	15331+00		Field Station#	15338+00	
Pic 9 Desc.	P1 check is degraded and needs to be replaced		Pic 10 Desc.	CWD is in good condition.

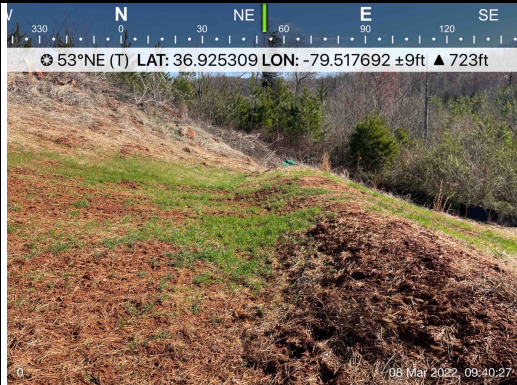
GPS Location	See photo		GPS Location	See photo	
Field Station#	15345+00		Field Station#	15346+87	
Pic 11 Desc.	Waterbars are in good condition		Pic 12 Desc.	Resource buffers remain well vegetated

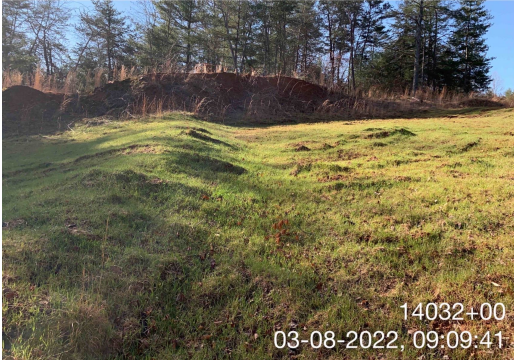
GPS Location	0	GPS Location	0		
Field Station#	14032+00	Field Station#	14032+00		
Pic 1 Desc.	Waterbar in acceptable condition		Pic 2 Desc.	Waterbar end treatment in acceptable condition

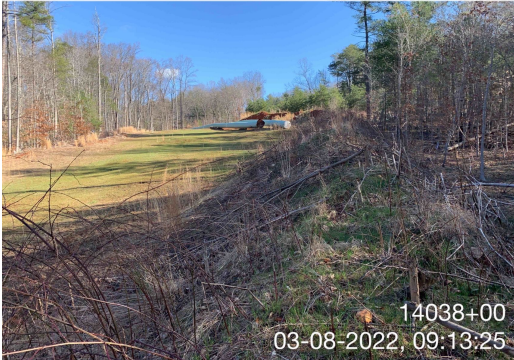
GPS Location	0	GPS Location	0		
Field Station#	14038+00	Field Station#	14040+00		
Pic 3 Desc.	Clean water diversion berm and temporary vegetative stabilization in acceptable conditions		Pic 4 Desc.	P1 silt fence in acceptable condition

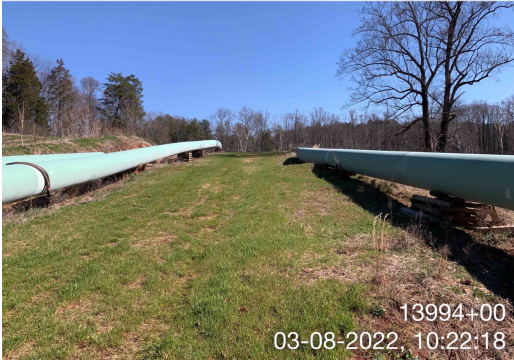
GPS Location	0	GPS Location	0		
Field Station#	13994+00	Field Station#	13968+00		
Pic 5 Desc.	Temporary vegetative stabilization in acceptable condition		Pic 6 Desc.	Sump pit and perimeter CFS in acceptable conditions

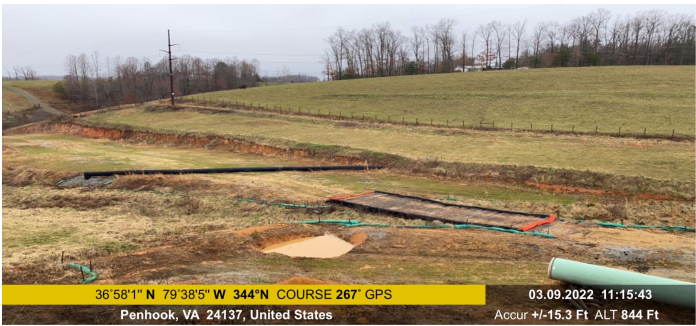
GPS Location	1	GPS Location	2		
Field Station#	14934+46	Field Station#	14940+00		
Pic 1 Desc.	Perimeter SSF and CFS triple stack in good condition.	Pic 2 Desc.	Natural drainage area and surrounding ECDs in place and functional.

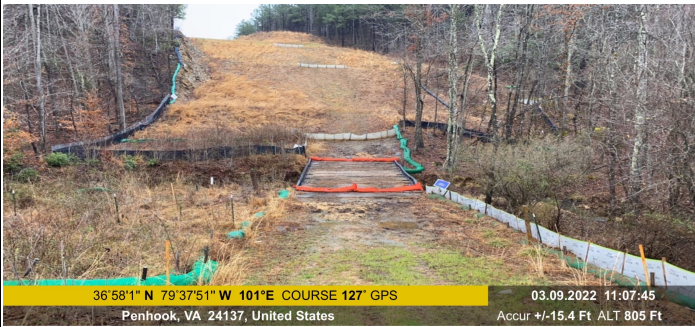
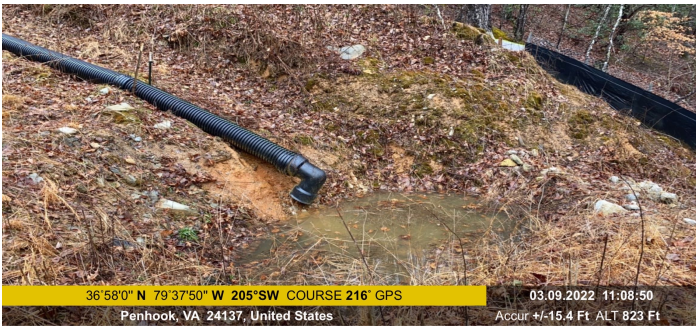
GPS Location	3	GPS Location	4		
Field Station#	14950+47	Field Station#	14952+00		
Pic 3 Desc.	Equipment bridge and surrounding ECDs in place and functional at stream crossing and resource buffer.	Pic 4 Desc.	Slope drain pipe and outlet sump in place and functional.

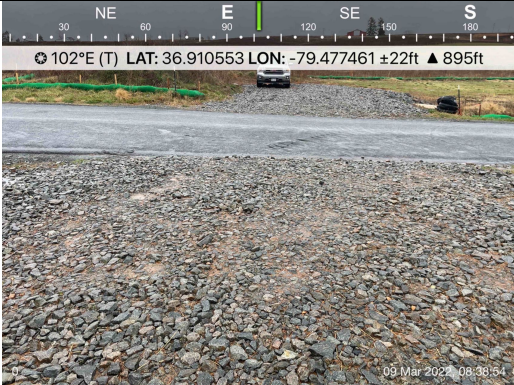
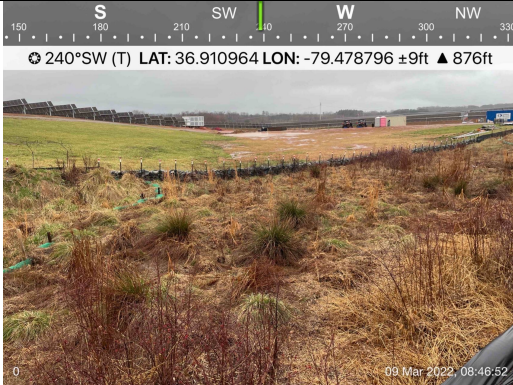
GPS Location	See photo		GPS Location	See photo	
Field Station#	15480+67		Field Station#	15475+00	
Pic 1 Desc.	RCEs are in good condition at all road crossings.		Pic 2 Desc.	3rd party rock outlet appears to be in good condition along drainage feature.

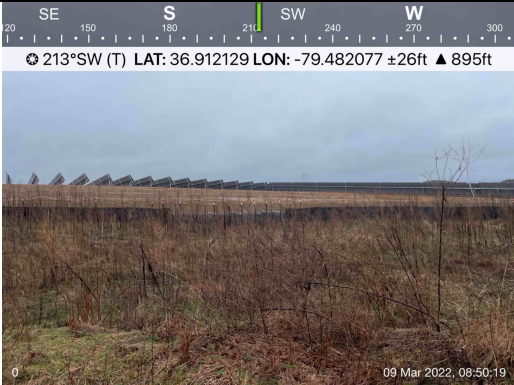
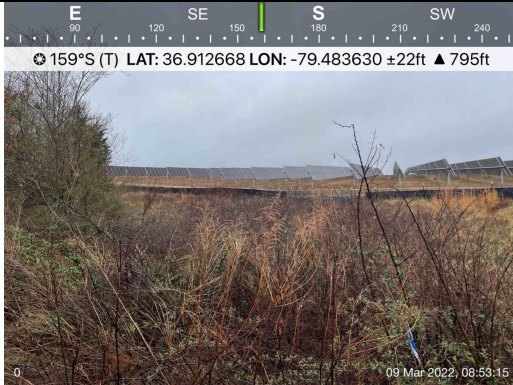
GPS Location	See photo		GPS Location	See photo	
Field Station#	15465+00		Field Station#	15460+81	
Pic 3 Desc.	No evidence of sedimentation from 3rd party disturbance.		Pic 4 Desc.	No evidence of sedimentation from 3rd party disturbance into CWD inlet.

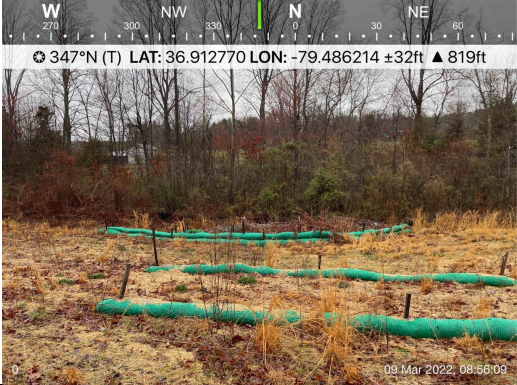
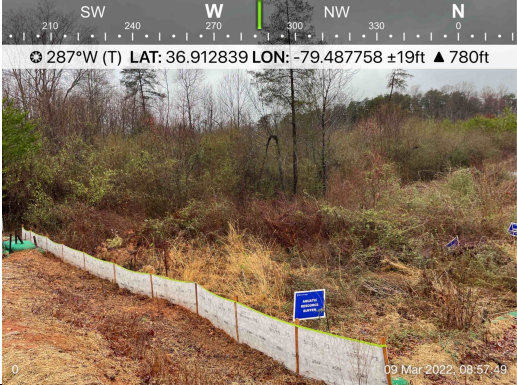
GPS Location	See photo		GPS Location	See photo	
Field Station#	15453+00		Field Station#	15447+60	
Pic 7 Desc.	CWD is in good condition		Pic 8 Desc.	P1 is in good condition at all stream and wetland buffers.

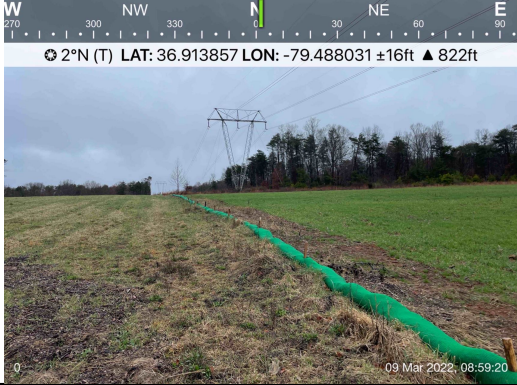
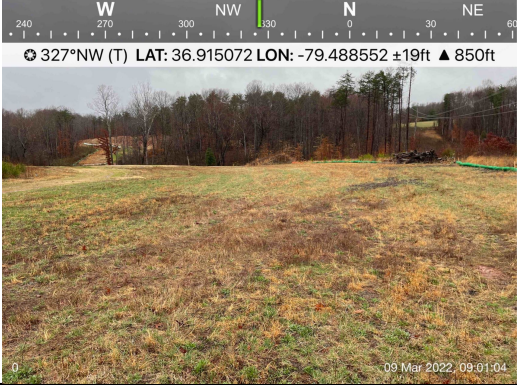
GPS Location	See photo		GPS Location	See photo	
Field Station#	15445+00		Field Station#	15440+00	
Pic 9 Desc.	CFS is in good condition		Pic 10 Desc.	Vegetation continues to fill in throughout this section

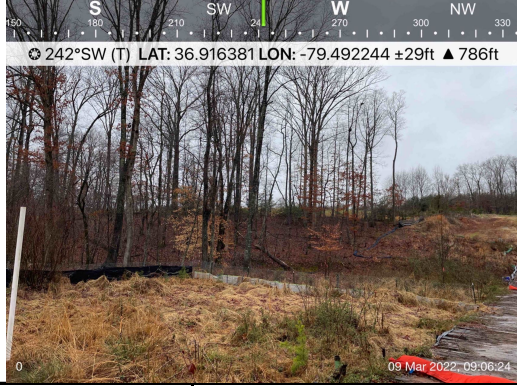
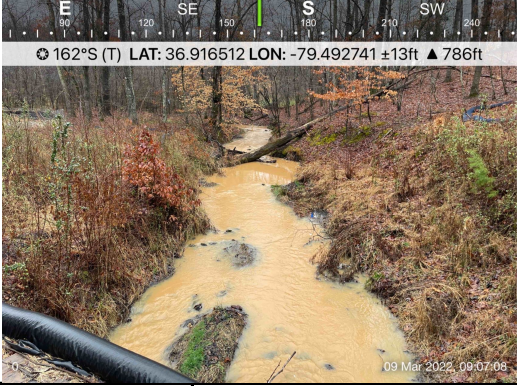
GPS Location	See photo		GPS Location	See photo	
Field Station#	15427+00		Field Station#	15426+40	
Pic 11 Desc.	Resource buffers remain well vegetated		Pic 12 Desc.	S-G4 is turbid entering ROW. This is a result of upstream disturbance not related to MVP ROW.

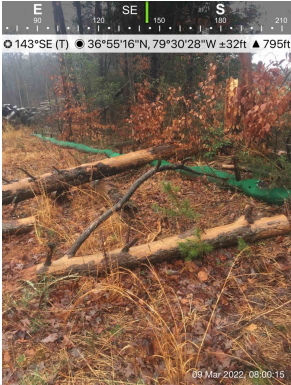
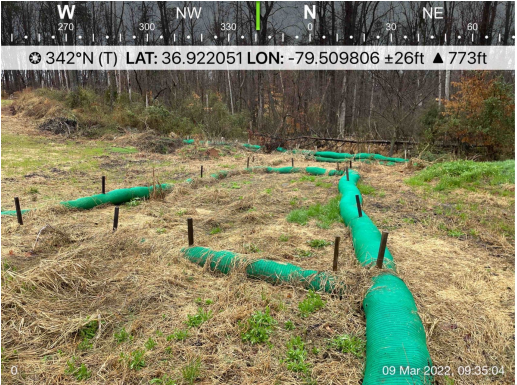
GPS Location	See photo	GPS Location	See photo		
Field Station#	15380+00	Field Station#	15375+00		
Pic 15 Desc.	Tree has fallen across CFS due to high wind conditions and needs to be removed.	Pic 16 Desc.	Drainage ECDs are in good condition and functioning.		
Insert image here		Insert image here			
GPS Location		GPS Location			
Field Station#		Field Station#			
Pic 17 Desc.		Pic 18 Desc.

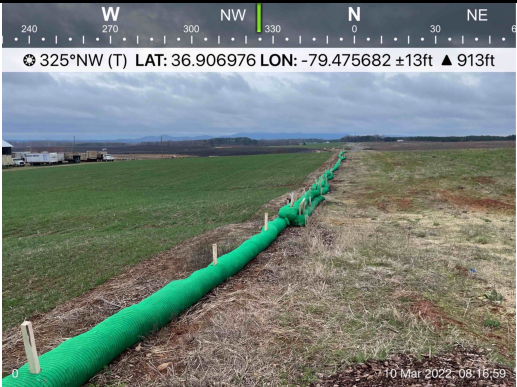
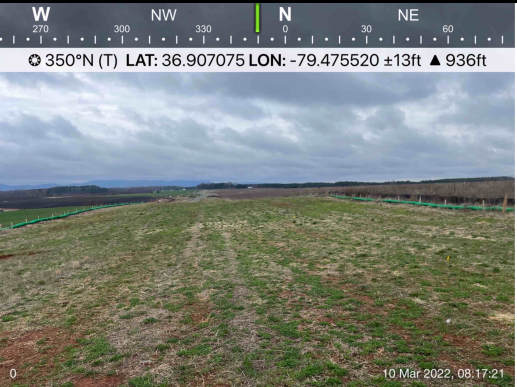
GPS Location	See photo		GPS Location	See photo	
Field Station#	15490+00		Field Station#	15495+00	
Pic 1 Desc.	Perimeter CFS is in good condition		Pic 2 Desc.	Vegetation continues to fill in throughout this section

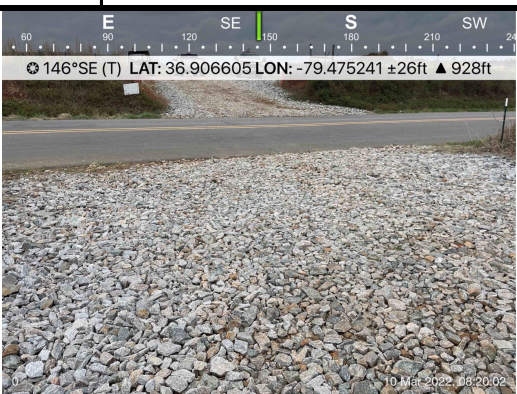
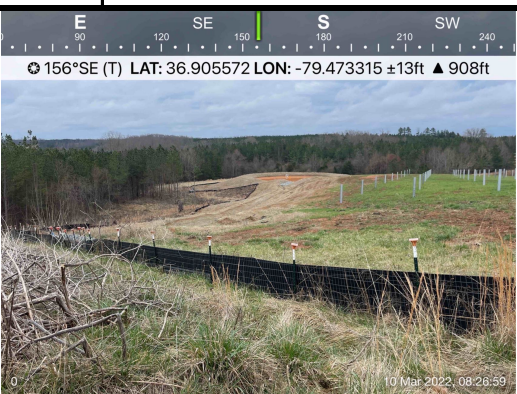
GPS Location	See photo		GPS Location	See photo	
Field Station#	15496+70		Field Station#	15501+00	
Pic 3 Desc.	RCEs are in good condition at all road crossings.		Pic 4 Desc.	No evidence of sedimentation from 3rd party disturbance

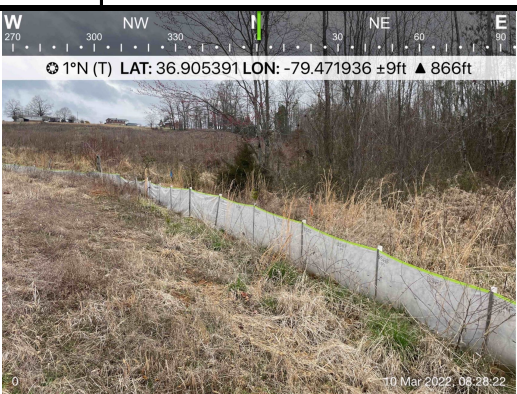
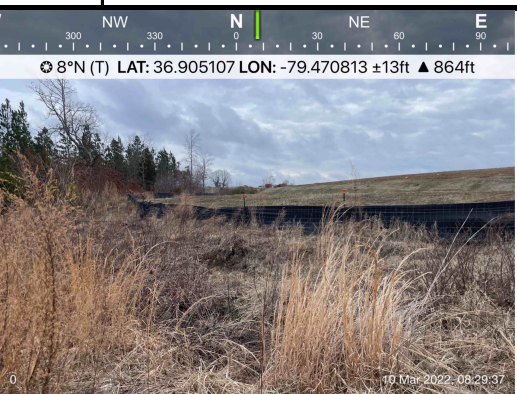
GPS Location	See photo		GPS Location	See photo	
Field Station#	15507+50		Field Station#	15510+00	
Pic 5 Desc.	P1 is in good condition at all stream and wetland buffers		Pic 6 Desc.	3rd party ECDs appear to be in good condition

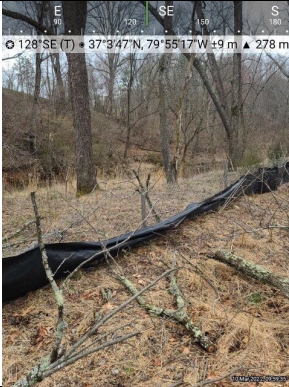
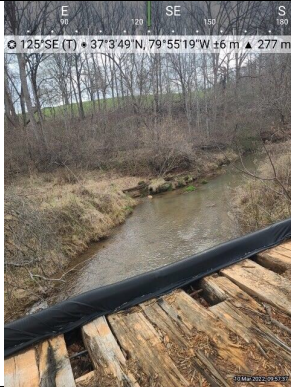
GPS Location	00000	GPS Location	00000		
Field Station#	13837+08	Field Station#	13834+04		
Pic 1 Desc.	Reinforced silt fence requires maintenance, added to the punch list for repair. Wind damage.	Pic 2 Desc.	Stream observation photo facing downstream during routine inspection today, no environmental issues observed at the time of inspection.

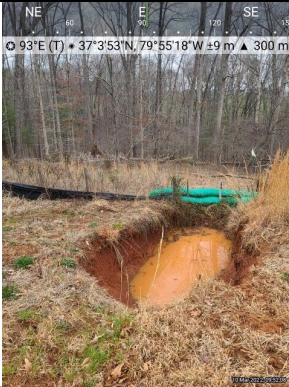
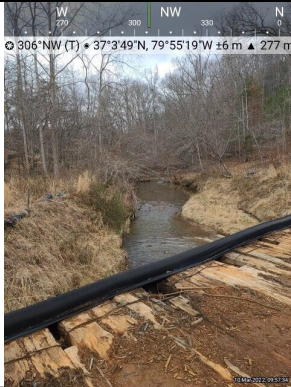
GPS Location	00000	GPS Location	00000		
Field Station#	13830+08	Field Station#	13834+04		
Pic 3 Desc.	Reinforced silt fence requires maintenance, added to the punch list for repair.	Pic 4 Desc.	Stream observation photo facing upstream during routine inspection today. No environmental issues observed at the time of inspection.

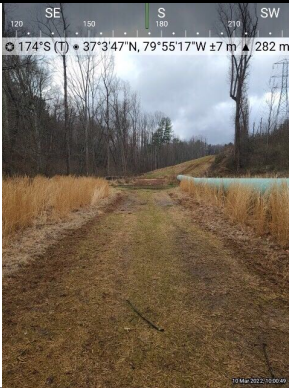
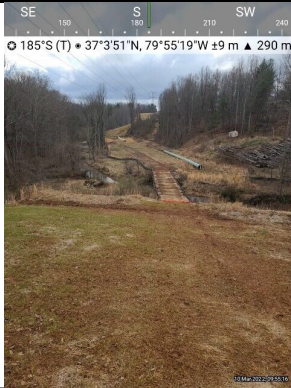
GPS Location	00000	GPS Location	00000		
Field Station#	13836+50	Field Station#	13829+00		
Pic 5 Desc.	Vegetation observation photo showing good coverage. No environmental issues observed at the time of inspection.	Pic 6 Desc.	Row photo showing stabilization and equipment bridge in place over stream crossing, no environmental issues observed at the time of inspection today.

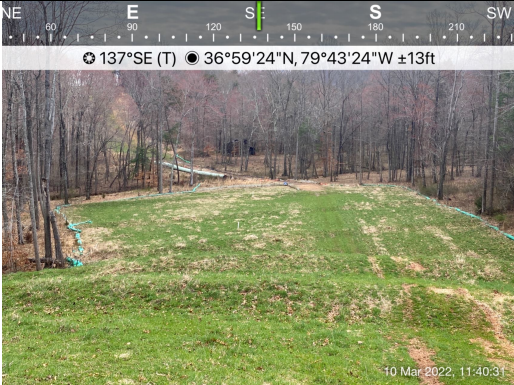
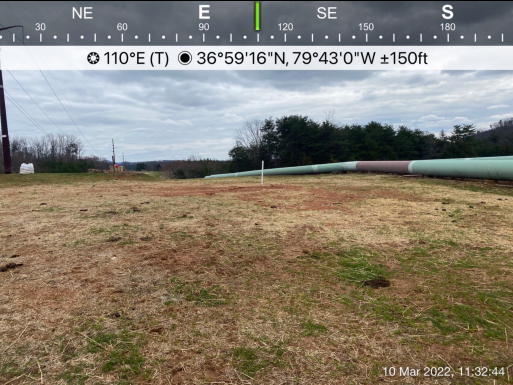
GPS Location	0	GPS Location	0		
Field Station#	14653+00	Field Station#	14675+00		
Pic 1 Desc.	Approximately 14653+00. Overview of ROW. Permanent vegetation.	Pic 2 Desc.	Approximately 14675+00. Overview of ROW. Livestock in area.

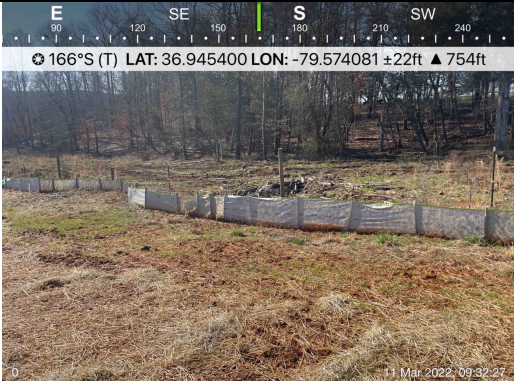
GPS Location	See photo		GPS Location	See photo	
Field Station#	15160+00		Field Station#	15165+57	
Pic 3 Desc.	Perimeter P1 is in good condition		Pic 4 Desc.	Rock filter inlet/outlet remains in good condition

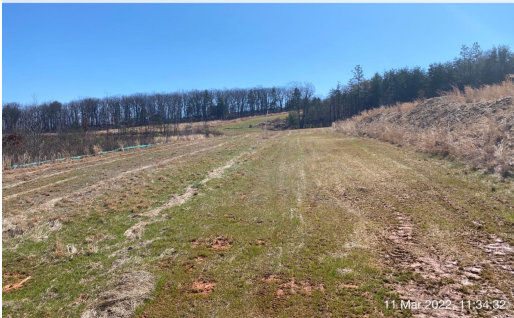
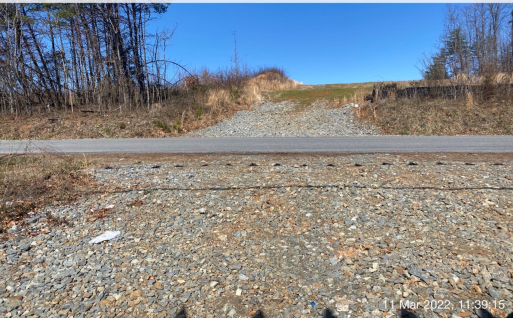
GPS Location	0	GPS Location	0		
Field Station#	14317+00	Field Station#	14333+60		
Pic 1 Desc.	Approximately 14317+00. Overview of ROW.		Pic 2 Desc.	Approximately 14333+60. Overview of road crossing and RCEs.
