Visual Site Inspection Report

Project Name	H-600 Pipeline Spread G	AFE	124300137	Spread	H-600 Pipeline Spread G
Contractor	Precision			Report #	36425
Inspector	Eric Hanlon			Date/Time	4/11/2022 7:33 AM
Permit #	TBD	Inspection Type	VA SWPP	Station Begin	11184+85
State	VA	Inspection Area	Full	Station End	11254+99
County	Giles	Ground	Muddy	Temperature (°F)	60.00
Municipality	N/A	Weather	Sunny	Rain Gauge (in)	0.00
				Rain Accumulation Time (days)	1.00

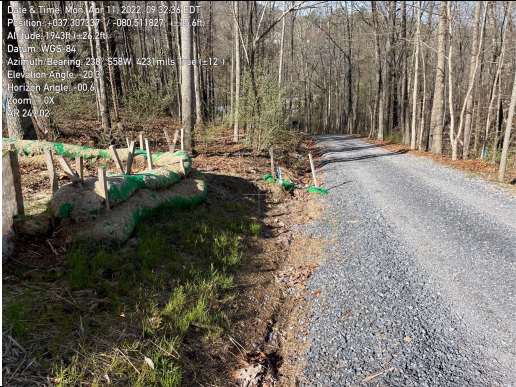
GPS Location	See photo	GPS Location	See photo		
Field Station#	11184+79	Field Station#	11191+47		
Pic 1 Desc.	AR 249.02 in good condition Rock check dams in place	Pic 2 Desc.	Clean water drainage feature in place

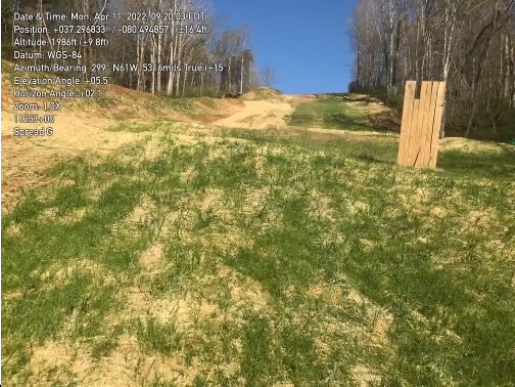
GPS Location	See photo	GPS Location	See photo		
Field Station#	11194+57	Field Station#	11253+00		
Pic 3 Desc.	Permanent water bars and level spreader in place	Pic 4 Desc.	Water bars in place

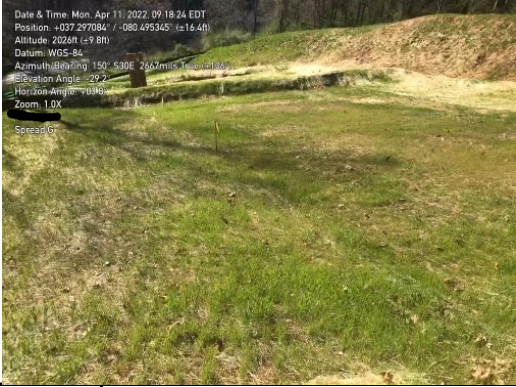
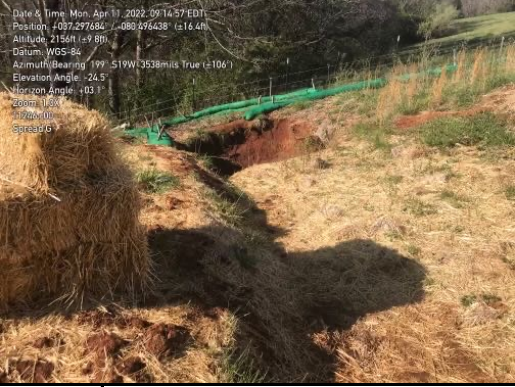
GPS Location	See photo	GPS Location	See photo		
Field Station#	11250+00	Field Station#	11246+00		
Pic 5 Desc.	Erosion control blanket in place	Pic 6 Desc.	ET in place

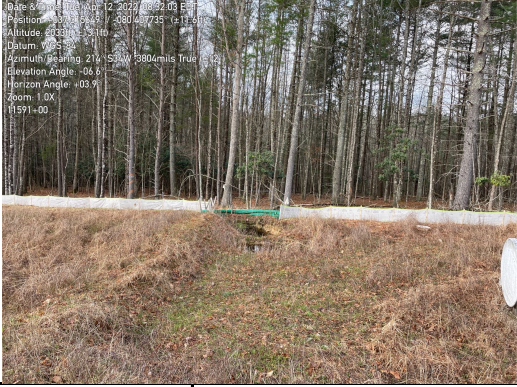
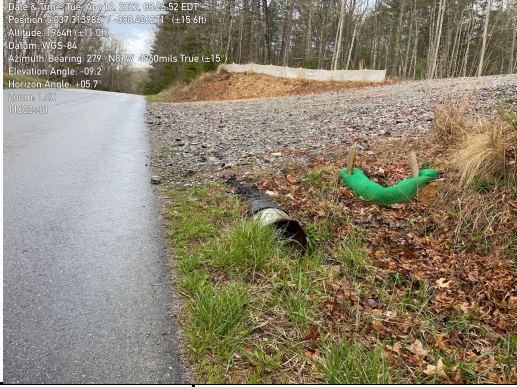
GPS Location	See photo	GPS Location	See photo		
Field Station#	11591+00	Field Station#	11600+01		
Pic 7 Desc.	ET in place	Pic 8 Desc.	RCE & culvert functional		
Insert image here		Insert image here			
GPS Location		GPS Location			
Field Station#		Field Station#			
Pic 9 Desc.		Pic 10 Desc.			
Insert image here		Insert image here			
GPS Location		GPS Location			
Field Station#		Field Station#			
Pic 11 Desc.		Pic 12 Desc.

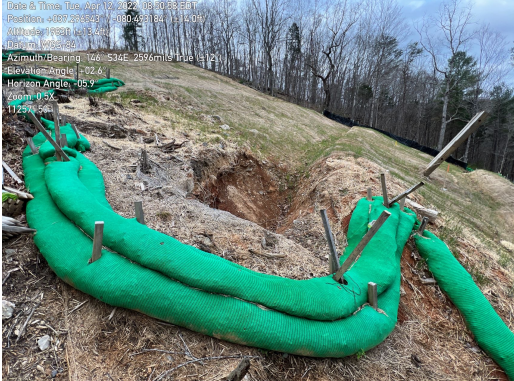
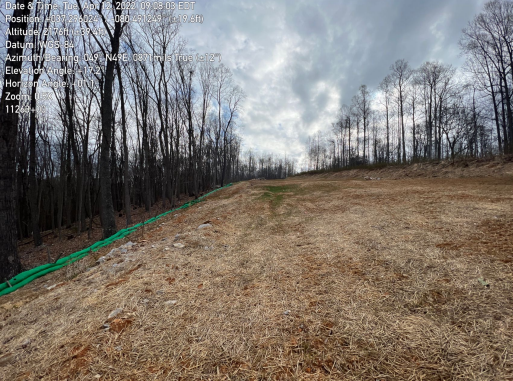
GPS Location	See Photo	GPS Location	See Photo		
Field Station#	11257+50	Field Station#	11263+00		
Pic 1 Desc.	Waterbar and end treatment	Pic 2 Desc.	Stabilization

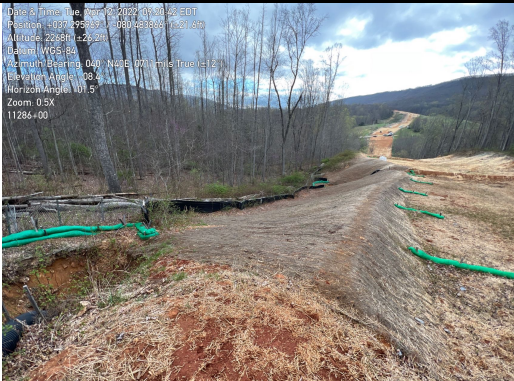
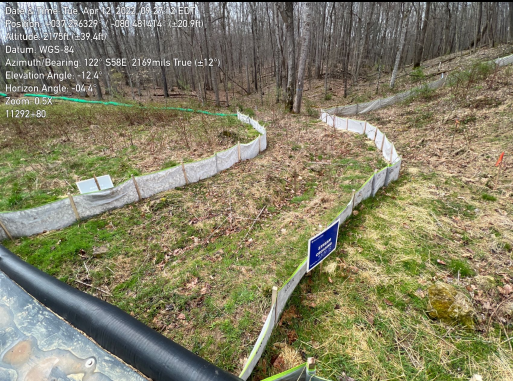
GPS Location	See Photo	GPS Location	See Photo		
Field Station#	11286+00	Field Station#	11292+80		
Pic 5 Desc.	Erosion control blanket	Pic 6 Desc.	S-MM18

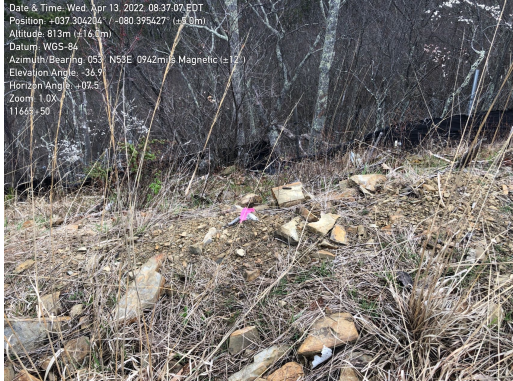
<p>Date & Time: Wed, Apr 13, 2022, 08:37:07 EDT Position: +037.30241° / -080.395427° (±5.0m) Altitude: 813m (±16.0m) Datum: WGS-84 Azimuth/Bearing: 053° N53E 0942mils Magnetic (±12°) Elevation Angle: -36.9° Horizon Angle: -07.5° Zoom: 1.0X 11665+50</p>			
GPS Location	On photo		GPS Location	On photo	
Field Station#	11670+00		Field Station#	11665+50	
Pic 1 Desc.	Top of Brush Mountain currently stable.		Pic 2 Desc.	COMMUNICATION, repair torn SSF fabric.

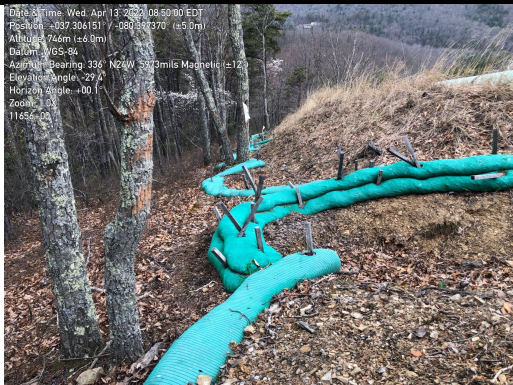
<p>Date & Time: Wed, Apr 13, 2022, 08:50:00 EDT Position: +037.30451° / -080.39701° (±5.0m) Altitude: 746m (±4.0m) Datum: WGS-84 Azimuth/Bearing: 336° N24W 3373mils Magnetic (±12°) Elevation Angle: -29.0° Horizon Angle: -00.1° Zoom: 1.0X 11656+00</p>			
GPS Location	On photo		GPS Location	On photo	
Field Station#	11657+00		Field Station#	11656+00	
Pic 5 Desc.	Perimeter ECDs in place, functional.		Pic 6 Desc.	CFS is worn on JNF and will be replaced before any ground disturbance occurs.

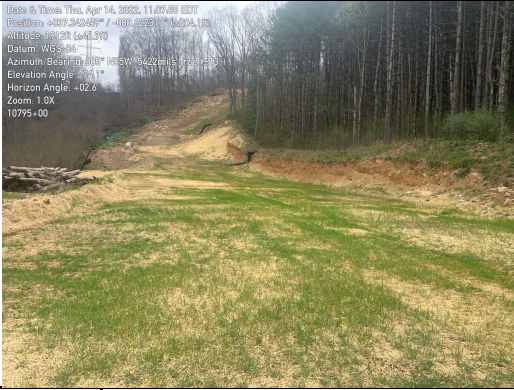
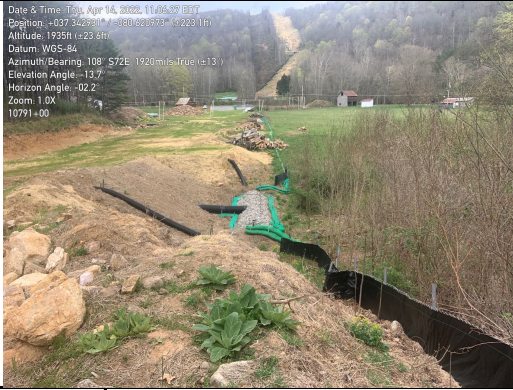
GPS Location	See photo	GPS Location	See photo		
Field Station#	10795+00	Field Station#	10791+00		
Pic 1 Desc.	Temporary vegetation/stabilization are acceptable	Pic 2 Desc.	Section of Row showing conditions and controls

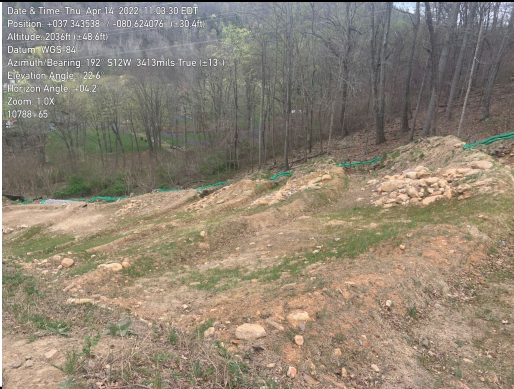
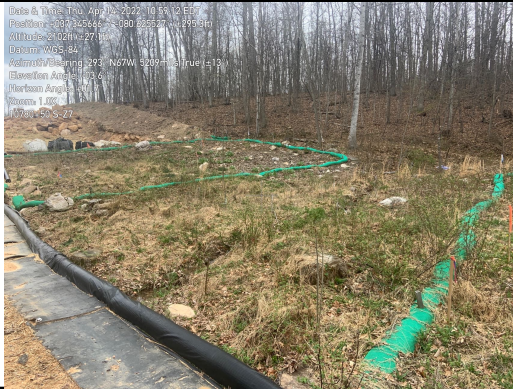
GPS Location	See photo	GPS Location	See photo		
Field Station#	10788+65	Field Station#	10780+50		
Pic 3 Desc.	Section of Row showing conditions and controls	Pic 4 Desc.	Conditions and controls at S-Z7

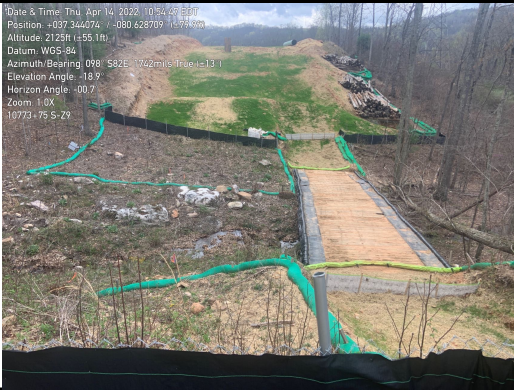
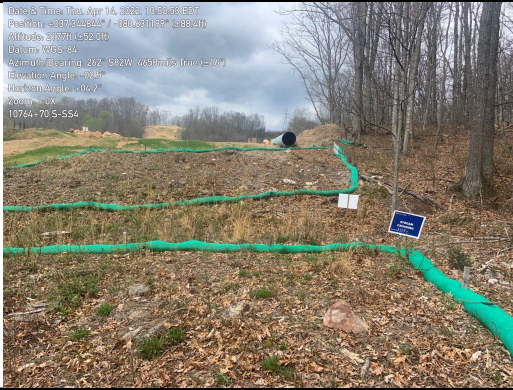
GPS Location	See photo	GPS Location	See photo		
Field Station#	10773+75	Field Station#	10764+70		
Pic 5 Desc.	Conditions and controls at S-Z9	Pic 6 Desc.	Conditions and controls at S-SS4

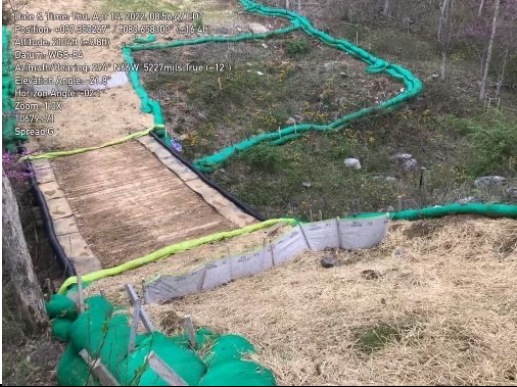
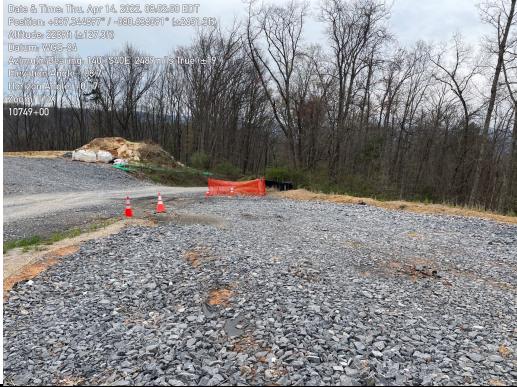
GPS Location	See photo	GPS Location	See photo		
Field Station#	10779+71	Field Station#	10749+00		
Pic 7 Desc.	Equipment bridge functional	Pic 8 Desc.	RCE functional
