Visual Site Inspection Report

Project Name	H-600 Pipeline Spread G	AFE	124300137	Spread	H-600 Pipeline Spread G
Contractor	Precision			Report #	36676
Inspector	Chris Burns			Date/Time	4/18/2022 9:02 AM
Permit #	TBD	Inspection Type	VA SWPP	Station Begin	11353+67
State	VA	Inspection Area	Partial	Station End	11471+56
County	Giles	Ground	Wet	Temperature (°F)	37.00
Municipality	N/A	Weather	Snow/Sleet	Rain Gauge (in)	0.00
				Rain Accumulation Time (days)	1.00

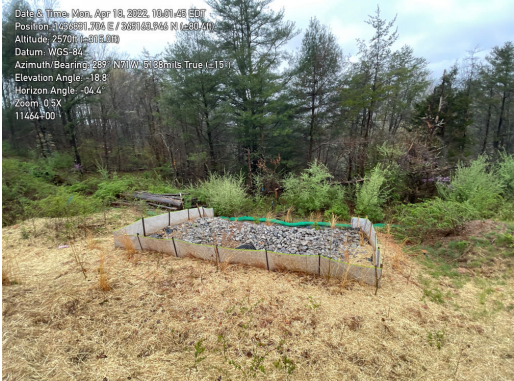
GPS Location	1	GPS Location	2		
Field Station#	11464+00	Field Station#	11451+18		
Pic 1 Desc.	Plunge pool functional.	Pic 2 Desc.	S-0012/S-0013.

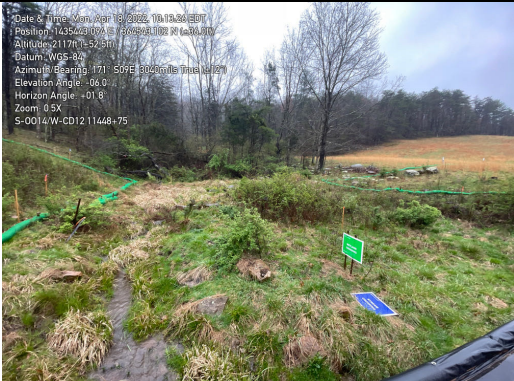
GPS Location	3	GPS Location	4		
Field Station#	11448+75	Field Station#	11439+00		
Pic 3 Desc.	S-0014/W-CD12.	Pic 4 Desc.	Section of restored RoW showing conditions and controls.

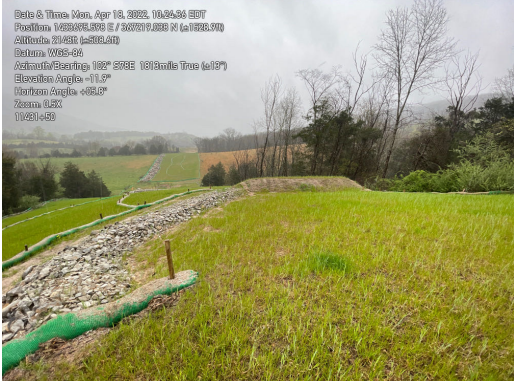
GPS Location	5	GPS Location	6		
Field Station#	11431+50	Field Station#	11431+50		
Pic 5 Desc.	Representative photo of permanent waterbar and level spreaders installed.	Pic 6 Desc.	Section of restored RoW showing conditions and controls.

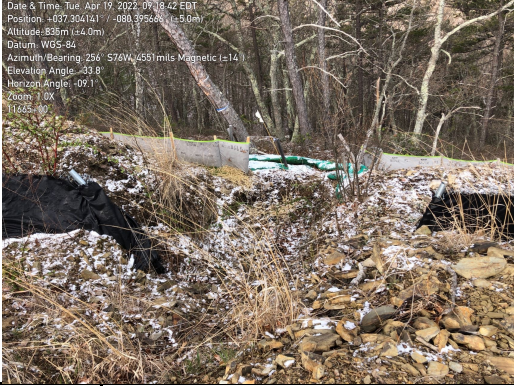
GPS Location	On photo	GPS Location	On photo		
Field Station#	11665+00	Field Station#	11664+00		
Pic 1 Desc.	Sumps and end treatments continue to adequately control stormwater runoff.	Pic 2 Desc.	No erosion being caused by runoff.

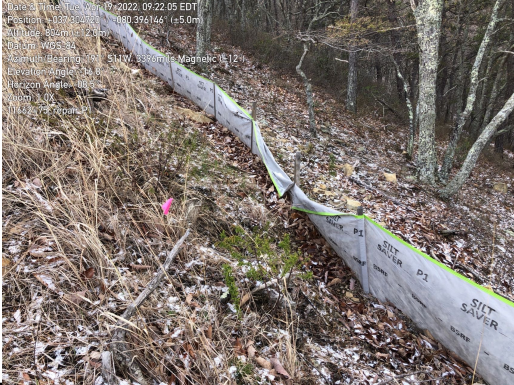
GPS Location	On photo	GPS Location	On photo		
Field Station#	11662+75	Field Station#	11660+00		
Pic 3 Desc.	COMMUNICATION; ECD maintenance needed at 11662+75.	Pic 4 Desc.	Perimeter ECDs are in acceptable condition.

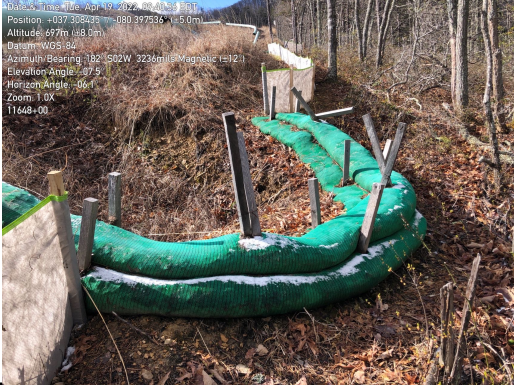
GPS Location	On photo	GPS Location	On photo		
Field Station#	11648+00	Field Station#	11634+00		
Pic 5 Desc.	No sediment movement evident.	Pic 6 Desc.	ROW stable. Slope breakers functional.

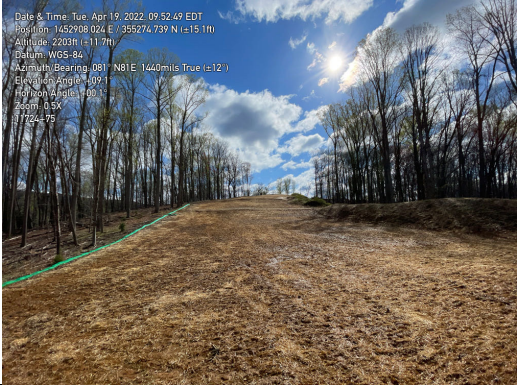
GPS Location	7	GPS Location	8		
Field Station#	11724+75	Field Station#	11740+60		
Pic 7 Desc.	Section of RoW showing conditions and controls.	Pic 8 Desc.	Overview S-EF65.

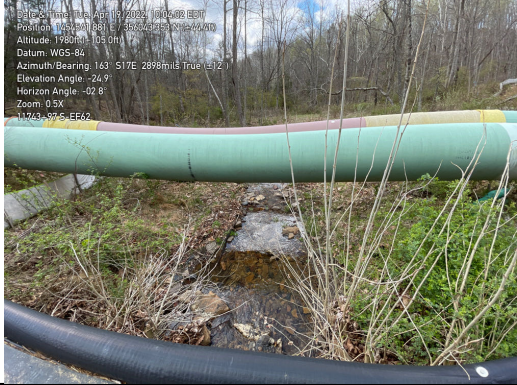
GPS Location	9	GPS Location	10		
Field Station#	11743+97	Field Station#	11755+00		
Pic 9 Desc.	S-EF62.	Pic 10 Desc.	Section of RoW showing conditions and controls.

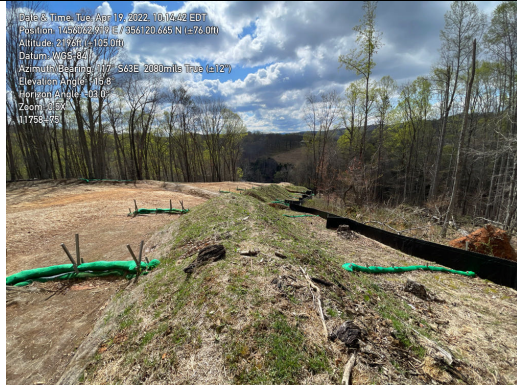
GPS Location	11	GPS Location	12		
Field Station#	11758+75	Field Station#	11767+44		
Pic 11 Desc.	Section of RoW showing conditions and controls.	Pic 12 Desc.	S-IJ52.

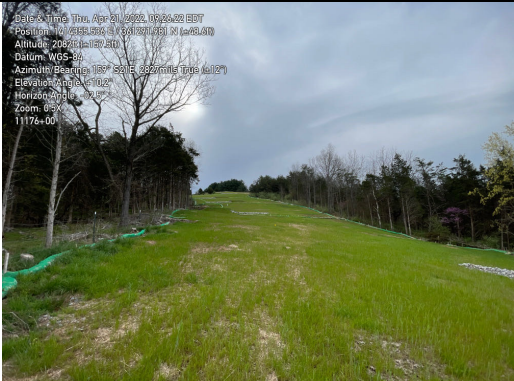
GPS Location	3	GPS Location	4		
Field Station#	11176+00	Field Station#	11159+50		
Pic 3 Desc.	Section of restored RoW showing conditions and controls.	Pic 4 Desc.	S-NN17.

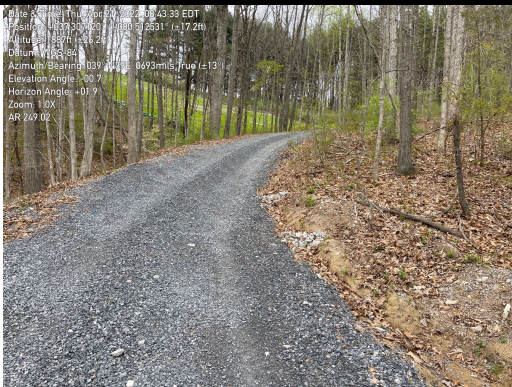
GPS Location	See photo		GPS Location	See photo	
Field Station#	11184+79		Field Station#	11185+00	
Pic 1 Desc.	Access road in good condition Rock check dams in place		Pic 2 Desc.	Perimeter controls in place

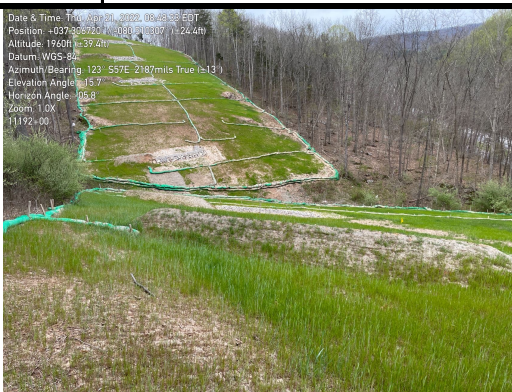
GPS Location	See photo		GPS Location	See photo	
Field Station#	11190+00		Field Station#	11191+12	
Pic 3 Desc.	Permanent water bars and level spreader in place		Pic 4 Desc.	Clean water drainage feature in place

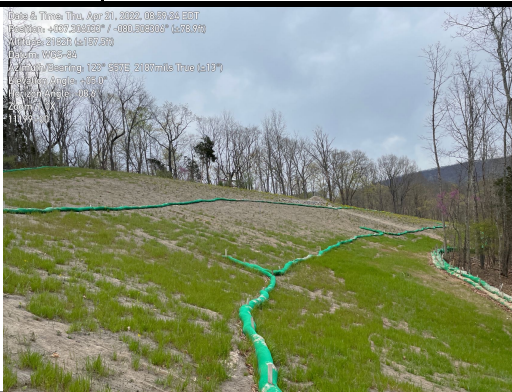
GPS Location	See photo		GPS Location	See photo	
Field Station#	11199+00		Field Station#	11213+00	
Pic 5 Desc.	Picture showing condition of row		Pic 6 Desc.	Area being monitored for stabilization

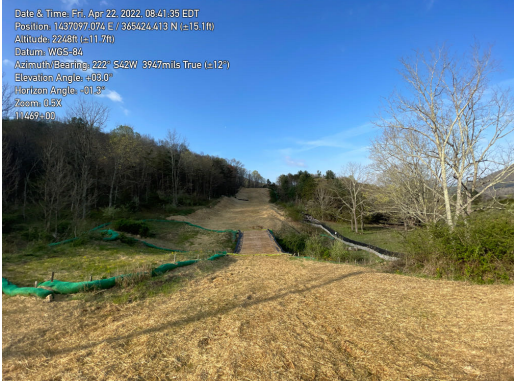
GPS Location	1	GPS Location	2		
Field Station#	11469+00	Field Station#	11451+87		
Pic 1 Desc.	Section of RoW showing conditions and controls.		Pic 2 Desc.	S-0012.

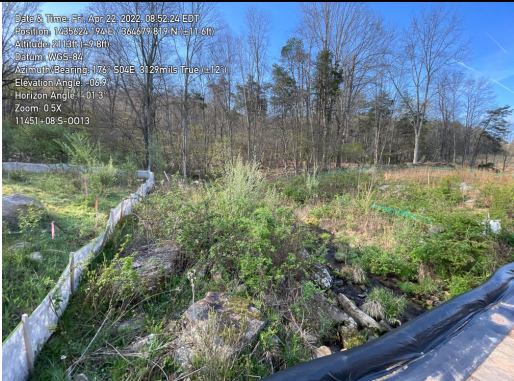
GPS Location	3	GPS Location	4		
Field Station#	11451+08	Field Station#	11448+93		
Pic 3 Desc.	S-0013.		Pic 4 Desc.	S-0014/W-CD12.

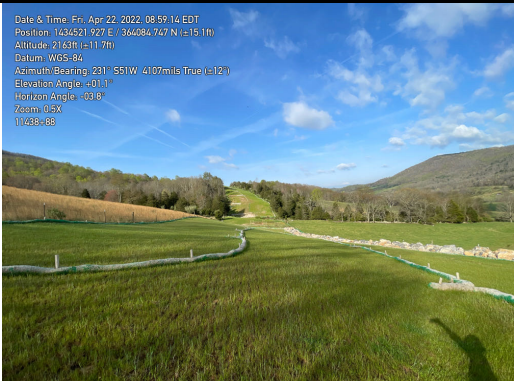
GPS Location	5	GPS Location	6		
Field Station#	11438+88	Field Station#	11430+00		
Pic 5 Desc.	Section of restored RoW showing conditions and controls.		Pic 6 Desc.	Representative photo of permanent waterbar and level spreaders installed.
