Visual Site Inspection Report

Project Name	H-600 Pipeline Spread G	AFE	124300137	Spread	H-600 Pipeline Spread G
Contractor	Precision			Report #	36933
Inspector	Rob Robertson			Date/Time	4/25/2022 11:18 AM
Permit #	TBD	Inspection Type	VA SWPP	Station Begin	11600+01
State	VA	Inspection Area	Full	Station End	11670+00
County	Montgomery	Ground	Dry	Temperature (°F)	61.00
Municipality	N/A	Weather	Sunny	Rain Gauge (in)	0.00
				Rain Accumulation Time (days)	1.00

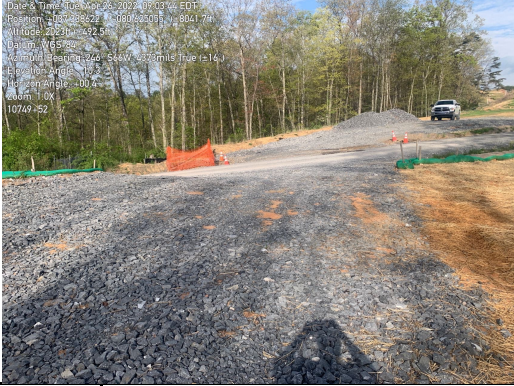
GPS Location	See photo.		GPS Location	See photo.	
Field Station#	10750+00		Field Station#	10753+00	
Pic 1 Desc.	RCE in place at Hendrickson Road.		Pic 2 Desc.	Waterbars in place. ROW temporarily stabilized with seed and mulch.

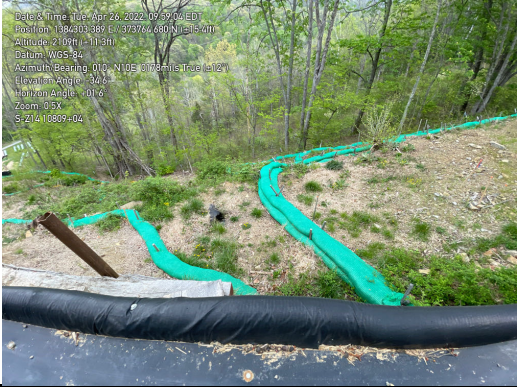
GPS Location	7	GPS Location	8		
Field Station#	10809+04	Field Station#	10803+75		
Pic 7 Desc.	S-Z14.	Pic 8 Desc.	Section of RoW showing conditions and controls.

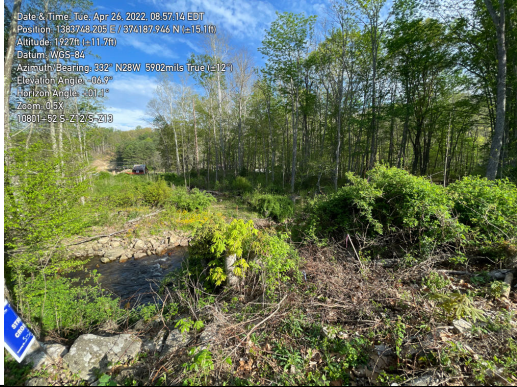
GPS Location	9	GPS Location	10		
Field Station#	10801+52	Field Station#	10799+00		
Pic 9 Desc.	Overview S-Z12/S-Z13.	Pic 10 Desc.	Overview S-Z10/W-Z3/S-Z11.		
Insert image here		Insert image here			
GPS Location		GPS Location			
Field Station#		Field Station#			
Pic 11 Desc.		Pic 12 Desc.

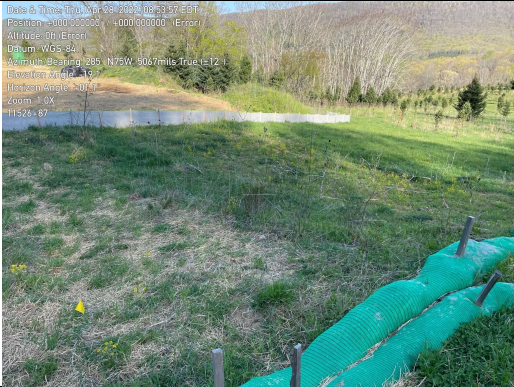
GPS Location	See Photo	GPS Location	See Photo		
Field Station#	1152+67	Field Station#	11531+00		
Pic 1 Desc.	Silt Fence	Pic 2 Desc.	Level Spreader

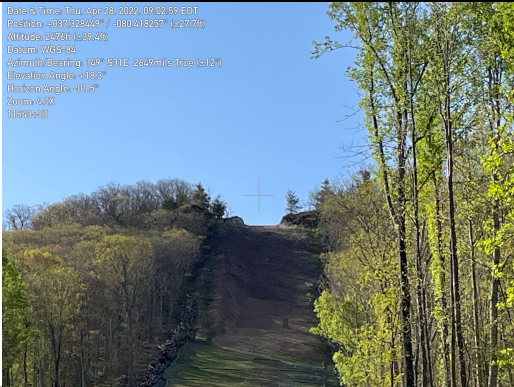
GPS Location	See Photo	GPS Location	See Photo		
Field Station#	11543+00	Field Station#	11585+48		
Pic 3 Desc.	Section of ROW showing conditions and controls	Pic 4 Desc.	S-PP21

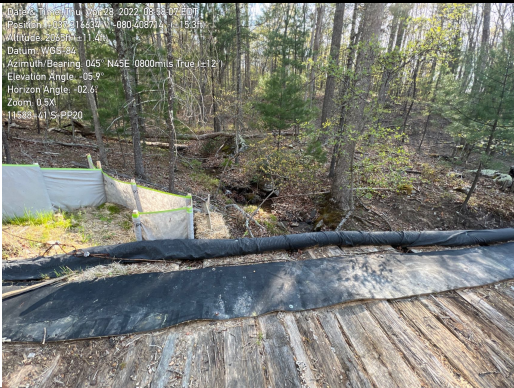
GPS Location	See Photo	GPS Location	See Photo		
Field Station#	11588+41	Field Station#	11593+00		
Pic 5 Desc.	S-PP20	Pic 6 Desc.	Perimeter controls

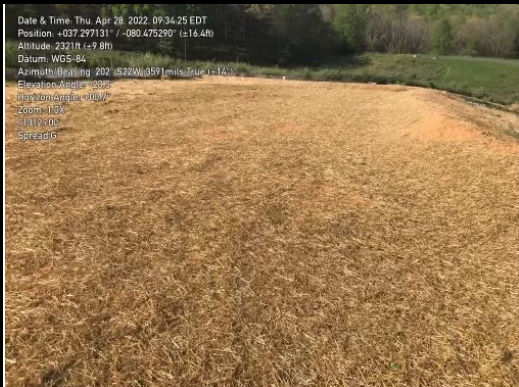
GPS Location	See Photo	GPS Location	See Photo		
Field Station#	11312+00	Field Station#	11293+05		
Pic 7 Desc.	Row stabilization	Pic 8 Desc.	Vegetated S-MM18 stream buffer zones. Soil disturbance from on site environmental crew traffic.

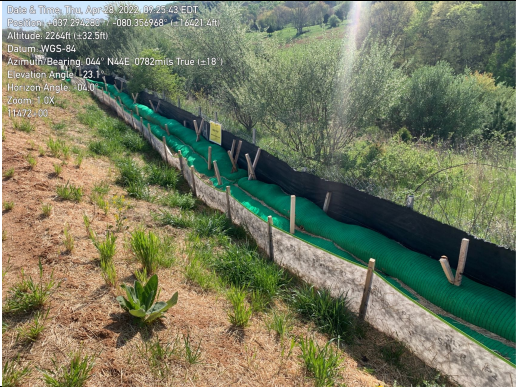
GPS Location	See photo.	GPS Location	See photo.
Field Station#	11472+00	Field Station#	11476+00
Pic 1 Desc.	Triple barrier ECDs in place at off ROW karst area.	Pic 2 Desc.	Stone inlet in place at slope drain pipe.

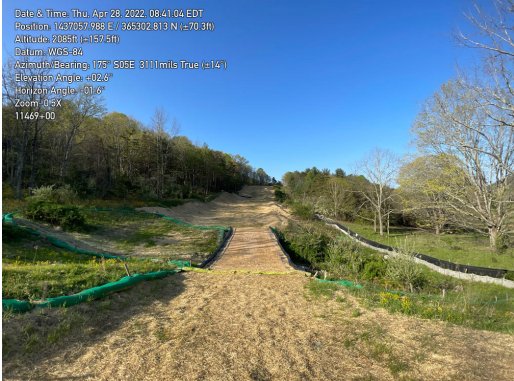
GPS Location	1	GPS Location	2		
Field Station#	11469+00	Field Station#	11451+87		
Pic 1 Desc.	Section of RoW showing conditions and controls.	Pic 2 Desc.	S-0012.

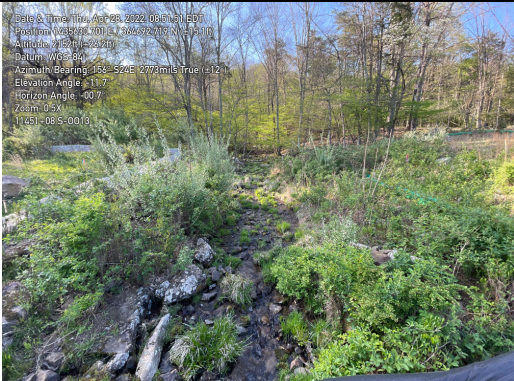
GPS Location	3	GPS Location	4		
Field Station#	11451+08	Field Station#	11448+93		
Pic 3 Desc.	S-0013.	Pic 4 Desc.	S-0014/W-CD12.

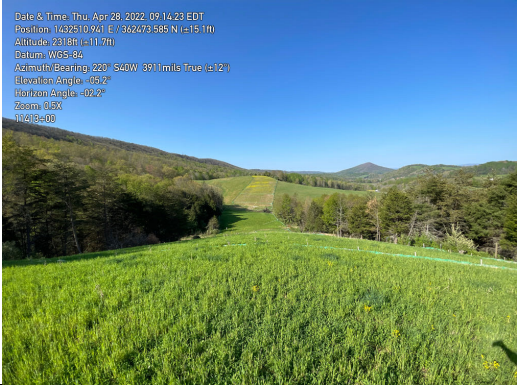
GPS Location	7	GPS Location	8		
Field Station#	11413+00	Field Station#	11397+00		
Pic 7 Desc.	Section of restored RoW showing conditions and controls.	Pic 8 Desc.	Section of restored RoW showing conditions and controls.

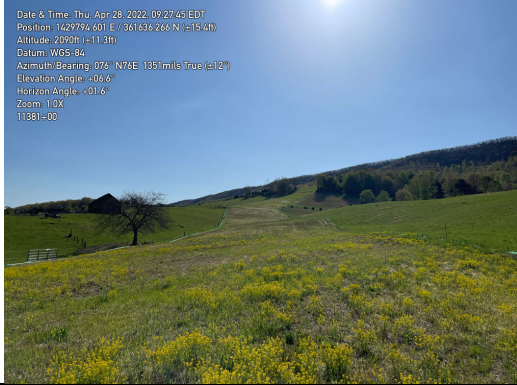
GPS Location	9	GPS Location	10		
Field Station#	11381+00	Field Station#	11367+00		
Pic 9 Desc.	Section of restored RoW showing conditions and controls.	Pic 10 Desc.	Section of restored RoW showing conditions.

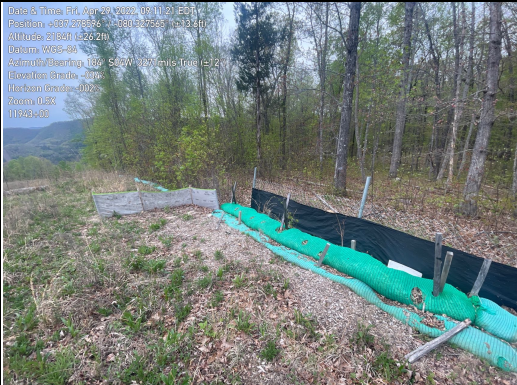
GPS Location	See Photo	GPS Location	See Photo		
Field Station#	11943+00	Field Station#	11939+66		
Pic 7 Desc.	Perimeter E&S controls to the presumed off LOD sensitive resource area.	Pic 8 Desc.	P1 Silt fencing and permanent vegetation.

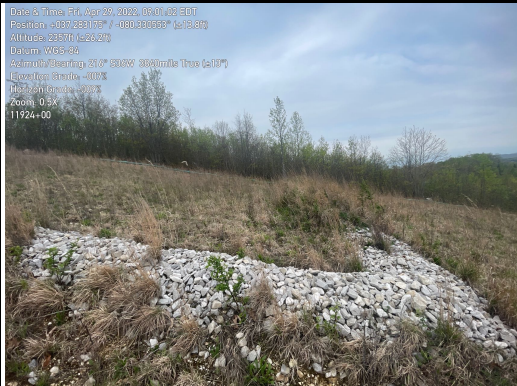
GPS Location	See Photo	GPS Location	See Photo		
Field Station#	11924+00	Field Station#	11907+00		
Pic 9 Desc.	Permanent level spreader condition	Pic 10 Desc.	Final Restoration Area

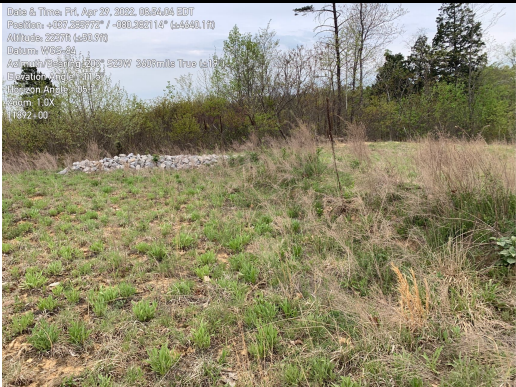
GPS Location	See photo.		GPS Location	See photo.	
Field Station#	11892+00		Field Station#	11864+00	
Pic 1 Desc.	Waterbar and level spreader in place.		Pic 2 Desc.	Sensitive resource buffer in place at P-KL2.

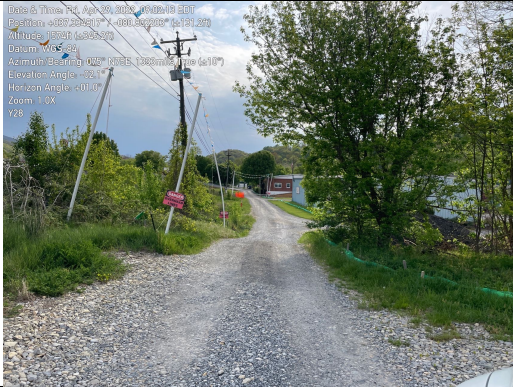
GPS Location		See photo				GPS Location		See photo			
Field Station#		12005+00				Field Station#		12005+00			
Pic 1 Desc.		Picture showing condition of y28				Pic 2 Desc.		Housekeeping trash in good condition y28

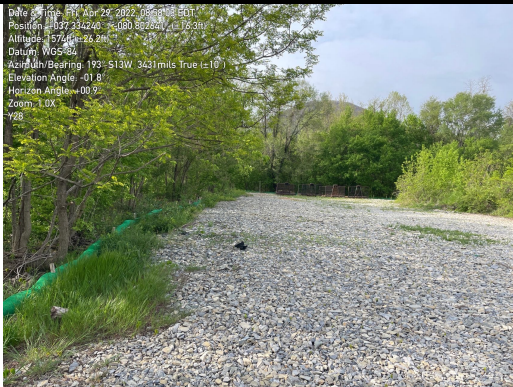
GPS Location		See photo				GPS Location		See photo			
Field Station#		12005+00				Field Station#		12005+00			
Pic 3 Desc.		CFS perimeter controls functional y28				Pic 4 Desc.		RCE functional y28

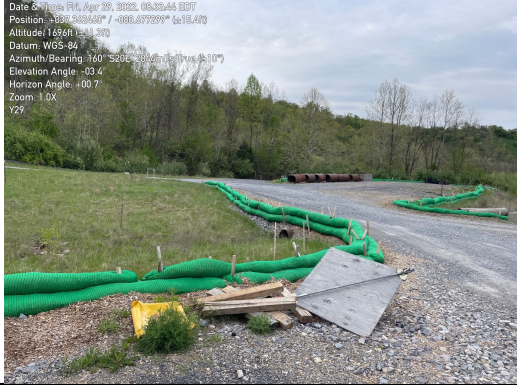
GPS Location	See photo	GPS Location	See photo		
Field Station#	12005+00	Field Station#	12005+00		
Pic 9 Desc.	Culvert functional y29	Pic 10 Desc.	Housekeeping in good condition y29

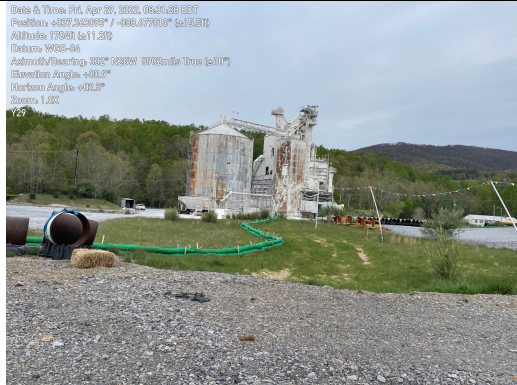
GPS Location	See photo	GPS Location	See photo		
Field Station#	12005+00	Field Station#	12005+00		
Pic 11 Desc.	Permanent stabilization in place y29	Pic 12 Desc.	CFS perimeter controls functional y29
