# Visual Site Inspection Report

<b>Project Name</b>	H-600 Pipeline Spread G	<b>AFE</b>	124300137	<b>Spread</b>	H-600 Pipeline Spread G
<b>Contractor</b>	Precision			<b>Report #</b>	36181
<b>Inspector</b>	Clint Sears			<b>Date/Time</b>	4/4/2022 10:22 AM
<b>Permit #</b>	TBD	<b>Inspection Type</b>	VA SWPP	<b>Station Begin</b>	10749+92
<b>State</b>	VA	<b>Inspection Area</b>	Partial	<b>Station End</b>	10798+92
<b>County</b>	Giles	<b>Ground</b>	Damp	<b>Temperature (°F)</b>	44.00
<b>Municipality</b>	N/A	<b>Weather</b>	Cloudy	<b>Rain Gauge (in)</b>	0.00
				<b>Rain Accumulation Time (days)</b>	1.00

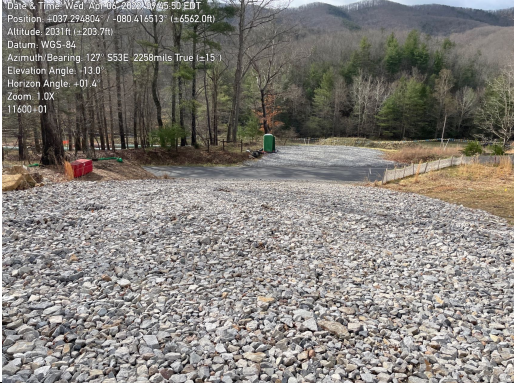
<b>GPS Location</b>	See photo	<b>GPS Location</b>	See photo		
<b>Field Station#</b>	11600+01	<b>Field Station#</b>	11528+00		
<b>Pic 1 Desc.</b>	RCE functional	<b>Pic 2 Desc.</b>	Over seeding needed

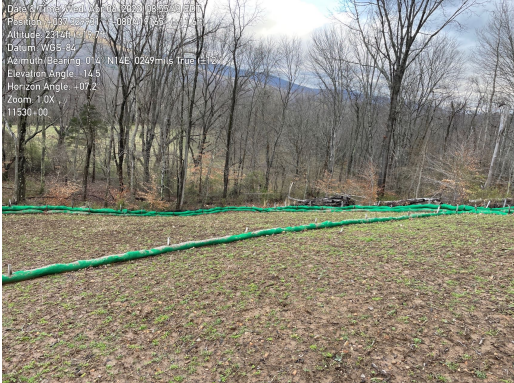
<b>GPS Location</b>	See photo	<b>GPS Location</b>	See photo		
<b>Field Station#</b>	11530+00	<b>Field Station#</b>	11536+00		
<b>Pic 3 Desc.</b>	Over seeding needed	<b>Pic 4 Desc.</b>	Picture showing condition of row

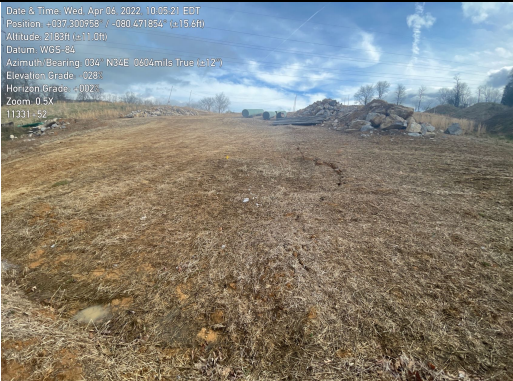
<p>Date &amp; Time: Wed Apr 06 2022 10:35:21 EDT Position: +037 300958 / -080 471854 / (+15.4m) Altitude: 2183ft (+11.0m) Datum: WGS-84 Azimuth Bearing: 030° 04'36" (1100mils true) (+14.7) Elevation Grade: +004 Horizon Grade: +006 Zoom: 0.5X 11331+52</p>			
<b>GPS Location</b>	See Photo	<b>GPS Location</b>	See Photo		
<b>Field Station#</b>	11353+67	<b>Field Station#</b>	11331+52		
<b>Pic 3 Desc.</b>	Perimeter super silt fence, P1 silt fencing, and RCE conditions at the additional parking area at AR256.02	<b>Pic 4 Desc.</b>	View of additional settlement over the ditch line. The Precision contractor is aware and ongoing repairs have not yet reached this area

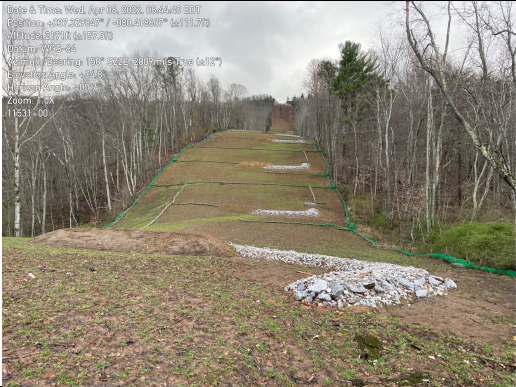
<b>GPS Location</b>	See photo	<b>GPS Location</b>	see photo		
<b>Field Station#</b>	11531+00	<b>Field Station#</b>	11533+00		
<b>Pic 1 Desc.</b>	ROW needing over seeded	<b>Pic 2 Desc.</b>	Water bar (other). Level spreader
