# Visual Site Inspection Report

<b>Project Name</b>	H-600 Pipeline Spread G	<b>AFE</b>	124300137	<b>Spread</b>	H-600 Pipeline Spread G
<b>Contractor</b>	Precision			<b>Report #</b>	37174
<b>Inspector</b>	Joe Sweeden			<b>Date/Time</b>	5/2/2022 7:11 AM
<b>Permit #</b>	TBD	<b>Inspection Type</b>	VA SWPP	<b>Station Begin</b>	10859+46
<b>State</b>	VA	<b>Inspection Area</b>	Partial	<b>Station End</b>	10929+80
<b>County</b>	Giles	<b>Ground</b>	Damp	<b>Temperature (°F)</b>	60.00
<b>Municipality</b>	N/A	<b>Weather</b>	Sunny	<b>Rain Gauge (in)</b>	0.30
				<b>Rain Accumulation Time (days)</b>	1.00

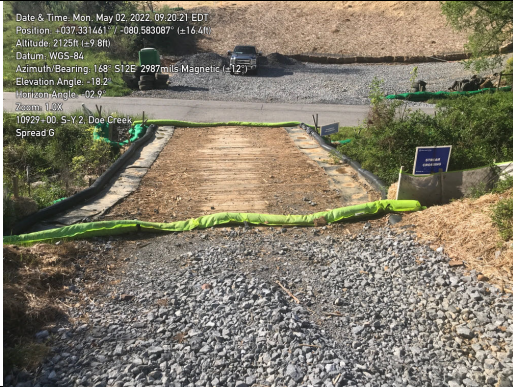
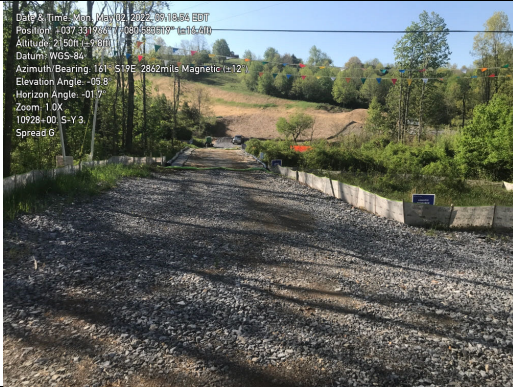
GPS Location		See photo				GPS Location		see photo			
Field Station#		10929+00				Field Station#		10928+00			
Pic 1 Desc.		SY 2				Pic 2 Desc.		SY 3

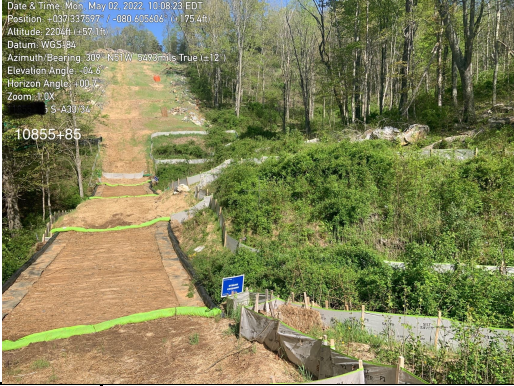
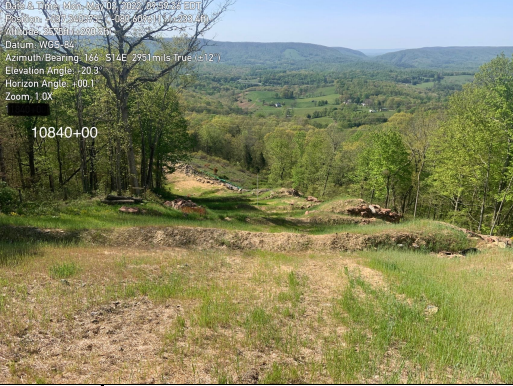
<b>GPS Location</b>	See photo	<b>GPS Location</b>	See photo		
<b>Field Station#</b>	10855+85	<b>Field Station#</b>	10840+00		
<b>Pic 1 Desc.</b>	Section of Row showing conditions and controls at S-A33/34	<b>Pic 2 Desc.</b>	Section of Row showing conditions and controls

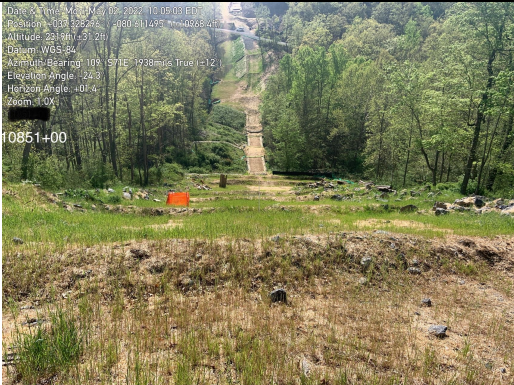
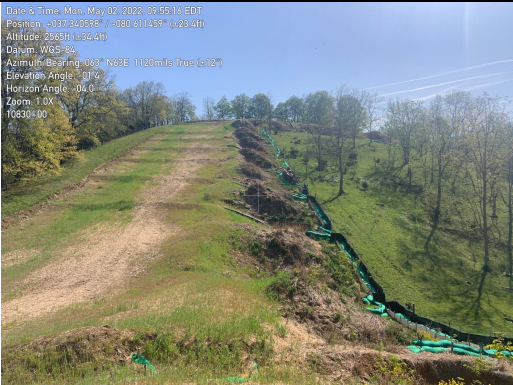
<b>GPS Location</b>	See photo	<b>GPS Location</b>	See photo		
<b>Field Station#</b>	10851+00	<b>Field Station#</b>	10830+00		
<b>Pic 3 Desc.</b>	Section of Row showing conditions and controls	<b>Pic 4 Desc.</b>	Section of Row showing conditions and controls

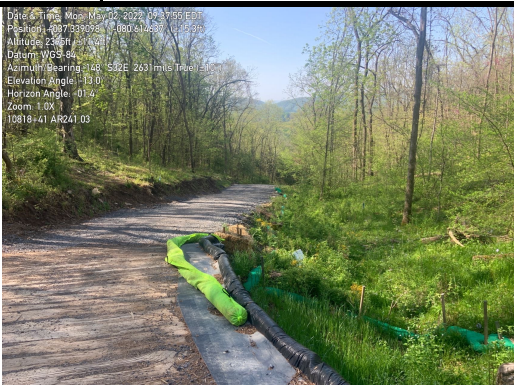
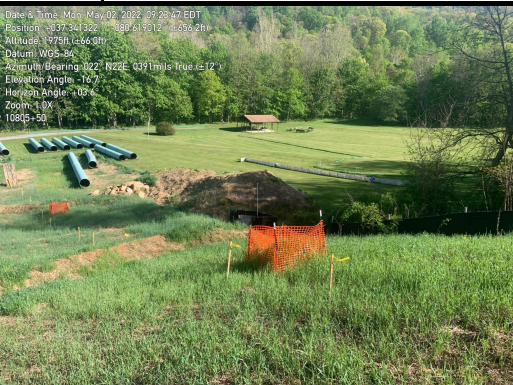
<b>GPS Location</b>	See photo	<b>GPS Location</b>	See photo		
<b>Field Station#</b>	10818+41	<b>Field Station#</b>	10805+50		
<b>Pic 5 Desc.</b>	AR241.03 is maintained in acceptable condition	<b>Pic 6 Desc.</b>	Section of Row showing conditions and controls

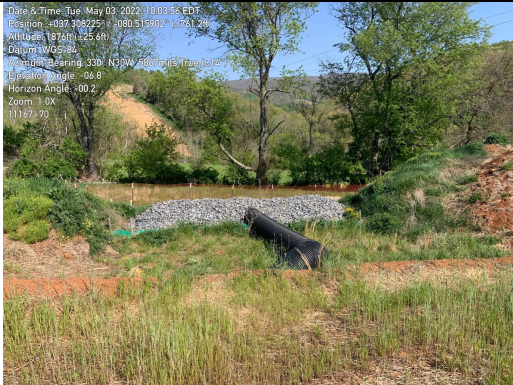
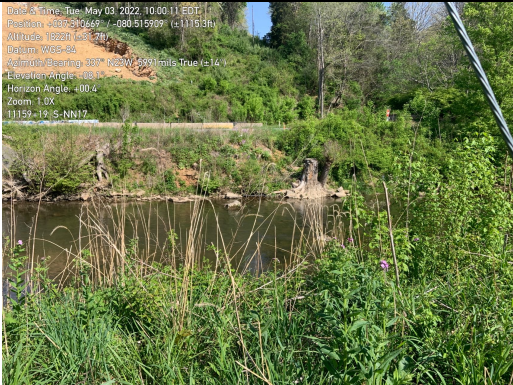
GPS Location	See photo		GPS Location	See photo	
Field Station#	11167+70		Field Station#	11159+19	
Pic 3 Desc.	Clean water diversion pipe and level spreader are in acceptable condition		Pic 4 Desc.	S-NN17

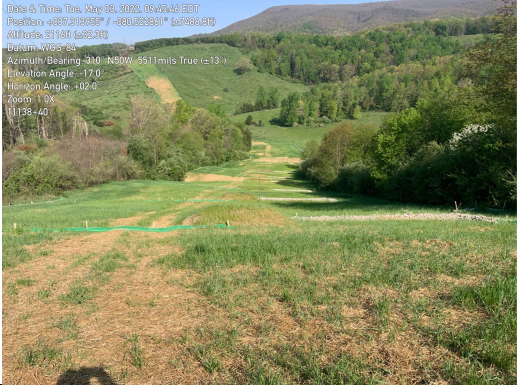
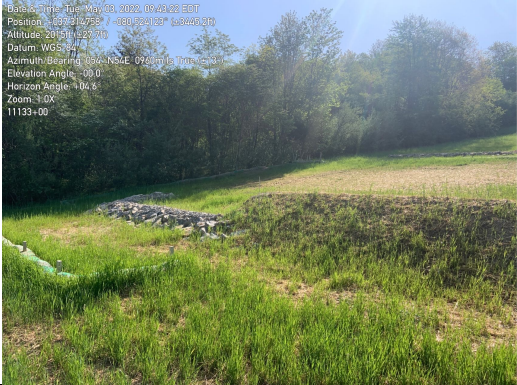
<b>GPS Location</b>	See photo		<b>GPS Location</b>	See photo	
<b>Field Station#</b>	11138+40		<b>Field Station#</b>	11133+00	
<b>Pic 7 Desc.</b>	Section of Row showing conditions and controls		<b>Pic 8 Desc.</b>	Representational photo of water bar and level spreader

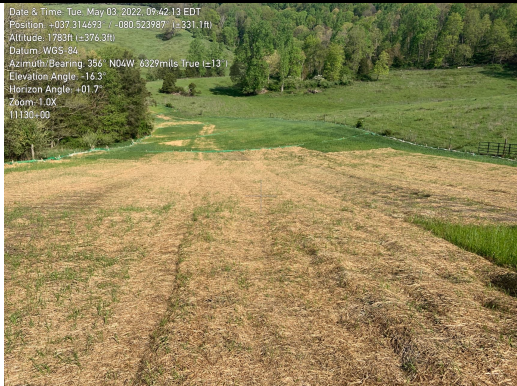
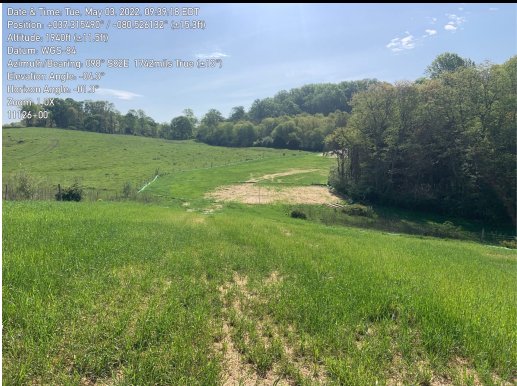
<b>GPS Location</b>	See photo		<b>GPS Location</b>	See photo	
<b>Field Station#</b>	11130+00		<b>Field Station#</b>	11126+00	
<b>Pic 9 Desc.</b>	Erosion control blanket is in place and in acceptable conditions		<b>Pic 10 Desc.</b>	Section of Row showing conditions and controls

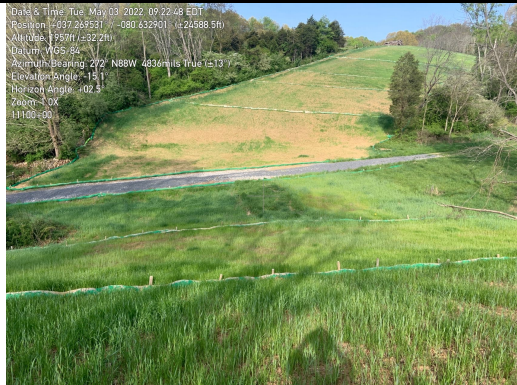
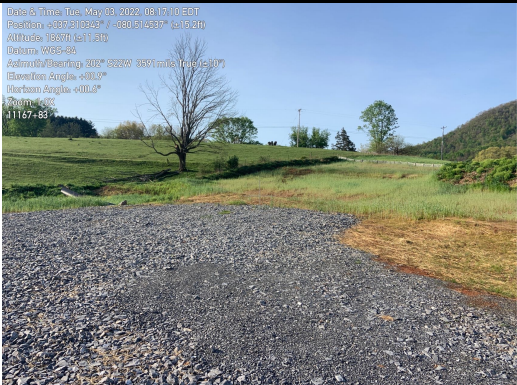
<b>GPS Location</b>	See photo		<b>GPS Location</b>	See photo	
<b>Field Station#</b>	11100+00		<b>Field Station#</b>	11167+83	
<b>Pic 11 Desc.</b>	Section of Row showing conditions and controls		<b>Pic 12 Desc.</b>	RCE at AR249.01 is in acceptable condition

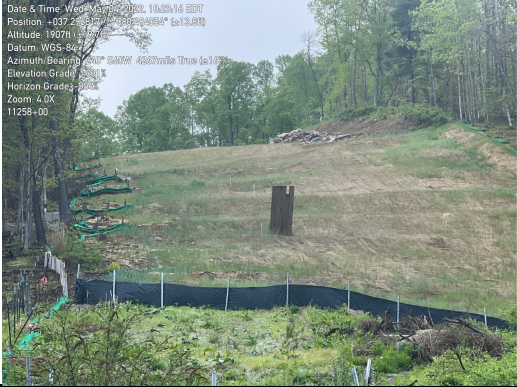
<b>GPS Location</b>		See Photo		<b>GPS Location</b>	
<b>Field Station#</b>		11258+00		<b>Field Station#</b>	
<b>Pic 13 Desc.</b>		Temporary stabilization of steep slope.		<b>Pic 14 Desc.</b>	
Insert image here		Insert image here			
<b>GPS Location</b>				<b>GPS Location</b>	
<b>Field Station#</b>				<b>Field Station#</b>	
<b>Pic 15 Desc.</b>				<b>Pic 16 Desc.</b>	
Insert image here		Insert image here			
<b>GPS Location</b>				<b>GPS Location</b>	
<b>Field Station#</b>				<b>Field Station#</b>	
<b>Pic 17 Desc.</b>				<b>Pic 18 Desc.</b>

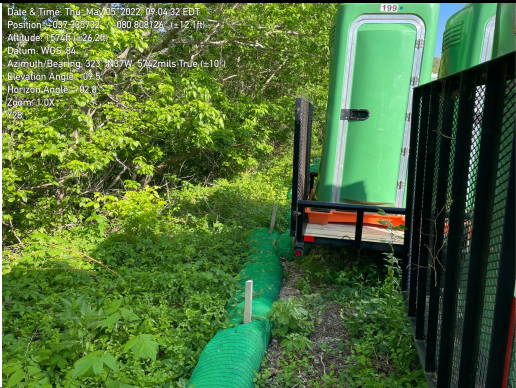
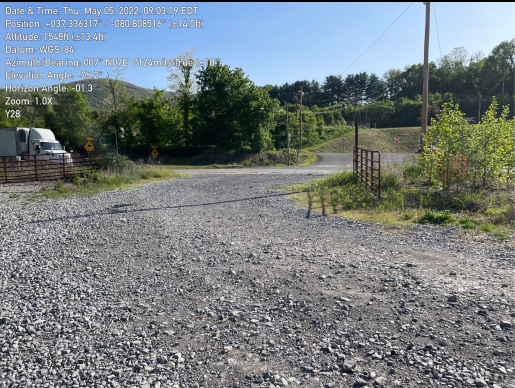
<b>GPS Location</b>	See photo	<b>GPS Location</b>	See photo		
<b>Field Station#</b>	12005+00	<b>Field Station#</b>	12005+00		
<b>Pic 5 Desc.</b>	CFS perimeter controls functional y28	<b>Pic 6 Desc.</b>	RCE functional y28

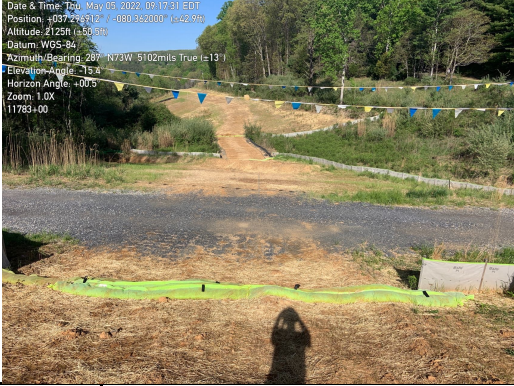
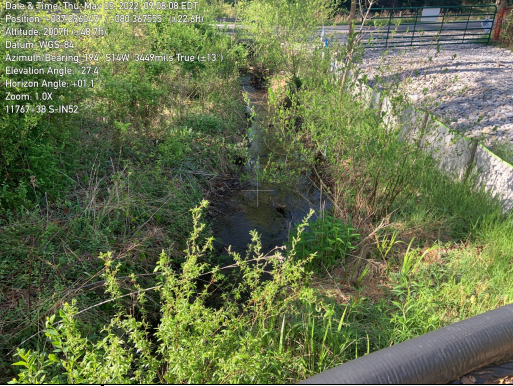
<b>GPS Location</b>	See photo	<b>GPS Location</b>	See photo		
<b>Field Station#</b>	11783+00	<b>Field Station#</b>	11767+38		
<b>Pic 1 Desc.</b>	Section of Row showing conditions and controls	<b>Pic 2 Desc.</b>	S-IJ52

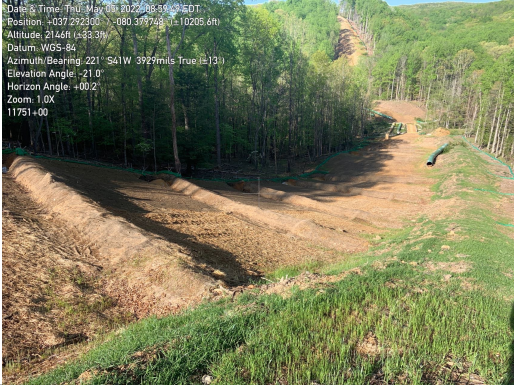
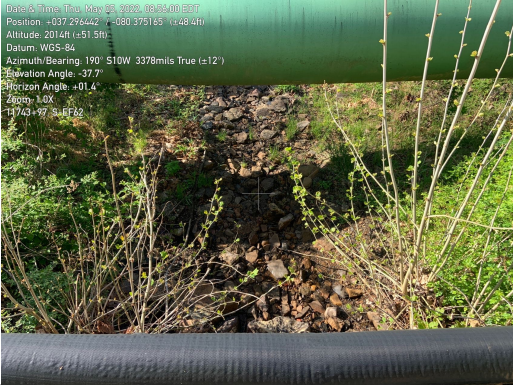
<b>GPS Location</b>	See photo	<b>GPS Location</b>	See photo		
<b>Field Station#</b>	11751+00	<b>Field Station#</b>	11743+97		
<b>Pic 3 Desc.</b>	Section of Row showing conditions and controls	<b>Pic 4 Desc.</b>	S-EF62

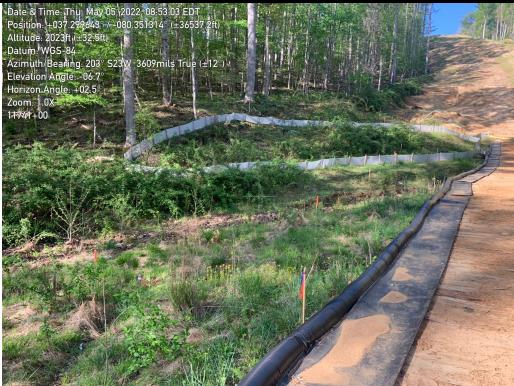
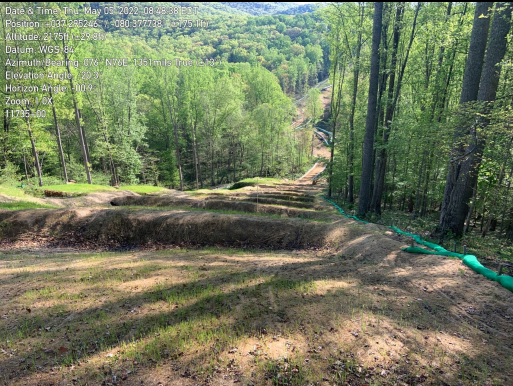
<b>GPS Location</b>	See photo	<b>GPS Location</b>	See photo		
<b>Field Station#</b>	11741+00	<b>Field Station#</b>	11735+00		
<b>Pic 5 Desc.</b>	Section of Row showing conditions and controls at S-EF65	<b>Pic 6 Desc.</b>	Section of Row showing conditions and controls

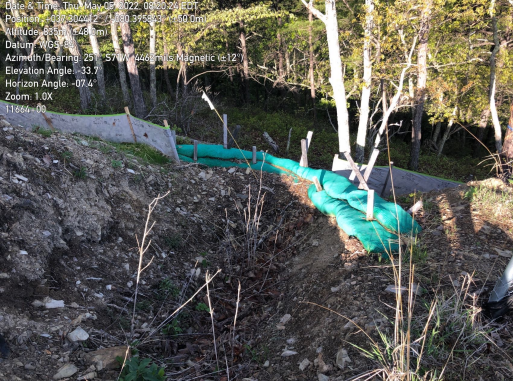
<b>GPS Location</b>	On photo	<b>GPS Location</b>	On photo		
<b>Field Station#</b>	11669+00	<b>Field Station#</b>	11664+00		
<b>Pic 1 Desc.</b>	Conditions stable at top of Brush Mountain.	<b>Pic 2 Desc.</b>	End treatments are functional and effectively controlling stormwater runoff.

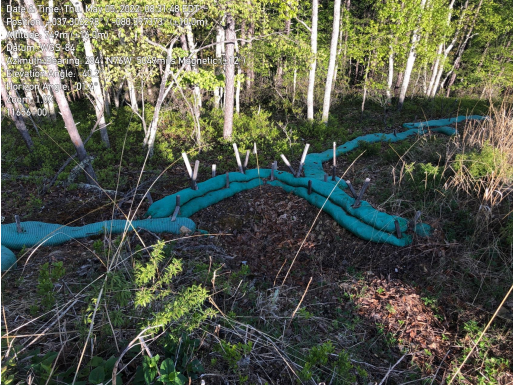
<b>GPS Location</b>	On photo	<b>GPS Location</b>	On photo		
<b>Field Station#</b>	11662+00	<b>Field Station#</b>	11656+00		
<b>Pic 3 Desc.</b>	Slope breakers functional. Grasses continue to emerge on JNF property.	<b>Pic 4 Desc.</b>	End treatments are functional. Worn CFS to be replaced once permits are curved and before any ground disturbance occurs.		
<p>Date &amp; Time: Thu May 05 2022 09:05:22 EDT  Position: +037.252329, -080.479680 (+5022.5m)  Altitude: 247m (+41.2m)  Datum: WGS 84  Azimuth Bearing: 170.510E 3022mils Magnetic (+12.1)  Elevation Angle: +04.5  Horizon Angle: +03.7  Zoom: 1.0x  11637+00</p>
