# Visual Site Inspection Report

<b>Project Name</b>	H-600 Pipeline Spread G	<b>AFE</b>	124300137	<b>Spread</b>	H-600 Pipeline Spread G
<b>Contractor</b>	Precision			<b>Report #</b>	37483
<b>Inspector</b>	Daniel Fortune			<b>Date/Time</b>	5/9/2022 6:09 PM
<b>Permit #</b>	TBD	<b>Inspection Type</b>	VA SWPP	<b>Station Begin</b>	11023+80
<b>State</b>	VA	<b>Inspection Area</b>	Partial	<b>Station End</b>	11098+47
<b>County</b>	Giles	<b>Ground</b>	Damp	<b>Temperature (°F)</b>	51.00
<b>Municipality</b>	N/A	<b>Weather</b>	Sunny	<b>Rain Gauge (in)</b>	0.50
				<b>Rain Accumulation Time (days)</b>	2.00

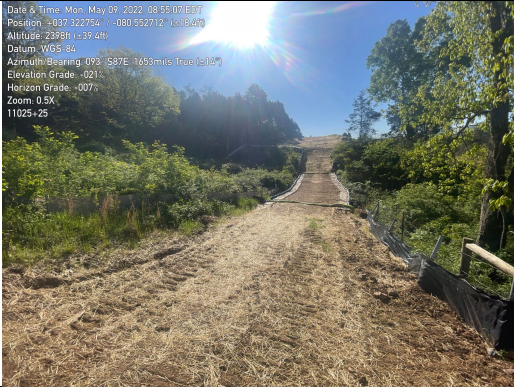
<b>GPS Location</b>	See Photo	<b>GPS Location</b>	See Photo		
<b>Field Station#</b>	11025+25	<b>Field Station#</b>	11045+00		
<b>Pic 1 Desc.</b>	S-IJ18 Equipment bridge condition.	<b>Pic 2 Desc.</b>	Temporary stabilization of water bar and sump pit condition.

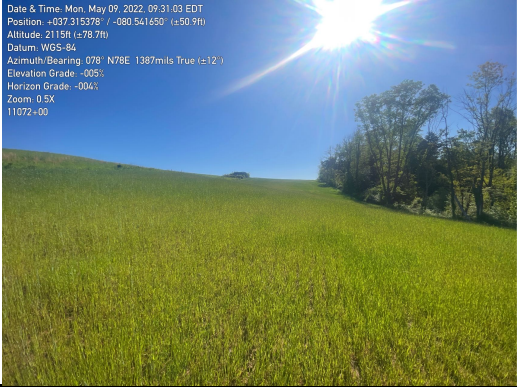
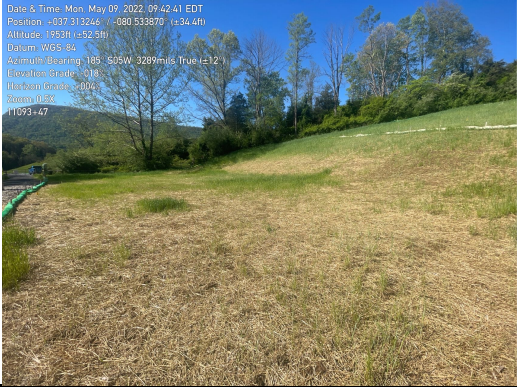
<b>GPS Location</b>	See Photo		<b>GPS Location</b>	See Photo	
<b>Field Station#</b>	11072+00		<b>Field Station#</b>	11093+47	
<b>Pic 7 Desc.</b>	Final Restoration Area		<b>Pic 8 Desc.</b>	Permanent restoration area. Recent reseedling has occurred.	
Insert image here			Insert image here

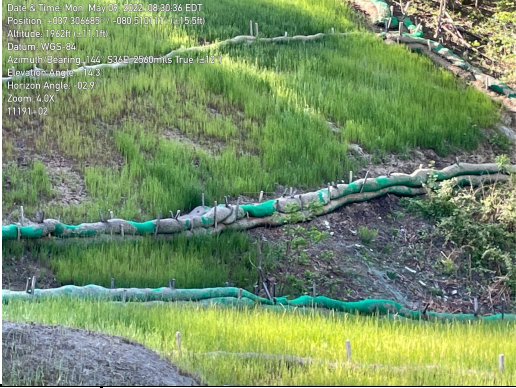
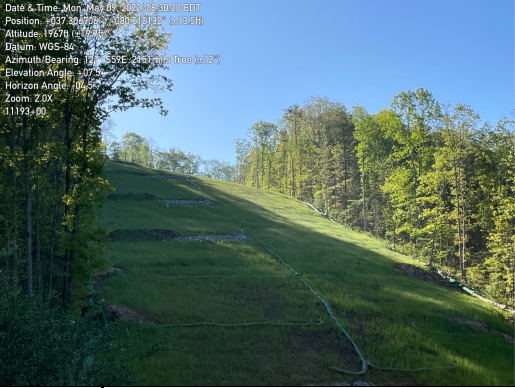
<p>Date &amp; Time: Mon, May 09, 2022, 08:30:36 EDT Position: -037.326881 / -080.519111 (-111.19) Altitude: 1920ft (-111.19) Datum: WGS-84 Azimuth/Bearing: 17.555E 330mils True (+12.5) Elevation Angle: -10.3 Horizon Angle: -02.9 Zoom: 2.0X 11193+00</p>			
<b>GPS Location</b>	See photo	<b>GPS Location</b>	See photo		
<b>Field Station#</b>	11191+02	<b>Field Station#</b>	11193+00		
<b>Pic 1 Desc.</b>	Clean water drainage feature functional	<b>Pic 2 Desc.</b>	Permanent water bars and level spreader in place

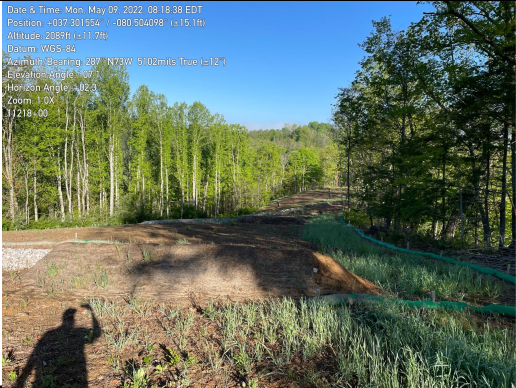
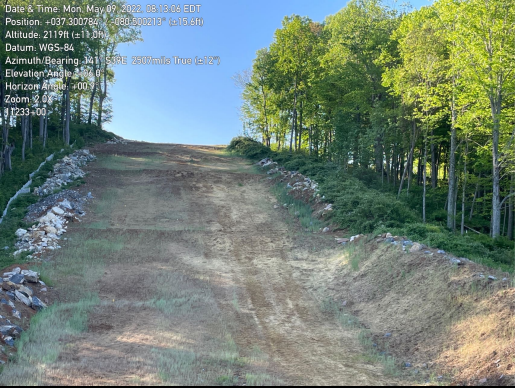
<p>Date &amp; Time: Mon, May 09, 2022, 08:18:38 EDT Position: -037.320154 / -080.504098 (-111.19) Altitude: 2119ft (-111.19) Datum: WGS-84 Azimuth/Bearing: 341.581E 350mils True (+12.5) Elevation Angle: +07.1 Horizon Angle: -00.3 Zoom: 2.0X 11233+00</p>			
<b>GPS Location</b>	See photo	<b>GPS Location</b>	See photo		
<b>Field Station#</b>	11218+00	<b>Field Station#</b>	11233+00		
<b>Pic 5 Desc.</b>	Picture showing condition of row	<b>Pic 6 Desc.</b>	Water bars in place

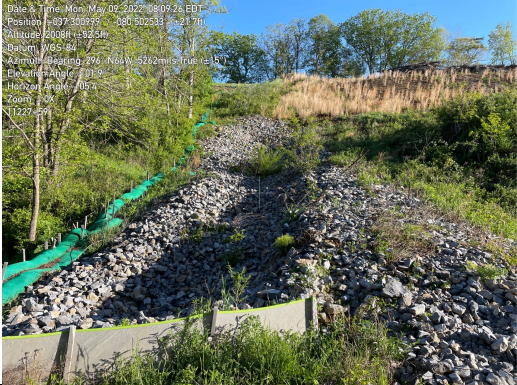
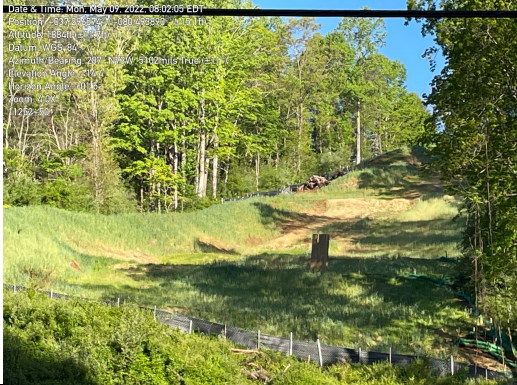
<b>GPS Location</b>	See photo	<b>GPS Location</b>	See photo		
<b>Field Station#</b>	11227+59	<b>Field Station#</b>	11252+50		
<b>Pic 7 Desc.</b>	Rock check dams in place	<b>Pic 8 Desc.</b>	SSF and ET in place		
Insert image here		Insert image here			
<b>GPS Location</b>		<b>GPS Location</b>			
<b>Field Station#</b>		<b>Field Station#</b>			
<b>Pic 9 Desc.</b>		<b>Pic 10 Desc.</b>			
Insert image here		Insert image here			
<b>GPS Location</b>		<b>GPS Location</b>			
<b>Field Station#</b>		<b>Field Station#</b>			
<b>Pic 11 Desc.</b>		<b>Pic 12 Desc.</b>

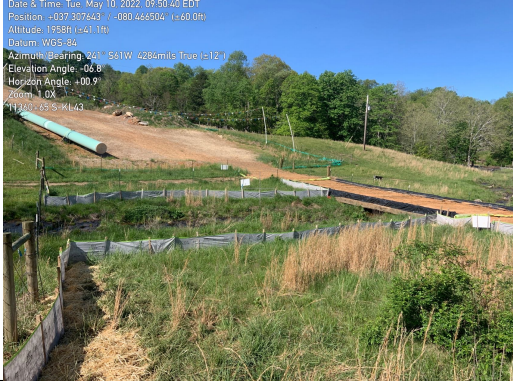
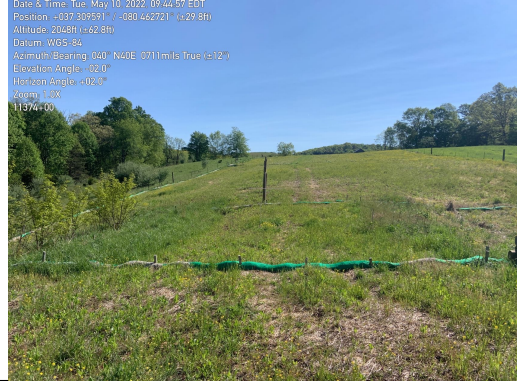
</div></div></div>			
GPS Location		See photo		GPS Location		See photo	
Field Station#		11360+65		Field Station#		11374+00	
Pic 1 Desc.		Section of Row showing conditions and controls at S-KL43		Pic 2 Desc.		Section of Row showing conditions and controls

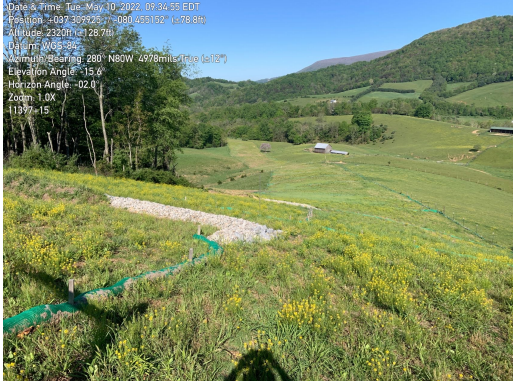
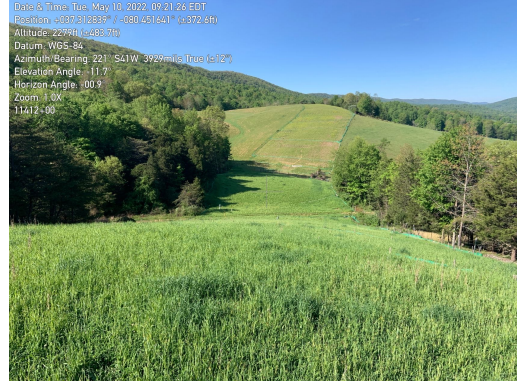
</div></div></div>			
GPS Location		See photo		GPS Location		See photo	
Field Station#		11397+15		Field Station#		11412+00	
Pic 3 Desc.		Section of Row showing conditions and controls		Pic 4 Desc.		Section of Row showing conditions and controls	
<div><div><div>Date &amp; Time: Tue, May 10, 2022, 09:18:52 EDT Position: +037.318466° / -080.449925° (-62.9ft) Altitude: 233ft (-74.4ft) Datum: WGS-84 Azimuth/Bearing: 231° S51W 410mils True (-121°) Elevation Angle: -00.5° Horizon Angle: +01.1° Zoom: 1.0X 11418+45</div><div>

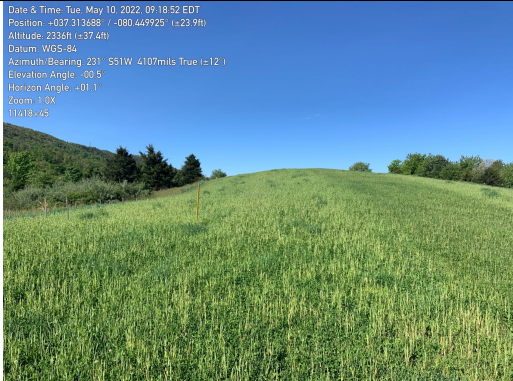
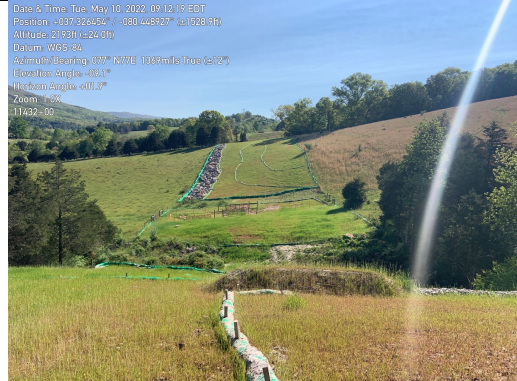
GPS Location		See photo		GPS Location		See photo	
Field Station#		11418+45		Field Station#		11432+00	
Pic 5 Desc.		Section of Row showing conditions and controls		Pic 6 Desc.		Section of Row showing conditions and controls

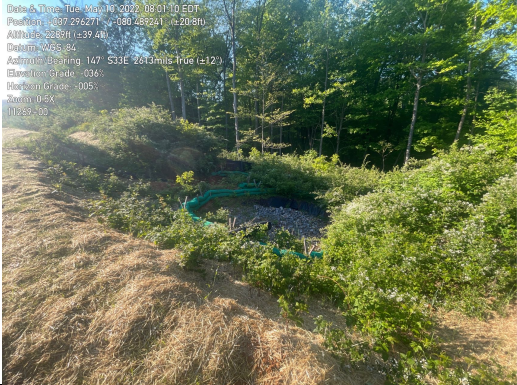
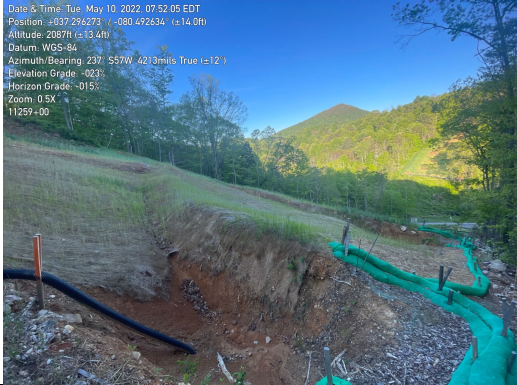
<b>GPS Location</b>	See Photo	<b>GPS Location</b>	See Photo		
<b>Field Station#</b>	11269+00	<b>Field Station#</b>	11259+00		
<b>Pic 7 Desc.</b>	CWDB and Plunge Pool conditions.	<b>Pic 8 Desc.</b>	Temporary stabilization of row and temporary water bar condition.		
Insert image here		Insert image here			
<b>GPS Location</b>		<b>GPS Location</b>			
<b>Field Station#</b>		<b>Field Station#</b>			
<b>Pic 9 Desc.</b>		<b>Pic 10 Desc.</b>			
Insert image here		Insert image here			
<b>GPS Location</b>		<b>GPS Location</b>			
<b>Field Station#</b>		<b>Field Station#</b>			
<b>Pic 11 Desc.</b>		<b>Pic 12 Desc.</b>

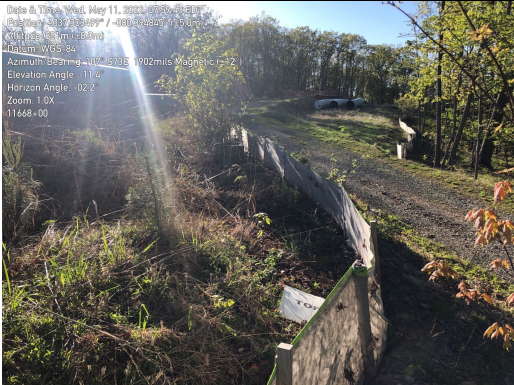
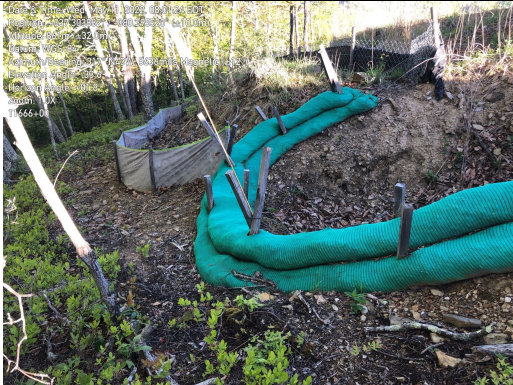
<b>GPS Location</b>	On photo	<b>GPS Location</b>	On photo		
<b>Field Station#</b>	11668+00	<b>Field Station#</b>	11666+00		
<b>Pic 1 Desc.</b>	Perimeter ECDs are functional.	<b>Pic 2 Desc.</b>	Perimeter ECDs are functional.

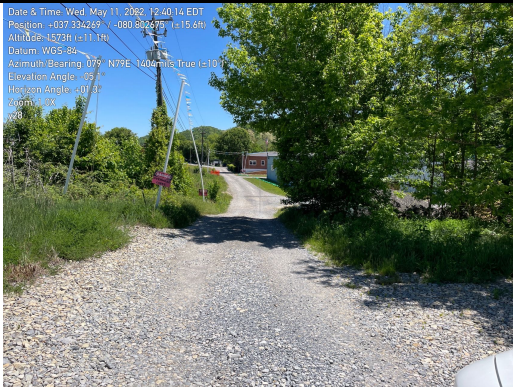
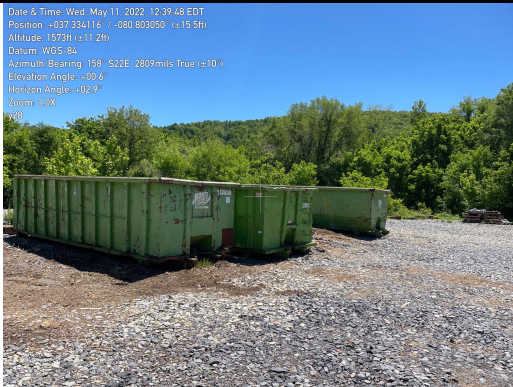
GPS Location	See photo		GPS Location	See photo	
Field Station#	12005+00		Field Station#	12005+00	
Pic 1 Desc.	Permanent stabilization and perimeter controls in place y28		Pic 2 Desc.	Housekeeping trash in good condition

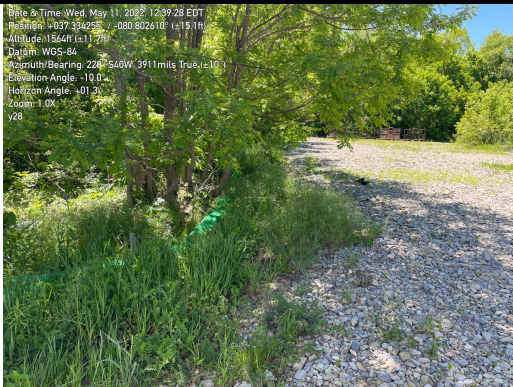
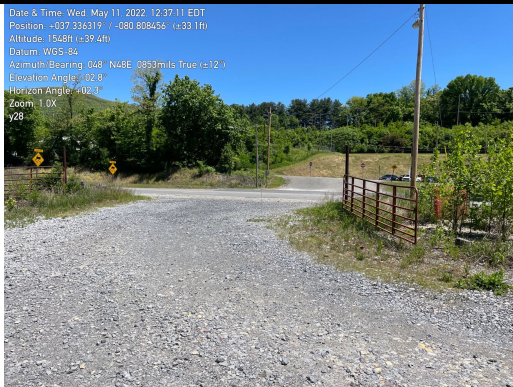
GPS Location	See photo		GPS Location	See photo	
Field Station#	12005+00		Field Station#	12005+00	
Pic 3 Desc.	CFS perimeter controls functional y28		Pic 4 Desc.	RCE functional y28

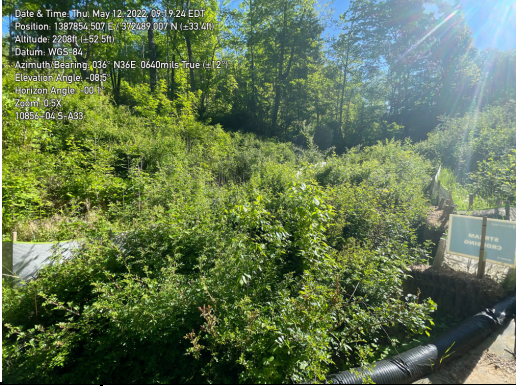
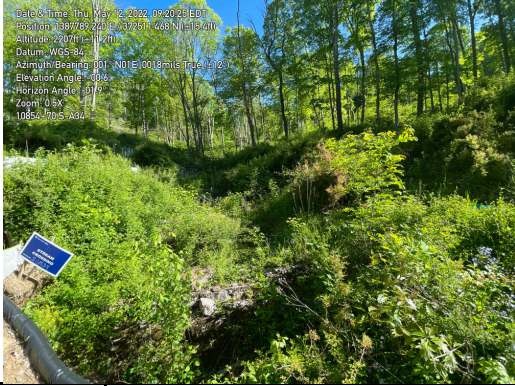
<b>GPS Location</b>	1	<b>GPS Location</b>	2		
<b>Field Station#</b>	10856+04	<b>Field Station#</b>	10854+70		
<b>Pic 1 Desc.</b>	S-A33.	<b>Pic 2 Desc.</b>	S-A34.

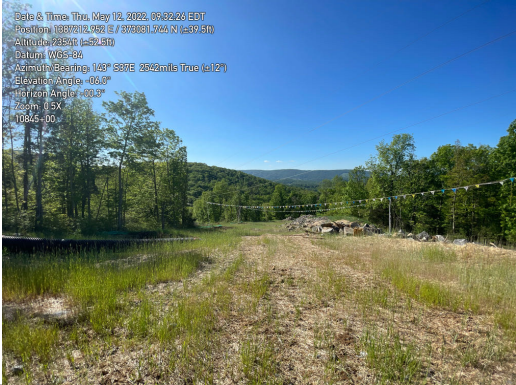
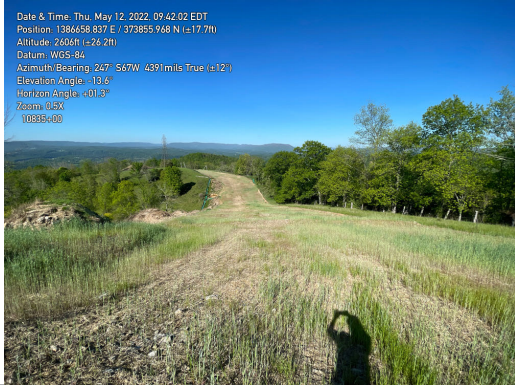
<b>GPS Location</b>	3	<b>GPS Location</b>	4		
<b>Field Station#</b>	10845+00	<b>Field Station#</b>	10835+00		
<b>Pic 3 Desc.</b>	Section of RoW showing conditions and controls.	<b>Pic 4 Desc.</b>	Section of RoW showing conditions and controls.

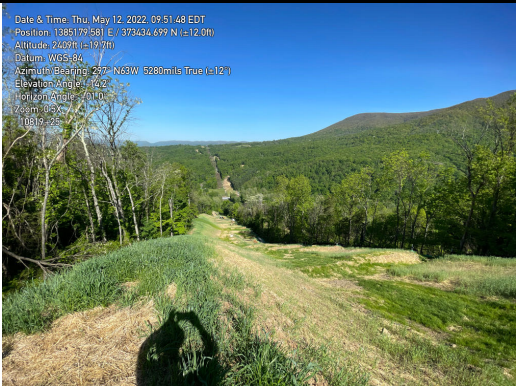
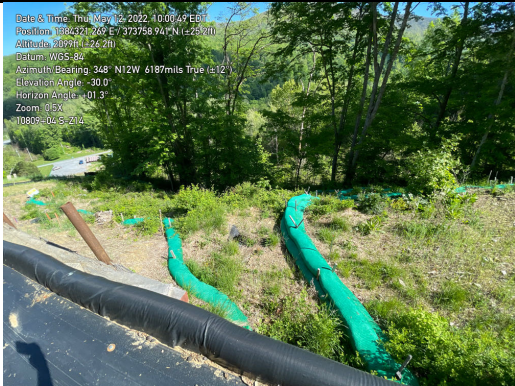
<b>GPS Location</b>	5	<b>GPS Location</b>	6		
<b>Field Station#</b>	10819+25	<b>Field Station#</b>	10809+04		
<b>Pic 5 Desc.</b>	Section of RoW showing conditions and controls.	<b>Pic 6 Desc.</b>	S-Z14.

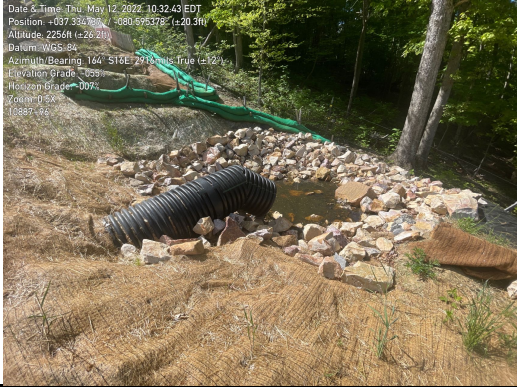
<p>Date &amp; Time: Thu, May 12, 2022, 10:32:43 EDT Position: +037.334738° / -080.595328° (+20.3ft) Altitude: 2256ft (+26.2ft) Datum: WGS-84 Azimuth/Bearing: 164° S18E 2319mils True (+12°) Elevation Grade: -029° Horizon Grade: -009° Zoom: 1.0X 10887+96</p>			
<b>GPS Location</b>	See Photo	<b>GPS Location</b>	See Photo		
<b>Field Station#</b>	10886+33	<b>Field Station#</b>	10887+96		
<b>Pic 7 Desc.</b>	Temporary water bar conditions. Water bars remain functional.	<b>Pic 8 Desc.</b>	Plunge pool conditions. Standing water within the plunge pool.

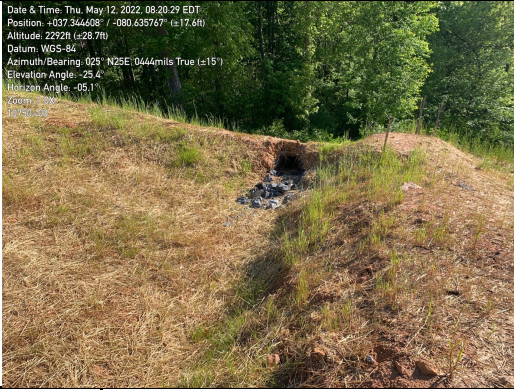
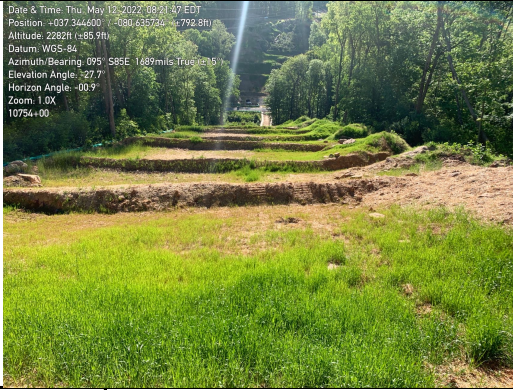
<b>GPS Location</b>	See photo.	<b>GPS Location</b>	See photo.		
<b>Field Station#</b>	10750+00	<b>Field Station#</b>	10754+00		
<b>Pic 1 Desc.</b>	Rock inlet in place at slope drain.	<b>Pic 2 Desc.</b>	Waterbars in place. ROW temporarily stabilized with seed and mulch.
