Visual Site Inspection Report

Project Name	H-600 Pipeline Spread H	AFE	124300138	Spread	H-600 Pipeline Spread H
Contractor	Precision			Report #	36684
Inspector	Bryan Cole			Date/Time	4/18/2022 2:30 PM
Permit #	TBD	Inspection Type	VA SWPP	Station Begin	13141+65
State	VA	Inspection Area	Partial	Station End	13316+21
County	Franklin	Ground	Wet	Temperature (°F)	34.00
Municipality	N/A	Weather	Snow/Sleet	Rain Gauge (in)	0.00
				Rain Accumulation Time (days)	0.00

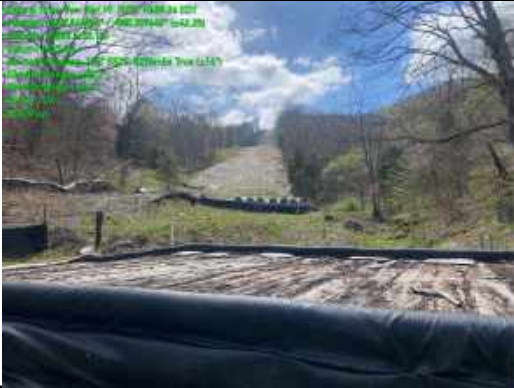
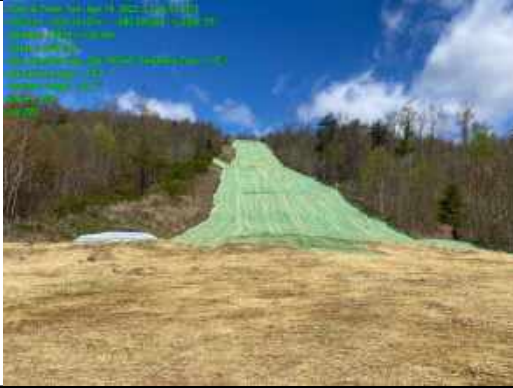
GPS Location	See photo for coordinates.		GPS Location	See photo for coordinates.	
Field Station#	12035+11		Field Station#	12071+80	
Pic 5 Desc.	ROW stabilized, S-G40 and S-PP23.		Pic 6 Desc.	MVP-MN-270, ROW stabilized.

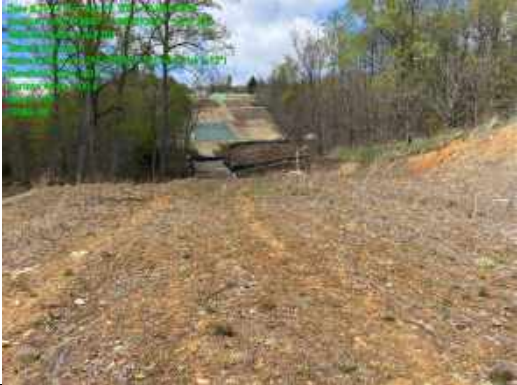
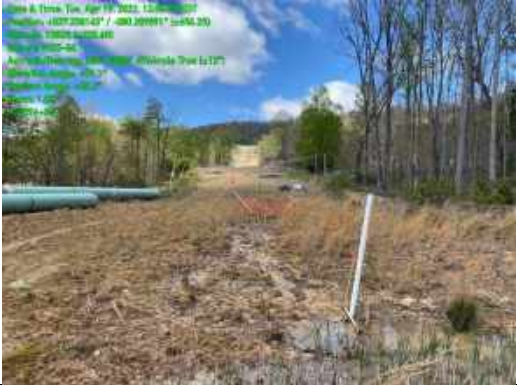
GPS Location	See photo for coordinates.		GPS Location	See photo for coordinates.	
Field Station#	12088+00		Field Station#	12096+84	
Pic 13 Desc.	ROW stable.		Pic 14 Desc.	ROW stable.

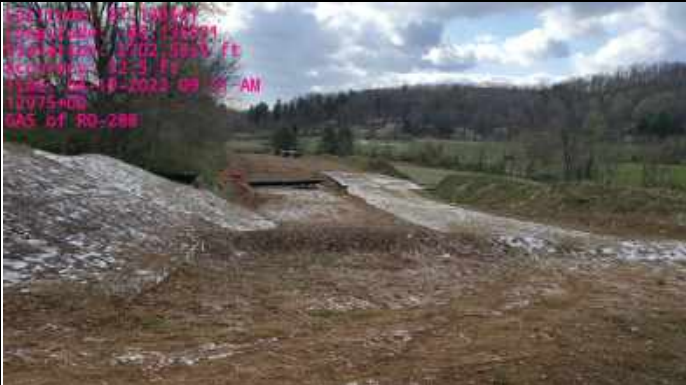
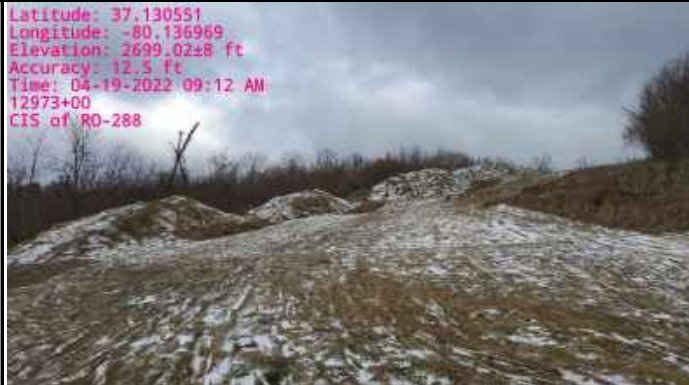
GPS Location	See pic for GPS location.		GPS Location	See pic for GPS location.	
Field Station#	12975+00		Field Station#	12973+00	
Pic 7 Desc.	Current ROW conditions.		Pic 8 Desc.	Current ROW conditions.

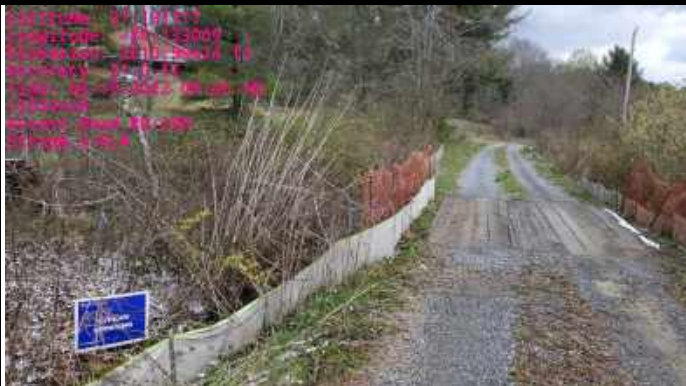
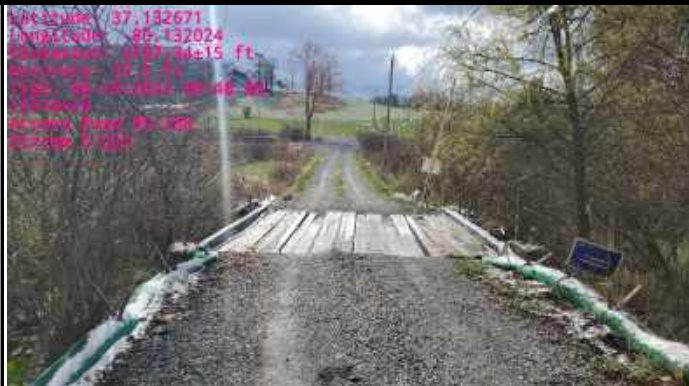
GPS Location	See pic for GPS location.		GPS Location	See pic for GPS location.	
Field Station#	12974+29		Field Station#	12974+29	
Pic 9 Desc.	Stream crossing S-KL4 on RO-288.		Pic 10 Desc.	Stream crossing S-Q20 on RO-288.

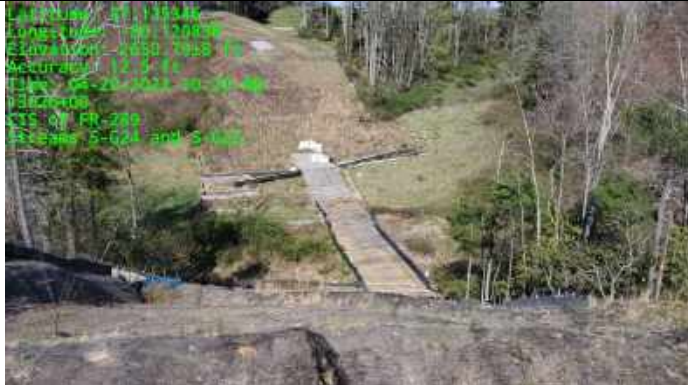
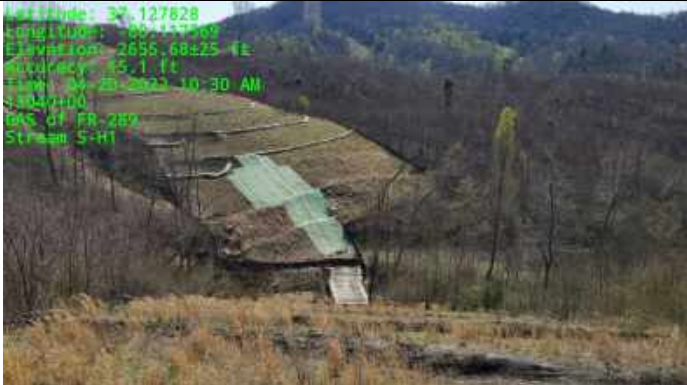
GPS Location	See pic for GPS location.		GPS Location	See pic for GPS location.	
Field Station#	13026+00		Field Station#	13040+00	
Pic 1 Desc.	Streams S-G24 and S-G25 from the GAS.		Pic 2 Desc.	Stream crossing S-H1 from the CIS.

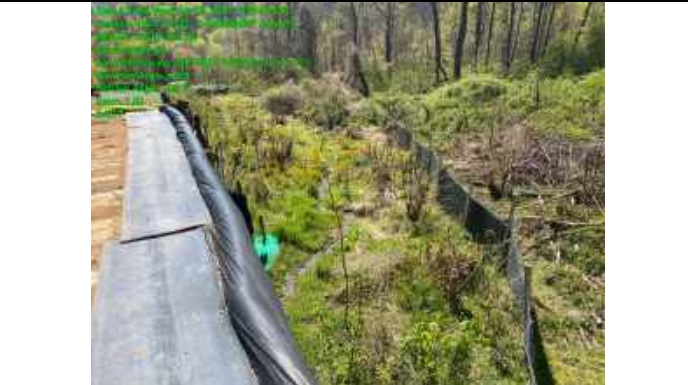
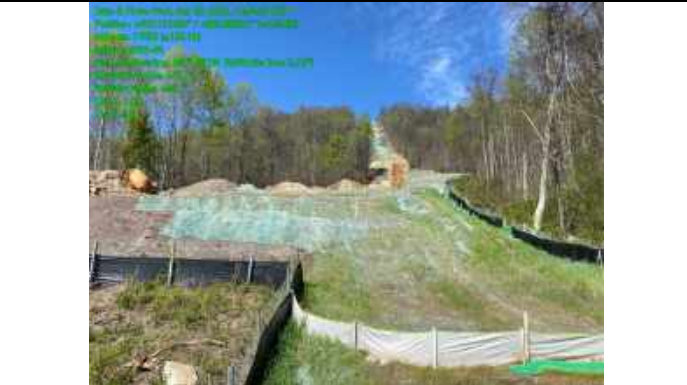
GPS Location	See pic for GPS location.		GPS Location	See pic for GPS location.	
Field Station#	13137+50		Field Station#	13137+00	
Pic 3 Desc.	Downstream side of stream S-D17/14.		Pic 4 Desc.	ROW conditions on the CIS of FR-292.

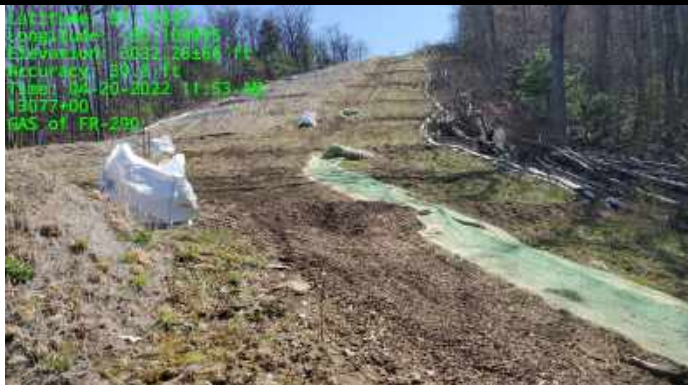
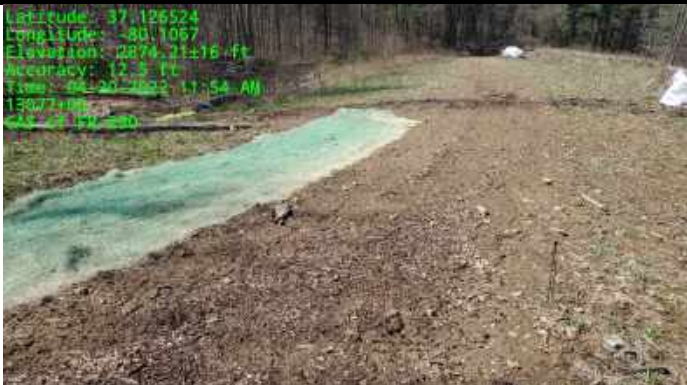
GPS Location	See pic for GPS location.		GPS Location	See pic for GPS location.	
Field Station#	13077+00		Field Station#	13077+00	
Pic 5 Desc.	Impacts made by 3rd party to vegetative stabilization.		Pic 6 Desc.	Impacts made by 3rd party to vegetative stabilization.

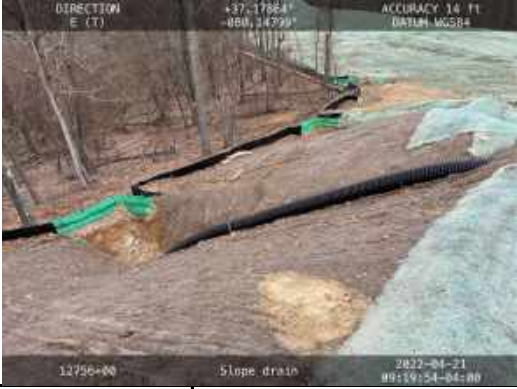
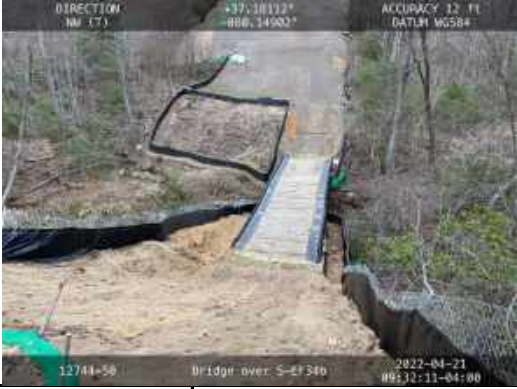
GPS Location	See photo for gps location data.		GPS Location	See photo for gps location data.	
Field Station#	12756+00		Field Station#	12744+50	
Pic 7 Desc.	Photo shows the slope drain.		Pic 8 Desc.	Photo shows the bridge over S-EF34b.

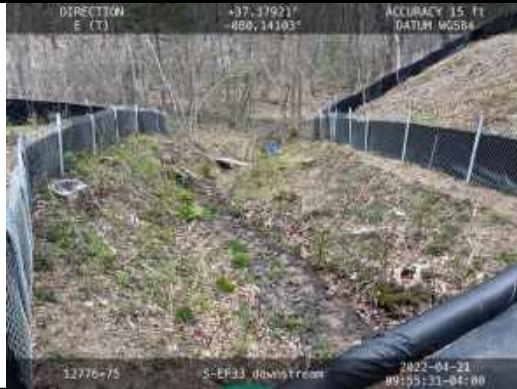
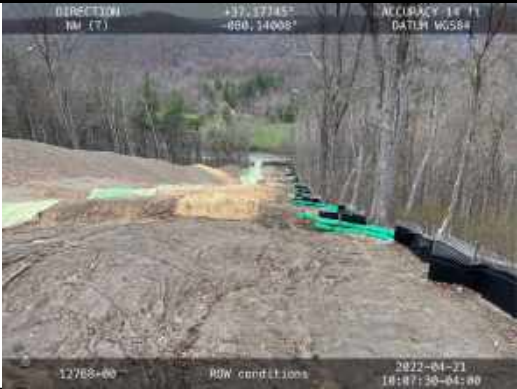
GPS Location	See photo for gps location data.		GPS Location	See photo for gps location data.	
Field Station#	12776+75		Field Station#	12768+00	
Pic 11 Desc.	Photo shows S-EF33 downstream from the bridge.		Pic 12 Desc.	Photo shows the ROW condition. ECDs are installed and functioning as designed.

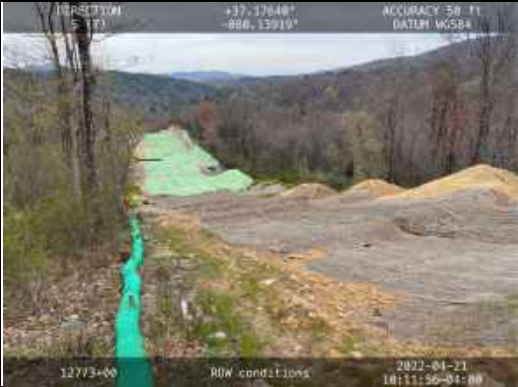
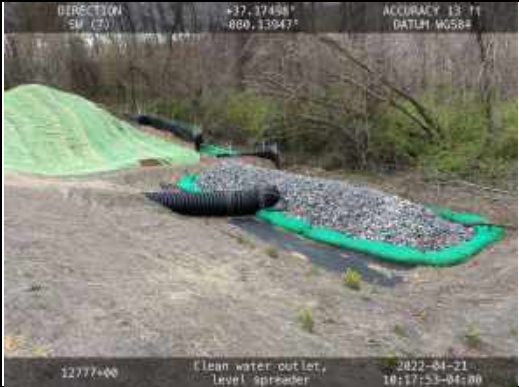
GPS Location	See photo for gps location data.		GPS Location	See photo for gps location data.	
Field Station#	12773+00		Field Station#	12777+00	
Pic 13 Desc.	Photo shows the ROW condition. ECDs are installed and functioning as designed.		Pic 14 Desc.	Photo shows the clean water outlet structure, level spreader.

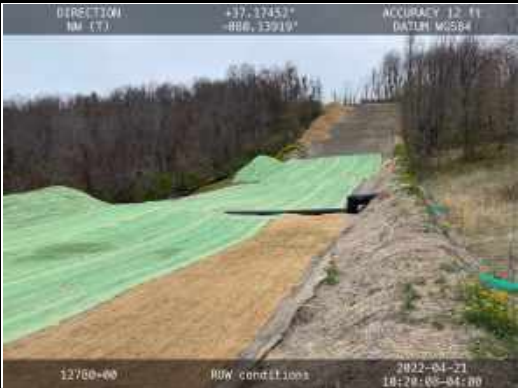
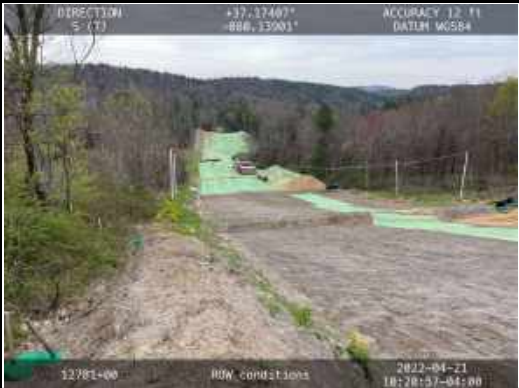
GPS Location	See photo for gps location data.		GPS Location	See photo for gps location data.	
Field Station#	12780+00		Field Station#	12781+00	
Pic 15 Desc.	Photo shows the ROW condition. ECDs are installed and functioning as designed.		Pic 16 Desc.	Photo shows the ROW condition. ECDs are installed and functioning as designed.

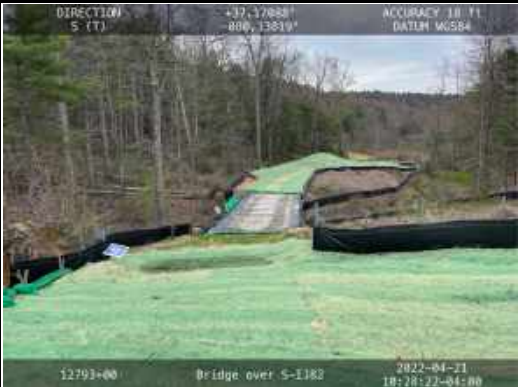
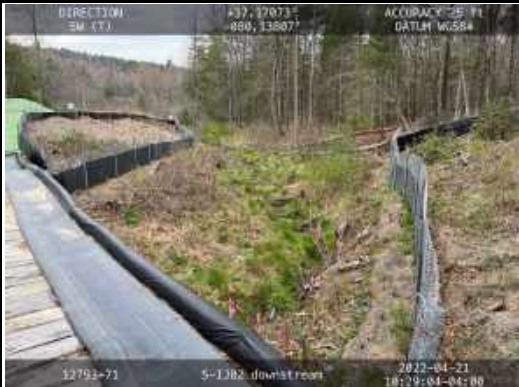
GPS Location	See photo for gps location data.		GPS Location	See photo for gps location data.	
Field Station#	12793+00		Field Station#	12793+71	
Pic 17 Desc.	Photo shows the bridge over stream S-IJ82.		Pic 18 Desc.	Photo shows S-IJ82 downstream from the bridge.

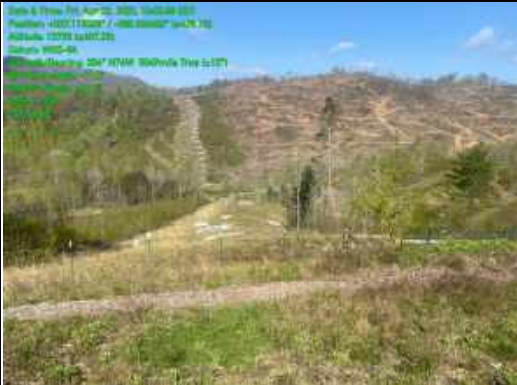
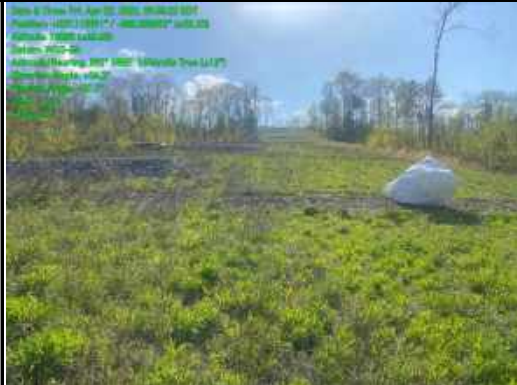
GPS Location	0		GPS Location	0	
Field Station#	13273+00		Field Station#	13264+00	
Pic 13 Desc.	ROW and ECDs In good condition and stable		Pic 14 Desc.	ROW and ECDs In good condition and stable

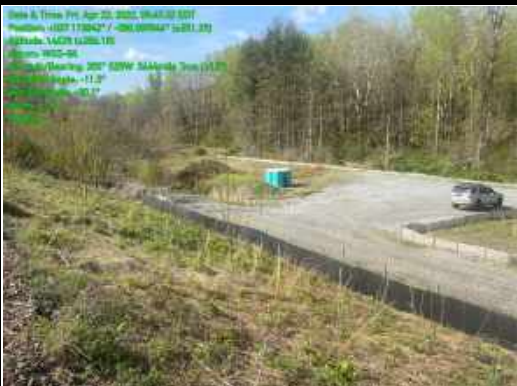
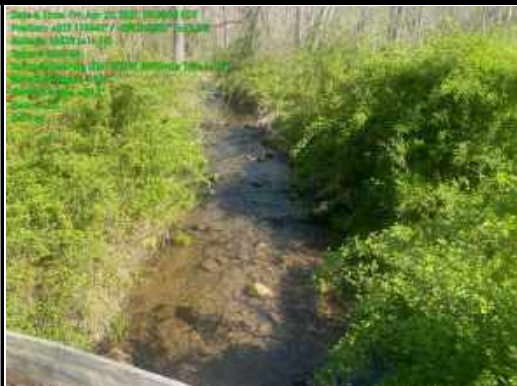
GPS Location	0		GPS Location	0	
Field Station#	13262+62		Field Station#	13260+66	
Pic 15 Desc.	Flanders Road Crossing in good condition		Pic 16 Desc.	MVP-S-II4 Upstream and Corresponding buffer zone in good condition
