Visual Site Inspection Report

Project Name	H-600 Pipeline Spread H	AFE	124300138	Spread	H-600 Pipeline Spread H
Contractor	Precision			Report #	37482
Inspector	Jonathan Altizer			Date/Time	5/9/2022 3:35 PM
Permit #	TBD	Inspection Type	VA SWPP	Station Begin	12725+00
State	VA	Inspection Area	Partial	Station End	12865+00
County	Roanoke	Ground	Damp	Temperature (°F)	70.00
Municipality	N/A	Weather	Sunny	Rain Gauge (in)	0.50
				Rain Accumulation Time (days)	2.00

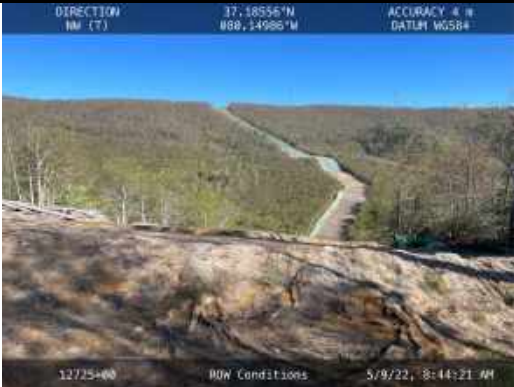
GPS Location	See photo		GPS Location	See photo	
Field Station#	12725+00		Field Station#	12725+00	
Pic 1 Desc.	Current ROW conditions. ROW is stable and ECDs are functional		Pic 2 Desc.	Current ROW conditions. ROW is stable and ECDs are functional

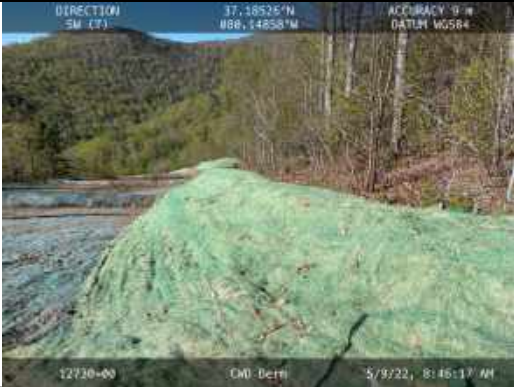
GPS Location	See photo		GPS Location	See photo	
Field Station#	12730+00		Field Station#	12736+00	
Pic 3 Desc.	CWD berm is functional		Pic 4 Desc.	Slope drain is functional

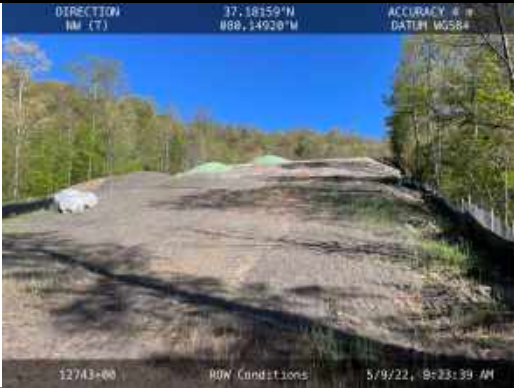
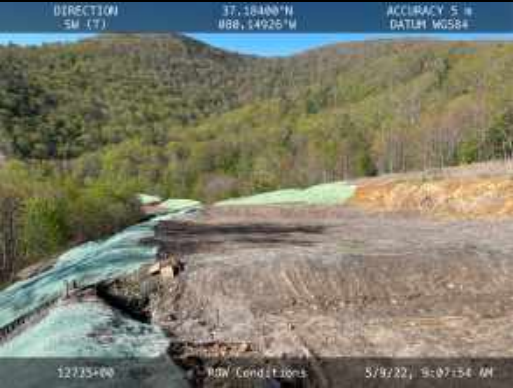
GPS Location	See photo		GPS Location	See photo	
Field Station#	12743+00		Field Station#	12735+00	
Pic 5 Desc.	Current ROW conditions. ROW is stable and ECDs are functional		Pic 6 Desc.	Current ROW conditions. ROW is stable and ECDs are functional

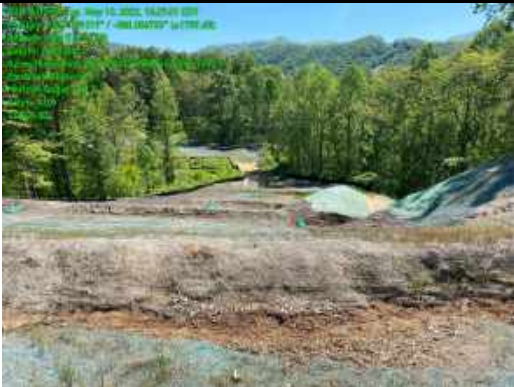
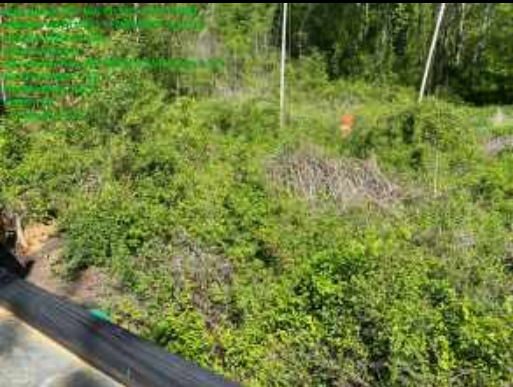
GPS Location	See photo for coordinates.		GPS Location	See photo for coordinates.	
Field Station#	13142+00		Field Station#	13146+50	
Pic 1 Desc.	ROW stabilized.		Pic 2 Desc.	S-D13, upstream, no turbidity noted.

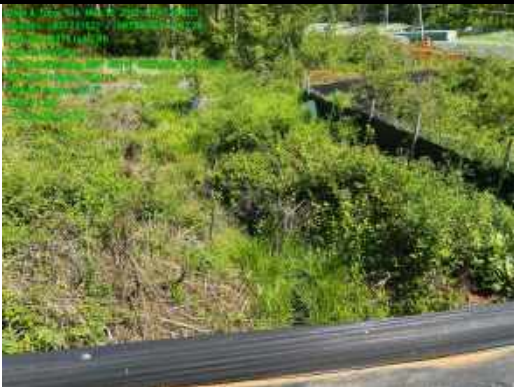
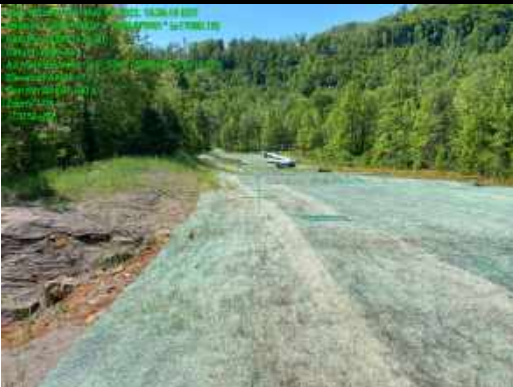
GPS Location	See photo for coordinates.		GPS Location	See photo for coordinates.	
Field Station#	13146+50		Field Station#	13154+00	
Pic 3 Desc.	S-D12, upstream, no turbidity noted.		Pic 4 Desc.	ROW stabilized.

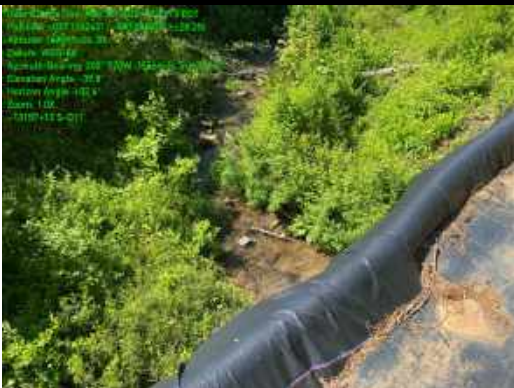
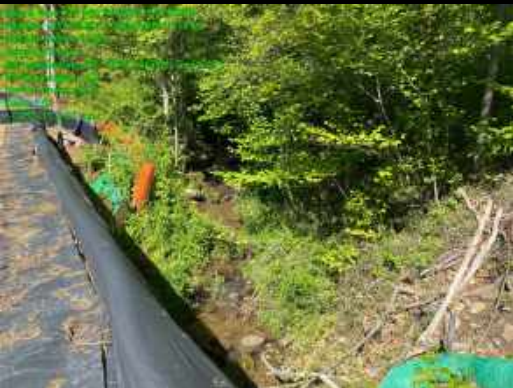
GPS Location	See photo for coordinates.		GPS Location	See photo for coordinates.	
Field Station#	13157+13		Field Station#	13157+13	
Pic 5 Desc.	S-D11, downstream, no turbidity noted.		Pic 6 Desc.	S-D11, upstream, no turbidity noted.

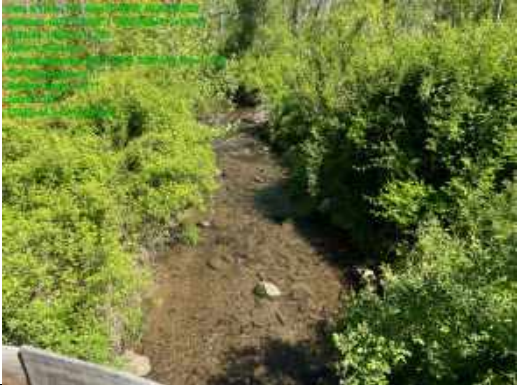
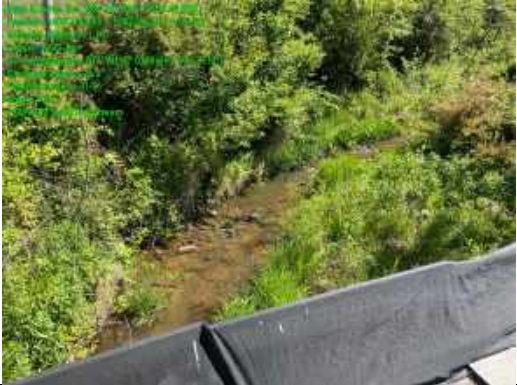
GPS Location	See photo for coordinates.		GPS Location	See photo for coordinates.	
Field Station#	13260+60		Field Station#	13309+09	
Pic 13 Desc.	S-II4, upstream, no turbidity noted.		Pic 14 Desc.	S-GH7, upstream, no turbidity noted.

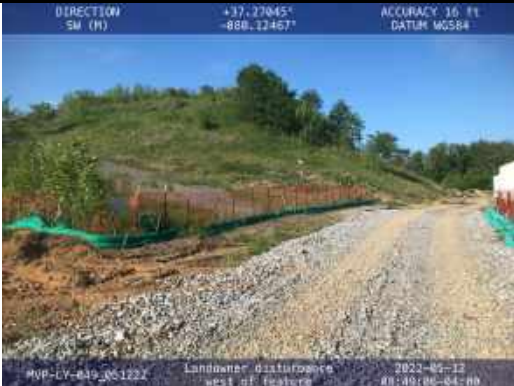
Pic 5 Desc.	Landowner soil disturbance west of feature W-CV21B. Areas not stabilized. Looking SW.	Pic 6 Desc.	Landowner soil disturbance and debris piled along triple stack compost filter sock and east of feature W-CV21B. Looking S.

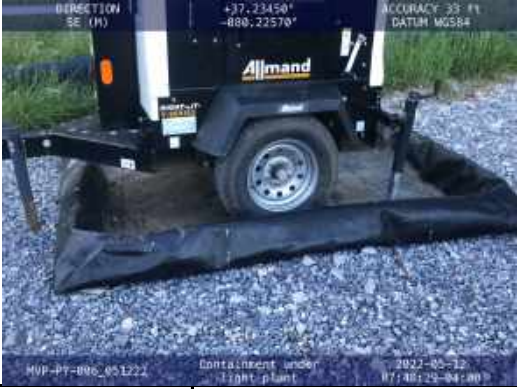
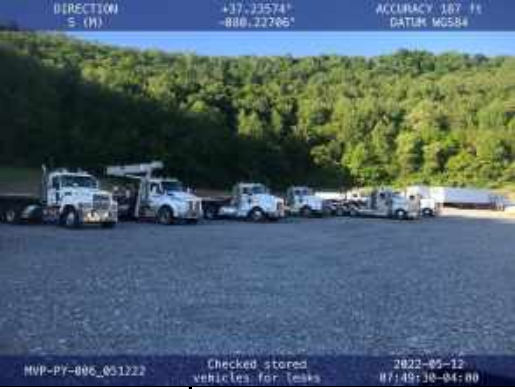
GPS Location	MVP-PY-006 See photo for gps data		GPS Location	MVP-PY-006 See photo for gps data	
Field Station#	+0		Field Station#	+0	
Pic 7 Desc.	Secondary containment under light plant. Free of fluids. Looking SE.		Pic 8 Desc.	Checked stored vehicles for new leaks. No new leaks located. Looking S.

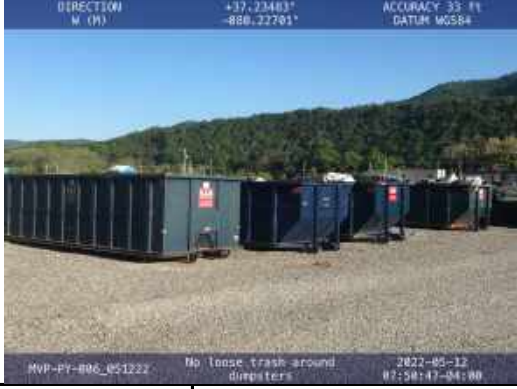
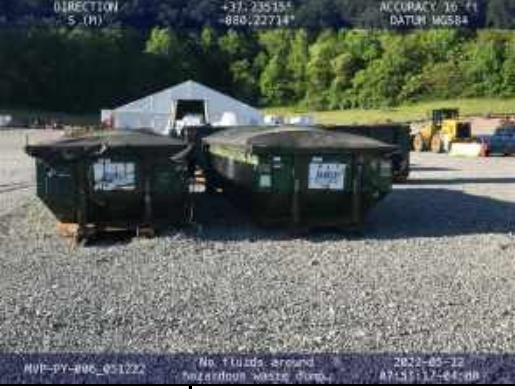
GPS Location	MVP-PY-006 See photo for gps data		GPS Location	MVP-PY-006 See photo for gps data	
Field Station#	+0		Field Station#	+0	
Pic 9 Desc.	No loose trash around dumpsters or in the yard. Looking W.		Pic 10 Desc.	No fluids or deposits around hazardous waste dumpsters. Looking S.

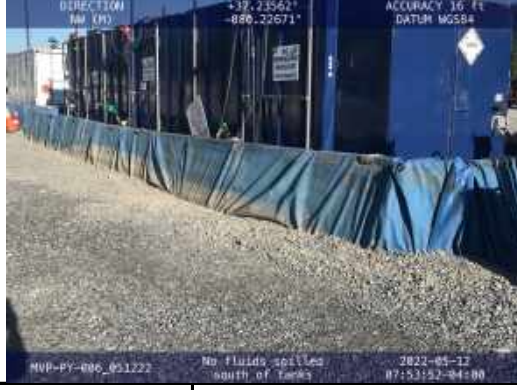
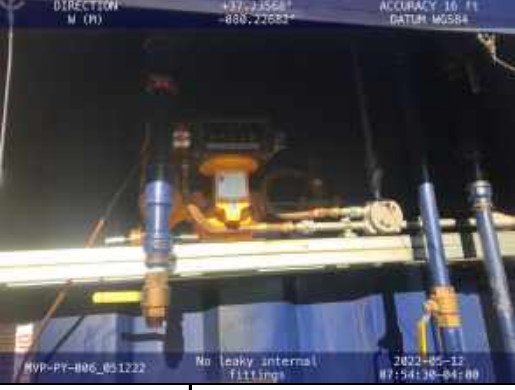
GPS Location	MVP-PY-006 See photo for gps data		GPS Location	MVP-PY-006 See photo for gps data	
Field Station#	+0		Field Station#	+0	
Pic 11 Desc.	Blue Bulk Fuel tanks no fluids spilled on the south side of tanks. Looking NW.		Pic 12 Desc.	Blue Bulk Fuel tanks no leaky internal fittings. Looking W.

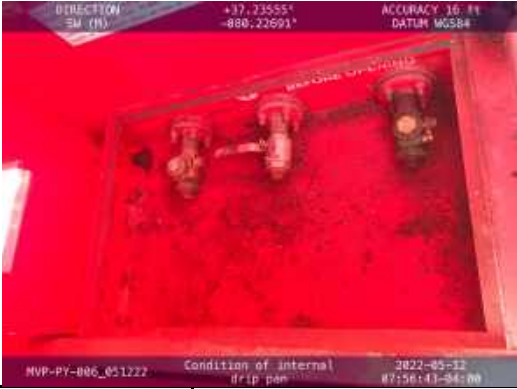
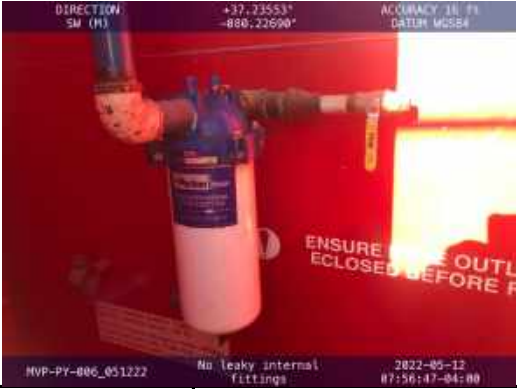
GPS Location	MVP-PY-006 See photo for gps data	GPS Location	MVP-PY-006 See photo for gps data		
Field Station#	+0	Field Station#	+0		
Pic 15 Desc.	Off Road Fuel unit condition of internal drip pan. Free of fluids. Looking SW.	Pic 16 Desc.	Off Road Fuel unit no leaky internal fittings. Looking SW.

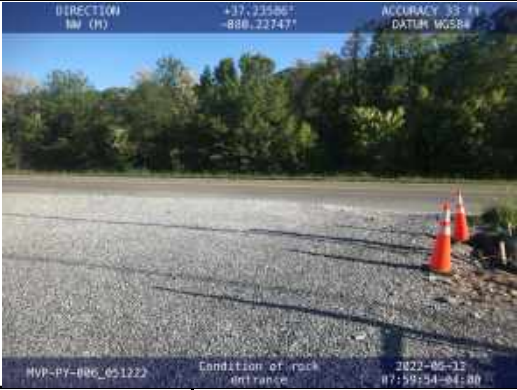
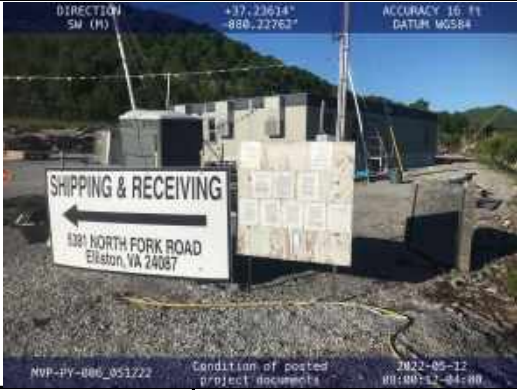
GPS Location	MVP-PY-006 See photo for gps data	GPS Location	MVP-PY-006 See photo for gps data		
Field Station#	+0	Field Station#	+0		
Pic 17 Desc.	Condition of rock entrance. No stone on public roadway. Looking NW.	Pic 18 Desc.	Condition of posted project documents at the main entrance. Looking SW.
