Visual Site Inspection Report

Project Name	H-600 Pipeline Spread I	AFE	124300139	Spread	H-600 Pipeline Spread I
Contractor	Precision			Report #	36412
Inspector	Ben Davenport			Date/Time	4/11/2022 9:38 AM
Permit #	TBD	Inspection Type	VA SWPP	Station Begin	14454+22
State	VA	Inspection Area	Partial	Station End	14546+75
County	Franklin	Ground	Damp	Temperature (°F)	66.00
Municipality	N/A	Weather	Sunny	Rain Gauge (in)	0.00
				Rain Accumulation Time (days)	0.00

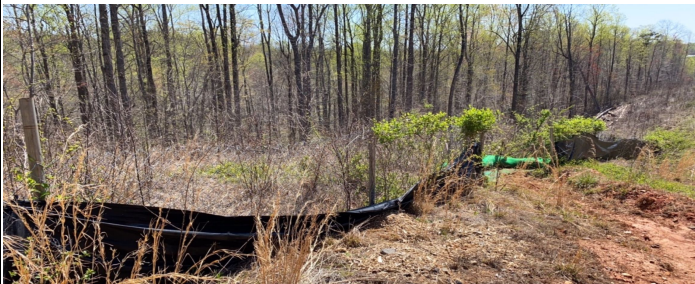
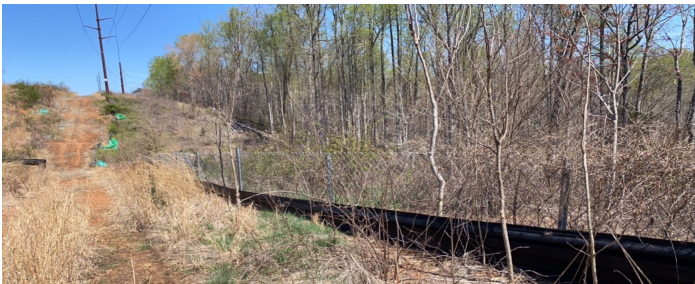
37°1'27" N 79°45'55" W 189°S COURSE -1' GPS Glade Hill, VA 24092, United States 04.11.2022 11:35:12 Accur +/-438.6 Ft ALT 1061 Ft			37°1'26" N 79°45'55" W 30°NE COURSE -1' GPS Glade Hill, VA 24092, United States 04.11.2022 11:33:27 Accur +/-105.7 Ft ALT 998 Ft		
GPS Location	1		GPS Location	2	
Field Station#	14461+00		Field Station#	14464+00	
Pic 1 Desc.	Routine maintenance. Reattach geotextile fabric to SSF fencing.		Pic 2 Desc.	Routine maintenance. Reattach geotextile fabric to SSF fencing.

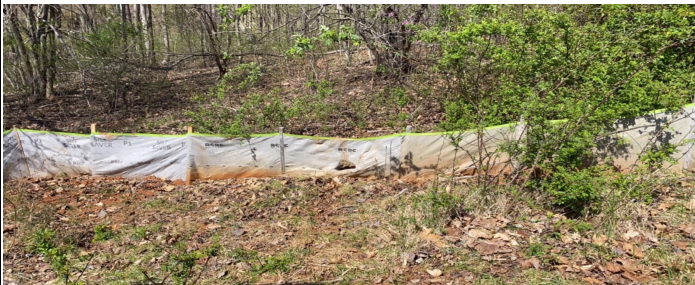
Pic 3 Desc.	Routine maintenance. Replace damaged perimeter P1 silt fence from cattle damage.		Pic 4 Desc.	Routine maintenance. Missing perimeter ECD from landowner damage.

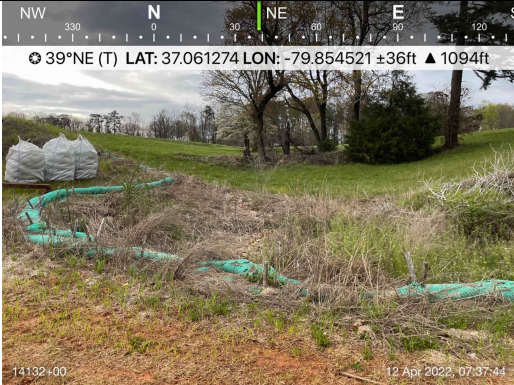
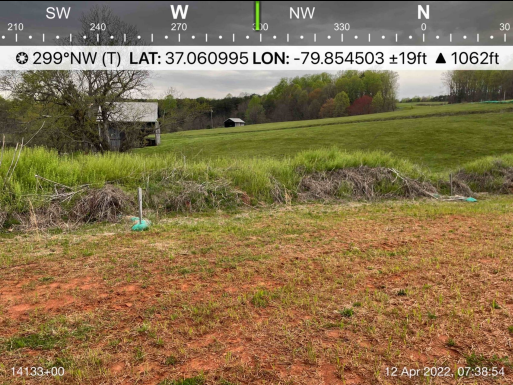
<p>299°NW (T) LAT: 37.060995 LON: -79.854503 ±19ft ▲ 1062ft</p> <p>14133+00 12 Apr 2022, 07:38:54</p>			
GPS Location	See photo		GPS Location	See photo	
Field Station#	14132+00		Field Station#	14133+00	
Pic 1 Desc.	CFS is degraded at CWD inlet and needs to be replaced		Pic 2 Desc.	CFS checks need to be replaced

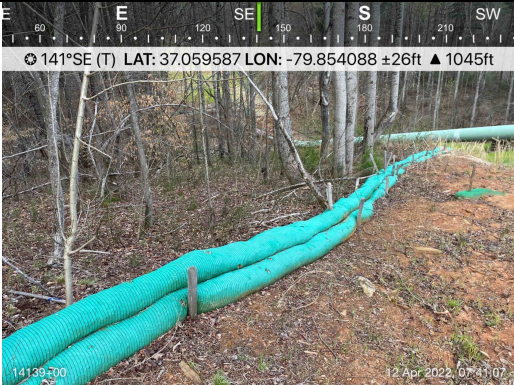
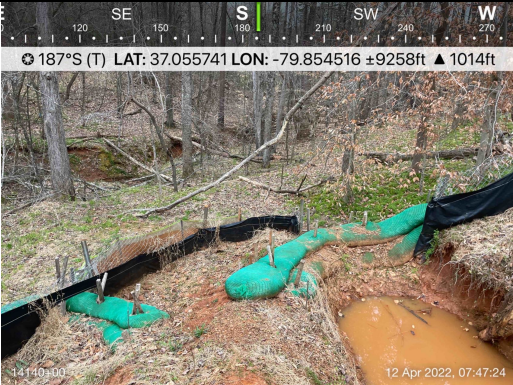
<p>187°S (T) LAT: 37.055741 LON: -79.854516 ±9258ft ▲ 1014ft</p> <p>14140+00 12 Apr 2022, 07:47:24</p>			
GPS Location	See photo		GPS Location	See photo	
Field Station#	14139+00		Field Station#	14140+00	
Pic 3 Desc.	Perimeter CFS is degraded and needs to be replaced		Pic 4 Desc.	CFS end treatment needs to be replaced

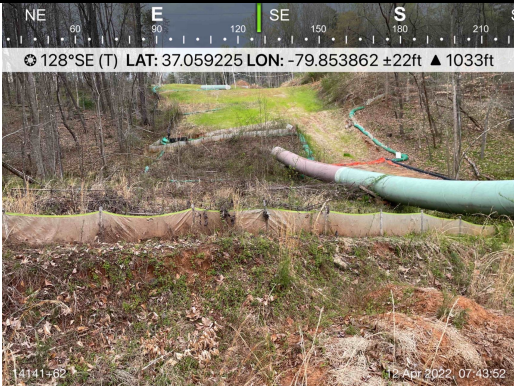
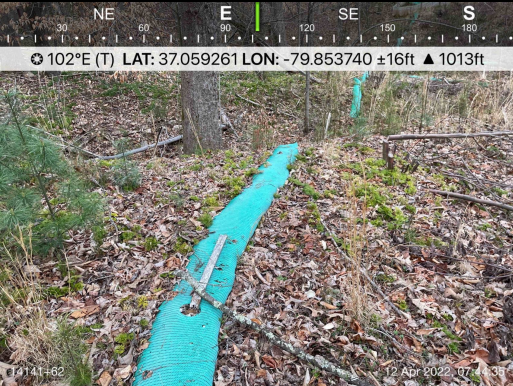
<p>102°E (T) LAT: 37.059261 LON: -79.853740 ±16ft ▲ 1013ft</p> <p>14141+62 12 Apr 2022, 07:44:34</p>			
GPS Location	See photo		GPS Location	See photo	
Field Station#	14141+62		Field Station#	14141+62	
Pic 5 Desc.	P1 needs to be replaced at stream buffer		Pic 6 Desc.	CFS needs to be replaced at stream buffer

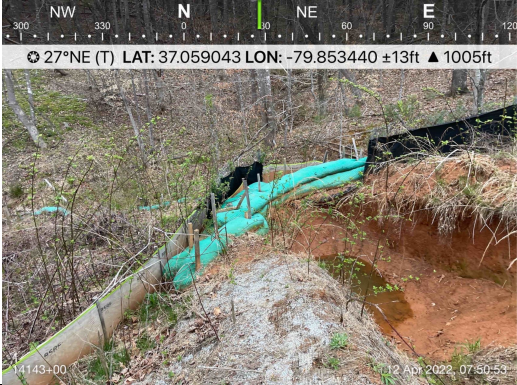
GPS Location	See photo		GPS Location	See photo	
Field Station#	14143+00		Field Station#	14143+00	
Pic 7 Desc.	CFS end treatment needs to be replaced		Pic 8 Desc.	P1 is degraded and needs to be replaced

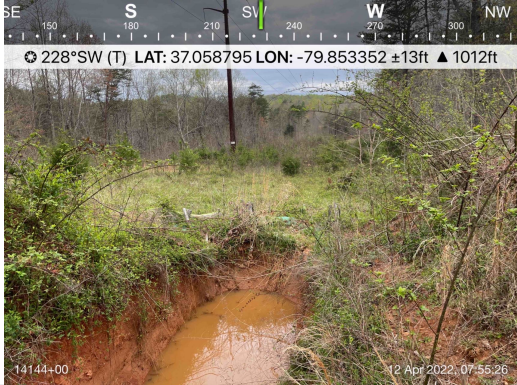
GPS Location	See photo		GPS Location	See photo	
Field Station#	14144+00		Field Station#	14144+50	
Pic 9 Desc.	CFS end treatment needs to be replaced		Pic 10 Desc.	Perimeter CFS is degraded and needs to be replaced

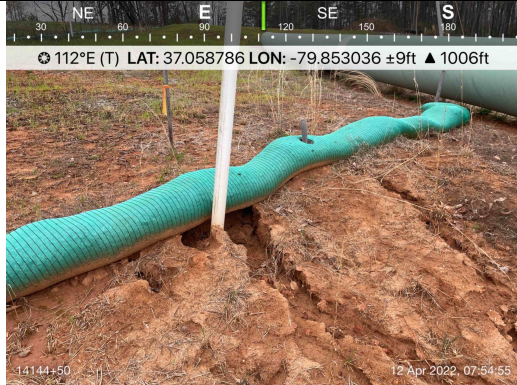
GPS Location	See photo		GPS Location	See photo	
Field Station#	14144+50		Field Station#	14146+00	
Pic 11 Desc.	CFS check needs to be replaced and area regraded.		Pic 12 Desc.	CFS needs to be replaced

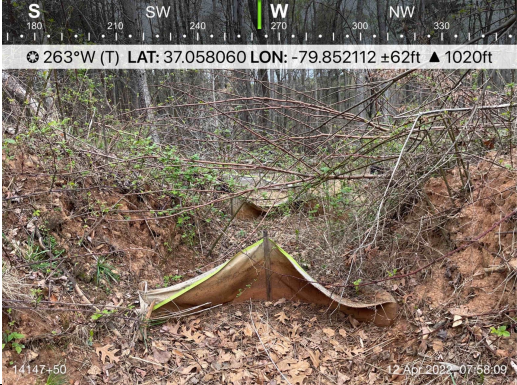
GPS Location	See photo		GPS Location	See photo	
Field Station#	14147+50		Field Station#	14149+00	
Pic 13 Desc.	P1 checks need to be replaced		Pic 14 Desc.	Triple stack CFS needs to be replaced

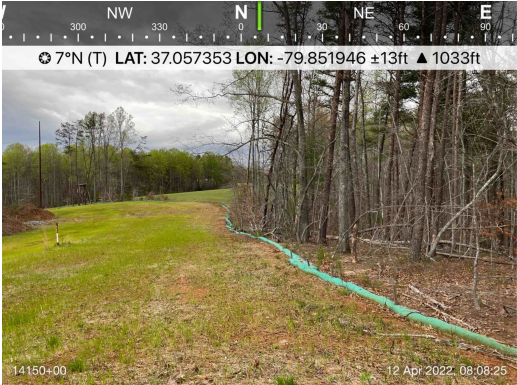
GPS Location	See photo		GPS Location	See photo	
Field Station#	14150+00		Field Station#	14152+00	
Pic 15 Desc.	Perimeter CFS needs to be replaced		Pic 16 Desc.	Perimeter CFS needs to be replaced

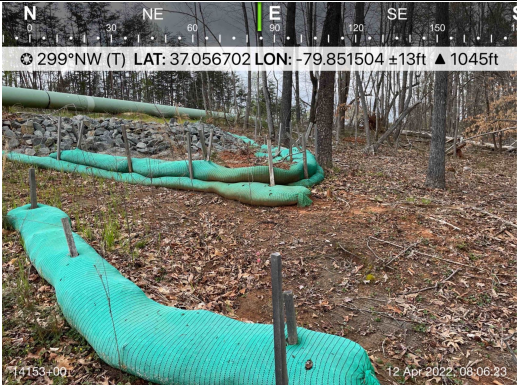
GPS Location	See photo		GPS Location	See photo	
Field Station#	14153+00		Field Station#	14155+00	
Pic 17 Desc.	CFS needs to be replaced		Pic 18 Desc.	CFS end treatment needs to be replaced

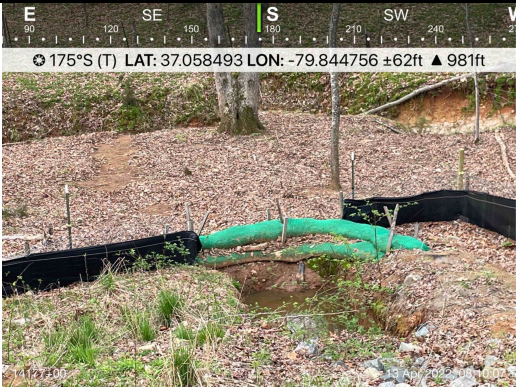
GPS Location	See photo		GPS Location	See photo	
Field Station#	14177+00		Field Station#	14179+00	
Pic 1 Desc.	CFS end treatment needs to be replaced		Pic 2 Desc.	CFS end treatment needs to be replaced

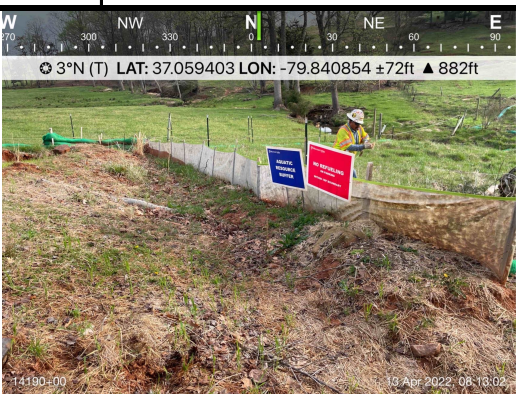
GPS Location	See photo		GPS Location	See photo	
Field Station#	14190+00		Field Station#	14190+25	
Pic 3 Desc.	P1 needs to be replaced at resource buffer		Pic 4 Desc.	CFS needs to be replaced

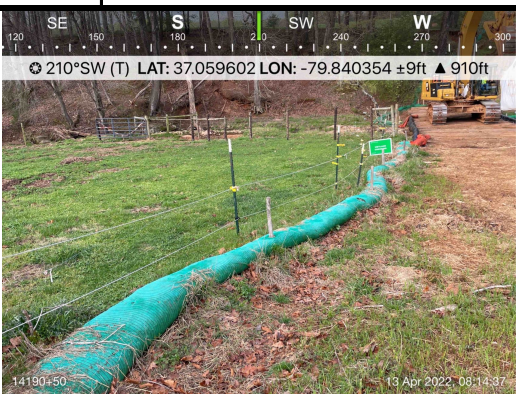
GPS Location	See photo		GPS Location	See photo	
Field Station#	14190+50		Field Station#	14191+00	
Pic 5 Desc.	CFS needs to be replaced		Pic 6 Desc.	CFS outlet needs to be replaced

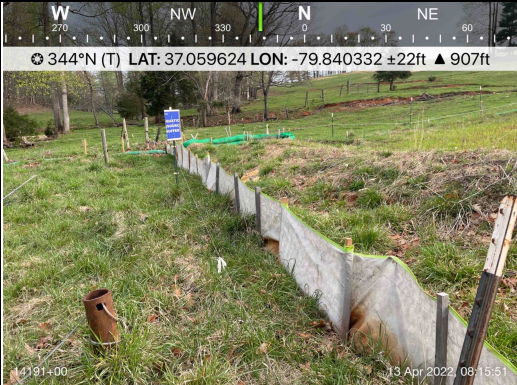
GPS Location	See photo		GPS Location	See photo	
Field Station#	14191+00		Field Station#	14195+00	
Pic 7 Desc.	P1 needs to be replaced at resource buffer		Pic 8 Desc.	Perimeter P1 needs to be replaced

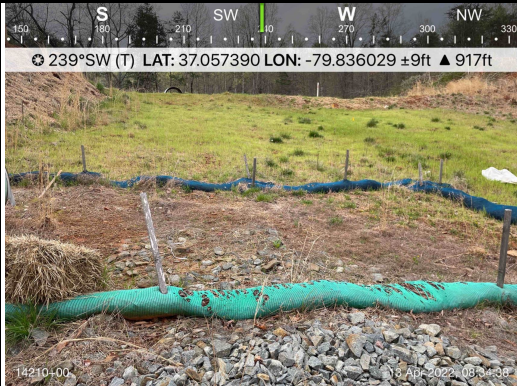
GPS Location	See photo		GPS Location	See photo	
Field Station#	14210+00		Field Station#	14212+63	
Pic 9 Desc.	CFS needs to be replaced		Pic 10 Desc.	CFS end treatment needs to be replaced

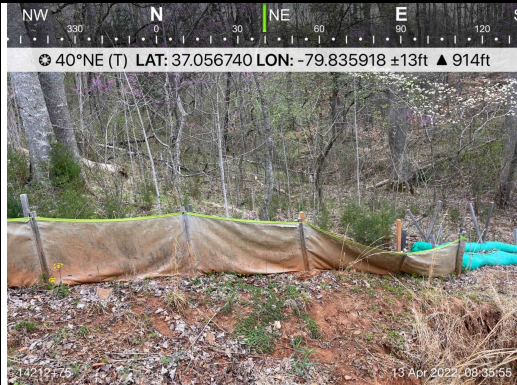
GPS Location	See photo		GPS Location	See photo	
Field Station#	14212+75		Field Station#	14213+00	
Pic 11 Desc.	P1 needs to be replaced		Pic 12 Desc.	CFS end treatment needs to be replaced

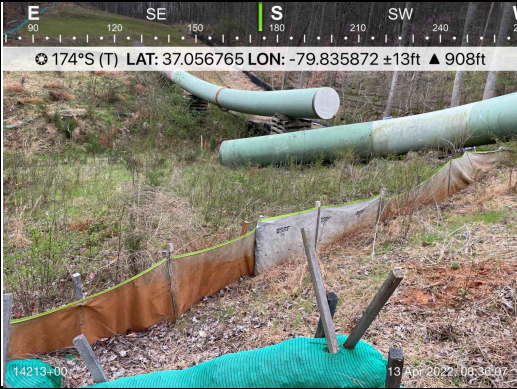
GPS Location	See photo		GPS Location	See photo	
Field Station#	14213+00		Field Station#	14213+75	
Pic 13 Desc.	P1 needs to be replaced at resource buffer		Pic 14 Desc.	CFS needs to be replaced at resource buffer

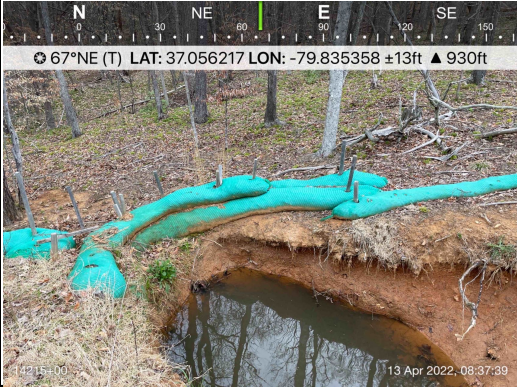
GPS Location	See photo		GPS Location	See photo	
Field Station#	14215+00		Field Station#	14216+00	
Pic 15 Desc.	CFS end treatment needs to be replaced		Pic 16 Desc.	Perimeter CFS needs to be replaced

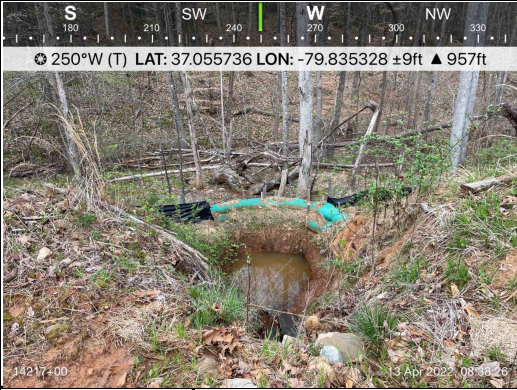
GPS Location	See photo		GPS Location	See photo	
Field Station#	14217+00		Field Station#	14218+00	
Pic 17 Desc.	CFS end treatment needs to be replaced		Pic 18 Desc.	CFS end treatment needs to be replaced
