Visual Site Inspection Report

Project Name	H-600 Pipeline Spread I	AFE	124300139	Spread	H-600 Pipeline Spread I
Contractor	Precision			Report #	36694
Inspector	Ben Farmer			Date/Time	4/18/2022 2:52 PM
Permit #	TBD	Inspection Type	VA SWPP	Station Begin	14062+17
State	VA	Inspection Area	Partial	Station End	14171+36
County	Franklin	Ground	Wet	Temperature (°F)	38.00
Municipality	N/A	Weather	Light Rain	Rain Gauge (in)	0.00
				Rain Accumulation Time (days)	0.00

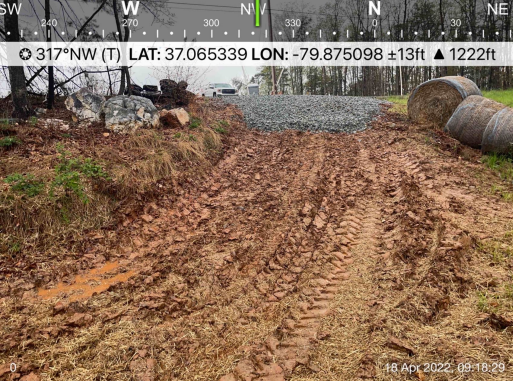
GPS Location	See photo	GPS Location	See photo		
Field Station#	14062+17	Field Station#	14063+00		
Pic 1 Desc.	RCEs are in good condition at all road crossings	Pic 2 Desc.	Area below RCE needs to be stabilized

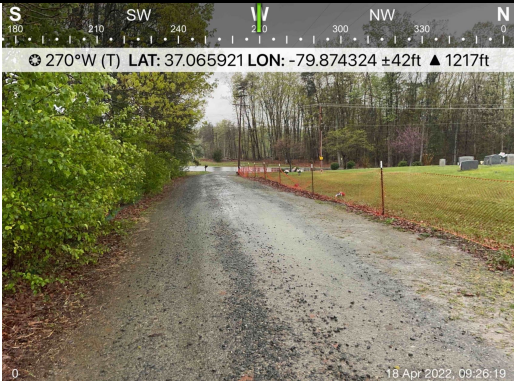
GPS Location	See photo	GPS Location	See photo		
Field Station#	14066+53	Field Station#	14070+00		
Pic 3 Desc.	Equipment bridge ECDs are in good condition and functioning	Pic 4 Desc.	CWDs are functioning as intended

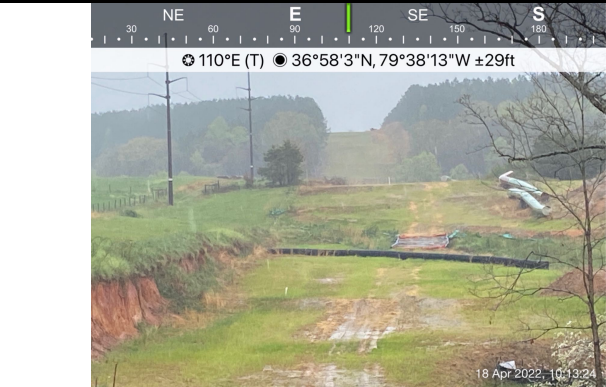
GPS Location	0		GPS Location	0	
Field Station#	14932+89		Field Station#	14940+00	
Pic 1 Desc.	Approximately 14932+89. Overview of stream crossing, equipment bridge and ECDs at stream S-G15.		Pic 2 Desc.	Approximately 14940+00. Overview of ROW.

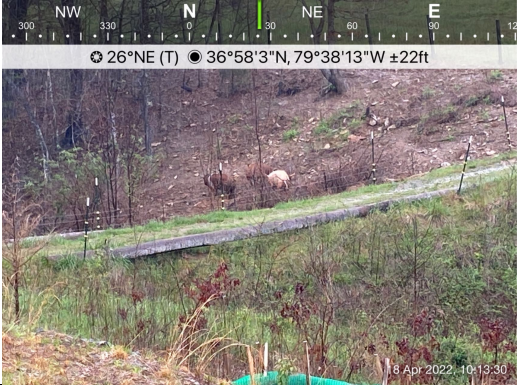
GPS Location	0	GPS Location			
Field Station#	14932+95	Field Station#			
Pic 7 Desc.	Approximately 14932+95. Observed hogs pinned upstream of crossing S-G15. Hogs are approximately 100' upstream and beyond	Pic 8 Desc.			
Insert image here		Insert image here			
GPS Location		GPS Location			
Field Station#		Field Station#			
Pic 9 Desc.		Pic 10 Desc.			
Insert image here		Insert image here			
GPS Location		GPS Location			
Field Station#		Field Station#			
Pic 11 Desc.		Pic 12 Desc.

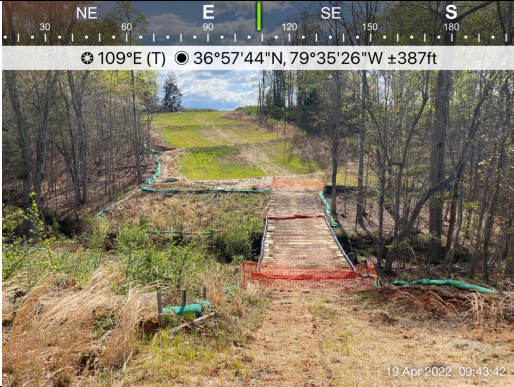
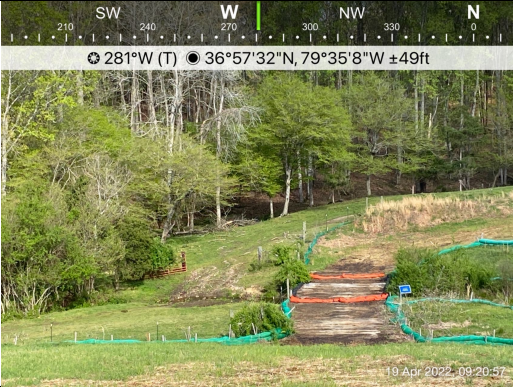
GPS Location	0	GPS Location	0		
Field Station#	15072+86	Field Station#	15092+95		
Pic 1 Desc.	Approximately 15072+86. Overview of stream crossing, equipment bridge and ECDs at stream S-G11.		Pic 2 Desc.	Approximately 15092+95. Overview of stream crossing, equipment bridge and ECDs at stream S-G9.

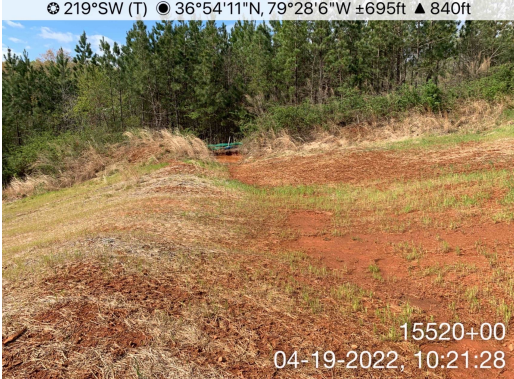
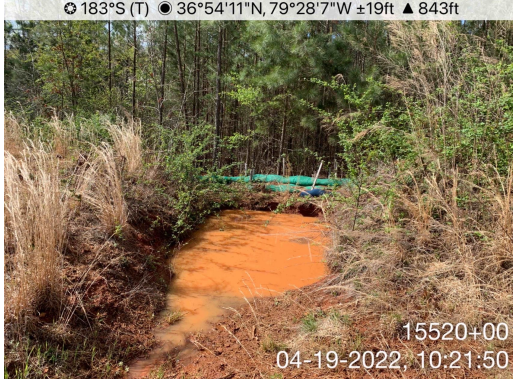
GPS Location	0		GPS Location	0	
Field Station#	15520+00		Field Station#	15520+00	
Pic 3 Desc.	Waterbar in acceptable condition		Pic 4 Desc.	Waterbar end treatment in acceptable condition

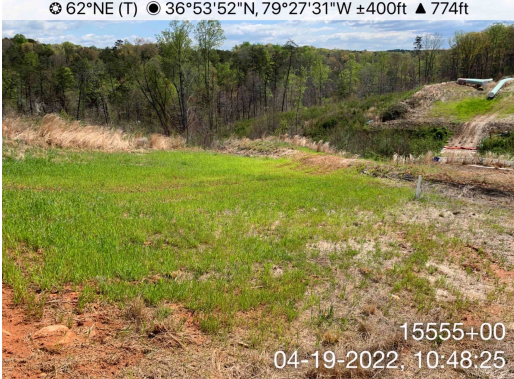
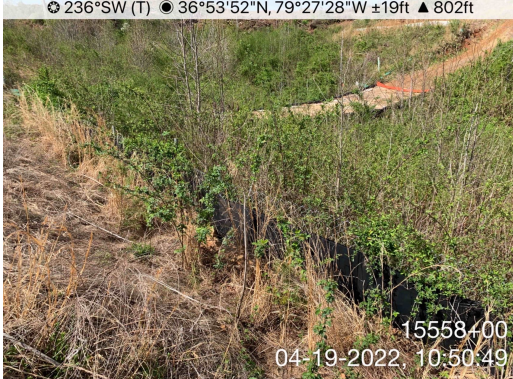
GPS Location	0		GPS Location	0	
Field Station#	15555+00		Field Station#	15558+00	
Pic 5 Desc.	Temporary vegetative stabilization in acceptable condition		Pic 6 Desc.	Super silt fence in acceptable condition

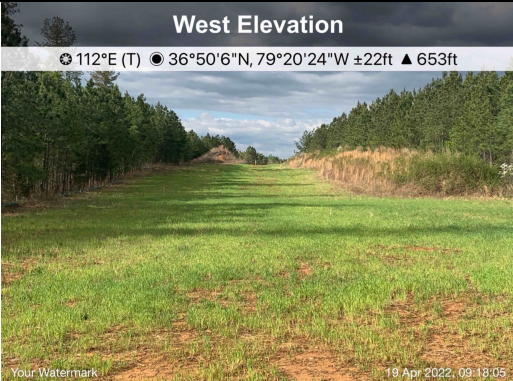
GPS Location	O		GPS Location	O	
Field Station#	12+00		Field Station#	6+00	
Pic 3 Desc.	Observing temporary stabilization,water bar, sump, end treatment and ECD's		Pic 4 Desc.	Observing temporary stabilization and water bar	
Insert image here			Insert image here		
GPS Location			GPS Location		
Field Station#			Field Station#		
Pic 5 Desc.			Pic 6 Desc.

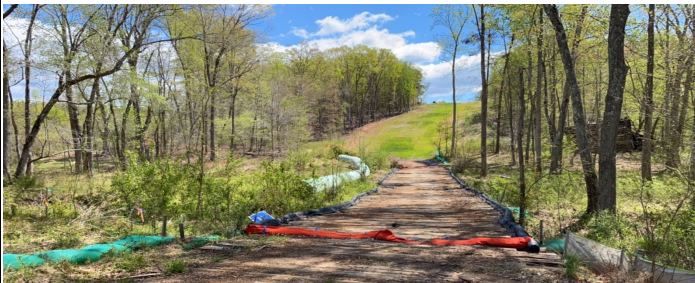
GPS Location	3	GPS Location	4		
Field Station#	14656+87	Field Station#	14664+00		
Pic 3 Desc.	Equipment bridge and surrounding ECDs in place and functional at stream crossing and resource buffer.		Pic 4 Desc.	ROW stabilized and vegetated in temporary area. Temporary diversion berm stabilized and vegetated.

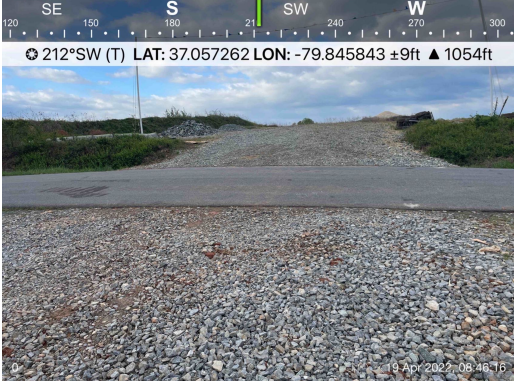
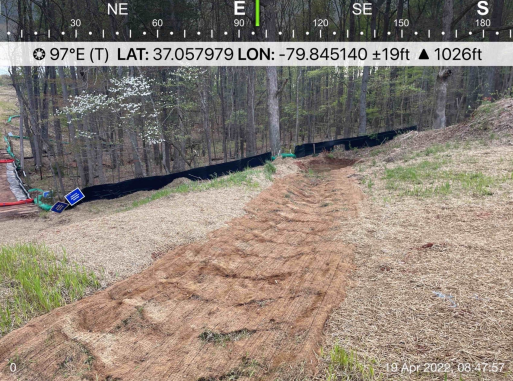
GPS Location	See photo		GPS Location	See photo	
Field Station#	14171+36		Field Station#	14175+00	
Pic 1 Desc.	RCEs are in good condition at all stream and wetland buffers		Pic 2 Desc.	Waterbars are functioning as intended

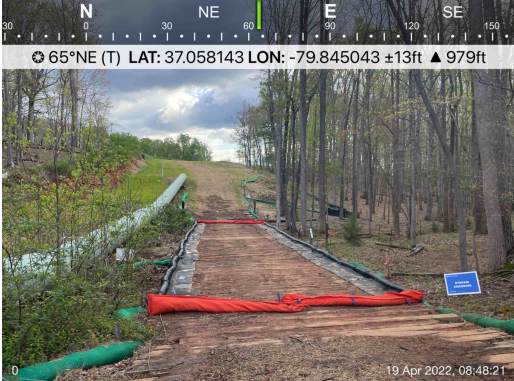
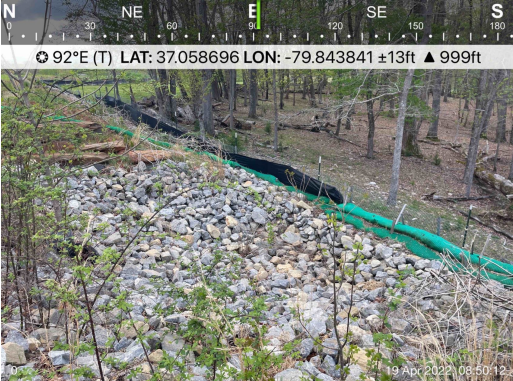
GPS Location	See photo		GPS Location	See photo	
Field Station#	13176+09		Field Station#	14180+00	
Pic 3 Desc.	Equipment bridge ECDs are in place and functioning		Pic 4 Desc.	CWDs are in good condition

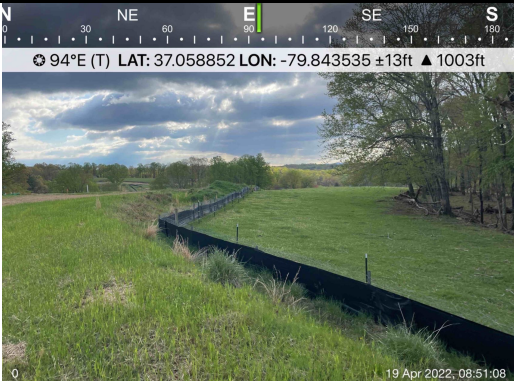
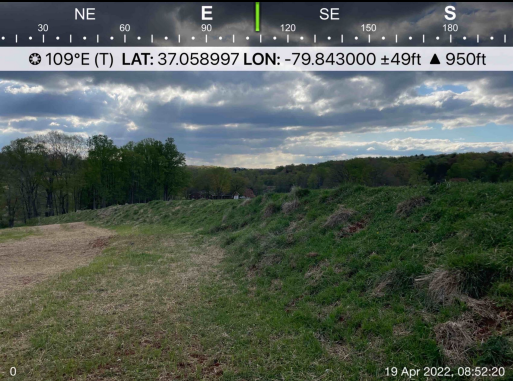
GPS Location	See photo		GPS Location	See photo	
Field Station#	14182+00		Field Station#	14183+00	
Pic 5 Desc.	SSF is in good condition throughout this section		Pic 6 Desc.	Topsoil berms remain stabilized

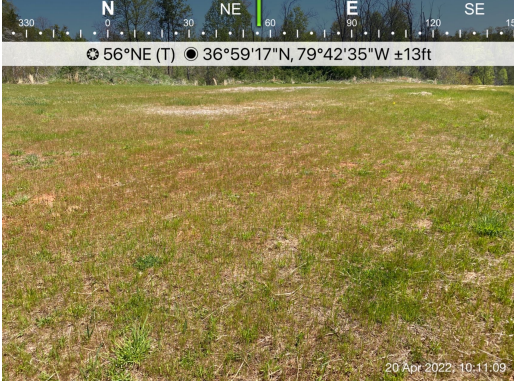
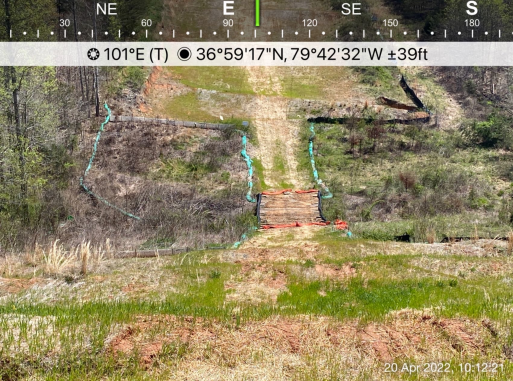
GPS Location	0	GPS Location	0		
Field Station#	14697+00	Field Station#	14700+75		
Pic 1 Desc.	Approximately 14697+00. Overview of ROW.		Pic 2 Desc.	Approximately 14700+75. Overview of stream crossing, equipment bridge and ECDs at stream S-H32.

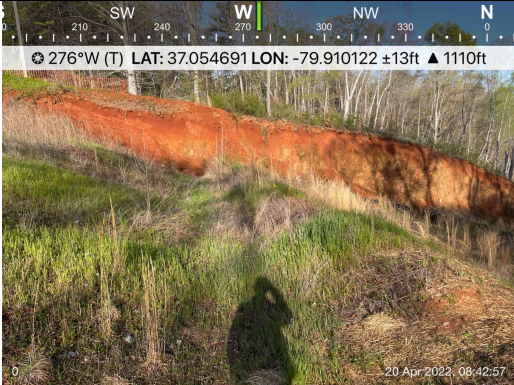
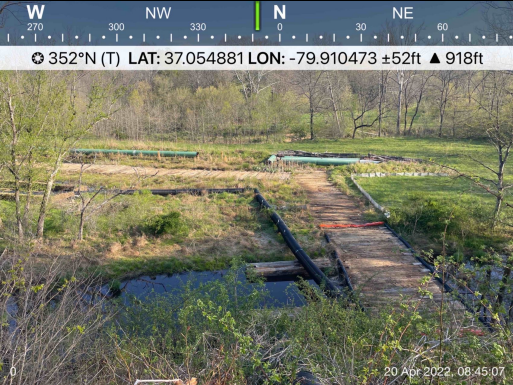
GPS Location	See photo		GPS Location	See photo	
Field Station#	13891+00		Field Station#	13889+00	
Pic 1 Desc.	Waterbars are in good condition		Pic 2 Desc.	Slope drain is functioning as intended

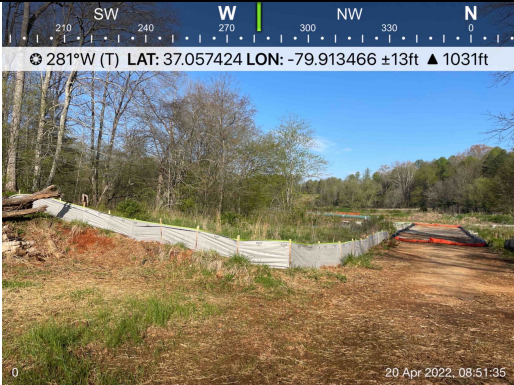
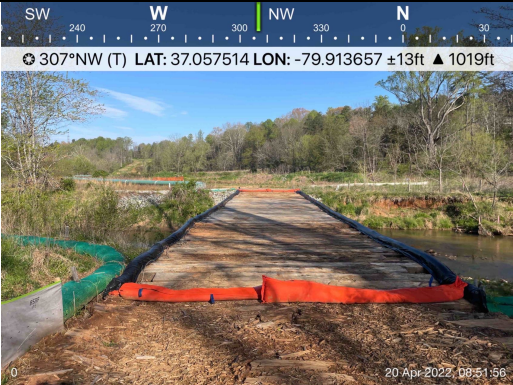
GPS Location	See photo		GPS Location	See photo	
Field Station#	13875+50		Field Station#	13875+25	
Pic 3 Desc.	P1 is in good condition at all stream and wetland buffers		Pic 4 Desc.	Equipment bridge ECDs are in good condition

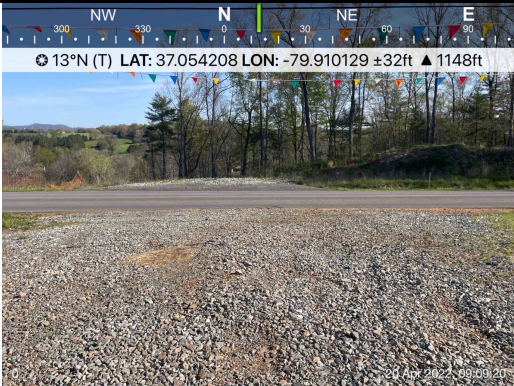
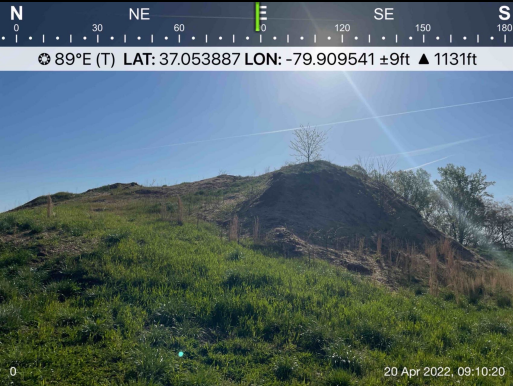
GPS Location	See photo		GPS Location	See photo	
Field Station#	13892+45		Field Station#	13897+00	
Pic 5 Desc.	RCEs are in good condition at all road crossings		Pic 6 Desc.	Topsoil pile remains stabilized

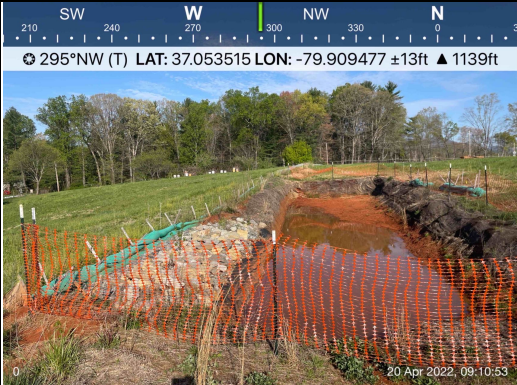
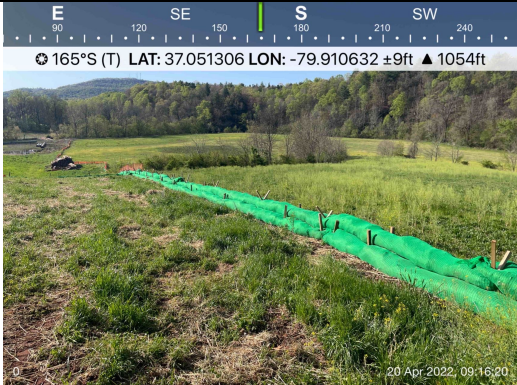
GPS Location	See photo		GPS Location	See photo	
Field Station#	13897+00		Field Station#	13907+00	
Pic 7 Desc.	Sediment trap is in good condition with no evidence of discharge		Pic 8 Desc.	CFS is in good condition

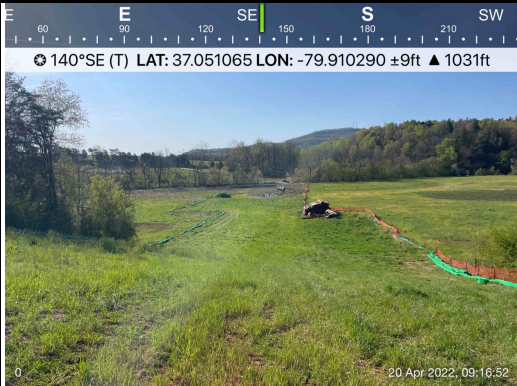
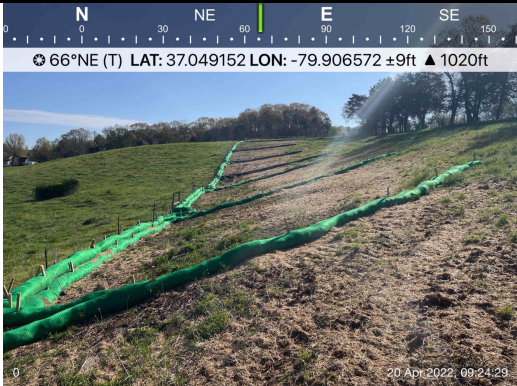
GPS Location	See photo		GPS Location	See photo	
Field Station#	13910+00		Field Station#	13922+00	
Pic 9 Desc.	Vegetation continues to fill in throughout this section		Pic 10 Desc.	CFS checks are in good condition and functioning on this slope

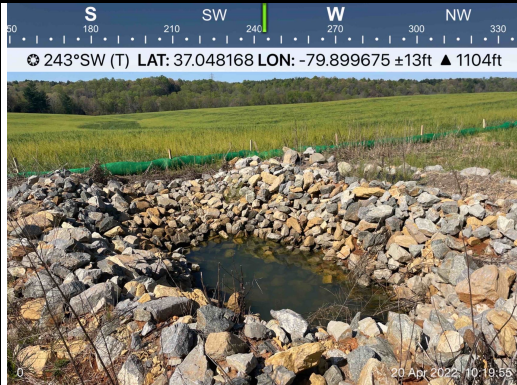
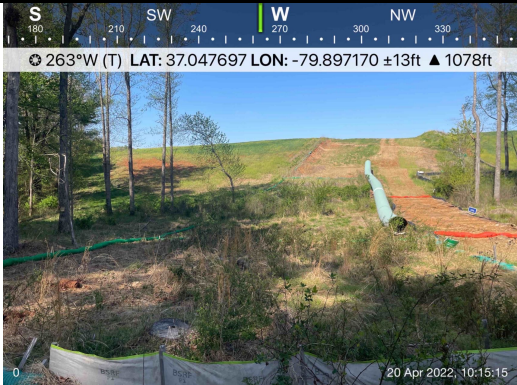
GPS Location	See photo		GPS Location	See photo	
Field Station#	13945+00		Field Station#	13950+00	
Pic 11 Desc.	CWDs are in good condition		Pic 12 Desc.	Resource buffers remain well vegetated.

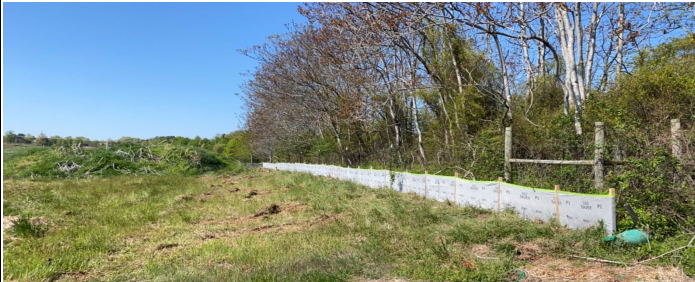
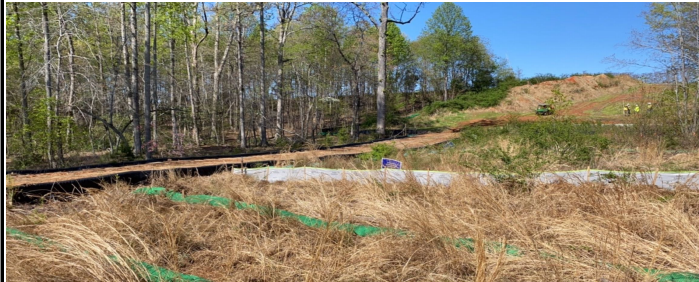
37°2'13" N 79°48'6" W 317°NW COURSE 243° GPS Glade Hill, VA 24092, United States 04.20.2022 10:46:16 Accur +/-28.5 Ft ALT 1145 Ft			37°2'10" N 79°47'57" W 242°SW COURSE 202° GPS Glade Hill, VA 24092, United States 04.20.2022 10:30:03 Accur +/-57.5 Ft ALT 1113 Ft		
GPS Location	1		GPS Location	2	
Field Station#	14345+95		Field Station#	14353+53	
Pic 1 Desc.	Contractor replaced perimeter P1 silt fence per punch list item.		Pic 2 Desc.	Contractor replaced ECDs in resource buffer per punch list item.

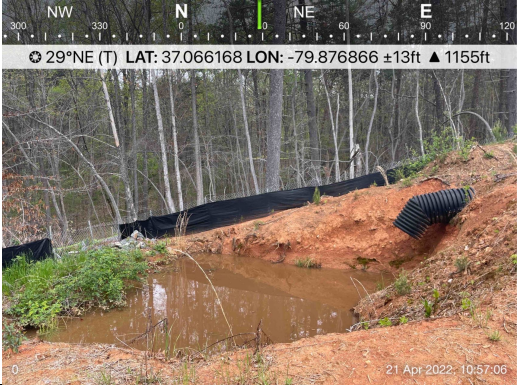
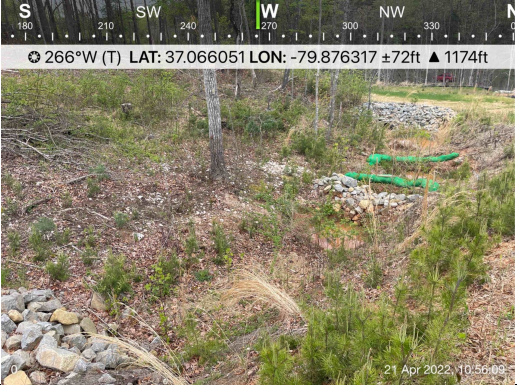
GPS Location	See photo	GPS Location	See photo		
Field Station#	14058+00	Field Station#	14059+00		
Pic 13 Desc.	Slope drain is in good condition and functioning	Pic 14 Desc.	Check dams are functioning as intended.		
Insert image here		Insert image here			
GPS Location		GPS Location			
Field Station#		Field Station#			
Pic 15 Desc.		Pic 16 Desc.			
Insert image here		Insert image here			
GPS Location		GPS Location			
Field Station#		Field Station#			
Pic 17 Desc.		Pic 18 Desc.

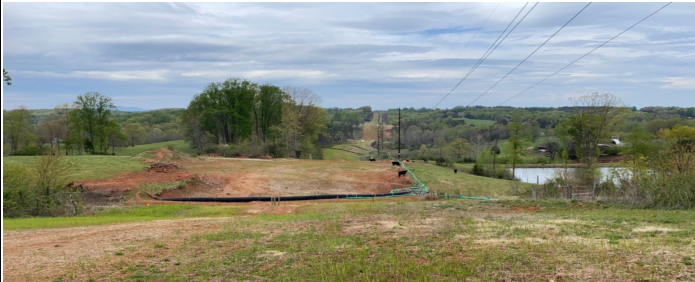
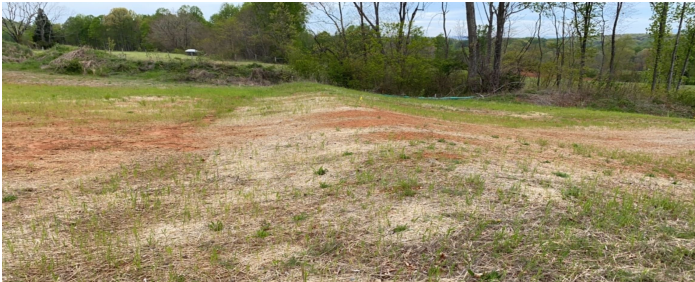
37°041' N 79°45'17" W 331°NW COURSE 349' GPS 1760 SR-674, Glade Hill, VA 24092, United States 04.21.2022 14:13:45 Accur +/-17.9 Ft ALT 1055 Ft			37°040' N 79°45'15" W 299°NW COURSE -1' GPS 1760 SR-674, Glade Hill, VA 24092, United States 04.21.2022 14:13:30 Accur +/-85.0 Ft ALT 1066 Ft		
GPS Location	1		GPS Location	2	
Field Station#	14518+00		Field Station#	14491+00	
Pic 1 Desc.	ROW stabilized and vegetated in temporary area; CWD pipe performing intended function.		Pic 2 Desc.	Water bar performing intended function.

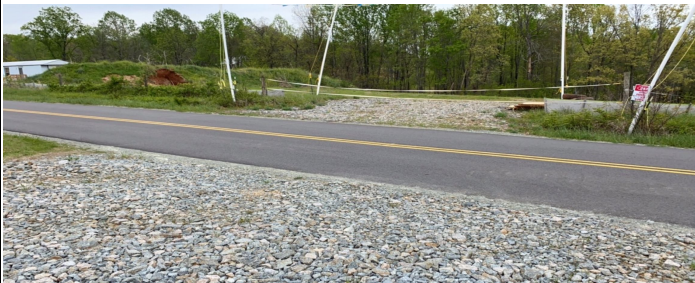
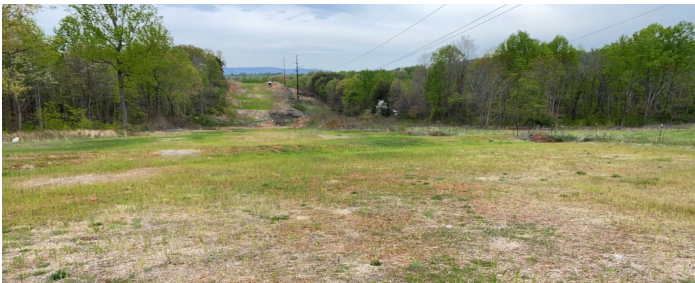
GPS Location	3		GPS Location	4	
Field Station#	14524+76		Field Station#	14529+00	
Pic 3 Desc.	RCE at Timber Ridge Rd in good condition.		Pic 4 Desc.	ROW stabilized and vegetated in temporary area.

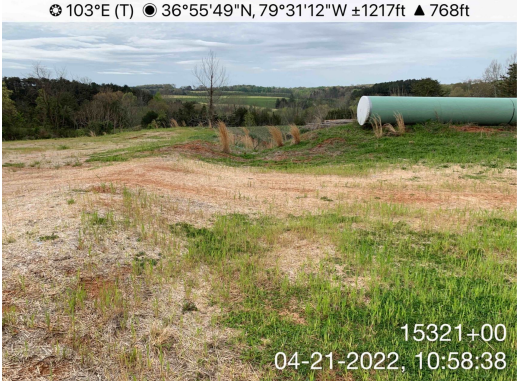
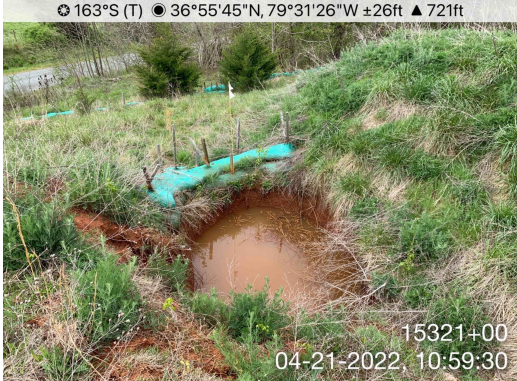
GPS Location	0	GPS Location	0		
Field Station#	15321+00	Field Station#	15321+00		
Pic 7 Desc.	Waterbar in acceptable condition		Pic 8 Desc.	Waterbar end treatment in acceptable condition

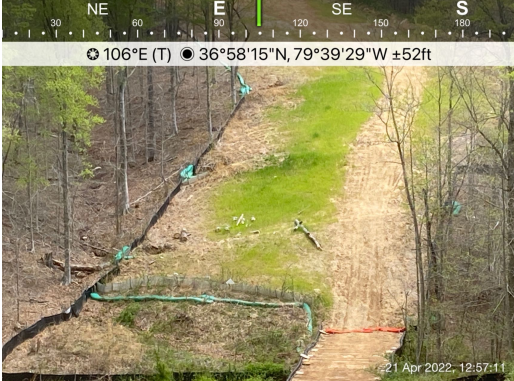
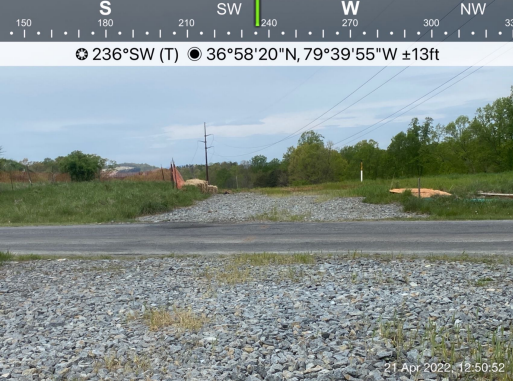
GPS Location	0	GPS Location	0		
Field Station#	14872+00	Field Station#	14845+50		
Pic 1 Desc.	Approximately 14872+00. Overview of ROW.	Pic 2 Desc.	Approximately 14845+50. Overview of road crossing and RCEs.

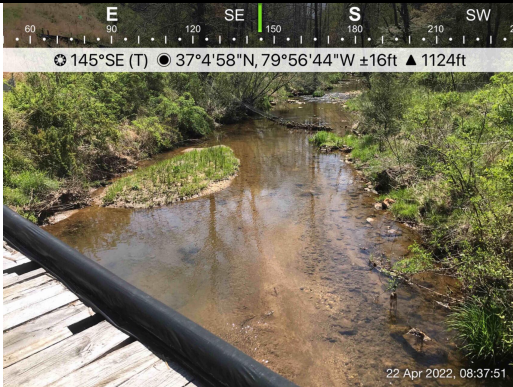
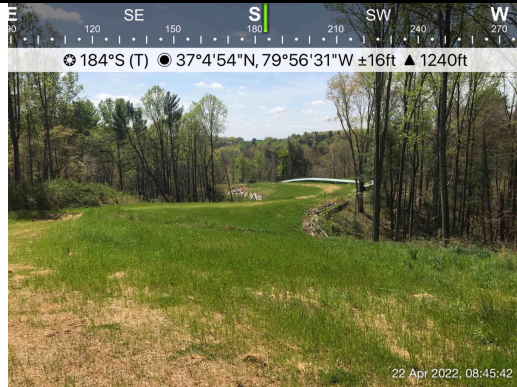
GPS Location	0000	GPS Location	0000		
Field Station#	13705+07	Field Station#	13714+00		
Pic 1 Desc.	Stream observation photo facing downstream during routine inspection today, no issues were observed at the time of inspection.

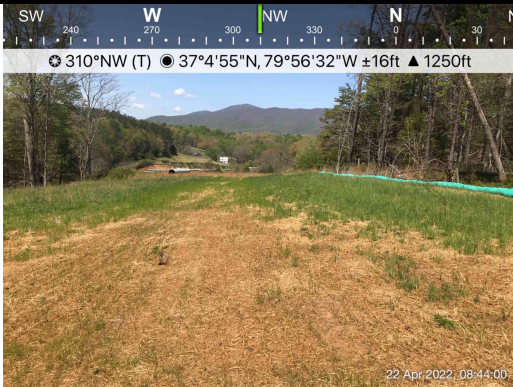
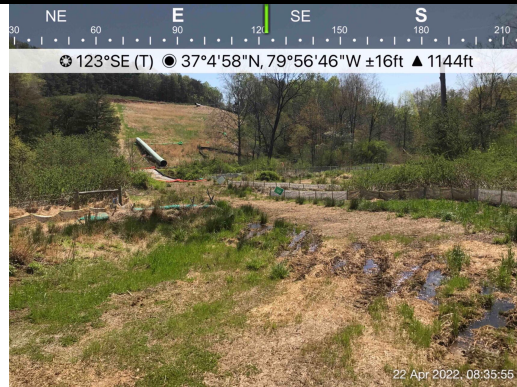
GPS Location	0000	GPS Location	0000		
Field Station#	13712+50	Field Station#	13702+61		
Pic 3 Desc.	Row photo showing vegetation and ECDs in place along the perimeter of the row, no issues observed at the time of inspection.

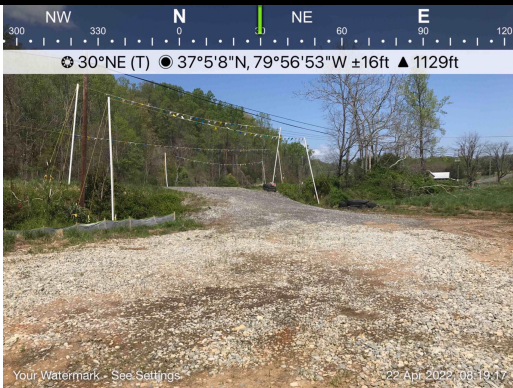
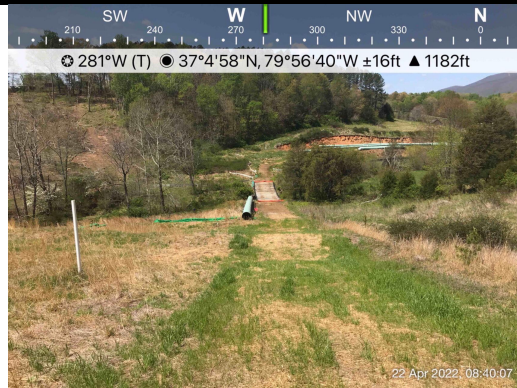
GPS Location	0000	GPS Location	0000		
Field Station#	13691+24	Field Station#	13706+87		
Pic 5 Desc.	Monitored RCEs during routine inspection today, no issues were observed at the time of inspection.				
Pic 6 Desc.	Row photo showing stabilization on hill side above stream crossing. Good vegetation observed. No environmental issues observed at the time of inspection.

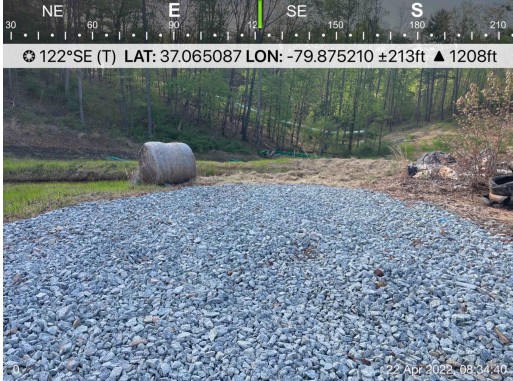
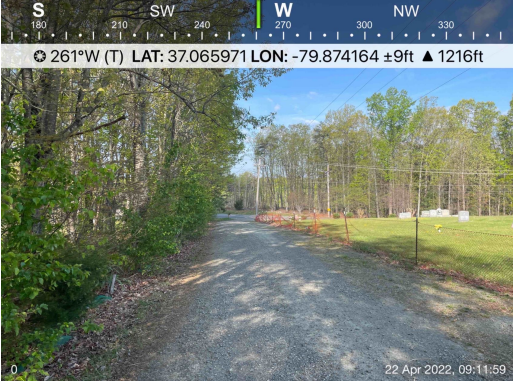
GPS Location	See photo		GPS Location	See photo	
Field Station#	14062+17		Field Station#	14072+87	
Pic 1 Desc.	RCEs are in good condition at all road crossings		Pic 2 Desc.	MVP-FR-309.05 remains in good condition with controls in place

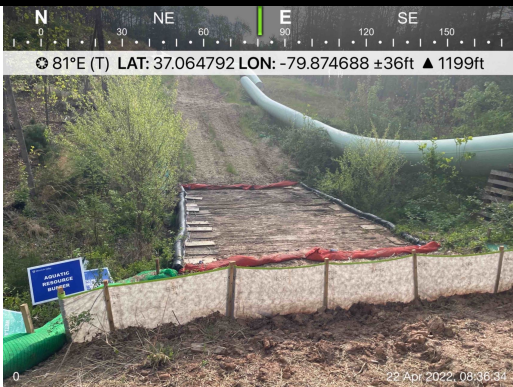
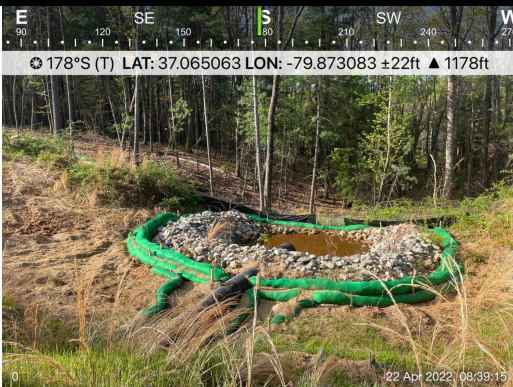
GPS Location	See photo		GPS Location	See photo	
Field Station#	14066+77		Field Station#	14070+00	
Pic 3 Desc.	Equipment bridge ECDs are in good condition and functioning		Pic 4 Desc.	CWDs are functioning as intended

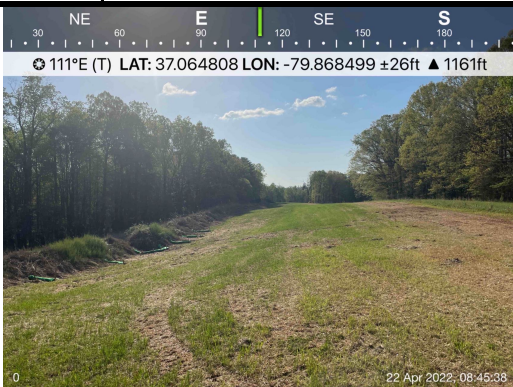
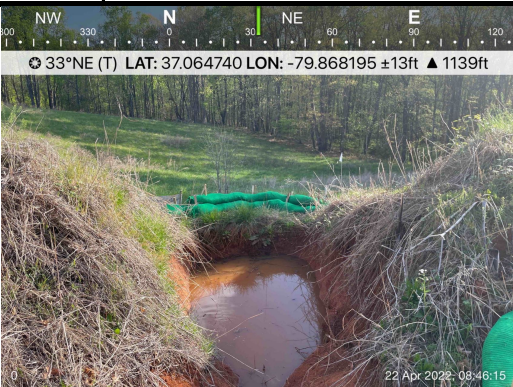
GPS Location	See photo		GPS Location	See photo	
Field Station#	14085+00		Field Station#	14085+00	
Pic 5 Desc.	Vegetation continues to fill in throughout this section		Pic 6 Desc.	End treatments are functioning as intended

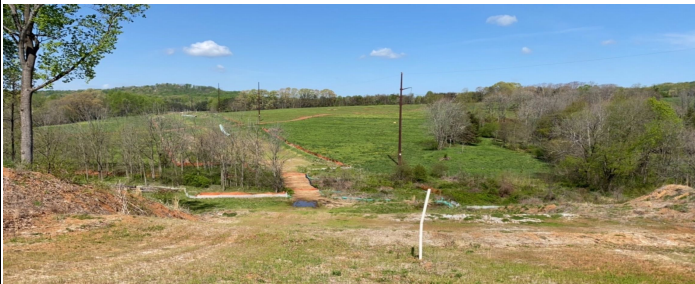
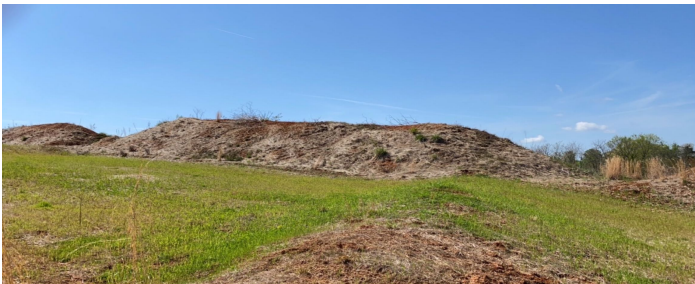
37°0'0" N 79°44'30" W 352°N COURSE 304° GPS 753 Simmons Creek Rd, Union Hall, VA 24176, United States 04.22.2022 10:56:34 Accur +/-33.4 Ft ALT 888 Ft			37°0'0" N 79°44'29" W 220°SW COURSE 110° GPS 753 Simmons Creek Rd, Union Hall, VA 24176, United States 04.22.2022 10:57:13 Accur +/-37.1 Ft ALT 888 Ft		
GPS Location	1	GPS Location	2		
Field Station#	14582+85	Field Station#	14587+00		
Pic 1 Desc.	Equipment bridge and surrounding ECDs in place and functional at stream crossing and resource buffer.		Pic 2 Desc.	Water bar performing intended function.
