Visual Site Inspection Report

Project Name	H-603 Pipeline Spread I	AFE	124300139	Spread	H-603 Pipeline Spread I	
Contractor	Precision			Report #	36934	
Inspector	John White			Date/Time	4/25/2022 11:20 AM	
Permit #	TBD	Inspection Type	VA SWPP	Station Begin	00+00	
State	VA	Inspection Area	Full	Station End	24+53	
County	Pittsylvania	Ground	Dry	Temperature (°F)	80.00	
Municipality	Chatham	Weather	Sunny	Rain Gauge (in)	0.00	
				Rain Accumulation Time (days)	6.00

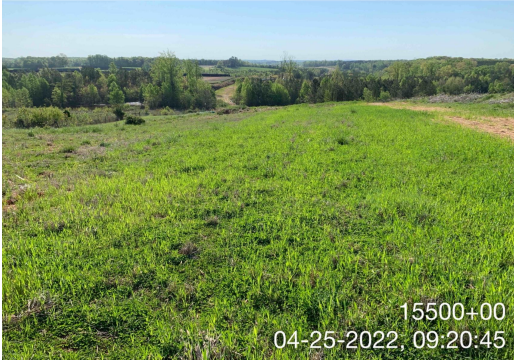
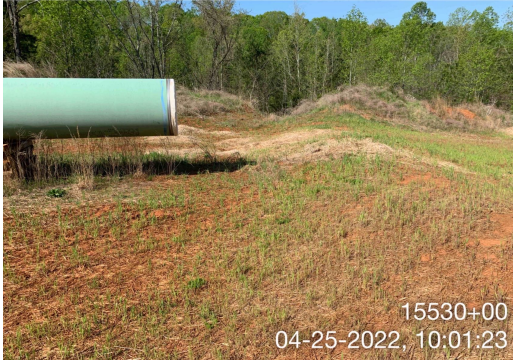
<p>15530+00 04-25-2022, 10:01:23</p>			
GPS Location	0	GPS Location	0		
Field Station#	15500+00	Field Station#	15530+00		
Pic 1 Desc.	Temporary vegetative stabilization in acceptable condition	Pic 2 Desc.	Waterbar in acceptable condition

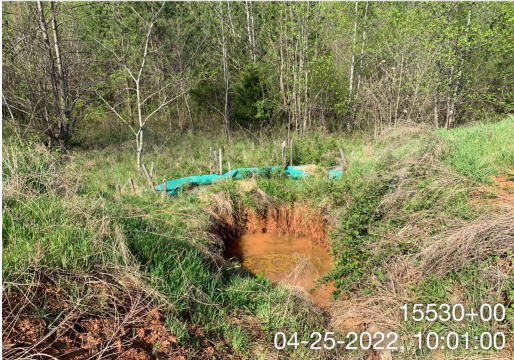
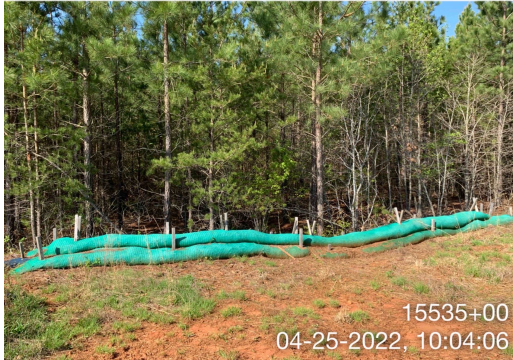
<p>15535+00 04-25-2022, 10:04:06</p>			
GPS Location	0	GPS Location	0		
Field Station#	15530+00	Field Station#	15535+00		
Pic 3 Desc.	Waterbar end treatment in acceptable condition	Pic 4 Desc.	CFS in acceptable condition

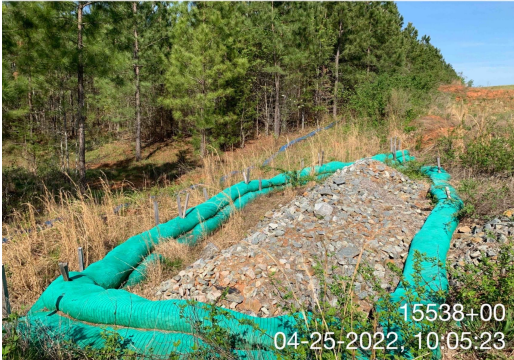
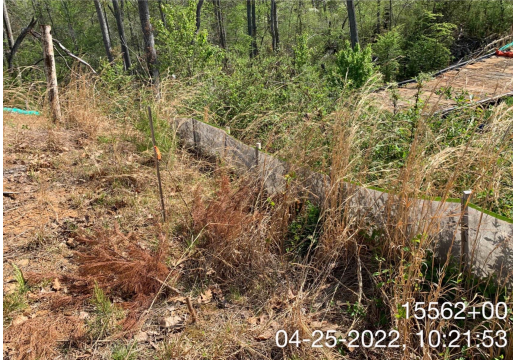
<p>15562+00 04-25-2022, 10:21:53</p>			
GPS Location	0	GPS Location	0		
Field Station#	15538+00	Field Station#	15562+00		
Pic 5 Desc.	Clean water diversion pipe and CFS in acceptable conditions	Pic 6 Desc.	P1 silt fence in acceptable condition

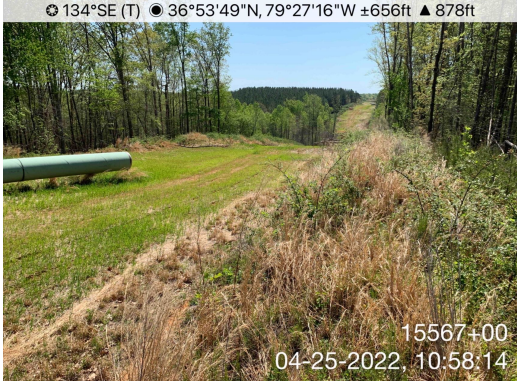
GPS Location	0	GPS Location	0		
Field Station#	15562+68	Field Station#	15567+00		
Pic 7 Desc.	Equipment bridge in acceptable condition		Pic 8 Desc.	Clean water diversion berm and temporary vegetative stabilization in acceptable conditions

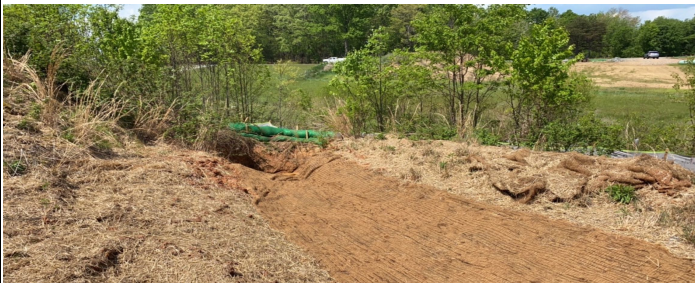
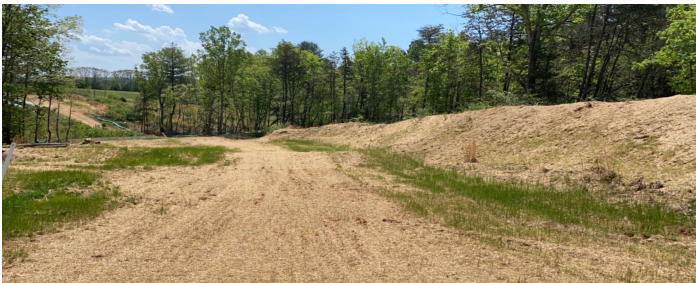
GPS Location	3	GPS Location	4		
Field Station#	14316+00	Field Station#	14335+00		
Pic 3 Desc.	Contractor replaced damaged ECDs throughout section.		Pic 4 Desc.	Contractor temporary seeded and stabilized ROW throughout section.

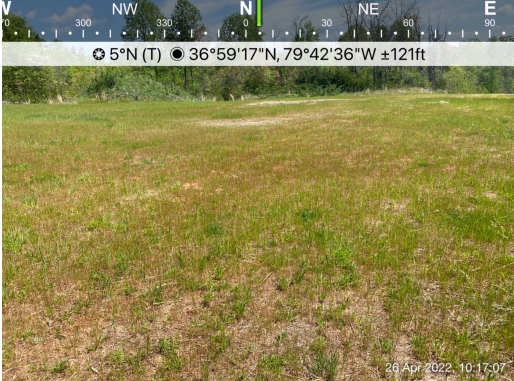
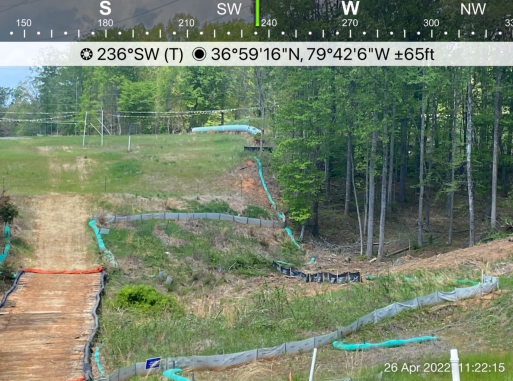
GPS Location	0	GPS Location	0		
Field Station#	14697+00	Field Station#	14716+50		
Pic 1 Desc.	Approximately 14697+00. Overview of ROW.	Pic 2 Desc.	Overview of wetland crossing, equipment bridge and ECDs at wetland W-H11. Third party disturbance and ECDs along and beyond north LOP.

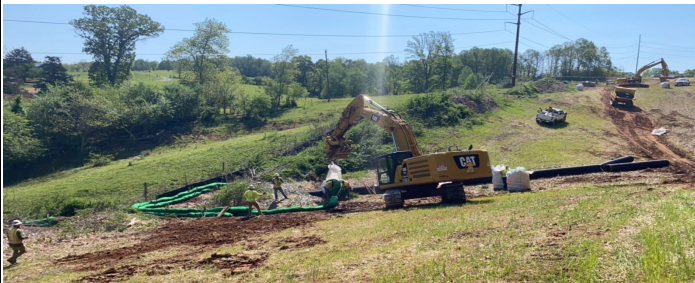
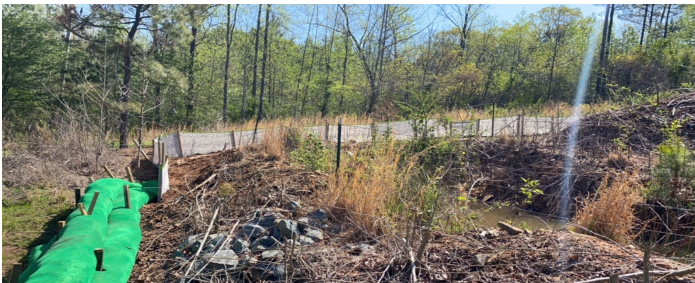
Pic 3 Desc.	Contractor replacing ECDs per punch list item.	Pic 4 Desc.	Contractor replaced damaged ECDs per punch list item.

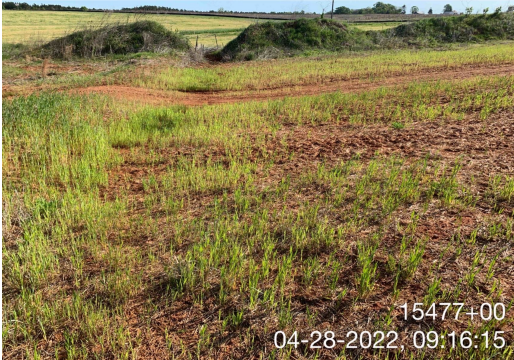
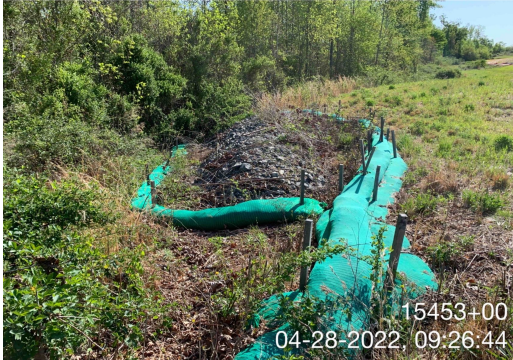
GPS Location	0	GPS Location	0		
Field Station#	15477+00	Field Station#	15453+00		
Pic 1 Desc.	Waterbar in acceptable condition	Pic 2 Desc.	Clean water diversion pipe and CFS in acceptable conditions

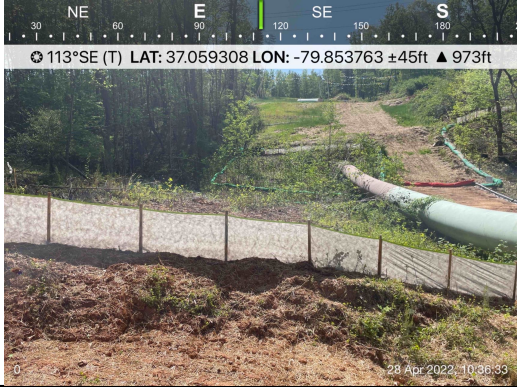
GPS Location	See photo	GPS Location	See photo		
Field Station#	14141+62	Field Station#	14157+00		
Pic 9 Desc.	P1 is in good condition at all stream and wetland buffers	Pic 10 Desc.	Slope drain is in good condition

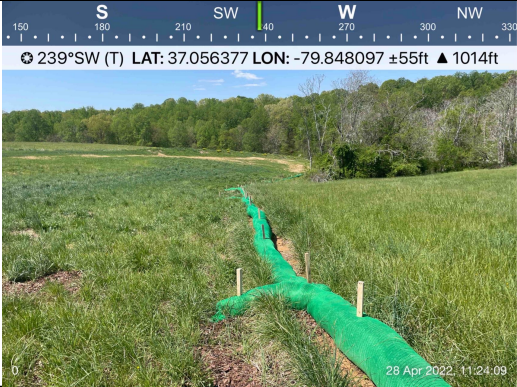
GPS Location	See photo	GPS Location	See photo		
Field Station#	14157+75	Field Station#	14165+00		
Pic 11 Desc.	Resource buffers remain well vegetated	Pic 12 Desc.	CFS is in good condition throughout this section.

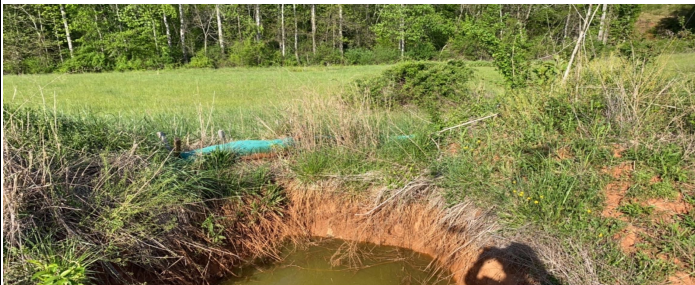
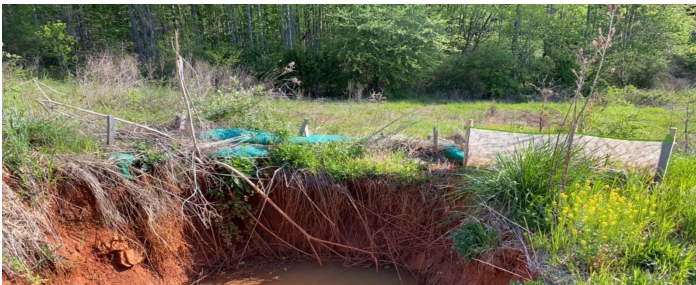
Pic 3 Desc.	Routine maintenance. Replace CFS end treatment.		Pic 4 Desc.	Routine maintenance. Replace CFS end treatment.

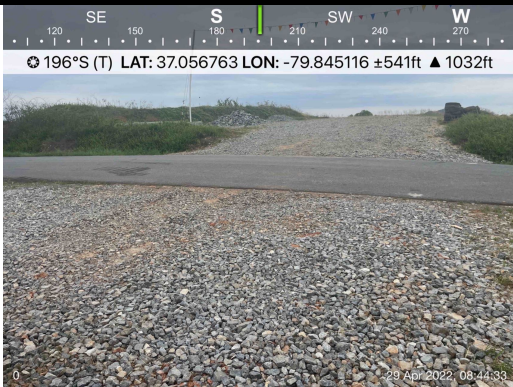
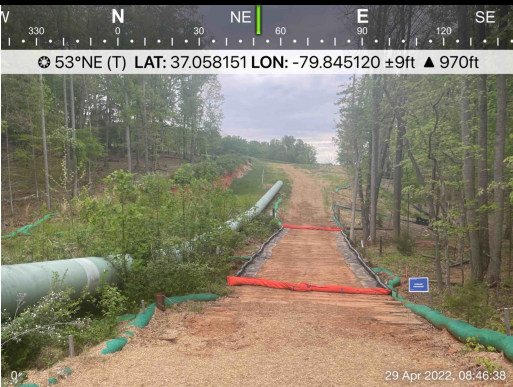
GPS Location	See photo		GPS Location	See photo	
Field Station#	14171+36		Field Station#	14176+09	
Pic 1 Desc.	RCEs are in good condition at all road crossings		Pic 2 Desc.	Equipment bridge ECDs are in place and functioning

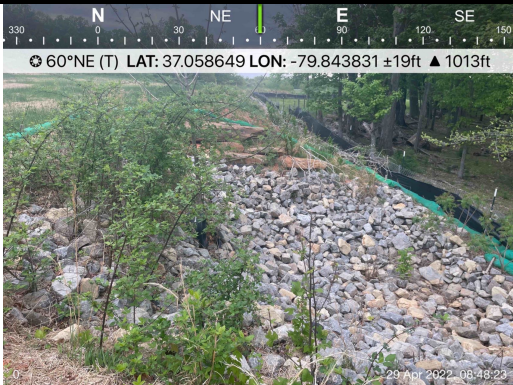
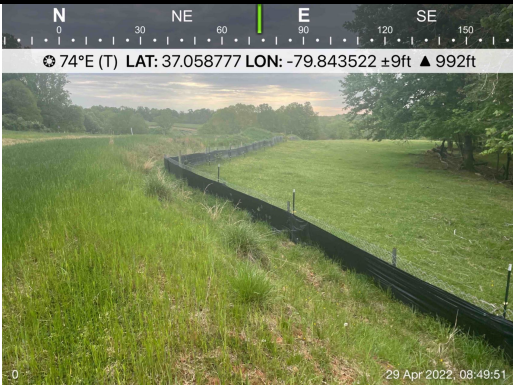
GPS Location	See photo		GPS Location	See photo	
Field Station#	14180+00		Field Station#	14182+00	
Pic 3 Desc.	CWDs are functioning as intended		Pic 4 Desc.	SSF is in good condition

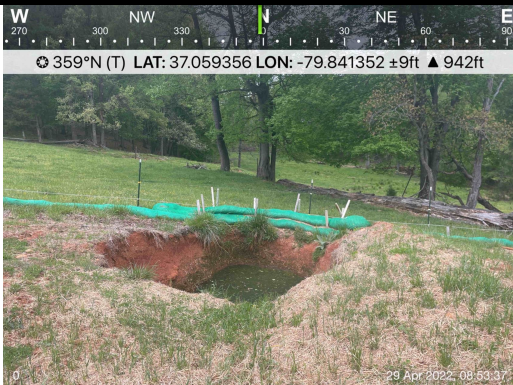
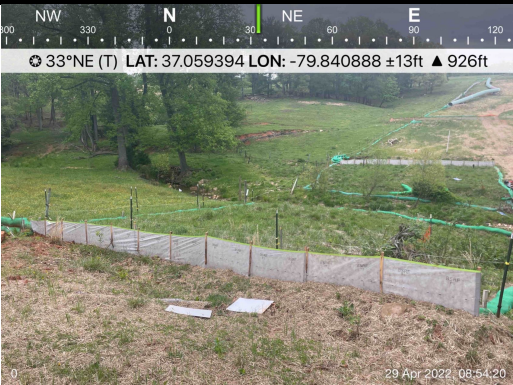
GPS Location	See photo		GPS Location	See photo	
Field Station#	14188+00		Field Station#	14190+40	
Pic 5 Desc.	End treatments are functioning		Pic 6 Desc.	P1 is in good condition at all stream and wetland buffers

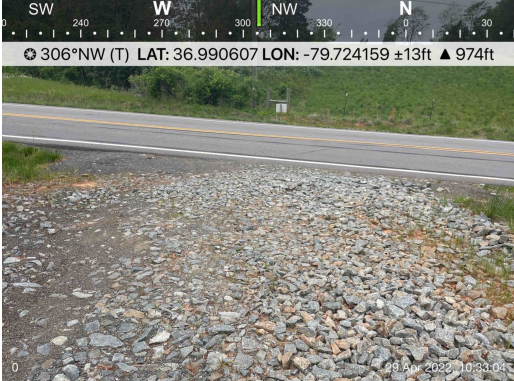
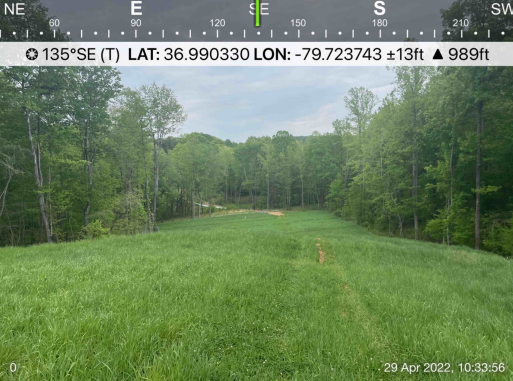
GPS Location	See photo		GPS Location	See photo	
Field Station#	14649+67		Field Station#	14651+00	
Pic 1 Desc.	RCEs are in good condition at all road crossings.		Pic 2 Desc.	Vegetation continues to fill in throughout this section

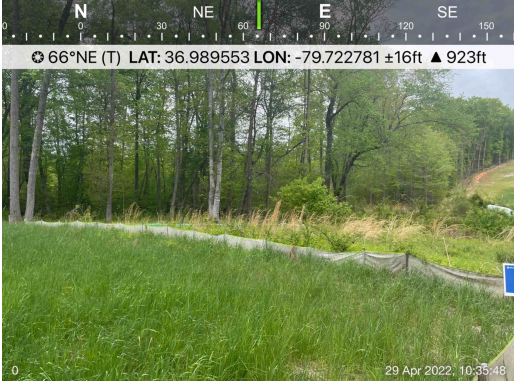
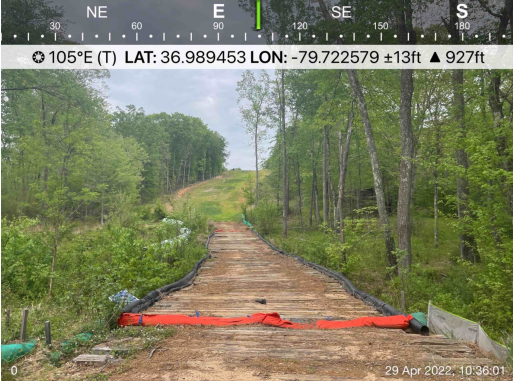
GPS Location	See photo		GPS Location	See photo	
Field Station#	14656+87		Field Station#	14656+87	
Pic 3 Desc.	P1 is in good condition at all stream and wetland buffers		Pic 4 Desc.	Equipment bridge ECDs are in good condition and functioning

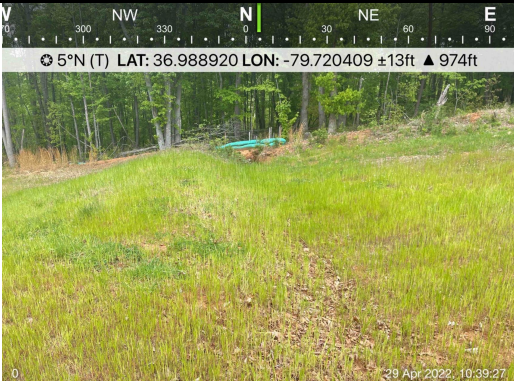
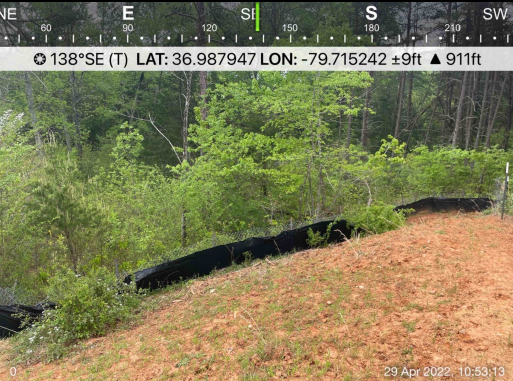
GPS Location	See photo		GPS Location	See photo	
Field Station#	14660+00		Field Station#	14680+00	
Pic 5 Desc.	Waterbars are in good condition		Pic 6 Desc.	SSF is in good condition
