Visual Site Inspection Report

Project Name	H-600 Pipeline Spread I	AFE	124300139	Spread	H-600 Pipeline Spread I
Contractor	Precision			Report #	37184
Inspector	Charles Head			Date/Time	5/2/2022 9:31 AM
Permit #	TBD	Inspection Type	VA SWPP	Station Begin	14694+77
State	VA	Inspection Area	Full	Station End	14802+19
County	Franklin	Ground	Dry	Temperature (°F)	70.00
Municipality	N/A	Weather	Sunny	Rain Gauge (in)	0.25
				Rain Accumulation Time (days)	2.00

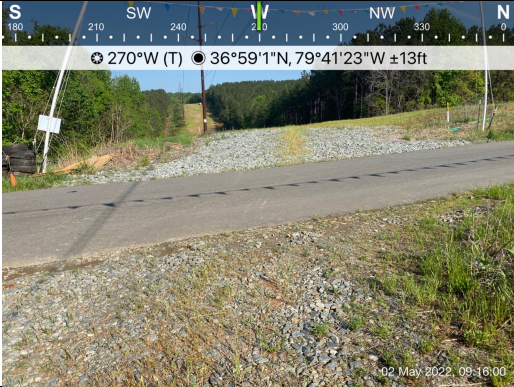
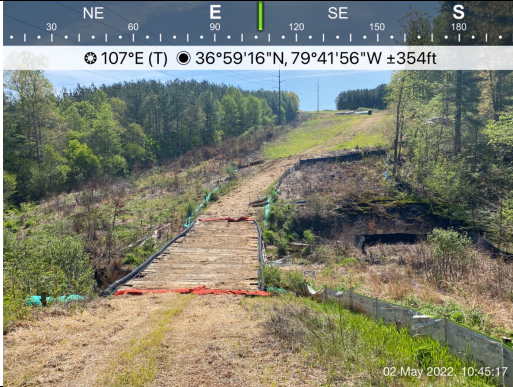
GPS Location	0	GPS Location	0		
Field Station#	14758+16	Field Station#	14729+19		
Pic 1 Desc.	Approximately 14758+16. Overview of road crossing and RCEs.	Pic 2 Desc.	Approximately 14729+19. Overview of stream crossing, equipment bridge and ECDs at stream S-A20.

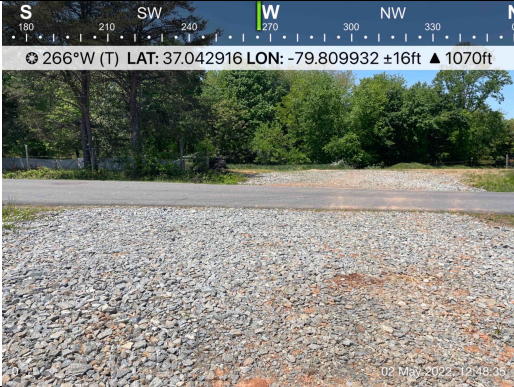
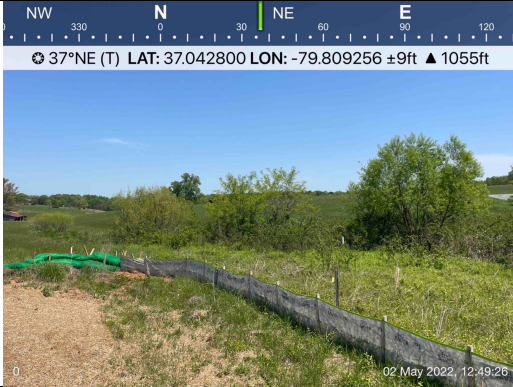
GPS Location	See photo		GPS Location	See photo	
Field Station#	14311+57		Field Station#	14314+79	
Pic 1 Desc.	RCEs are in good condition at all road crossings.		Pic 2 Desc.	P1 is in good condition at all stream and wetland buffers

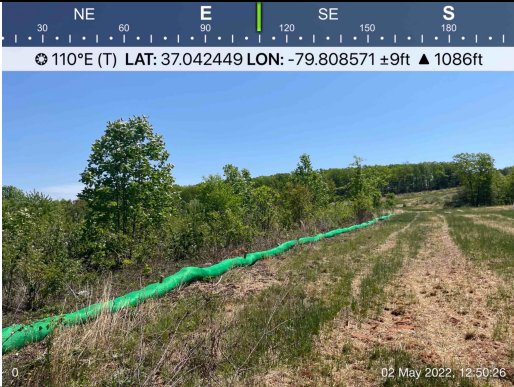
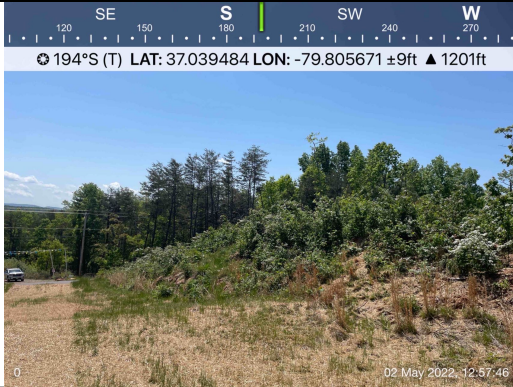
GPS Location	See photo		GPS Location	See photo	
Field Station#	14320+00		Field Station#	14330+00	
Pic 3 Desc.	Perimeter CFS is in good condition		Pic 4 Desc.	Topsoil berms remain stabilized

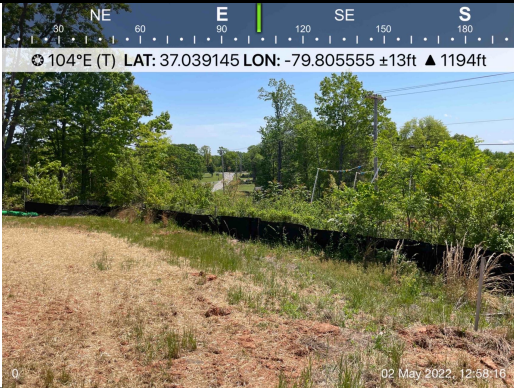
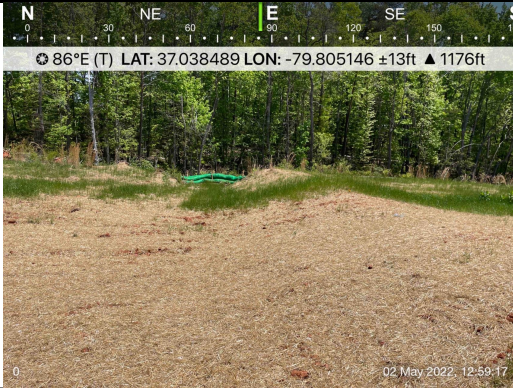
GPS Location	See photo		GPS Location	See photo	
Field Station#	14333+27		Field Station#	14335+00	
Pic 5 Desc.	SSF is in good condition		Pic 6 Desc.	Waterbars are functioning as intended

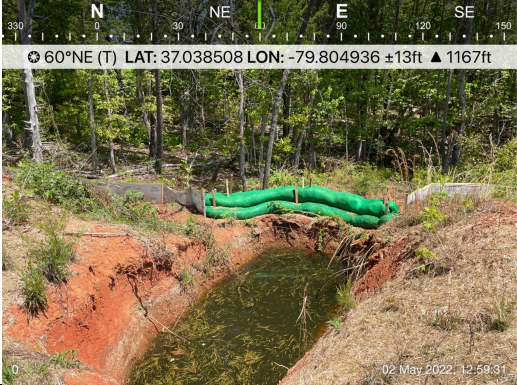
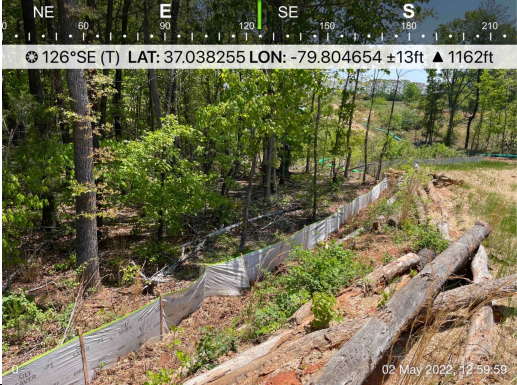
GPS Location	See photo		GPS Location	See photo	
Field Station#	14335+00		Field Station#	14337+00	
Pic 7 Desc.	End treatments are in good condition		Pic 8 Desc.	Perimeter P1 is in good condition

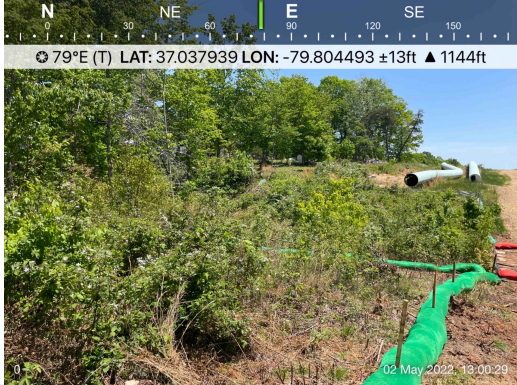
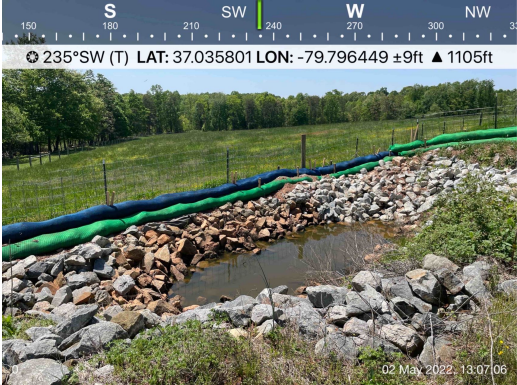
GPS Location	See photo		GPS Location	See photo	
Field Station#	14338+56		Field Station#	14365+00	
Pic 9 Desc.	Resource buffers remain well vegetated		Pic 10 Desc.	CWDs are functioning as intended

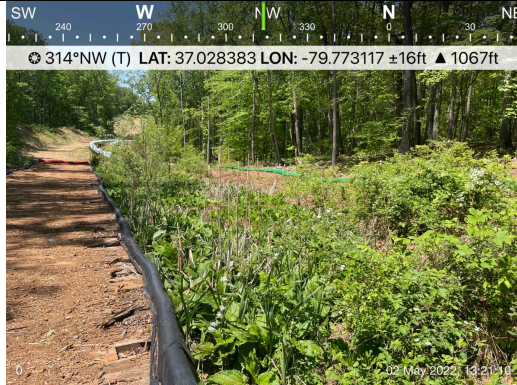
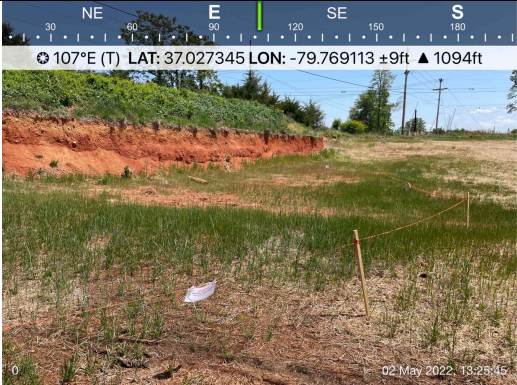
GPS Location	See photo		GPS Location	See photo	
Field Station#	14440+00		Field Station#	14451+25	
Pic 11 Desc.	Resource buffers remain well vegetated		Pic 12 Desc.	Avian nest buffer remains in good condition.

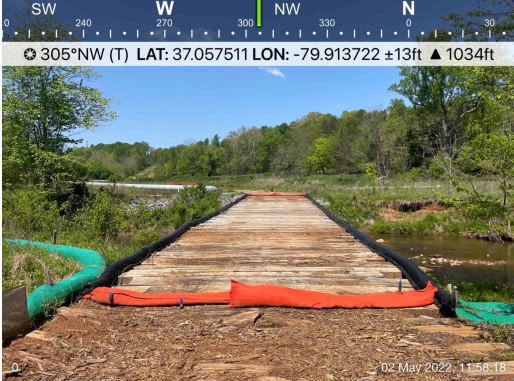
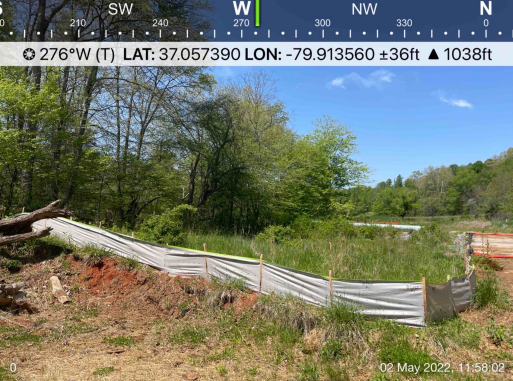
GPS Location	See photo		GPS Location	See photo	
Field Station#	13875+73		Field Station#	13876+00	
Pic 1 Desc.	Equipment bridge ECDs are in good condition and functioning		Pic 2 Desc.	P1 is in good condition at all stream and wetland buffers

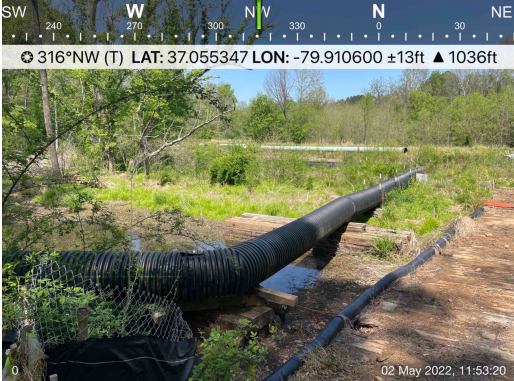
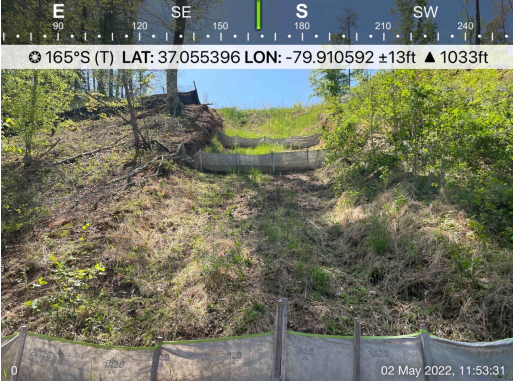
GPS Location	See photo		GPS Location	See photo	
Field Station#	13888+50		Field Station#	13889+00	
Pic 3 Desc.	Slope drain is functioning as intended		Pic 4 Desc.	Slope remains stabilized with controls in place

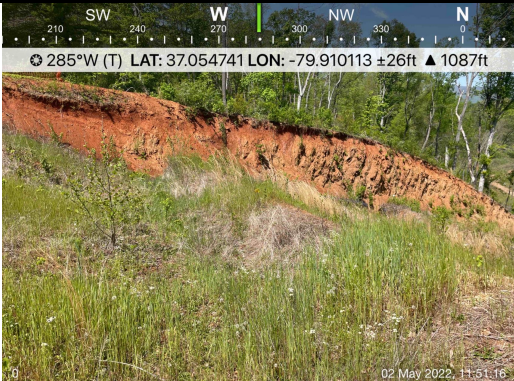
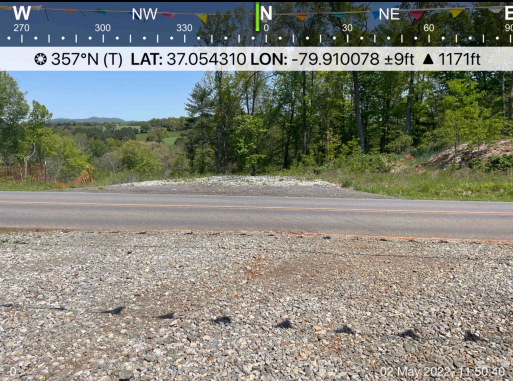
GPS Location	See photo		GPS Location	See photo	
Field Station#	13891+00		Field Station#	13892+45	
Pic 5 Desc.	Waterbars are in good condition		Pic 6 Desc.	RCEs are in good condition at all road crossings.

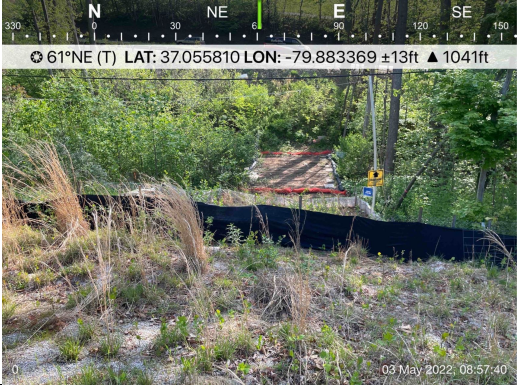
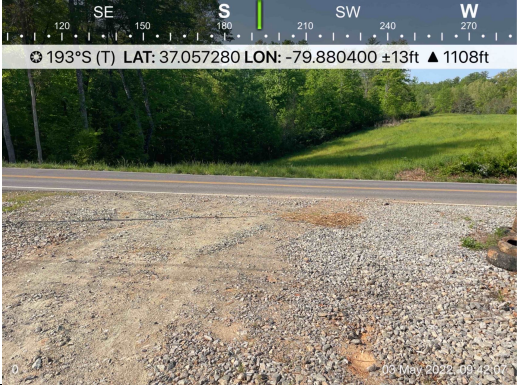
GPS Location	See photo		GPS Location	See photo	
Field Station#	14009+15		Field Station#	14018+47	
Pic 7 Desc.	SSF is in good condition		Pic 8 Desc.	RCEs are in good condition at all road crossings.

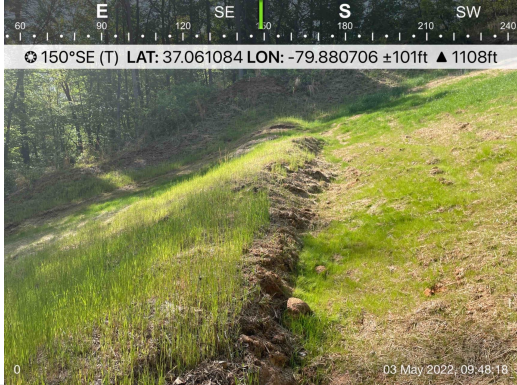
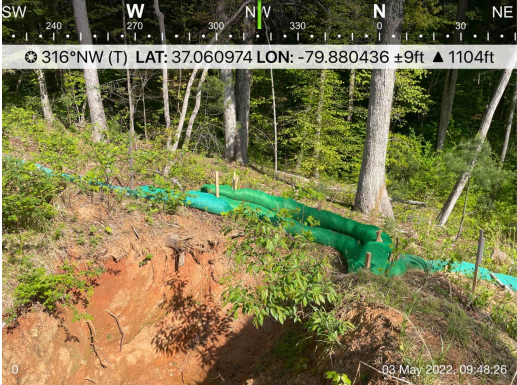
GPS Location	See photo		GPS Location	See photo	
Field Station#	14033+00		Field Station#	14033+00	
Pic 9 Desc.	Waterbars are in good condition		Pic 10 Desc.	End treatments are functioning as intended

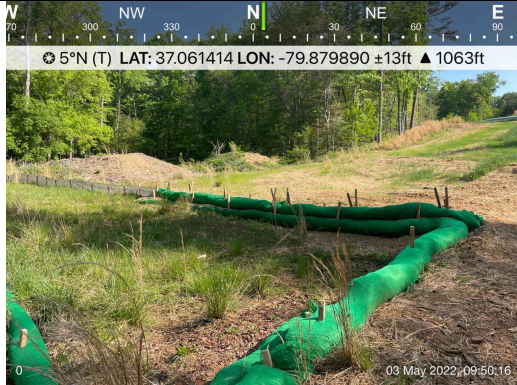
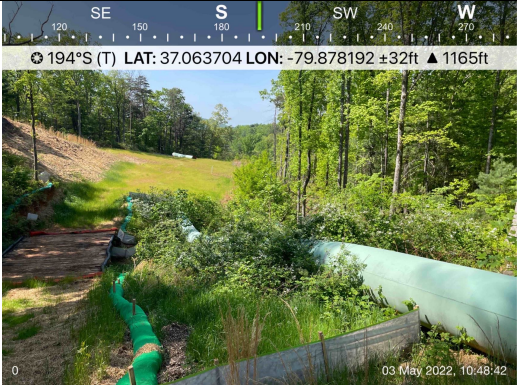
GPS Location	See photo		GPS Location	See photo	
Field Station#	14036+00		Field Station#	14045+71	
Pic 11 Desc.	CFS is in good condition condition		Pic 12 Desc.	Resource buffers remain well vegetated

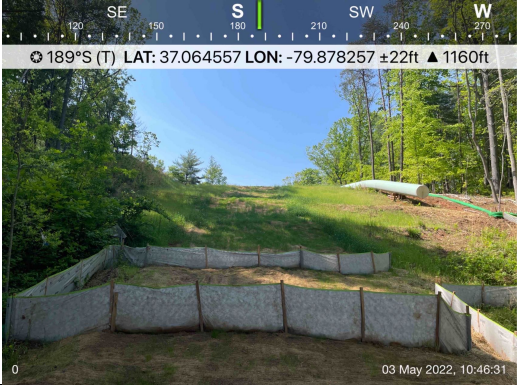
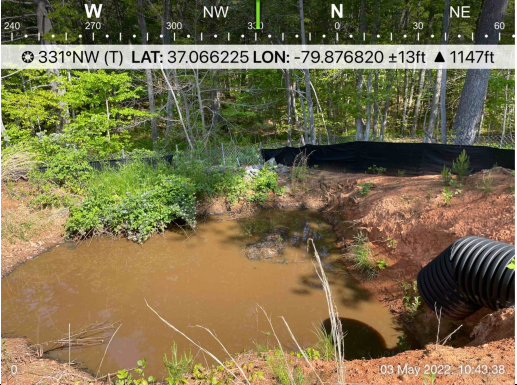
GPS Location	See photo		GPS Location	See photo	
Field Station#	14050+00		Field Station#	14053+00	
Pic 13 Desc.	Slope remains stabilized with controls in place		Pic 14 Desc.	Slope drain is functioning as intended

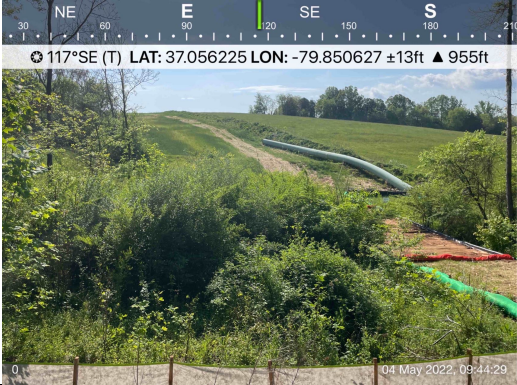
GPS Location	See photo	GPS Location			
Field Station#	14157+55	Field Station#			
Pic 13 Desc.	Resource buffers remain well vegetated.	Pic 14 Desc.			
Insert image here		Insert image here			
GPS Location		GPS Location			
Field Station#		Field Station#			
Pic 15 Desc.		Pic 16 Desc.			
Insert image here		Insert image here			
GPS Location		GPS Location			
Field Station#		Field Station#			
Pic 17 Desc.		Pic 18 Desc.

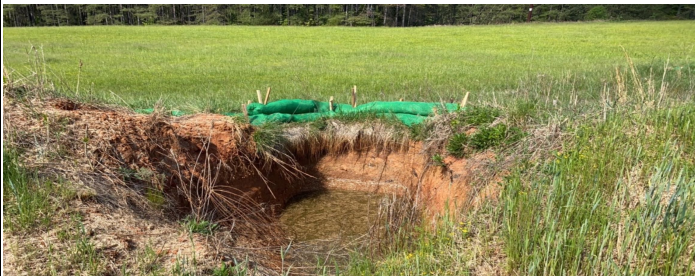
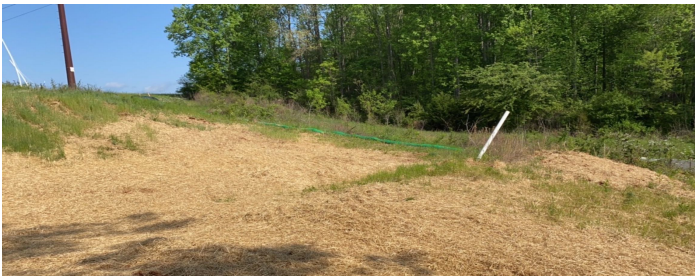
Field Station#	14587+00	Field Station#	14566+00		
Pic 3 Desc.	Sump pit and CFS end treatment performing intended functions.		Pic 4 Desc.	Water bar performing intended function. ROW stabilized and vegetated in temporary area.

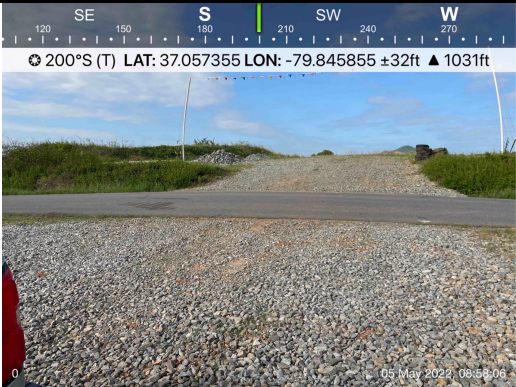
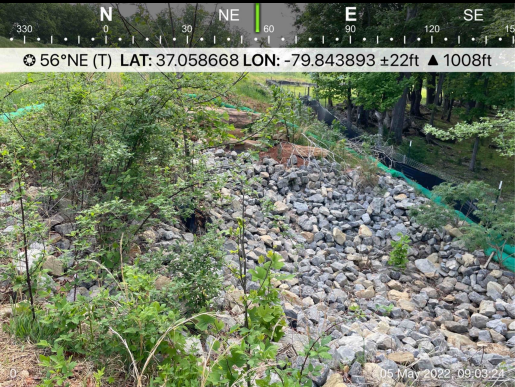
GPS Location	See photo		GPS Location	See photo	
Field Station#	14171+36		Field Station#	14180+00	
Pic 1 Desc.	RCEs are in good condition at all road crossings		Pic 2 Desc.	CWD is functioning as intended

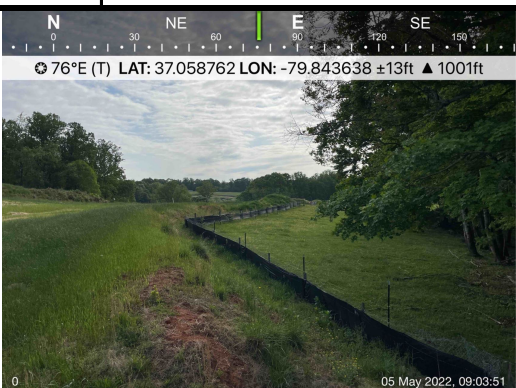
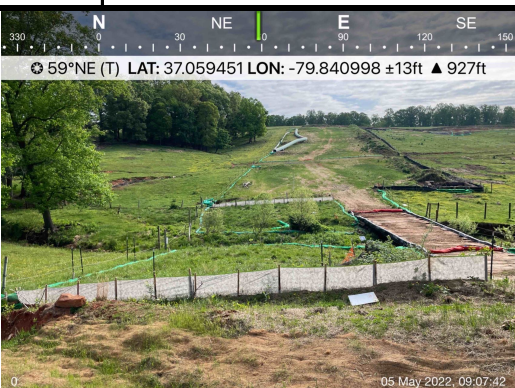
GPS Location	See photo		GPS Location	See photo	
Field Station#	14182+00		Field Station#	14190+00	
Pic 3 Desc.	SSF is in good condition		Pic 4 Desc.	P1 is in good condition at all stream and wetland buffers

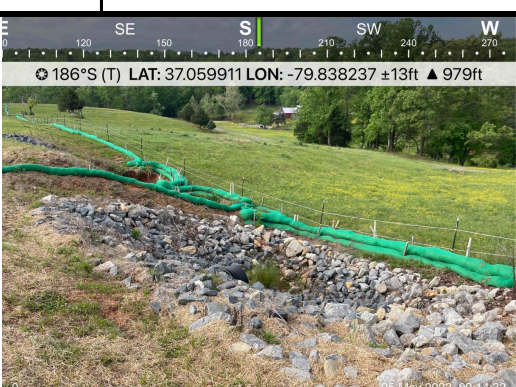
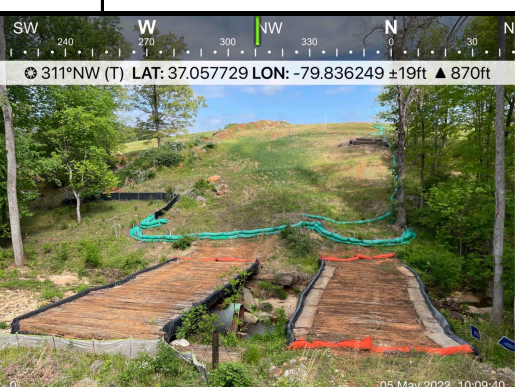
GPS Location	See photo		GPS Location	See photo	
Field Station#	14200+00		Field Station#	14209+00	
Pic 5 Desc.	CWD is functioning as intended		Pic 6 Desc.	Equipment bridge ECDs are in good condition

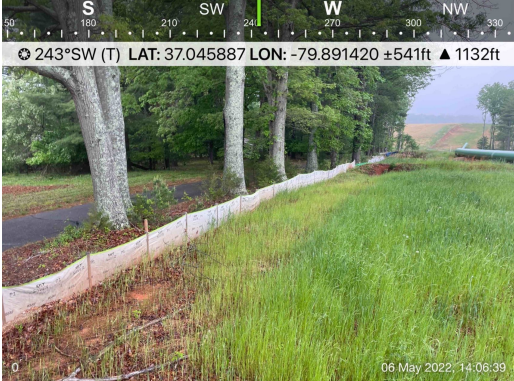
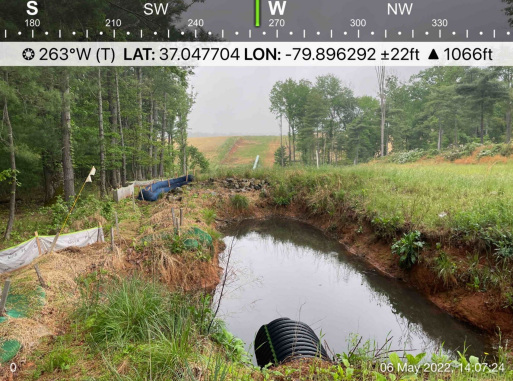
GPS Location	See photo		GPS Location	See photo	
Field Station#	13956+00		Field Station#	13955+00	
Pic 1 Desc.	Perimeter P1 is in good condition		Pic 2 Desc.	Slope drain is in good condition and functioning

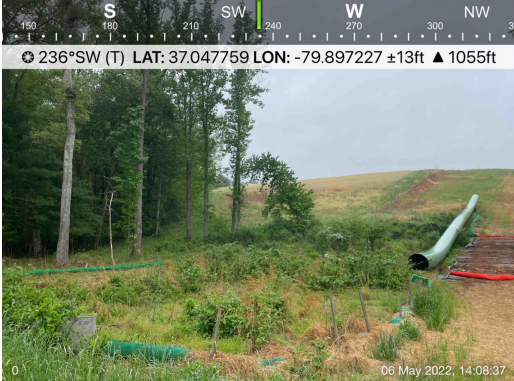
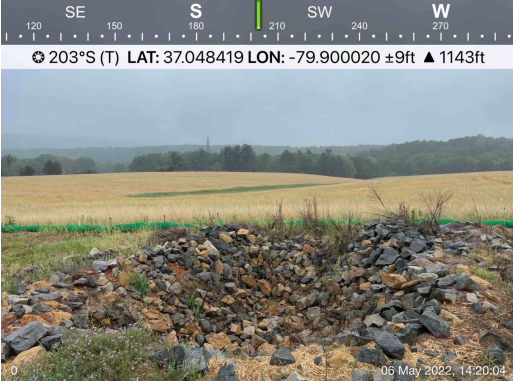
GPS Location	See photo		GPS Location	See photo	
Field Station#	13950+00		Field Station#	13942+00	
Pic 3 Desc.	Resource buffers remain well vegetated		Pic 4 Desc.	CWDs are functioning as intended

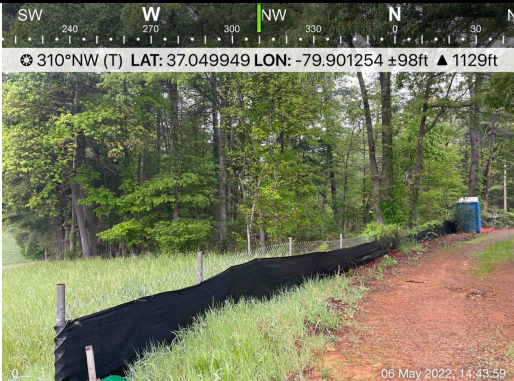
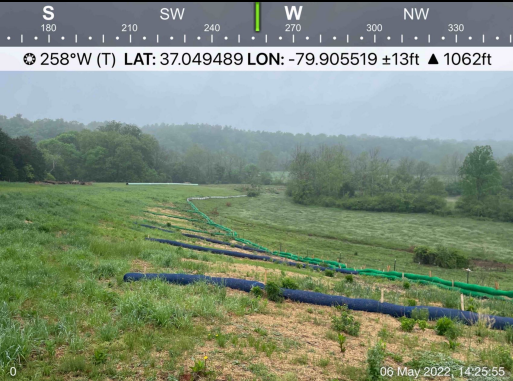
GPS Location	See photo		GPS Location	See photo	
Field Station#	13939+50		Field Station#	13924+00	
Pic 5 Desc.	SSF is in good condition		Pic 6 Desc.	CFS is in good condition throughout this section

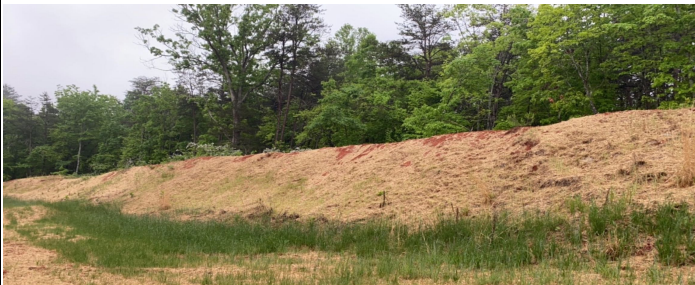
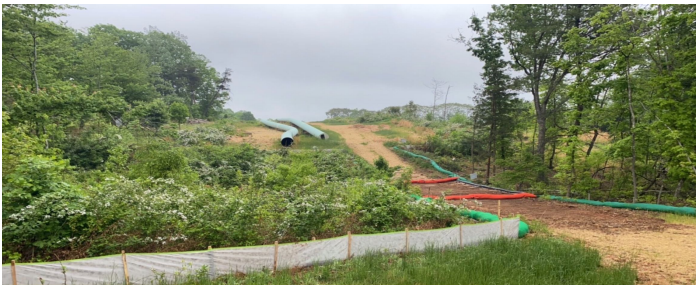
GPS Location	3		GPS Location	4	
Field Station#	14351+00		Field Station#	14338+56	
Pic 3 Desc.	Temporary diversion berm stabilized by contractor.		Pic 4 Desc.	Equipment bridge and surrounding ECDs in place and functional at stream crossing and resource buffer.

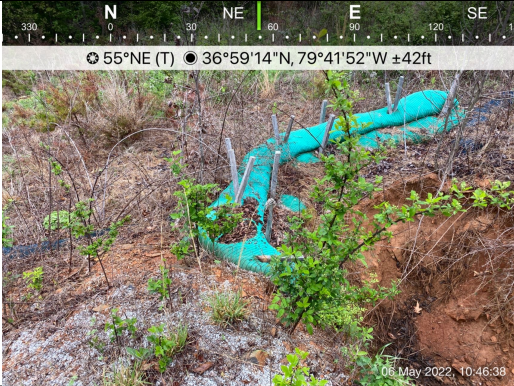
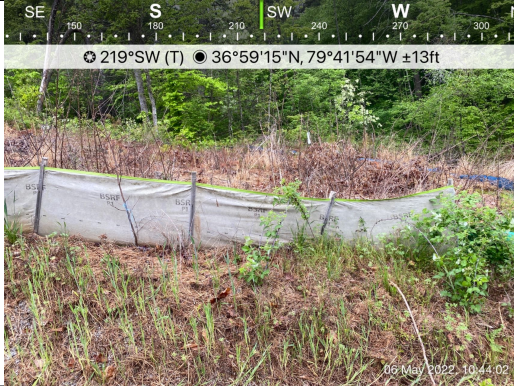
GPS Location	0	GPS Location	0		
Field Station#	14731+25	Field Station#	14729+50		
Pic 5 Desc.	Approximately 14731+25. CFS end treatment requires maintenance. Weathered, torn and damaged by wildlife.		Pic 6 Desc.	Approximately 14729+50. P-1 requires maintenance. Weathered and torn.
