# Visual Site Inspection Report

<b>Project Name</b>	H-600 Pipeline Spread G	<b>AFE</b>	124300137	<b>Spread</b>	H-600 Pipeline Spread G
<b>Contractor</b>	Precision			<b>Report #</b>	37925
<b>Inspector</b>	Rob Robertson			<b>Date/Time</b>	5/23/2022 10:59 AM
<b>Permit #</b>	TBD	<b>Inspection Type</b>	VA SWPP	<b>Station Begin</b>	11600+01
<b>State</b>	VA	<b>Inspection Area</b>	Full	<b>Station End</b>	11670+00
<b>County</b>	Montgomery	<b>Ground</b>	Wet	<b>Temperature (°F)</b>	65.00
<b>Municipality</b>	N/A	<b>Weather</b>	Light Rain	<b>Rain Gauge (in)</b>	0.10
				<b>Rain Accumulation Time (days)</b>	1.00

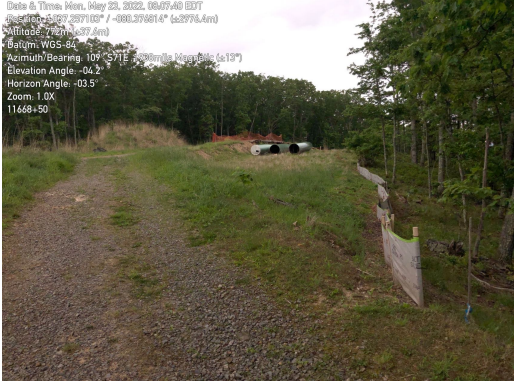
<b>GPS Location</b>	On photo	<b>GPS Location</b>	On photo		
<b>Field Station#</b>	11668+50	<b>Field Station#</b>	11663+00		
<b>Pic 1 Desc.</b>	Stable conditions at top of Brush Mountain.	<b>Pic 2 Desc.</b>	Slope breakers functional. ROW stable.

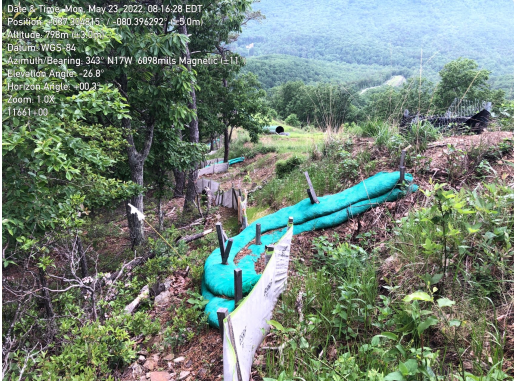
<b>GPS Location</b>	On photo	<b>GPS Location</b>	On photo		
<b>Field Station#</b>	11661+00	<b>Field Station#</b>	11645+00		
<b>Pic 3 Desc.</b>	ECDs in place.	<b>Pic 4 Desc.</b>	ECDs in place.

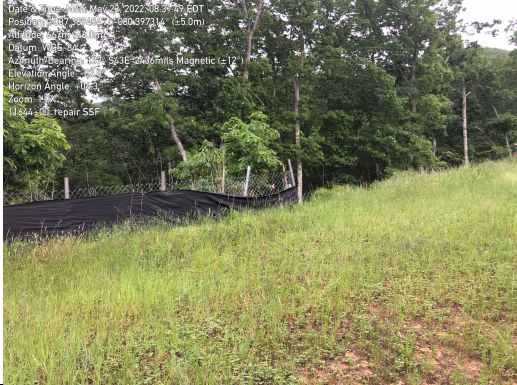
<p><small>Date &amp; Time: Mon, May 23, 2022, 08:57:39 EDT Position: -037.313576, 39.08049415 (±5.0m) Altitude: 582m (±4.0m) Datum: WGS-84 Azimuth/Bearing: 200° S20W 3956mils Magnetic (±12°) Elevation Angle: -35.1° Horizon Angle: +01.1° Zoom: 1.0X 11644+00 repair SSF</small></p>			
<b>GPS Location</b>	On photo	<b>GPS Location</b>	On photo		
<b>Field Station#</b>	11607+81	<b>Field Station#</b>	11644+00		
<b>Pic 7 Desc.</b>	The S-006 crossing is stable.	<b>Pic 8 Desc.</b>	COMMUNICATION; photo example of SSF repair requested.		
Insert image here		Insert image here

E&S BMPs	Compliance Level	Corrective Action	Corrective Time Frame	Date Repaired
Silt Fence (Reinforce Filter Fence)	Communication	Repair SSF 3 locations	48 Hours	
Cleanwater Diversion Berm	Acceptable			
Cleanwater Diversion Pipe	Acceptable			
Compost Filter Sock	Acceptable			
Plunge Pool	Acceptable			
Sensitive Resource Buffer	Acceptable			
Silt Fence (Filter Fabric Fence)	Acceptable			
Waterbar	Acceptable			
Waterbar End Treatment	Acceptable

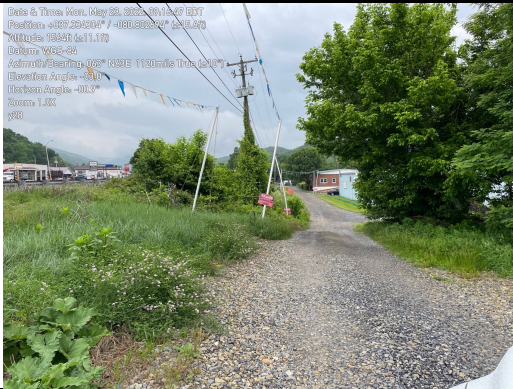
GPS Location	See photo		GPS Location	See photo	
Field Station#	12005+00		Field Station#	12005+00	
Pic 1 Desc.	Permanent stabilization in place y28		Pic 2 Desc.	CFS perimeter controls functional y28

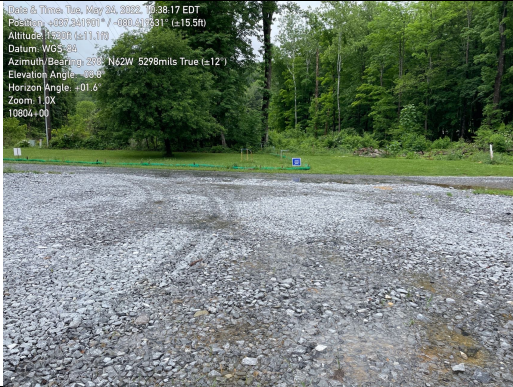
GPS Location		See photo		GPS Location		See photo
Field Station#		10804+00		Field Station#		10929+00
Pic 1 Desc.		RCE functional		Pic 2 Desc.		Equipment bridge functional

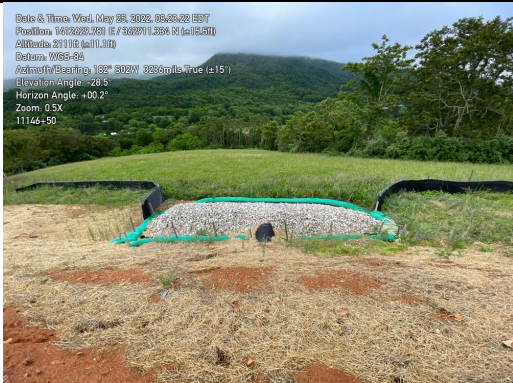
GPS Location 5		GPS Location 6			
Field Station# 11140+00		Field Station# 11146+50			
Pic 5 Desc. Section of restored RoW showing conditions and controls.		Pic 6 Desc. CWDP outlet protection functional.

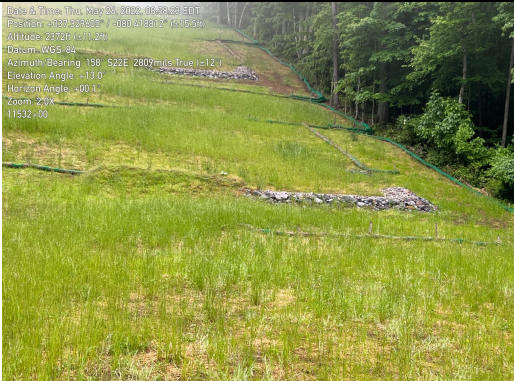
<b>GPS Location</b>	See Photo	<b>GPS Location</b>	See Photo		
<b>Field Station#</b>	11532+00	<b>Field Station#</b>	11582+00		
<b>Pic 3 Desc.</b>	Level spreader	<b>Pic 4 Desc.</b>	Section of ROW showing conditions

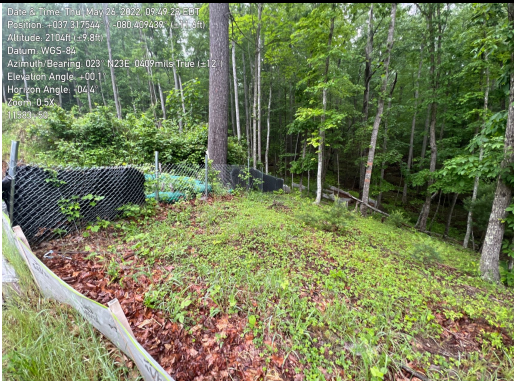
<b>GPS Location</b>	See Photo	<b>GPS Location</b>	See Photo		
<b>Field Station#</b>	11583+50	<b>Field Station#</b>	11584+00		
<b>Pic 5 Desc.</b>	P1 Silt Fence checks	<b>Pic 6 Desc.</b>	Water bar and Sump Pit

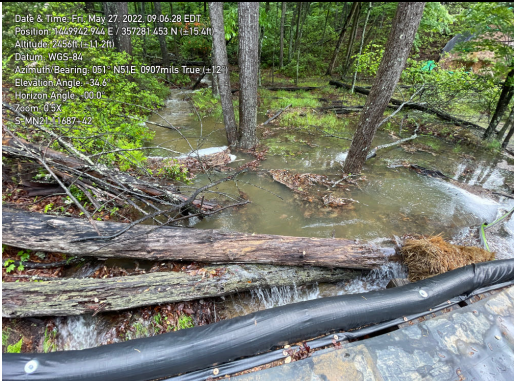
<b>GPS Location</b>	3	<b>GPS Location</b>	4		
<b>Field Station#</b>	11687+42	<b>Field Station#</b>	11704+10		
<b>Pic 3 Desc.</b>	Upstream S-MN21 dammed by naturally fallen trees and debris.	<b>Pic 4 Desc.</b>	S-MN22.

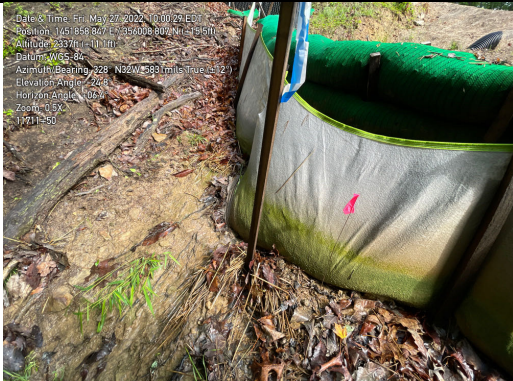
<b>GPS Location</b>	5	<b>GPS Location</b>	6		
<b>Field Station#</b>	11710+50	<b>Field Station#</b>	11711+50		
<b>Pic 5 Desc.</b>	Section of RoW showing conditions and controls.	<b>Pic 6 Desc.</b>	Undermined P-1.
