# Visual Site Inspection Report

<b>Project Name</b>	H-600 Pipeline Spread G	<b>AFE</b>	124300137	<b>Spread</b>	H-600 Pipeline Spread G
<b>Contractor</b>	Precision			<b>Report #</b>	38181
<b>Inspector</b>	David Schoolcraft			<b>Date/Time</b>	5/30/2022 1:03 PM
<b>Permit #</b>	TBD	<b>Inspection Type</b>	VA SWPP	<b>Station Begin</b>	10655+00
<b>State</b>	VA	<b>Inspection Area</b>	Full	<b>Station End</b>	10749+92
<b>County</b>	Giles	<b>Ground</b>	Damp	<b>Temperature (°F)</b>	85.00
<b>Municipality</b>	N/A	<b>Weather</b>	Sunny	<b>Rain Gauge (in)</b>	0.00
				<b>Rain Accumulation Time (days)</b>	1.00

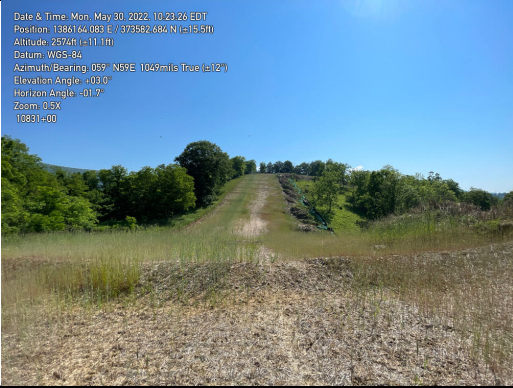
GPS Location				5				GPS Location				6			
Field Station#				10826+50				Field Station#				10831+00			
Pic 5 Desc.				CWDP outlet protection functional.				Pic 6 Desc.				Section of RoW showing conditions and controls.

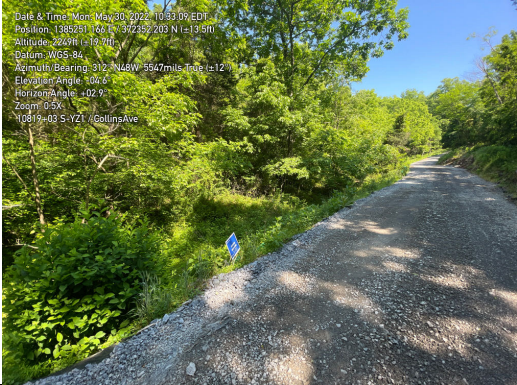
<b>GPS Location</b>	7	<b>GPS Location</b>	8		
<b>Field Station#</b>	10819+03	<b>Field Station#</b>	1087+50		
<b>Pic 7 Desc.</b>	S-YZ1/Collins Ave.	<b>Pic 8 Desc.</b>	Temporary repair on previously reported punch list item.

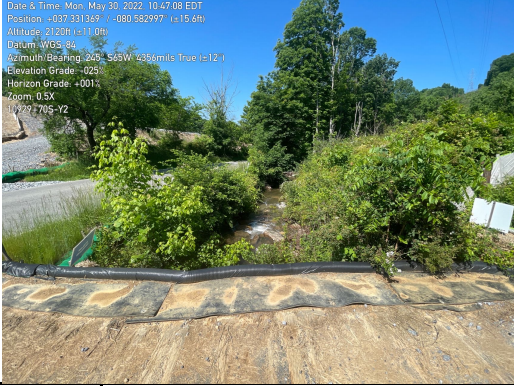
<b>GPS Location</b>	See Photo	<b>GPS Location</b>	See Photo		
<b>Field Station#</b>	10883+10	<b>Field Station#</b>	10926+45		
<b>Pic 3 Desc.</b>	Over view of the S-A32 stream resource conditions. All ECDs found functional		<b>Pic 4 Desc.</b>	Perimeter CFS and empty sump pit conditions.

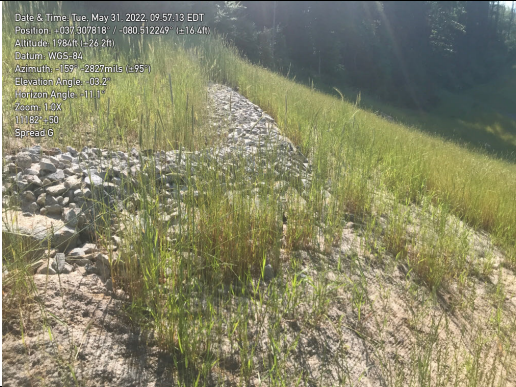
<b>GPS Location</b>	See photo		<b>GPS Location</b>	see photo	
<b>Field Station#</b>	11182+50		<b>Field Station#</b>	11174+00	
<b>Pic 1 Desc.</b>	Level spreader		<b>Pic 2 Desc.</b>	Water bar, level spreader

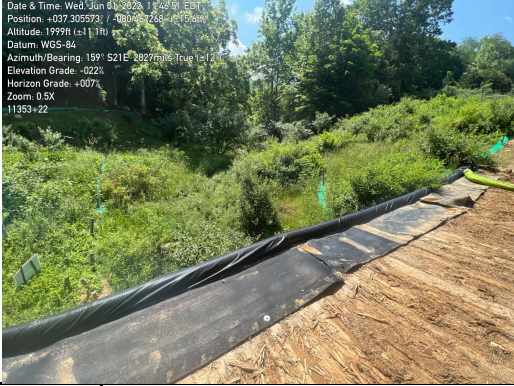
<b>GPS Location</b>	See photo		<b>GPS Location</b>	See photo	
<b>Field Station#</b>	11353+22		<b>Field Station#</b>	11346+00	
<b>Pic 1 Desc.</b>	S-NN11 Stream resource condition.		<b>Pic 2 Desc.</b>	Temporary stabilization

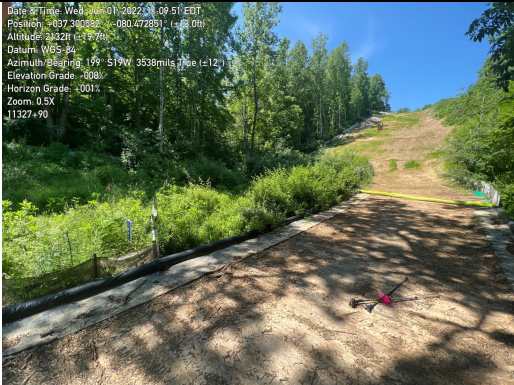
<b>GPS Location</b>	See photo		<b>GPS Location</b>	See photo	
<b>Field Station#</b>	11327+90		<b>Field Station#</b>	11313+59	
<b>Pic 3 Desc.</b>	S-NN12 Stream conditions		<b>Pic 4 Desc.</b>	Perimeter super silt fence and protected sump pit conditions.

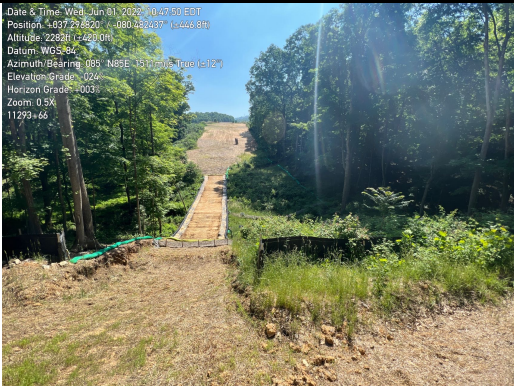
<b>GPS Location</b>	See photo		<b>GPS Location</b>	See photo	
<b>Field Station#</b>	11293+66		<b>Field Station#</b>	11285+20	
<b>Pic 5 Desc.</b>	Over view of the S-MM18		<b>Pic 6 Desc.</b>	Side slope CC4 stabilization.

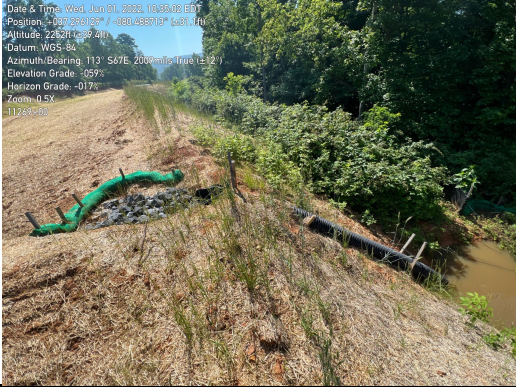
<b>GPS Location</b>	See photo	<b>GPS Location</b>	See photo		
<b>Field Station#</b>	11269+00	<b>Field Station#</b>	11265+00		
<b>Pic 7 Desc.</b>	Stone inlet protection and slope drain pipe conditions. All found functional.	<b>Pic 8 Desc.</b>	Continued temporary vegetation growth.

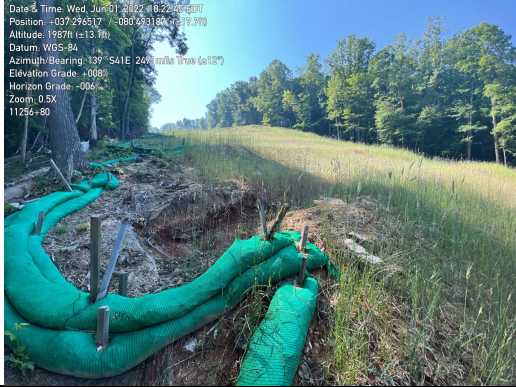
<b>GPS Location</b>	See photo	<b>GPS Location</b>			
<b>Field Station#</b>	11256+80	<b>Field Station#</b>			
<b>Pic 9 Desc.</b>	Steep slope temporary stabilization and perimeter CFS end treatment controls.	<b>Pic 10 Desc.</b>

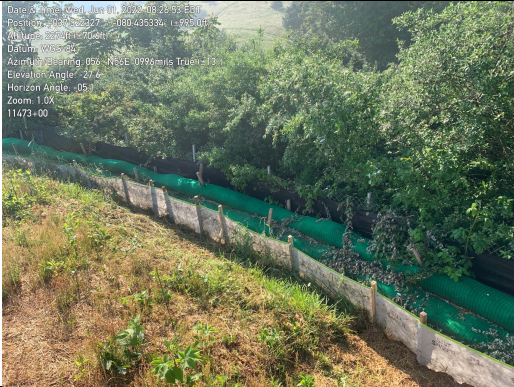
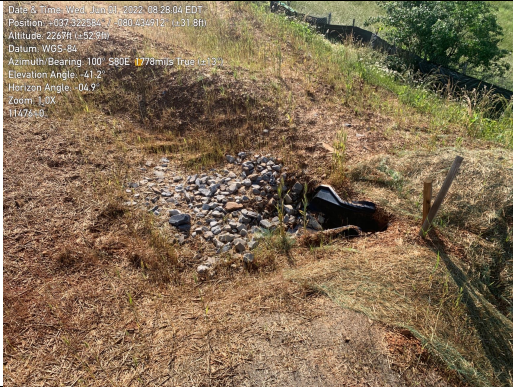
<b>GPS Location</b>	See photo for GPS location.		<b>GPS Location</b>	See photo for GPS location.	
<b>Field Station#</b>	11473+00		<b>Field Station#</b>	11476+00	
<b>Pic 1 Desc.</b>	Triple barrier ECDs in place at off ROW karst area.		<b>Pic 2 Desc.</b>	Rock inlet protection in place at slope drain.

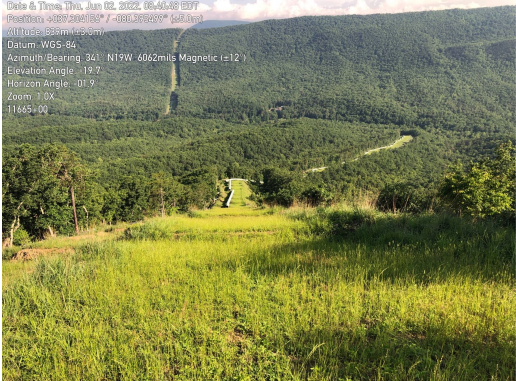
<b>GPS Location</b>	On photo	<b>GPS Location</b>	On photo		
<b>Field Station#</b>	11665+00	<b>Field Station#</b>	11660+00		
<b>Pic 1 Desc.</b>	Slope breakers functional. ROW surface stable.	<b>Pic 2 Desc.</b>	ECDs in place. ROW is currently stable.

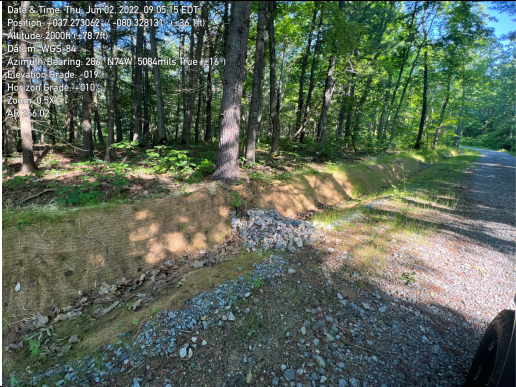
<b>GPS Location</b>	See photo	<b>GPS Location</b>	See photo		
<b>Field Station#</b>	11929+18	<b>Field Station#</b>	11973+00		
<b>Pic 1 Desc.</b>	AR 266.02 conditions.	<b>Pic 2 Desc.</b>	Heavily vegetated final restoration area.

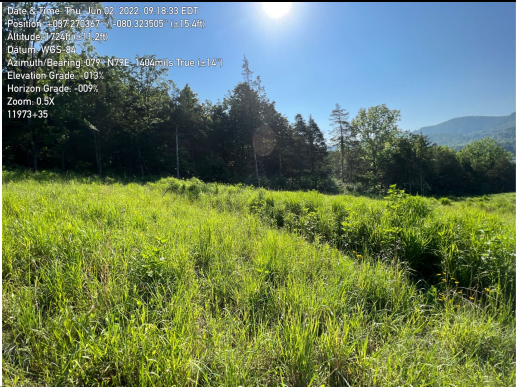
<b>GPS Location</b>	See photo	<b>GPS Location</b>	See photo		
<b>Field Station#</b>	11973+35	<b>Field Station#</b>	11978+86		
<b>Pic 3 Desc.</b>	Vegetated water bar conditions.	<b>Pic 4 Desc.</b>	Perimeter controls protecting the off LOD karst area.

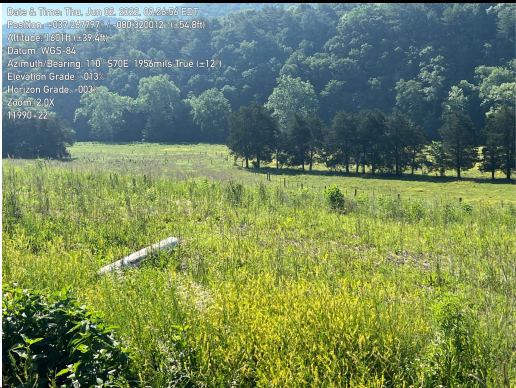
<b>GPS Location</b>	See photo	<b>GPS Location</b>	See photo		
<b>Field Station#</b>	11990+22	<b>Field Station#</b>	12000+00		
<b>Pic 5 Desc.</b>	Final restoration area	<b>Pic 6 Desc.</b>	Final restoration area.

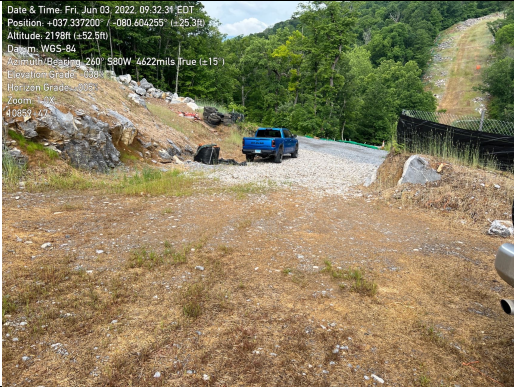
<b>GPS Location</b>	See photo	<b>GPS Location</b>	See photo		
<b>Field Station#</b>	10859+47	<b>Field Station#</b>	10861+00		
<b>Pic 1 Desc.</b>	RCE conditions	<b>Pic 2 Desc.</b>	Temporary vegetation through the travel lane.

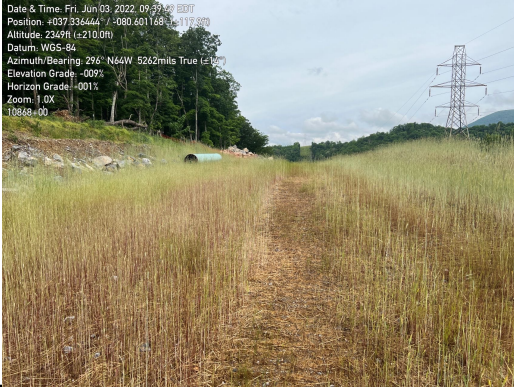
<b>GPS Location</b>	See photo	<b>GPS Location</b>	See photo		
<b>Field Station#</b>	10868+00	<b>Field Station#</b>	10880+00		
<b>Pic 3 Desc.</b>	Temporary stabilization of row	<b>Pic 4 Desc.</b>	Steep slope stabilization and current water bar conditions.

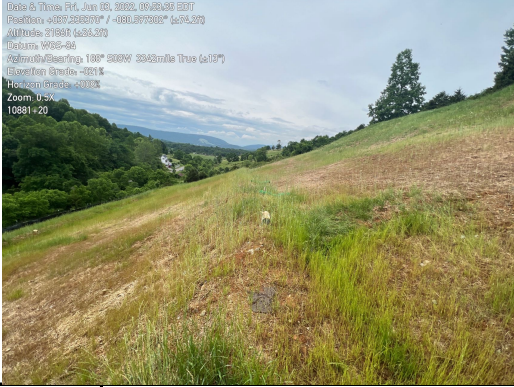
<b>GPS Location</b>	See photo	<b>GPS Location</b>	See photo		
<b>Field Station#</b>	10881+20	<b>Field Station#</b>	10883+10		
<b>Pic 5 Desc.</b>	Temporary vegetated water bar conditions.	<b>Pic 6 Desc.</b>	S-A32 Stream conditions.
