Visual Site Inspection Report

Project Name	H-600 Pipeline Spread G	AFE	124300137	Spread	H-600 Pipeline Spread G
Contractor	Precision			Report #	38691
Inspector	Jared Saunders			Date/Time	6/13/2022 3:33 PM
Permit #	TBD	Inspection Type	VA SWPP	Station Begin	11471+56
State	VA	Inspection Area	Partial	Station End	11524+16
County	Craig	Ground	Dry	Temperature (°F)	85.00
Municipality	N/A	Weather	Sunny	Rain Gauge (in)	0.00
				Rain Accumulation Time (days)	1.00

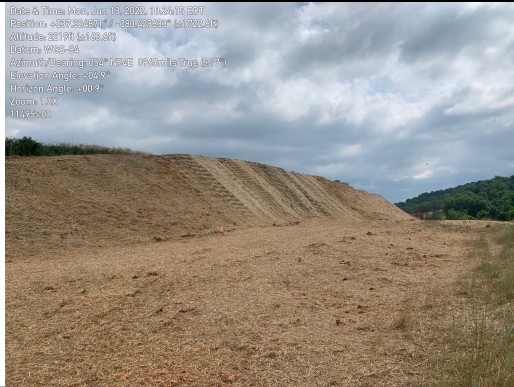
GPS Location	See photo for GPS location.		GPS Location	See photo for GPS location.		
Field Station#	11490+00		Field Station#	11495+00		
Pic 3 Desc.	RCE in place at Stevers Gap Road.		Pic 4 Desc.	Sloughing spoil pile repaired and stabilized with ECB.		
<div><div><div>Date & Time: Mon Jun 13 2022 10:29:12 EDT Position: +080.222029° / +400.428475° (+15.4m) Altitude: 2213ft (+15.4m) Datum: WGS-84 Azimuth/Bearing: 025° N25E 044mils True (+16°) Elevation Angle: -23.3° Horizon Angle: 101.1° Zoom: 1.0x 11503+00</div><div>

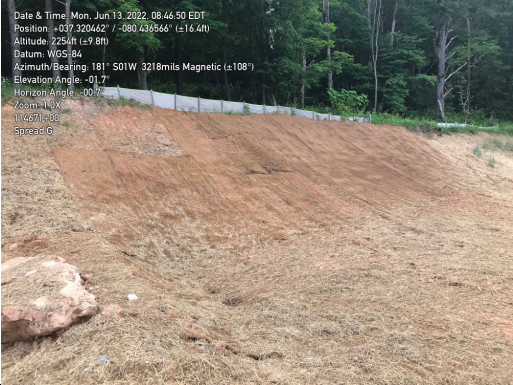
GPS Location				See photo				GPS Location				see photo			
Field Station#				11468+50				Field Station#				11471+00			
Pic 1 Desc.				S-CD 14				Pic 2 Desc.				Repaired slough

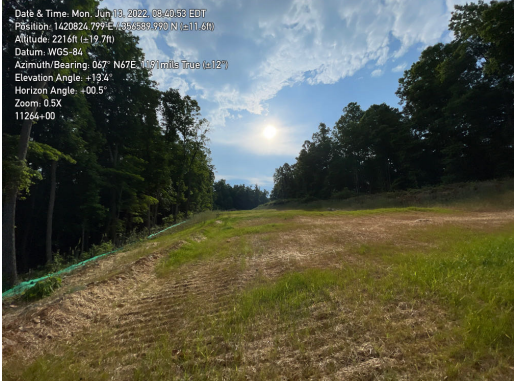
GPS Location	1	GPS Location	2		
Field Station#	11264+00	Field Station#	11271+00		
Pic 1 Desc.	Section of RoW showing conditions and controls.		Pic 2 Desc.	Plunge pool functional.

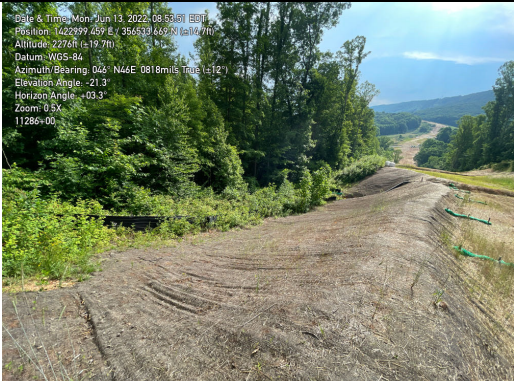
GPS Location	3	GPS Location	4		
Field Station#	11286+00	Field Station#	11292+80		
Pic 3 Desc.	Perimeter controls functional.		Pic 4 Desc.	S-MM18.

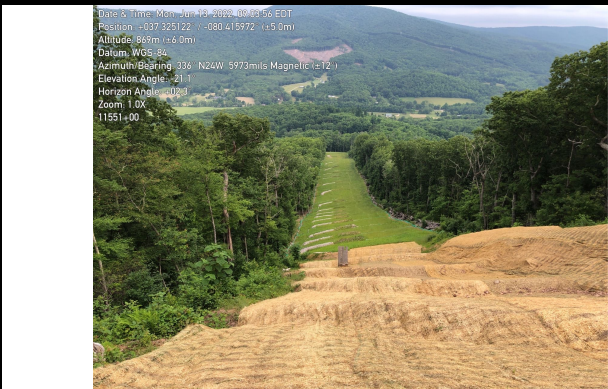
<p>Date & Time: Mon, Jun 13, 2022, 08:49:52 EDT Position: +037.32912° / -080.41572° (±5.0m) Altitude: 869m (±6.0m) Datum: WGS 84 Azimuth/Bearing: 136° N24W 5973mils Magnetic (±12°) Elevation Angle: -21.1° Horizon Angle: -00.4° Zoom: 1.0X 11551+00</p>		
GPS Location	On photo		GPS Location	On photo	
Field Station#	11547+50		Field Station#	11551+00	
Pic 1 Desc.	COMMUNICATION. Unused materials to be removed from ROW.		Pic 2 Desc.	COMMUNICATION. Erosion blanket improperly installed.

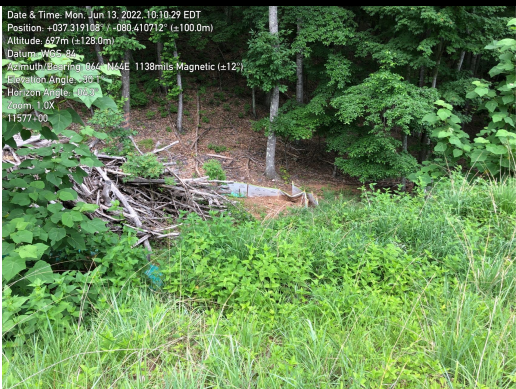
GPS Location	On photo		GPS Location	On photo	
Field Station#	11577+00		Field Station#	11583+00	
Pic 3 Desc.	COMMUNICATION. Replace worn P1. Add additional run of silt fence for added protection.		Pic 4 Desc.	COMMUNICATION. Replace worn P1 upslope of S-PP21.

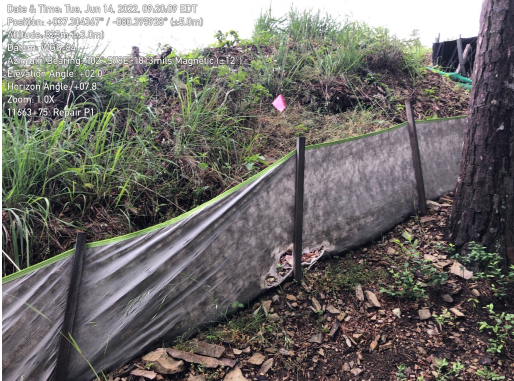
GPS Location	On photo	GPS Location	On photo		
Field Station#	11663+75	Field Station#	11660+00		
Pic 3 Desc.	COMMUNICATION. Replace worn P1.	Pic 4 Desc.	ECDs in place and functional.

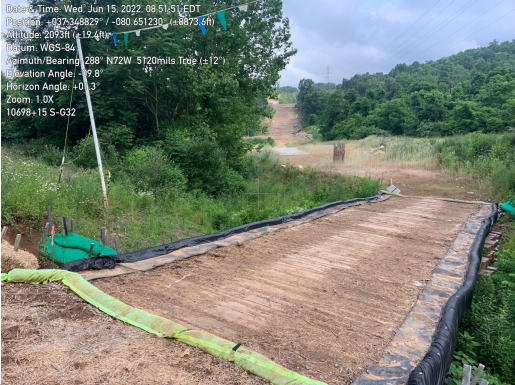
GPS Location	See photo	GPS Location	See photo		
Field Station#	10689+92	Field Station#	10698+15		
Pic 3 Desc.	Clean water diversion pipe and level spreader are in acceptable condition	Pic 4 Desc.	Section of Row showing conditions and controls at S-G32		
<p>Date & Time: Wed Jun 15, 2022 08:42:39 EDT Position: -037.346893 / -080.644589 (+217.4ft) Altitude: 2311ft (+87.9ft) Datum: WGS-84 Azimuth/Bearing: 284° N74°W 5084ftmils True (+12°) Elevation Angle: +25.9° Horizon Angle: +00.3° Zoom: 1.0X 10704+30</p>

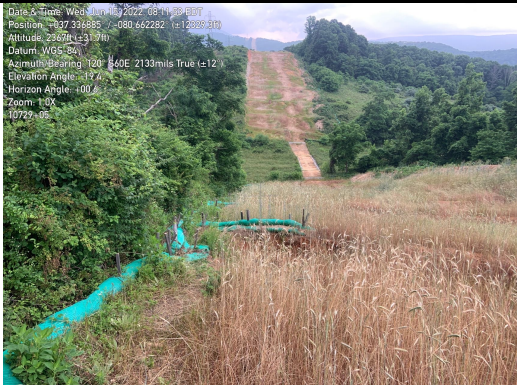
GPS Location	See photo	GPS Location	See photo		
Field Station#	10715+50	Field Station#	10729+05		
Pic 11 Desc.	Sump pit, CFS and SSF are in acceptable condition	Pic 12 Desc.	Section of Row showing conditions and controls
