# Visual Site Inspection Report

<b>Project Name</b>	H-600 Pipeline Spread G	<b>AFE</b>	124300137	<b>Spread</b>	H-600 Pipeline Spread G
<b>Contractor</b>	Precision			<b>Report #</b>	38453
<b>Inspector</b>	Patrick Shields			<b>Date/Time</b>	6/6/2022 3:46 PM
<b>Permit #</b>	TBD	<b>Inspection Type</b>	VA SWPP	<b>Station Begin</b>	11023+80
<b>State</b>	VA	<b>Inspection Area</b>	Full	<b>Station End</b>	11098+47
<b>County</b>	Giles	<b>Ground</b>	Dry	<b>Temperature (°F)</b>	72.00
<b>Municipality</b>	N/A	<b>Weather</b>	Sunny	<b>Rain Gauge (in)</b>	0.00
				<b>Rain Accumulation Time (days)</b>	1.00

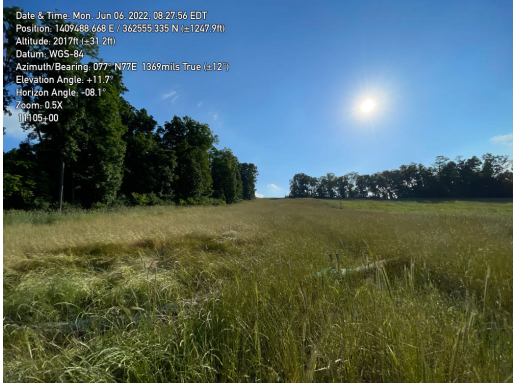
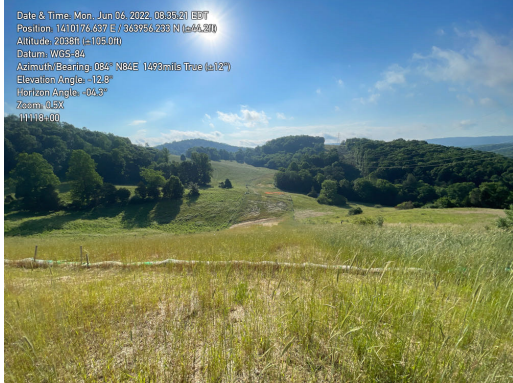
GPS Location				1				GPS Location				2			
Field Station#				11105+00				Field Station#				11118+00			
Pic 1 Desc.				Section of restored RoW showing conditions and controls.				Pic 2 Desc.				Section of restored RoW showing conditions and controls.

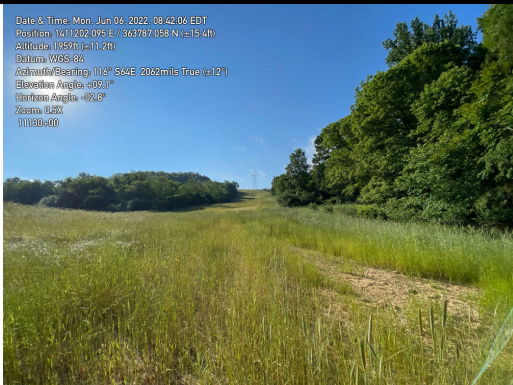
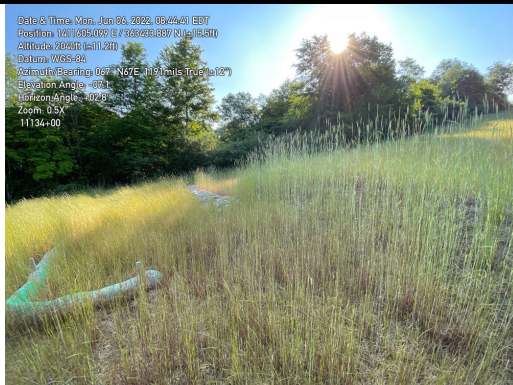
GPS Location				3				GPS Location				4			
Field Station#				11130+00				Field Station#				11134+00			
Pic 3 Desc.				Section of restored RoW showing conditions and controls.				Pic 4 Desc.				Representative photo of permanent waterbar and level spreaders installed.

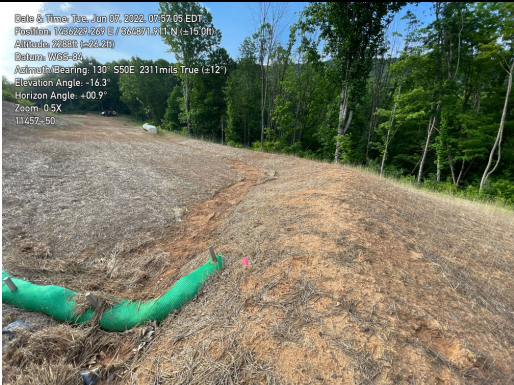
<b>GPS Location</b>	3	<b>GPS Location</b>	4		
<b>Field Station#</b>	11457+50	<b>Field Station#</b>	11455+50		
<b>Pic 3 Desc.</b>	Repair waterbar throat and stabilize.		<b>Pic 4 Desc.</b>	Clean out CFS.

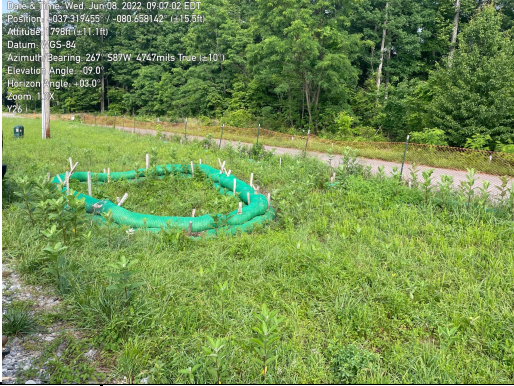
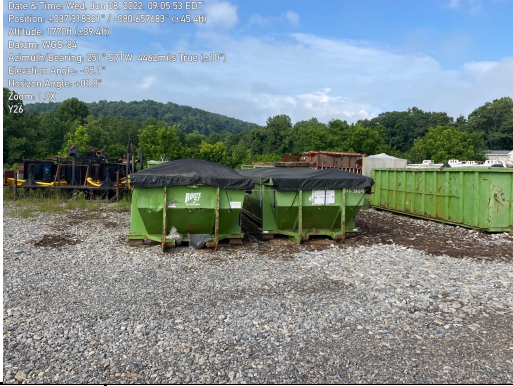
<b>GPS Location</b>	See photo	<b>GPS Location</b>	See photo		
<b>Field Station#</b>	12005+00	<b>Field Station#</b>	12005+00		
<b>Pic 1 Desc.</b>	CFS in place y26	<b>Pic 2 Desc.</b>	Housekeeping trash in good condition y26

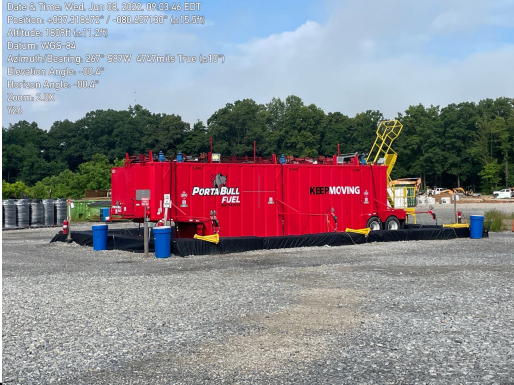
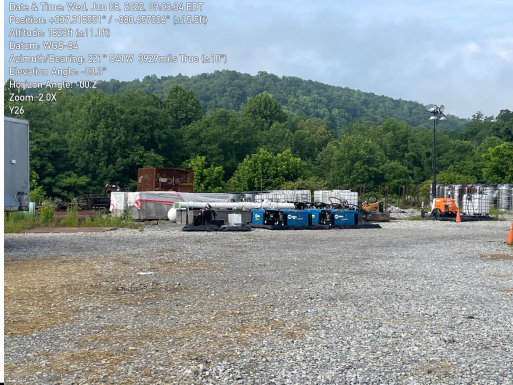
<b>GPS Location</b>	See photo	<b>GPS Location</b>	See photo		
<b>Field Station#</b>	12005+00	<b>Field Station#</b>	12005+00		
<b>Pic 3 Desc.</b>	Secondary containment in place y26	<b>Pic 4 Desc.</b>	Secondary containment in place y26

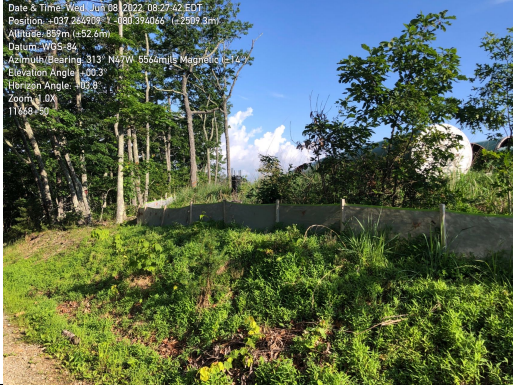
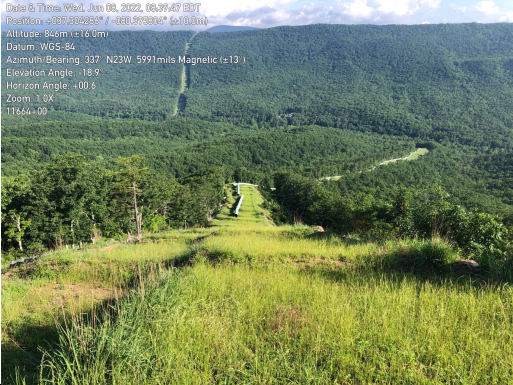
GPS Location		On photo				GPS Location		On photo			
Field Station#		11668+50				Field Station#		11664+00			
Pic 1 Desc.		Perimeter ECDs are in place, effective.				Pic 2 Desc.		Slope breakers functional and surface stable.

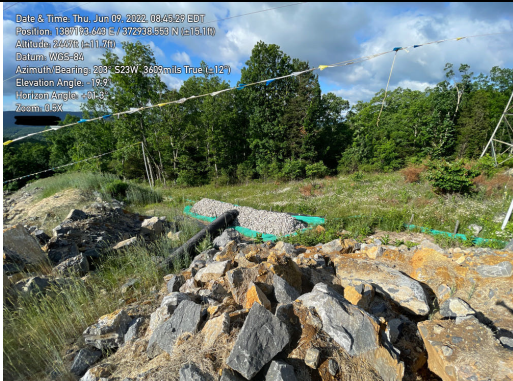
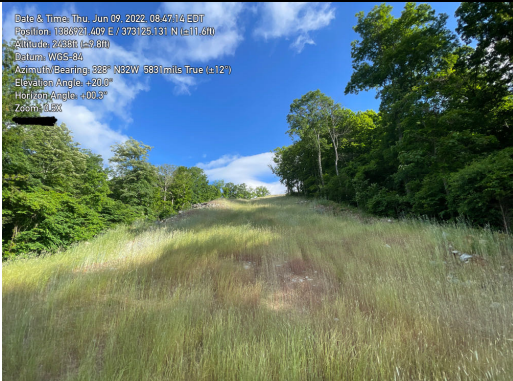
GPS Location	3	GPS Location	4		
Field Station#	10847+00	Field Station#	10843+00		
Pic 3 Desc.	CWDP outlet protection functional.	Pic 4 Desc.	Section of RoW showing conditions and controls.

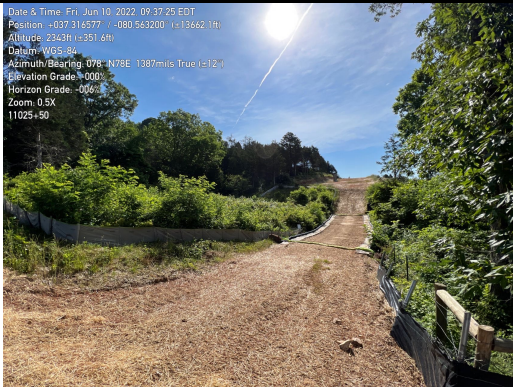
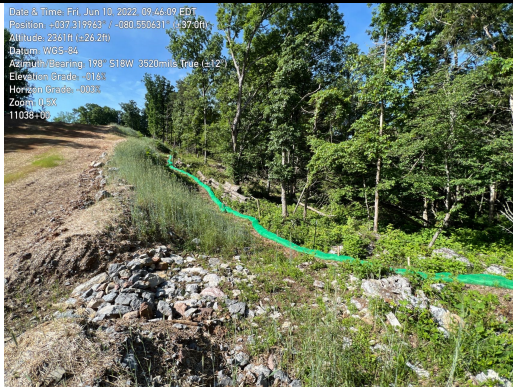
GPS Location		See photo						GPS Location		See photo	
Field Station#		11025+50						Field Station#		11038+00	
Pic 1 Desc.		Stream buffer in place						Pic 2 Desc.		CFS perimeter control in place
