# Visual Site Inspection Report

<b>Project Name</b>	H-600 Pipeline Spread H	<b>AFE</b>	124300138	<b>Spread</b>	H-600 Pipeline Spread H
<b>Contractor</b>	Precision			<b>Report #</b>	37712
<b>Inspector</b>	Jordan Davis			<b>Date/Time</b>	5/16/2022 3:28 PM
<b>Permit #</b>	TBD	<b>Inspection Type</b>	VA SWPP	<b>Station Begin</b>	12119+17
<b>State</b>	VA	<b>Inspection Area</b>	Partial	<b>Station End</b>	12284+75
<b>County</b>	Montgomery	<b>Ground</b>	Damp	<b>Temperature (°F)</b>	75.00
<b>Municipality</b>	N/A	<b>Weather</b>	Cloudy	<b>Rain Gauge (in)</b>	0.30
				<b>Rain Accumulation Time (days)</b>	2.00

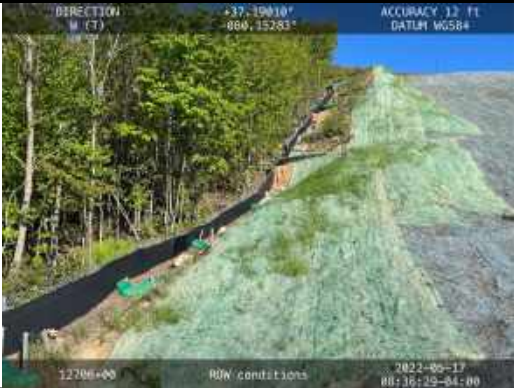
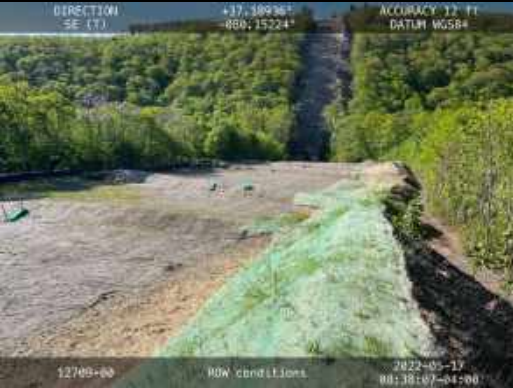
<b>Field Station#</b>	12706+00		<b>Field Station#</b>	12709+00	
<b>Pic 5 Desc.</b>	Photo shows the ROW condition. ECDs are installed and functioning as designed.		<b>Pic 6 Desc.</b>	Photo shows the ROW condition. ECDs are installed and functioning as designed.

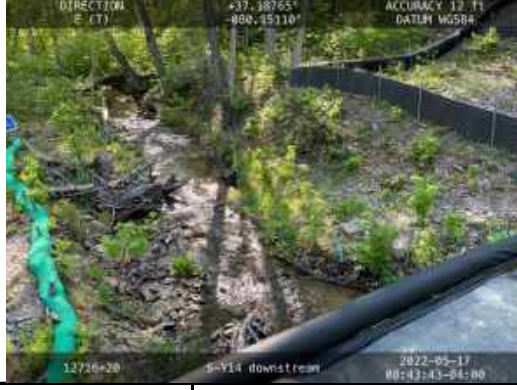
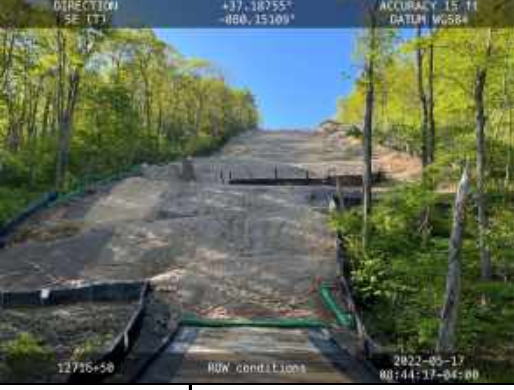
<b>Pic 11 Desc.</b>	Photo shows S-Y14 downstream from the bridge.		<b>Pic 12 Desc.</b>	Photo shows the ROW condition. ECDs are installed and functioning as designed.

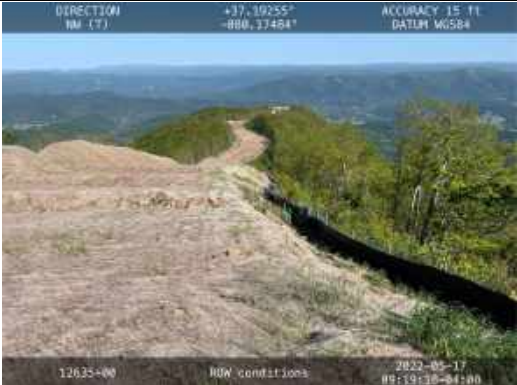
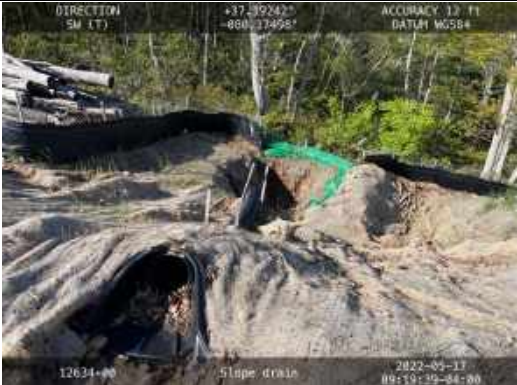
<b>Field Station#</b>	12635+00		<b>Field Station#</b>	12634+00	
<b>Pic 17 Desc.</b>	Photo shows the ROW condition. ECDs are installed and functioning as designed.		<b>Pic 18 Desc.</b>	Photo shows the slope drain.

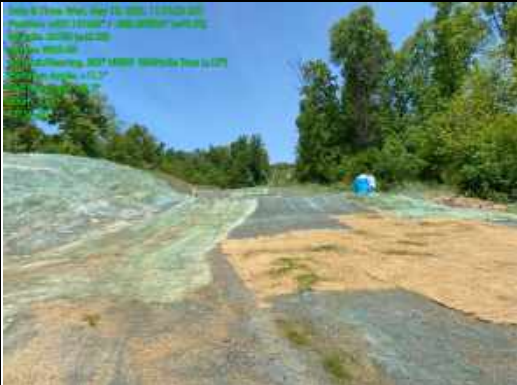
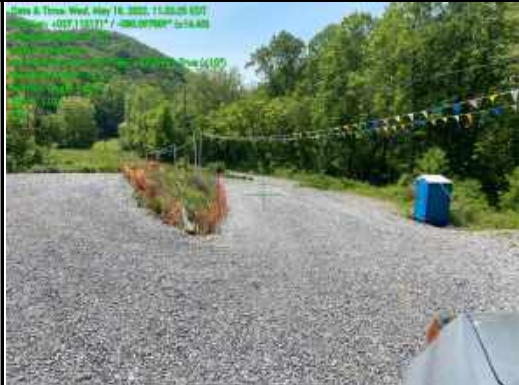
GPS Location	See pic for GPS location.		GPS Location	See pic for GPS location.	
Field Station#	13116+00		Field Station#	13115+97	
Pic 13 Desc.	Current ROW conditions.		Pic 14 Desc.	ATWS at FR-291 and Callaway Road.

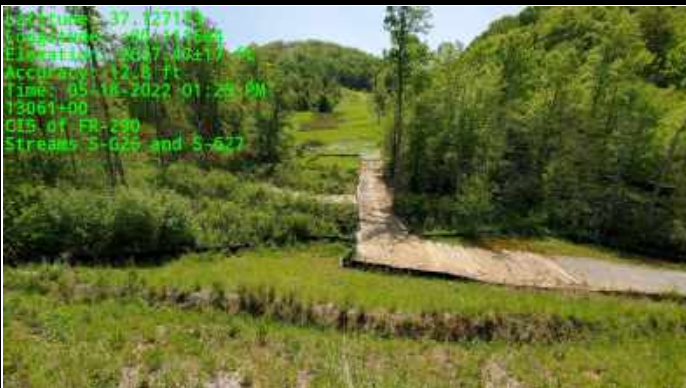
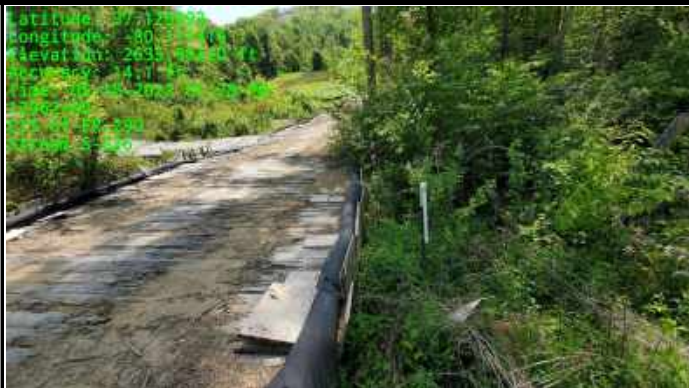
GPS Location	See pic for GPS location.		GPS Location	See pic for GPS location.	
Field Station#	13061+00		Field Station#	13062+00	
Pic 15 Desc.	Current ROW conditions.		Pic 16 Desc.	Downstream side of stream S-G26.

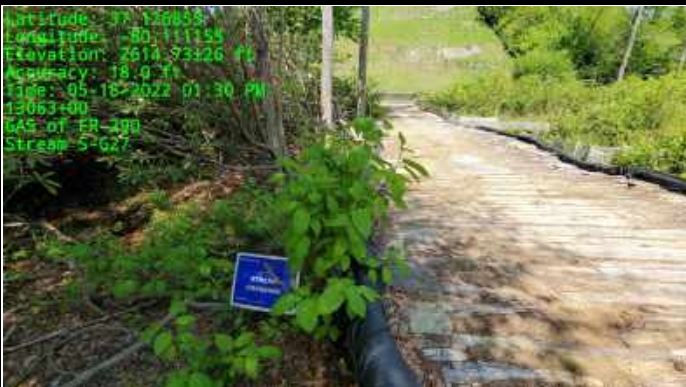
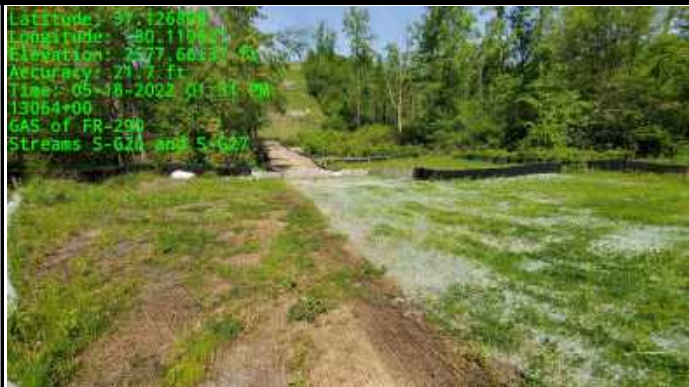
GPS Location	See pic for GPS location.		GPS Location	See pic for GPS location.	
Field Station#	13063+00		Field Station#	13064+00	
Pic 17 Desc.	Downstream side of stream S-G27.		Pic 18 Desc.	Streams S-G26 and S-G27 from the GAS.

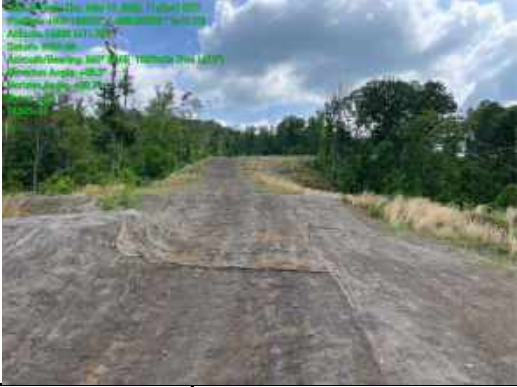
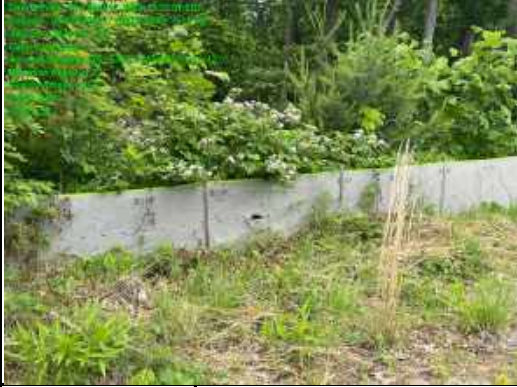
<b>Pic 17 Desc.</b>	Damage noted in silt fence perimeter control; added to the Punch List for maintenance.		<b>Pic 18 Desc.</b>
