# Visual Site Inspection Report

<b>Project Name</b>	H-600 Pipeline Spread H	<b>AFE</b>	124300138	<b>Spread</b>	H-600 Pipeline Spread H
<b>Contractor</b>	Precision	<b>Report #</b>	38425		
<b>Inspector</b>	Pat Davis	<b>Date/Time</b>	6/6/2022 4:00 PM		
<b>Permit #</b>	TBD	<b>Inspection Type</b>	VA SWPP	<b>Station Begin</b>	+0
<b>State</b>	VA	<b>Inspection Area</b>	Partial	<b>Station End</b>	+0
<b>County</b>	Montgomery	<b>Ground</b>	Dry	<b>Temperature (°F)</b>	65.00
<b>Municipality</b>	N/A	<b>Weather</b>	Sunny	<b>Rain Gauge (in)</b>	0.00
				<b>Rain Accumulation Time (days)</b>	0.00

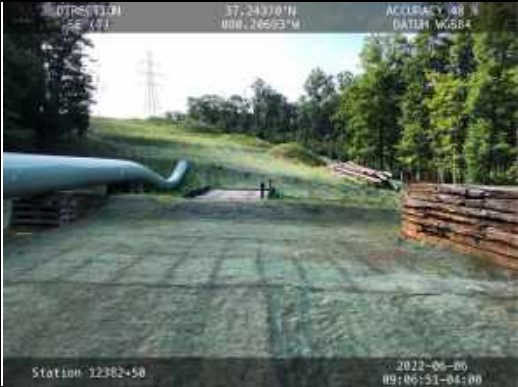
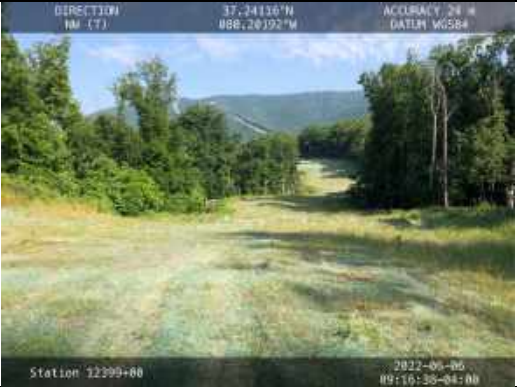
<b>GPS Location</b>	Please see photo for details.		<b>GPS Location</b>	Please see photo for details.	
<b>Field Station#</b>	12382+50		<b>Field Station#</b>	12399+00	
<b>Pic 13 Desc.</b>	Photo shows the stabilized ROW conditions with waterbars and that all ECDs are installed and are functioning as designed.		<b>Pic 14 Desc.</b>	Photo shows the stabilized ROW conditions with waterbars and that all ECDs are installed and are functioning as designed.

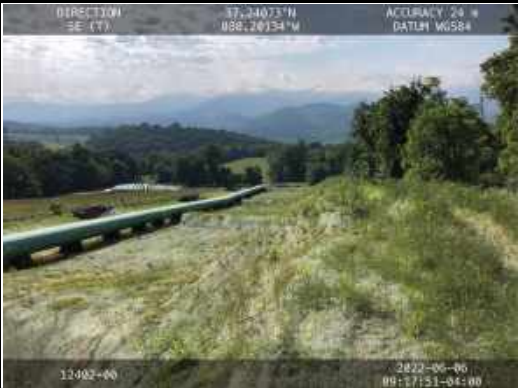
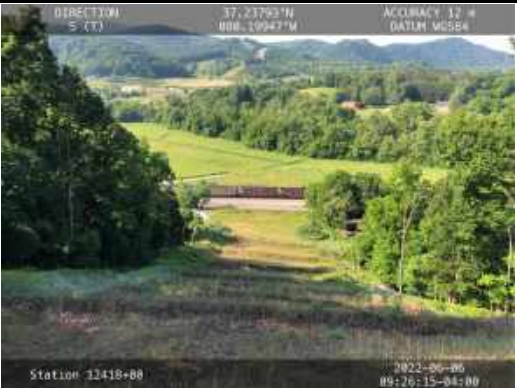
<b>GPS Location</b>	Please see photo for details.		<b>GPS Location</b>	Please see photo for details.	
<b>Field Station#</b>	12402+00		<b>Field Station#</b>	12418+00	
<b>Pic 15 Desc.</b>	Photo shows the stabilized ROW conditions with waterbars and that all ECDs are installed and are functioning as designed.		<b>Pic 16 Desc.</b>	Photo shows the stabilized ROW conditions with waterbars and that all ECDs are installed and are functioning as designed.

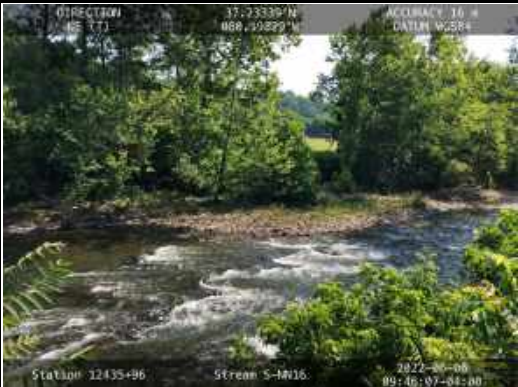
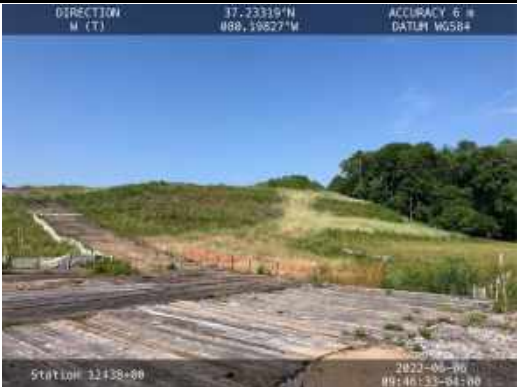
<b>GPS Location</b>	Please see photo for details.		<b>GPS Location</b>	Please see photo for details.	
<b>Field Station#</b>	12435+96		<b>Field Station#</b>	12438+00	
<b>Pic 17 Desc.</b>	Photo shows overview of Stream S-NN16 from the going away side.		<b>Pic 18 Desc.</b>	Photo shows the stabilized ROW conditions with waterbars and that all ECDs are installed and are functioning as designed.

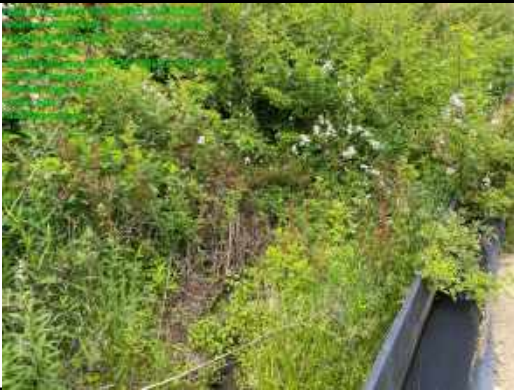
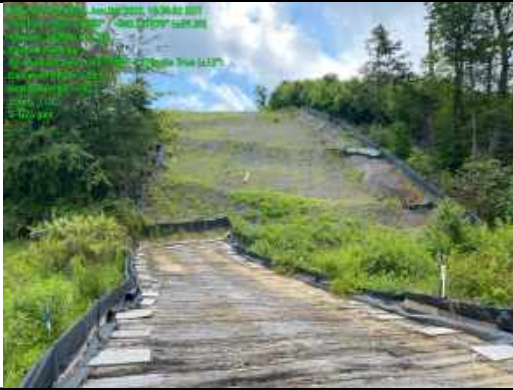
<b>GPS Location</b>	See photo for coordinates.		<b>GPS Location</b>	See photo for coordinates.	
<b>Field Station#</b>	13024+06		<b>Field Station#</b>	13024+06	
<b>Pic 5 Desc.</b>	S-G25, downstream, no flow noted, channel substrate saturated.		<b>Pic 6 Desc.</b>	Going away side of S-G25, right of way stabilized.

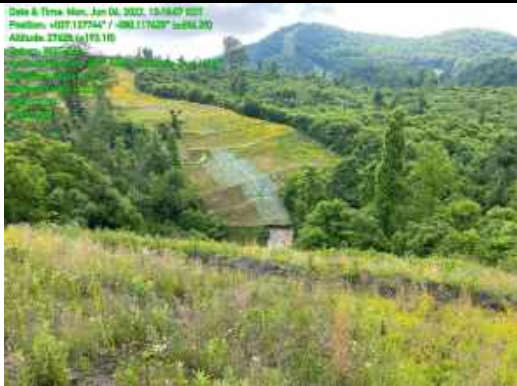
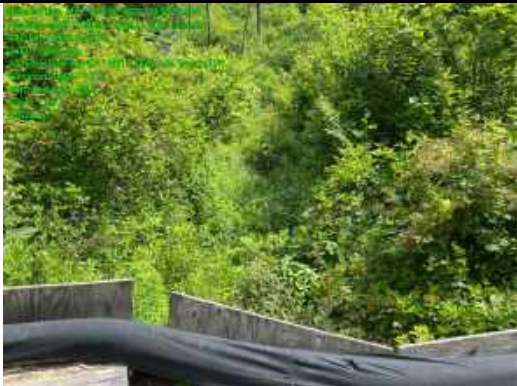
<b>GPS Location</b>	See photo for coordinates.		<b>GPS Location</b>	See photo for coordinates.	
<b>Field Station#</b>	13040+00		<b>Field Station#</b>	13061+89	
<b>Pic 9 Desc.</b>	S-H1, right of way stabilized.		<b>Pic 10 Desc.</b>	S-G26, upstream, no turbidity noted.

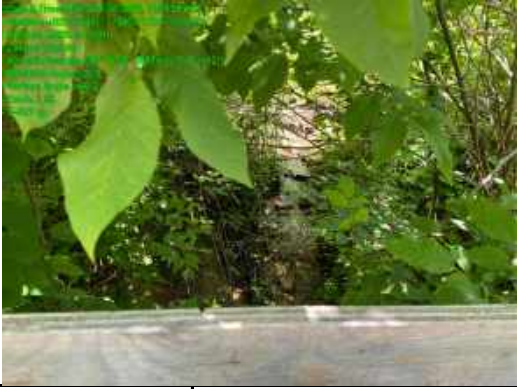
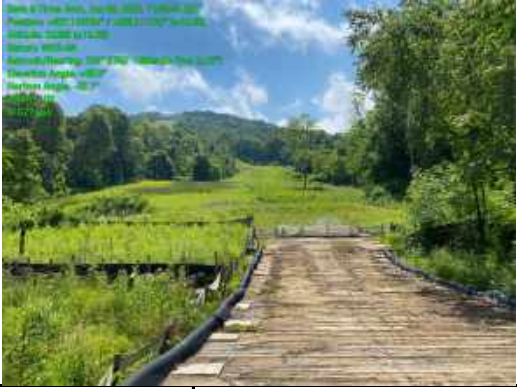
<b>GPS Location</b>	See photo for coordinates.		<b>GPS Location</b>	See photo for coordinates.	
<b>Field Station#</b>	13062+96		<b>Field Station#</b>	13062+96	
<b>Pic 13 Desc.</b>	S-G27, upstream, no turbidity noted.		<b>Pic 14 Desc.</b>	Right of way well vegetated, ECDs in acceptable condition.

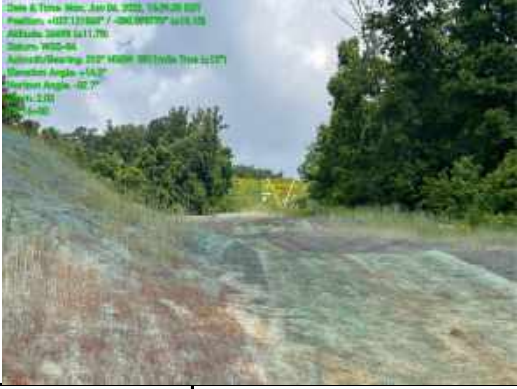
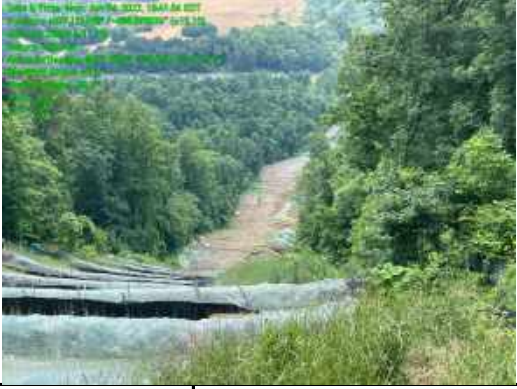
<b>GPS Location</b>	See photo for coordinates.		<b>GPS Location</b>	See photo for coordinates.	
<b>Field Station#</b>	13116+00		<b>Field Station#</b>	13119+00	
<b>Pic 15 Desc.</b>	Right of way stabilized, vegetation establishing.		<b>Pic 16 Desc.</b>	Right of way stabilized, vegetation establishing.

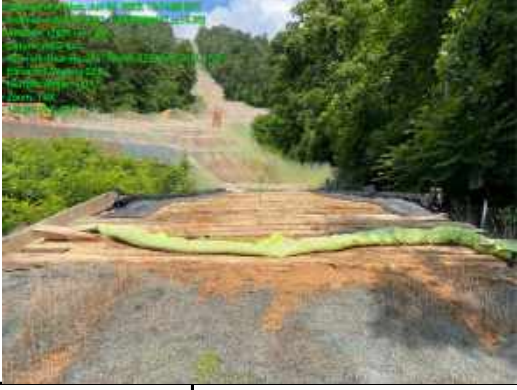
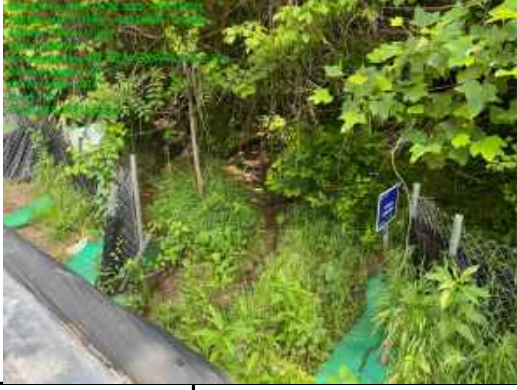
<b>GPS Location</b>	See photo for coordinates.		<b>GPS Location</b>	See photo for coordinates.	
<b>Field Station#</b>	13137+78		<b>Field Station#</b>	13137+78	
<b>Pic 17 Desc.</b>	S-D17/14, equipment bridge in acceptable condition, right of way stabilized.		<b>Pic 18 Desc.</b>	S-D17/14, upstream, no turbidity noted.

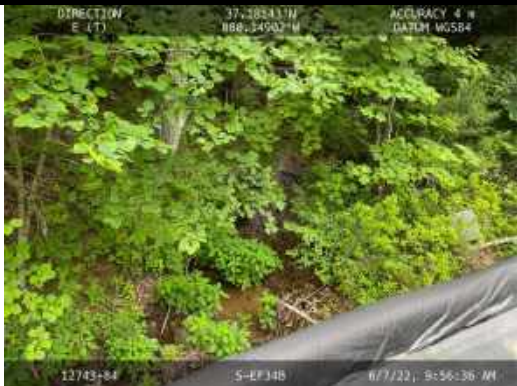
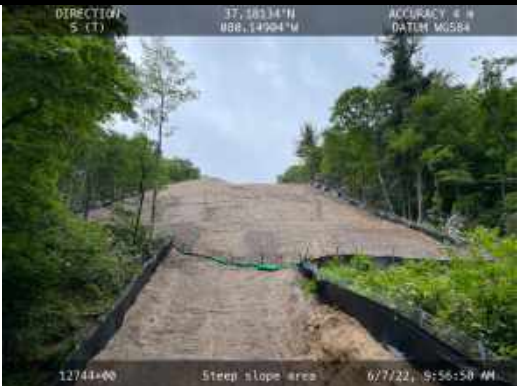
<b>GPS Location</b>	See photo		<b>GPS Location</b>	See photo	
<b>Field Station#</b>	12743+84		<b>Field Station#</b>	12744+00	
<b>Pic 9 Desc.</b>	Downstream of crossing at Stream S-EF34B		<b>Pic 10 Desc.</b>	Current ROW conditions. ROW is stable and ECDs are functional.

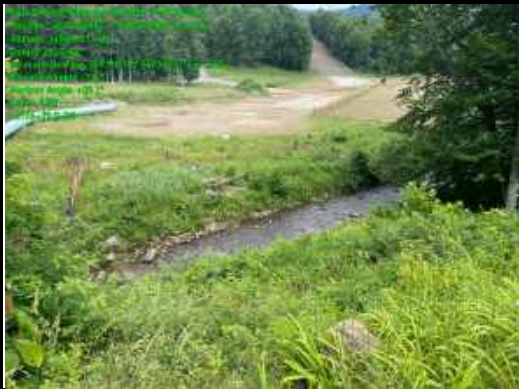
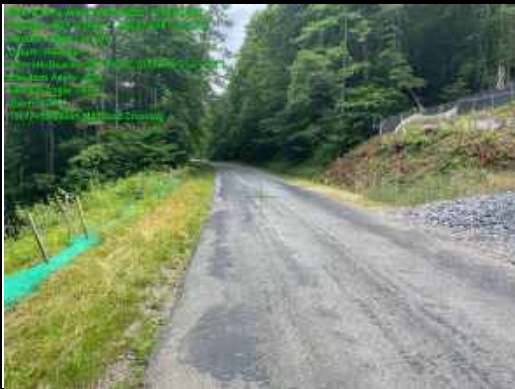
GPS Location		0		GPS Location		0		GPS Location		0					
Field Station#		13196+79		Field Station#		13197+55		Field Station#		13197+55					
Pic 13 Desc.		MVP-S-D8 and corresponding buffer zone in good condition				Pic 14 Desc.		Dillion Mill Road Crossing in good condition

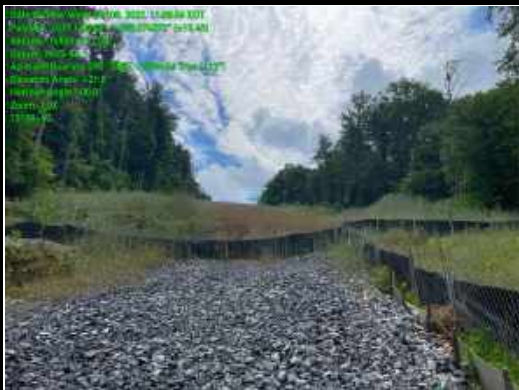
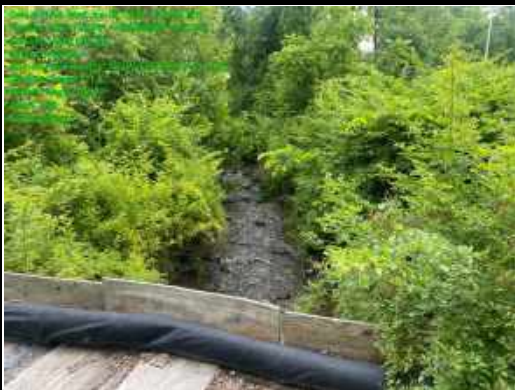
GPS Location		0		GPS Location		0		GPS Location		0					
Field Station#		13198+00		Field Station#		13260+66		Field Station#		13260+66					
Pic 15 Desc.		ROW and ECDs In good condition and stable				Pic 16 Desc.		MVP-S-II4 and corresponding buffer zone in good condition

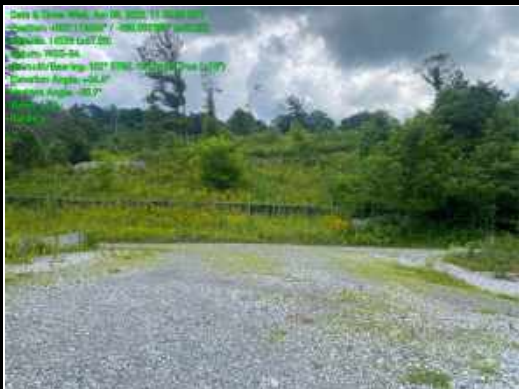
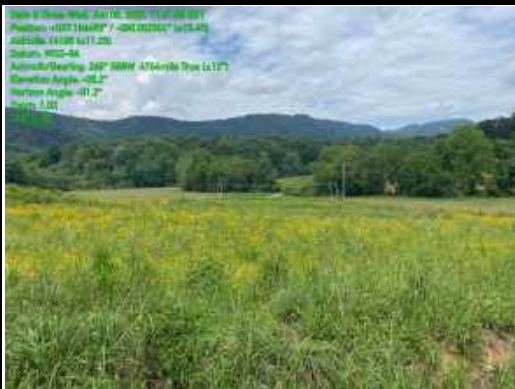
GPS Location		0		GPS Location		0		GPS Location		0					
Field Station#		13262+62		Field Station#		13314+00		Field Station#		13314+00					
Pic 17 Desc.		Flanders Road Crossing in good condition				Pic 18 Desc.		ROW and ECDs In good condition and stable

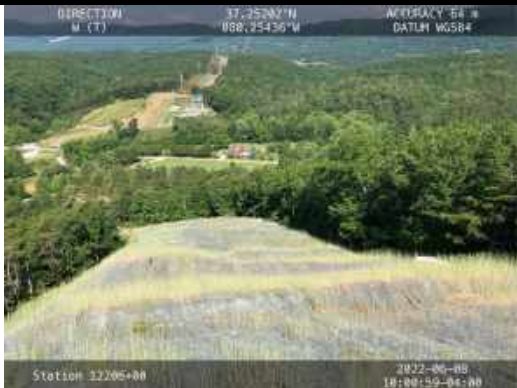
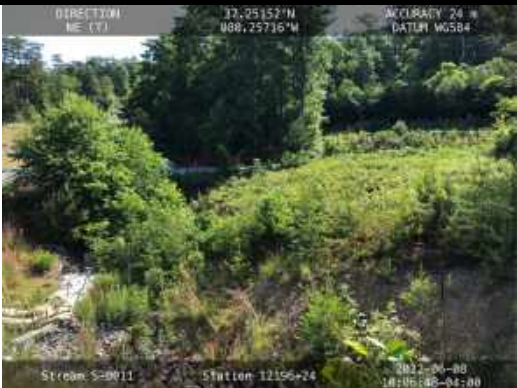
<b>GPS Location</b>	Please see photo for details.		<b>GPS Location</b>	Please see photo for details.	
<b>Field Station#</b>	12206+00		<b>Field Station#</b>	12196+24	
<b>Pic 9 Desc.</b>	Photo shows the stabilized ROW conditions with water bars and that all ECDs are installed and are functioning as designed.		<b>Pic 10 Desc.</b>	Photo shows overview of Stream S-0011 and its buffer zone.

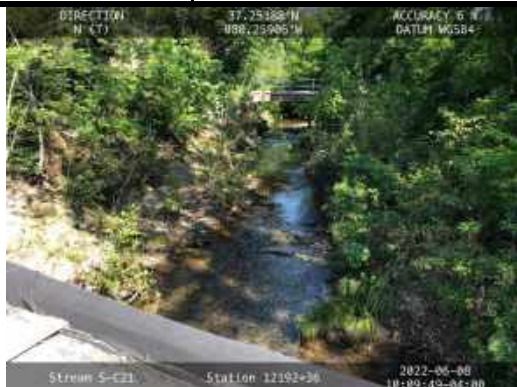
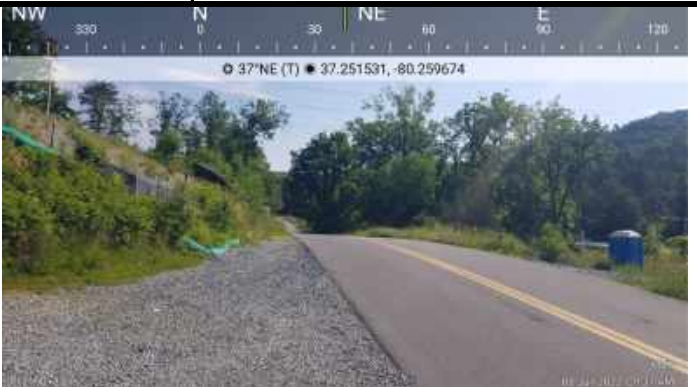
<b>GPS Location</b>	Please see photo for details.		<b>GPS Location</b>	Please see photo for details.	
<b>Field Station#</b>	12192+36		<b>Field Station#</b>	12190+85	
<b>Pic 11 Desc.</b>	Photo shows upstream view of Stream S-C21 from the equipment bridge spanning the Stream channel.		<b>Pic 12 Desc.</b>	Photo shows ST RTE 629 BRADSHAW ROAD.

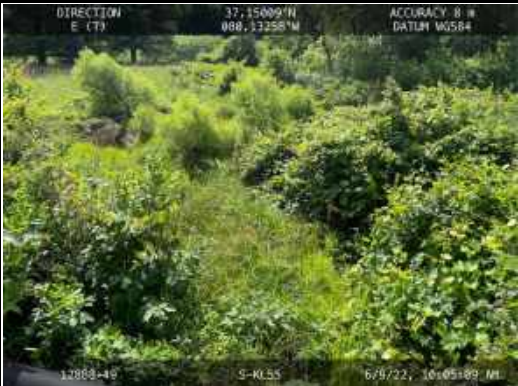
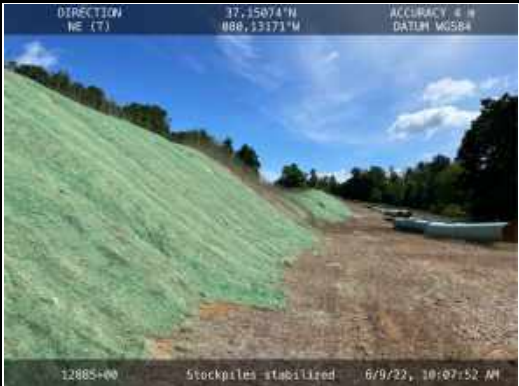
<b>GPS Location</b>	See photo		<b>GPS Location</b>	See photo	
<b>Field Station#</b>	12888+49		<b>Field Station#</b>	12885+00	
<b>Pic 15 Desc.</b>	Downstream of crossing at Stream S-KL55		<b>Pic 16 Desc.</b>	Stockpiles are well stabilized

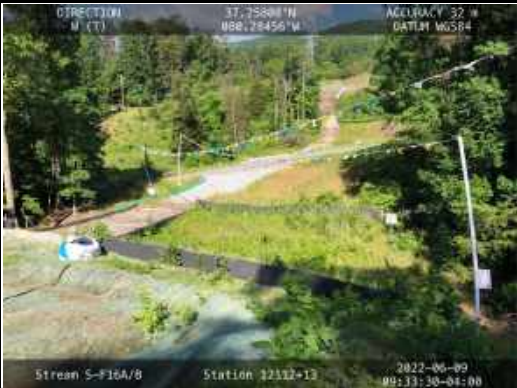
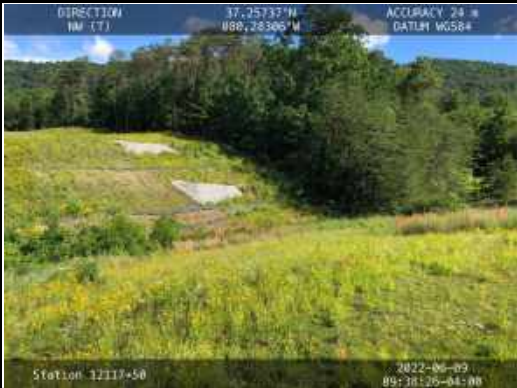
<b>GPS Location</b>	Please see photo for details.		<b>GPS Location</b>	Please see photo for details.	
<b>Field Station#</b>	12112+13		<b>Field Station#</b>	12117+50	
<b>Pic 15 Desc.</b>	Photo shows overview of Stream S-F16A/B and its buffer zone from the going away side.		<b>Pic 16 Desc.</b>	Photo shows stabilized permanent restoration area of the ROW with permanent slope breakers equipped with level spreaders.

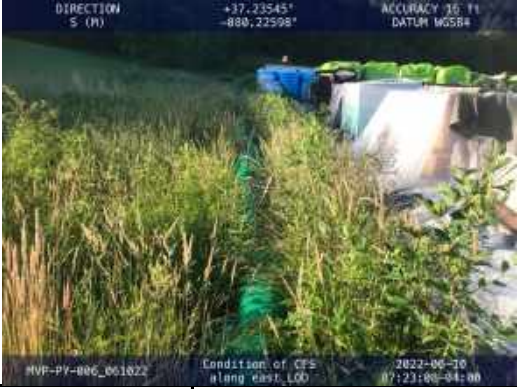
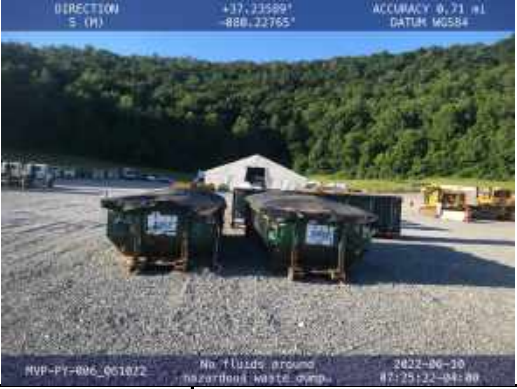
<b>GPS Location</b>	MVP-PY-006 See photo for gps data		<b>GPS Location</b>	MVP-PY-006 See photo for gps data	
<b>Field Station#</b>	+0		<b>Field Station#</b>	+0	
<b>Pic 13 Desc.</b>	Condition of compost filter sock along east LOD. Looking S.		<b>Pic 14 Desc.</b>	No deposits or fluids around hazardous waste dumpsters. Looking S.

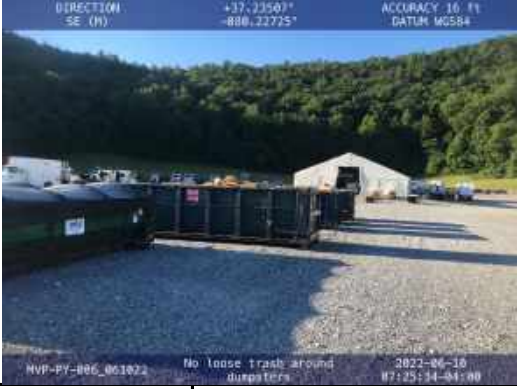
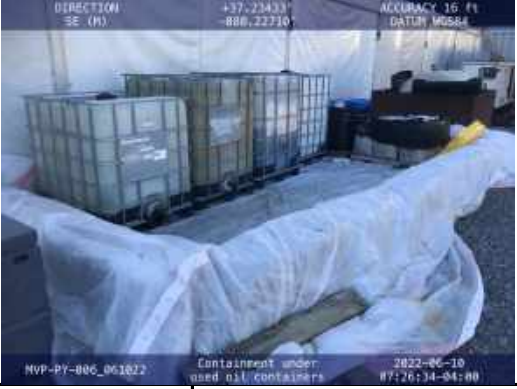
<b>GPS Location</b>	MVP-PY-006 See photo for gps data		<b>GPS Location</b>	MVP-PY-006 See photo for gps data	
<b>Field Station#</b>	+0		<b>Field Station#</b>	+0	
<b>Pic 15 Desc.</b>	No loose trash around dumpsters or in the yard. Looking SE.		<b>Pic 16 Desc.</b>	Secondary containment under used oil containers. Free of fluids. Looking SE.

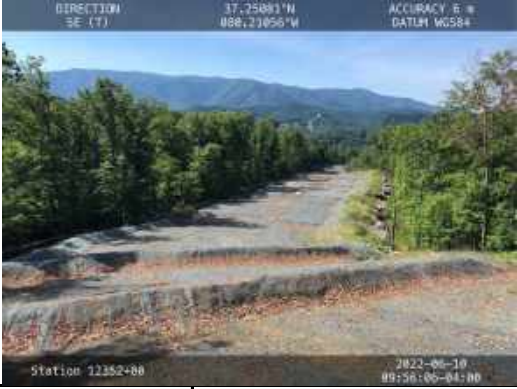
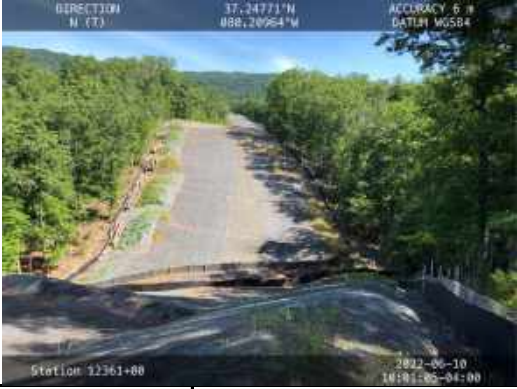
<b>GPS Location</b>	Please see photo for details.		<b>GPS Location</b>	Please see photo for details.	
<b>Field Station#</b>	12352+00		<b>Field Station#</b>	12361+00	
<b>Pic 7 Desc.</b>	Photo shows the stabilized ROW conditions with waterbars and that all ECDs are installed and are functioning as designed.		<b>Pic 8 Desc.</b>	Photo shows the stabilized ROW conditions with waterbars and that all ECDs are installed and are functioning as designed.

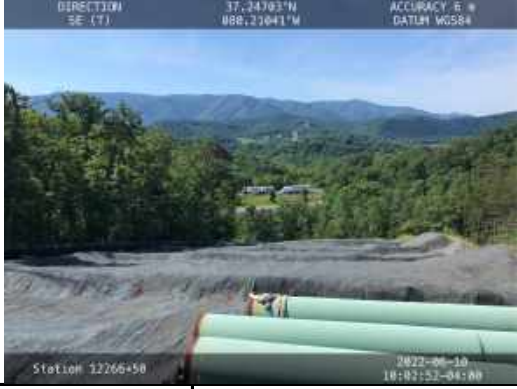
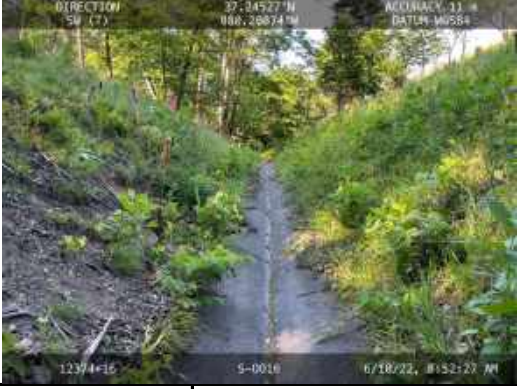
<b>GPS Location</b>	Please see photo for details.		<b>GPS Location</b>	Please see photo for details.	
<b>Field Station#</b>	12366+50		<b>Field Station#</b>	12374+16	
<b>Pic 9 Desc.</b>	Photo shows the stabilized ROW conditions with waterbars and that all ECDs are installed and are functioning as designed.		<b>Pic 10 Desc.</b>	Photo shows upstream view of Stream S-0016.

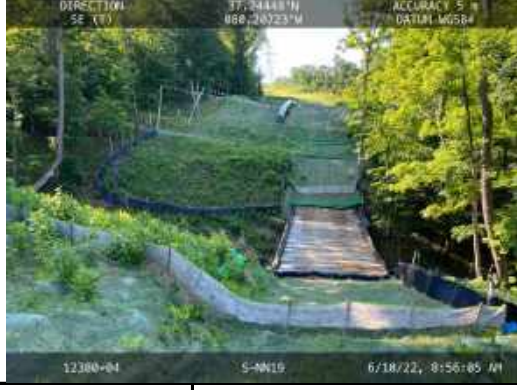
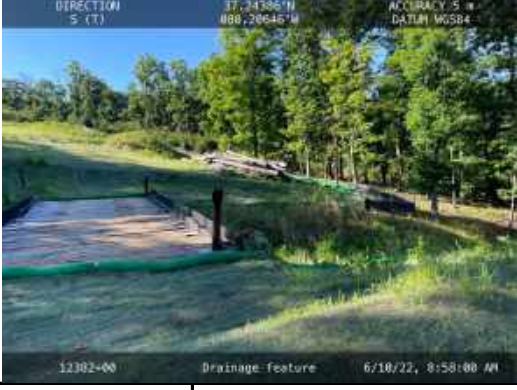
<b>GPS Location</b>	Please see photo for details.		<b>GPS Location</b>	Please see photo for details.	
<b>Field Station#</b>	12380+04		<b>Field Station#</b>	12382+00	
<b>Pic 11 Desc.</b>	Photo shows overview of Stream S-NN19 and its buffer zone from the coming in side.		<b>Pic 12 Desc.</b>	Photo shows stabilized ROW conditions along with equipment bridge spanning drainage feature.
